**The Road Inventory  
of  
Point Reyes National Seashore  
PORE – 8530**

**Road Inventory Program**

Prepared By:  
Federal Highway Administration  
Eastern Federal Lands Highway Division  
Cycle 3

# Point Reyes National Seashore in California

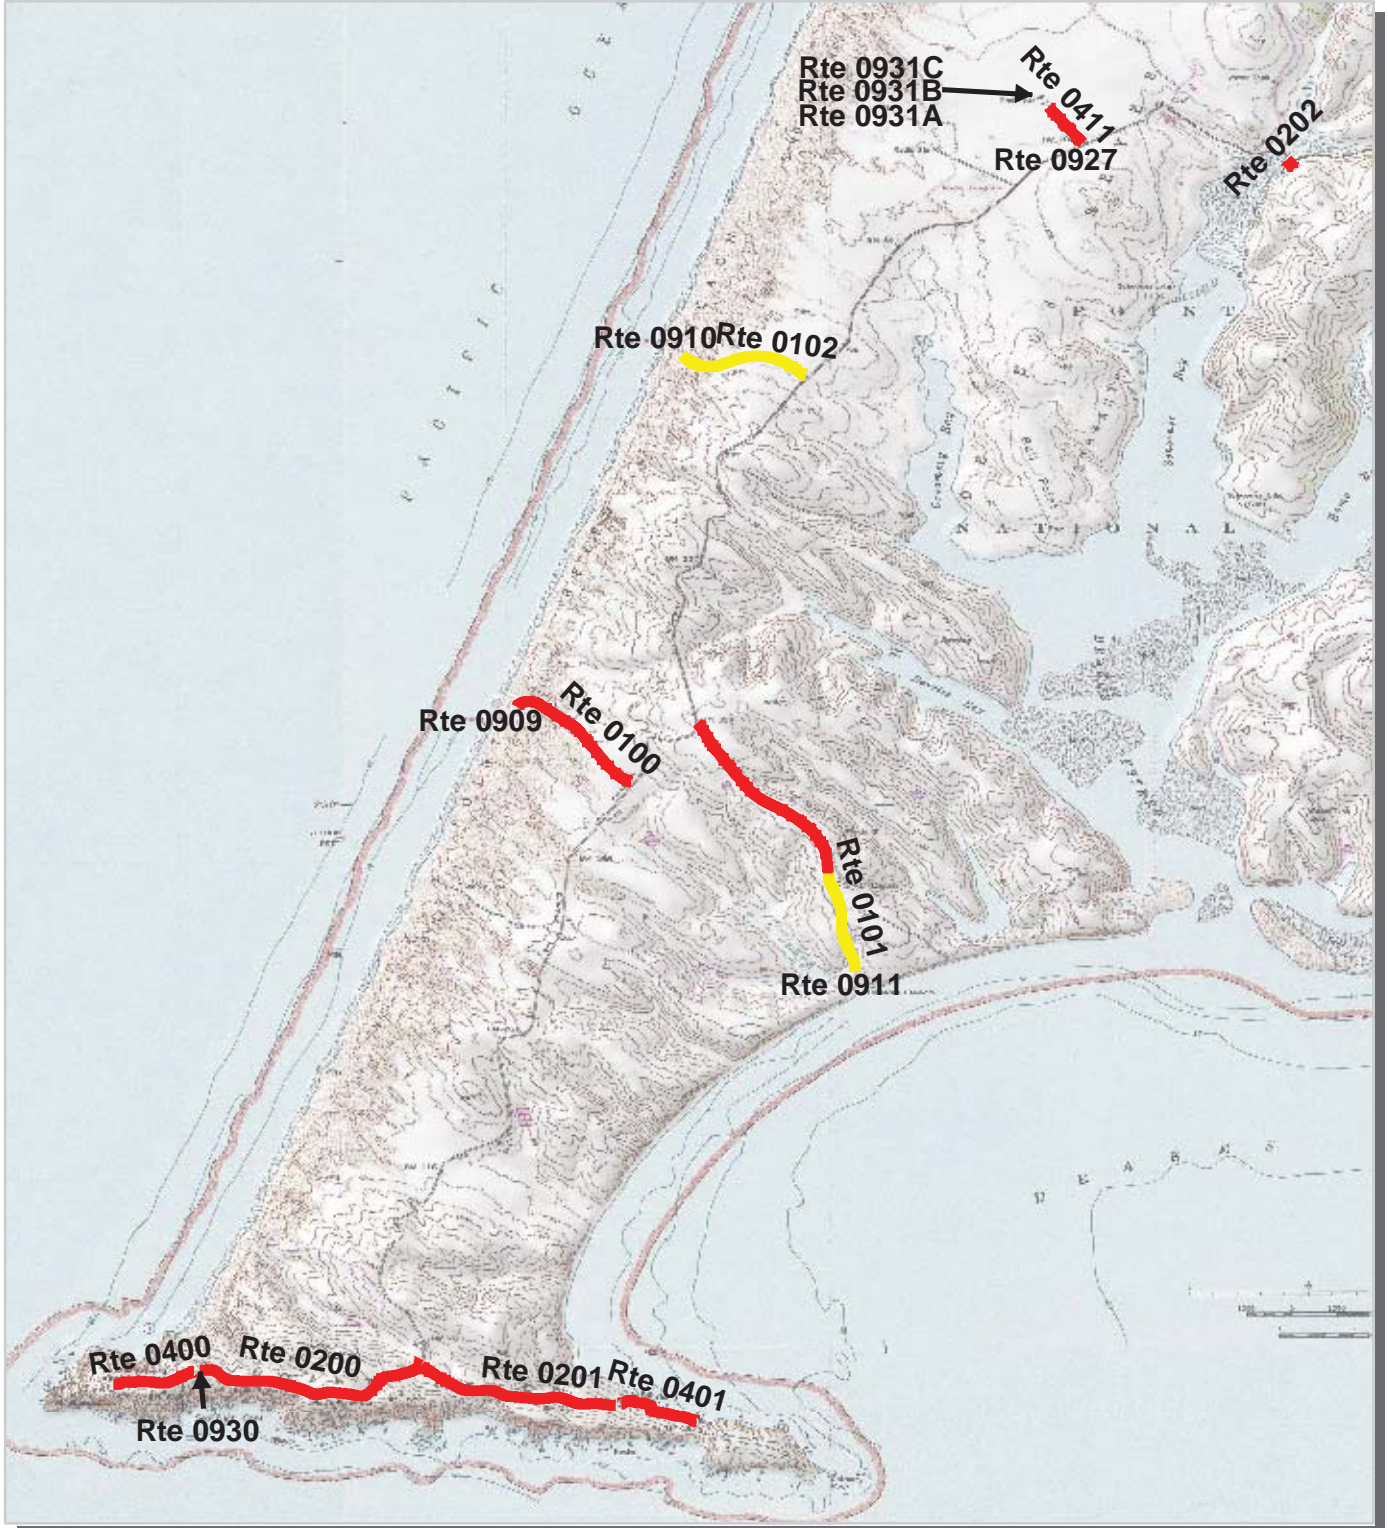
# Point Reyes National Seashore Route Condition Area Map 2 PCR - Mile by Mile

PCR	Poor	<span style="background-color: red; width: 20px; height: 10px; display: inline-block;"></span>	Fair	<span style="background-color: yellow; width: 20px; height: 10px; display: inline-block;"></span>	Good	<span style="background-color: green; width: 20px; height: 10px; display: inline-block;"></span>	Excellent	<span style="background-color: blue; width: 20px; height: 10px; display: inline-block;"></span>
		(<=60)		(61 - 84)		(85 - 94)		(95 - 100)

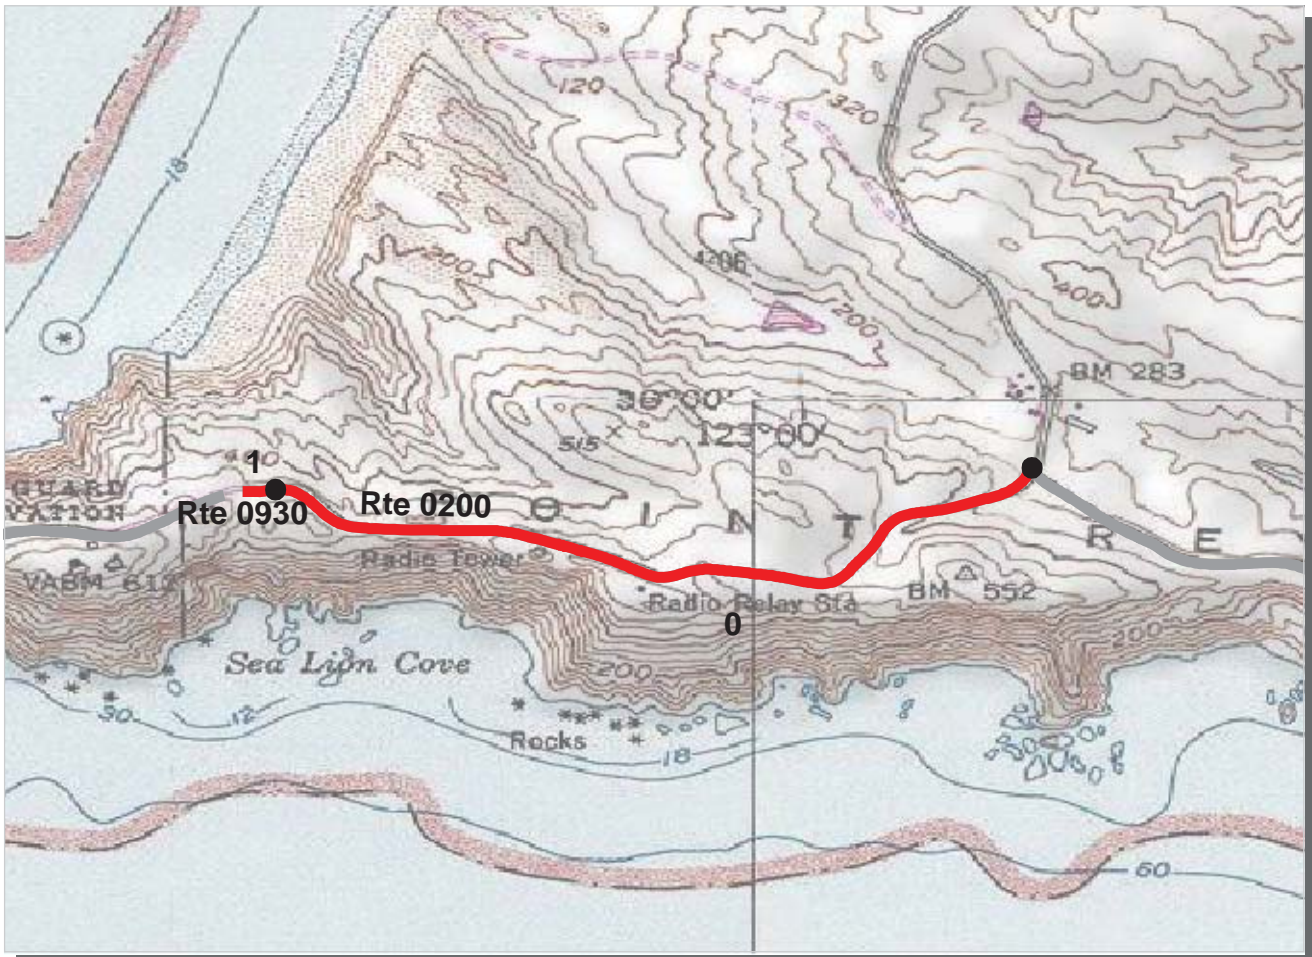
**ROUTE: 0102 NORTH BEACH ROAD**

Section Number	0				
Section Length (mi)	0.60				
AADT	**				
SADT	**				
ADT Date	**				
<b>Cross Section Information</b>					
Number of Lanes	2				
Paved Width (ft)	22				
Lane Width (ft)	11				
Shoulder Width (ft)	2				
<b>Roadway Condition Information</b>					
PCR (Pavement Condition Rating)	74				
RCI (Roughness Condition Index)	98				
SCR (Surface Condition Rating)	62				
Alligator Cracking Index	100				
Rutting Index	62				
Patching Index	100				
Transverse Cracking Index	99				
Longitudinal Cracking Index	99				
Shoulder Condition Rating	GOOD				
Drainage Condition Rating	GOOD

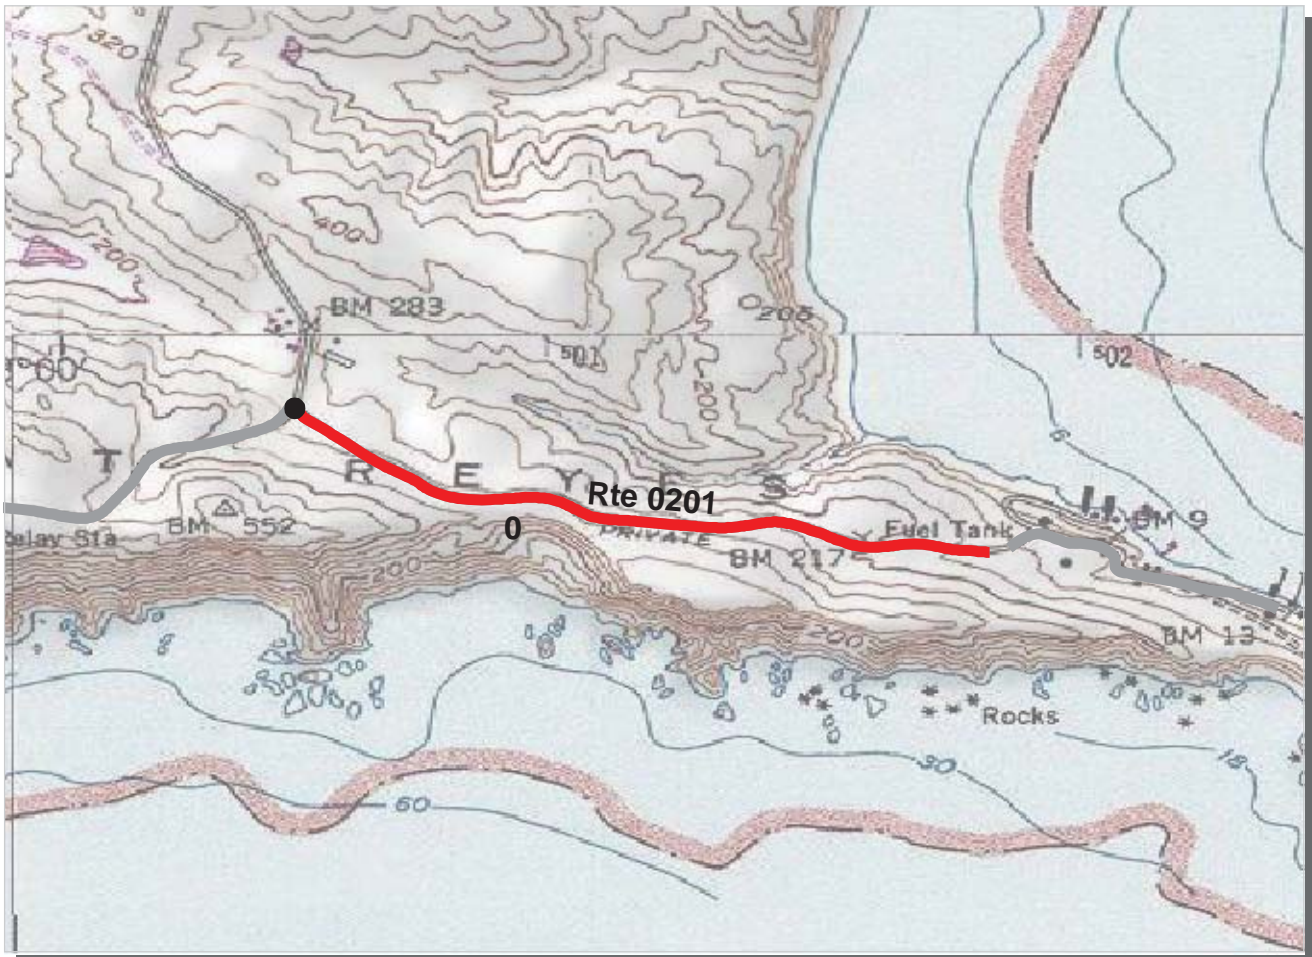
**ROUTE: 0200 LIGHTHOUSE ROAD**

Section Number	0	1			
Section Length (mi)	1.00	0.05			
AADT	**				
SADT	**				
ADT Date	**				
<b>Cross Section Information</b>					
Number of Lanes	2	2			
Paved Width (ft)	19	19			
Lane Width (ft)	8	9			
Shoulder Width (ft)	0	6			
<b>Roadway Condition Information</b>					
PCR (Pavement Condition Rating)	31	46			
RCI (Roughness Condition Index)	43	-1			
SCR (Surface Condition Rating)	28	46			
Alligator Cracking Index	82	95			
Rutting Index	36	58			
Patching Index	98	93			
Transverse Cracking Index	99	100			
Longitudinal Cracking Index	99	99			
Shoulder Condition Rating	N/A	N/C			
Drainage Condition Rating	GOOD	GOOD

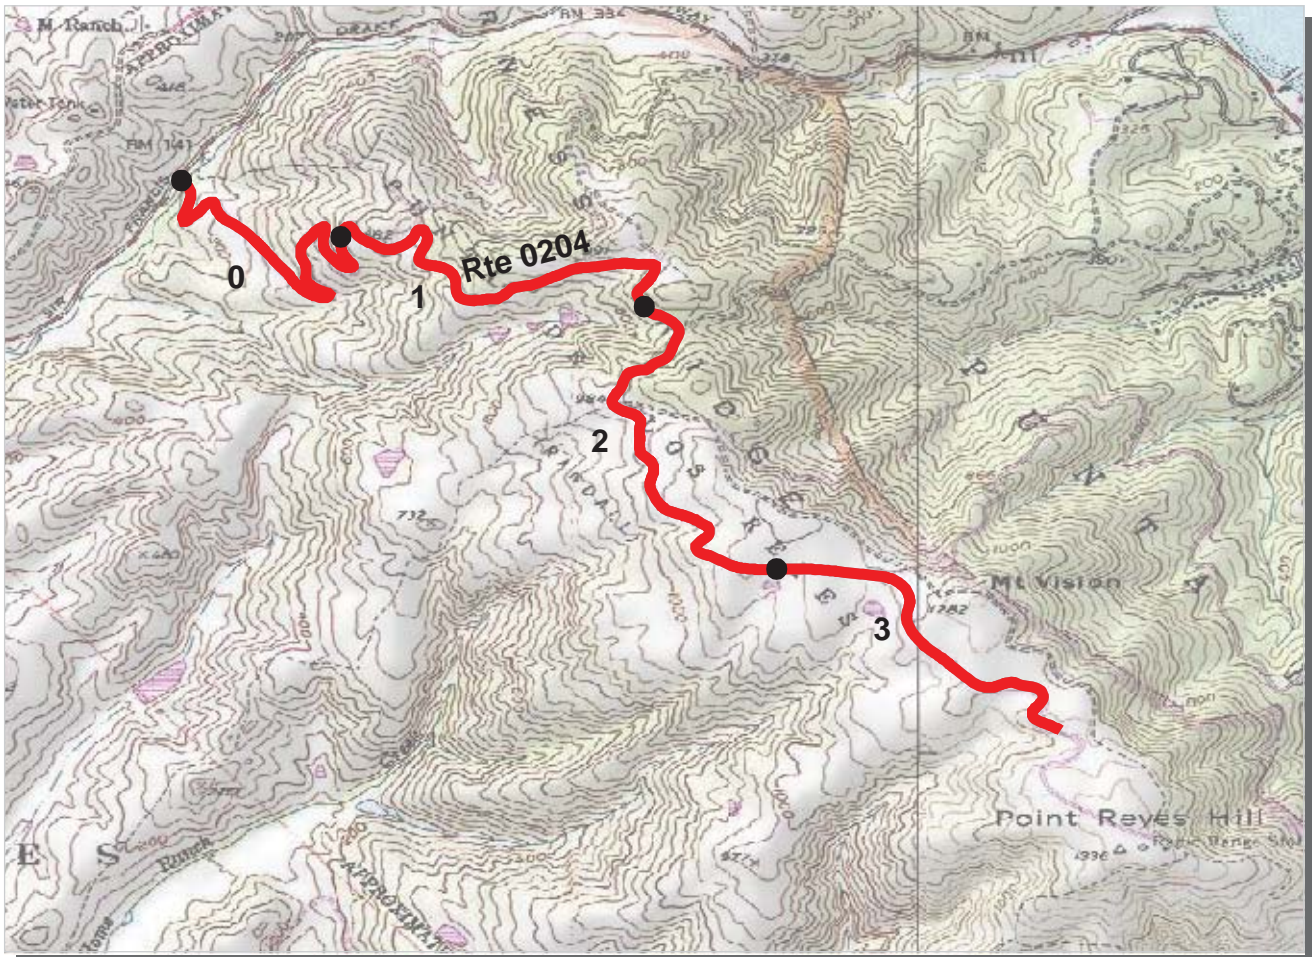
**ROUTE: 0203 ESTERO TRAILHEAD ROAD**

Section Number	0				
Section Length (mi)	0.97				
AADT	**				
SADT	**				
ADT Date	**				
<b>Cross Section Information</b>					
Number of Lanes	1				
Paved Width (ft)	8				
Lane Width (ft)	8				
Shoulder Width (ft)	0				
<b>Roadway Condition Information</b>					
PCR (Pavement Condition Rating)	22				
RCI (Roughness Condition Index)	28				
SCR (Surface Condition Rating)	24				
Alligator Cracking Index	71				
Rutting Index	47				
Patching Index	98				
Transverse Cracking Index	99				
Longitudinal Cracking Index	98				
Shoulder Condition Rating	N/A				
Drainage Condition Rating	GOOD

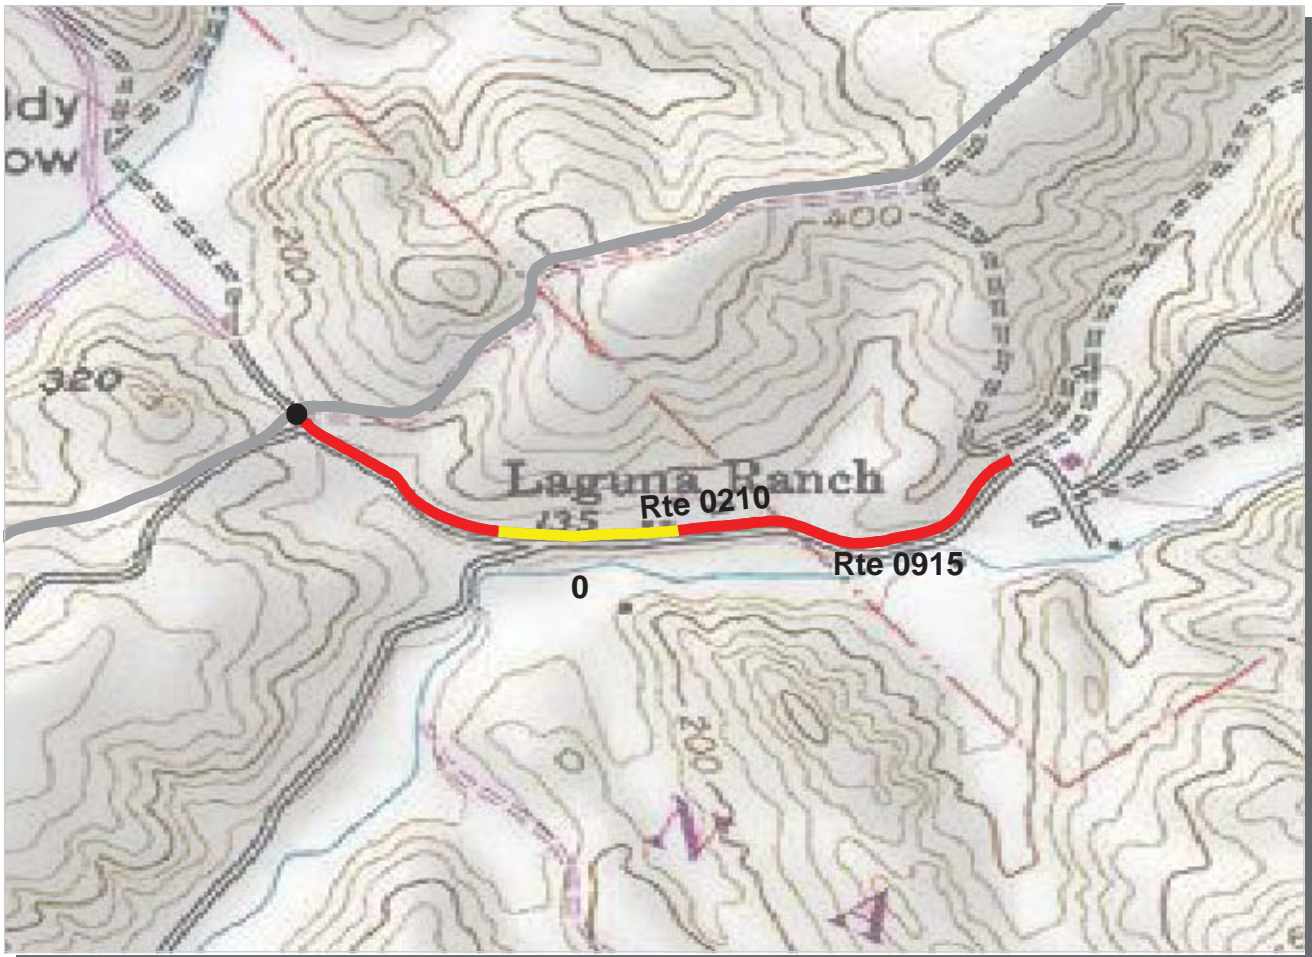
ROUTE: 0206 LIMANTOUR BEACH TRAIL ACCESS ROAD

Section Number	0				
Section Length (mi)	0.37				
AADT	**				
SADT	**				
ADT Date	**				
<b>Cross Section Information</b>					
Number of Lanes	2				
Paved Width (ft)	19				
Lane Width (ft)	9				
Shoulder Width (ft)	0				
<b>Roadway Condition Information</b>					
PCR (Pavement Condition Rating)	42				
RCI (Roughness Condition Index)	55				
SCR (Surface Condition Rating)	34				
Alligator Cracking Index	94				
Rutting Index	52				
Patching Index	99				
Transverse Cracking Index	98				
Longitudinal Cracking Index	89				
Shoulder Condition Rating	N/A				
Drainage Condition Rating	GOOD

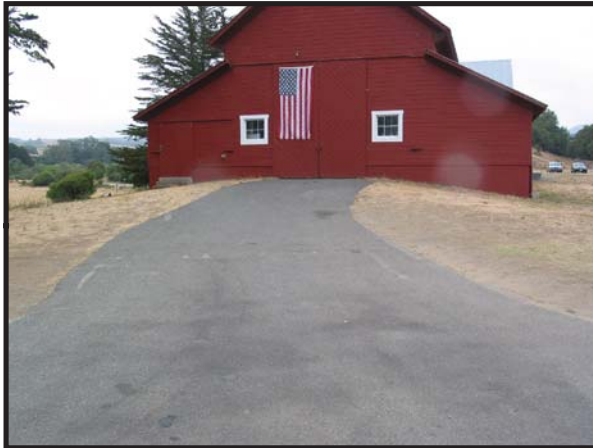
## Route 0403

Route	Length (mi)	Width (ft)	Area (sq ft)	Lane Miles *	Condition / PCR	Surface Type
0403	0.01	0.00	1620	0.03	GOOD / 90	AS

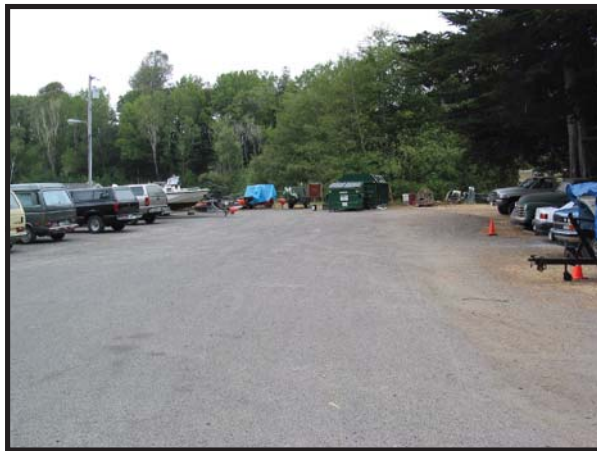
**Point Reyes National Seashore**  
**Route 0902A**  
 BEAR VALLEY MAINTENANCE AREA "A"  
 Adjacent to Route 0410 on Right

Route	Public / NonPublic	Date Visited	Area (sq ft)	Lane Miles *	Surface Type	Condition / PCR
0902A	Public	8/29/2002	6857	0.12	AS	FAIR / 73

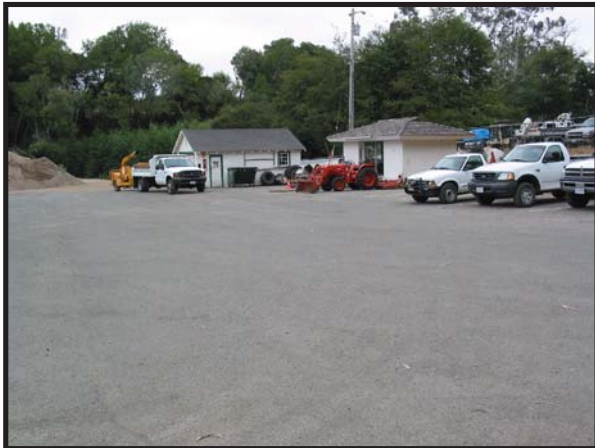
**Point Reyes National Seashore**  
**Route 0902B**  
BEAR VALLEY MAINTENANCE AREA "B"  
At End of Route 0410

Route	Public / NonPublic	Date Visited	Area (sq ft)	Lane Miles *	Surface Type	Condition / PCR
0902B	NonPublic	8/29/2002	22419	0.39	AS	FAIR / 73

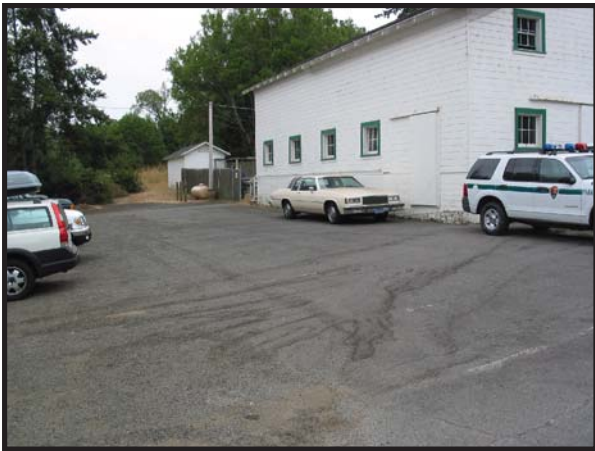
**Point Reyes National Seashore**  
**Route 0903**  
 LIGHTHOUSE RESIDENCE PARKING  
 At End of Route 0400

Route	Public / NonPublic	Date Visited	Area (sq ft)	Lane Miles *	Surface Type	Condition / PCR
0903	NonPublic	8/29/2002	742	0.01	AS	FAIR / 73

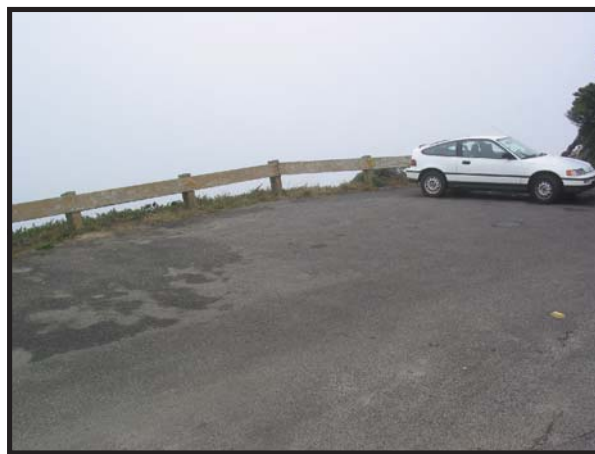
## Route 0904

Route	Public / NonPublic	Date Visited	Area (sq ft)	Lane Miles *	Surface Type	Condition / PCR
0904	Public	8/29/2002	10134	0.17	OC	GOOD / 90

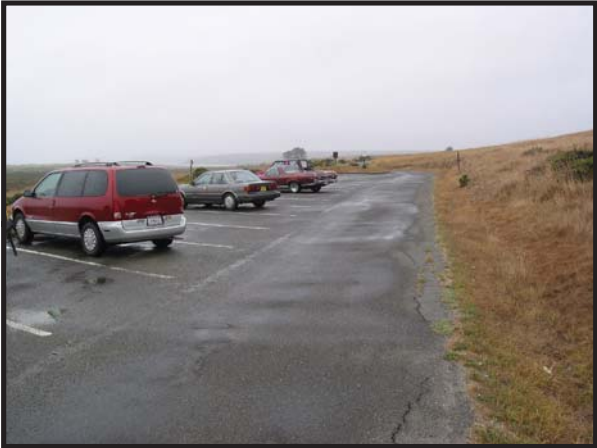
## Route 0905

Route	Public / NonPublic	Date Visited	Area (sq ft)	Lane Miles *	Surface Type	Condition / PCR
0905	NonPublic	8/29/2002	2826	0.05	OC	POOR / 45

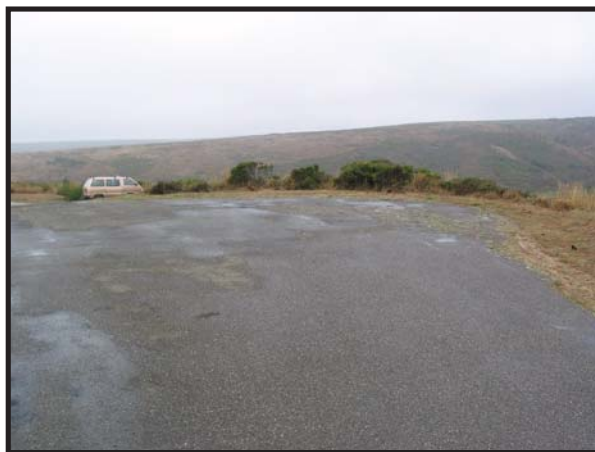
## Route 0909

Route	Public / NonPublic	Date Visited	Area (sq ft)	Lane Miles *	Surface Type	Condition / PCR
0909	Public	8/29/2002	96058	1.65	OC	FAIR / 73

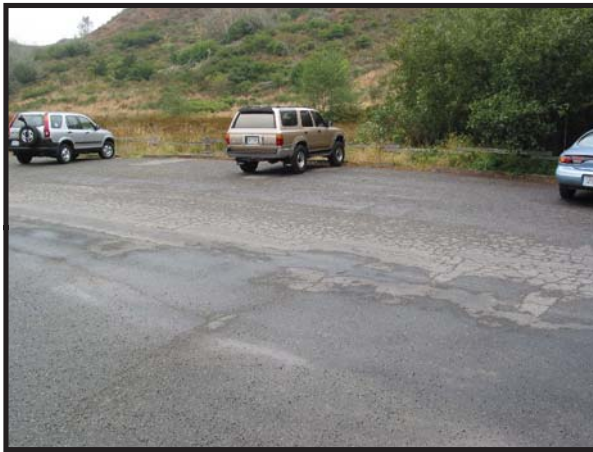
**Point Reyes National Seashore**  
**Route 0925**  
**MORGAN HORSE RANCH HANDICAP PARKING**  
 Adjacent to Route 0408

Route	Public / NonPublic	Date Visited	Area (sq ft)	Lane Miles *	Surface Type	Condition / PCR
0925	Public	8/29/2002	675	0.01	AS	GOOD / 90
