The Road Inventory of Prince William Forest Park PRWI – 3700

Road Inventory Program

Prepared By:
Federal Highway Administration
Eastern Federal Lands Highway Division
Cycle 3

Prince William Forest Park in Virginia

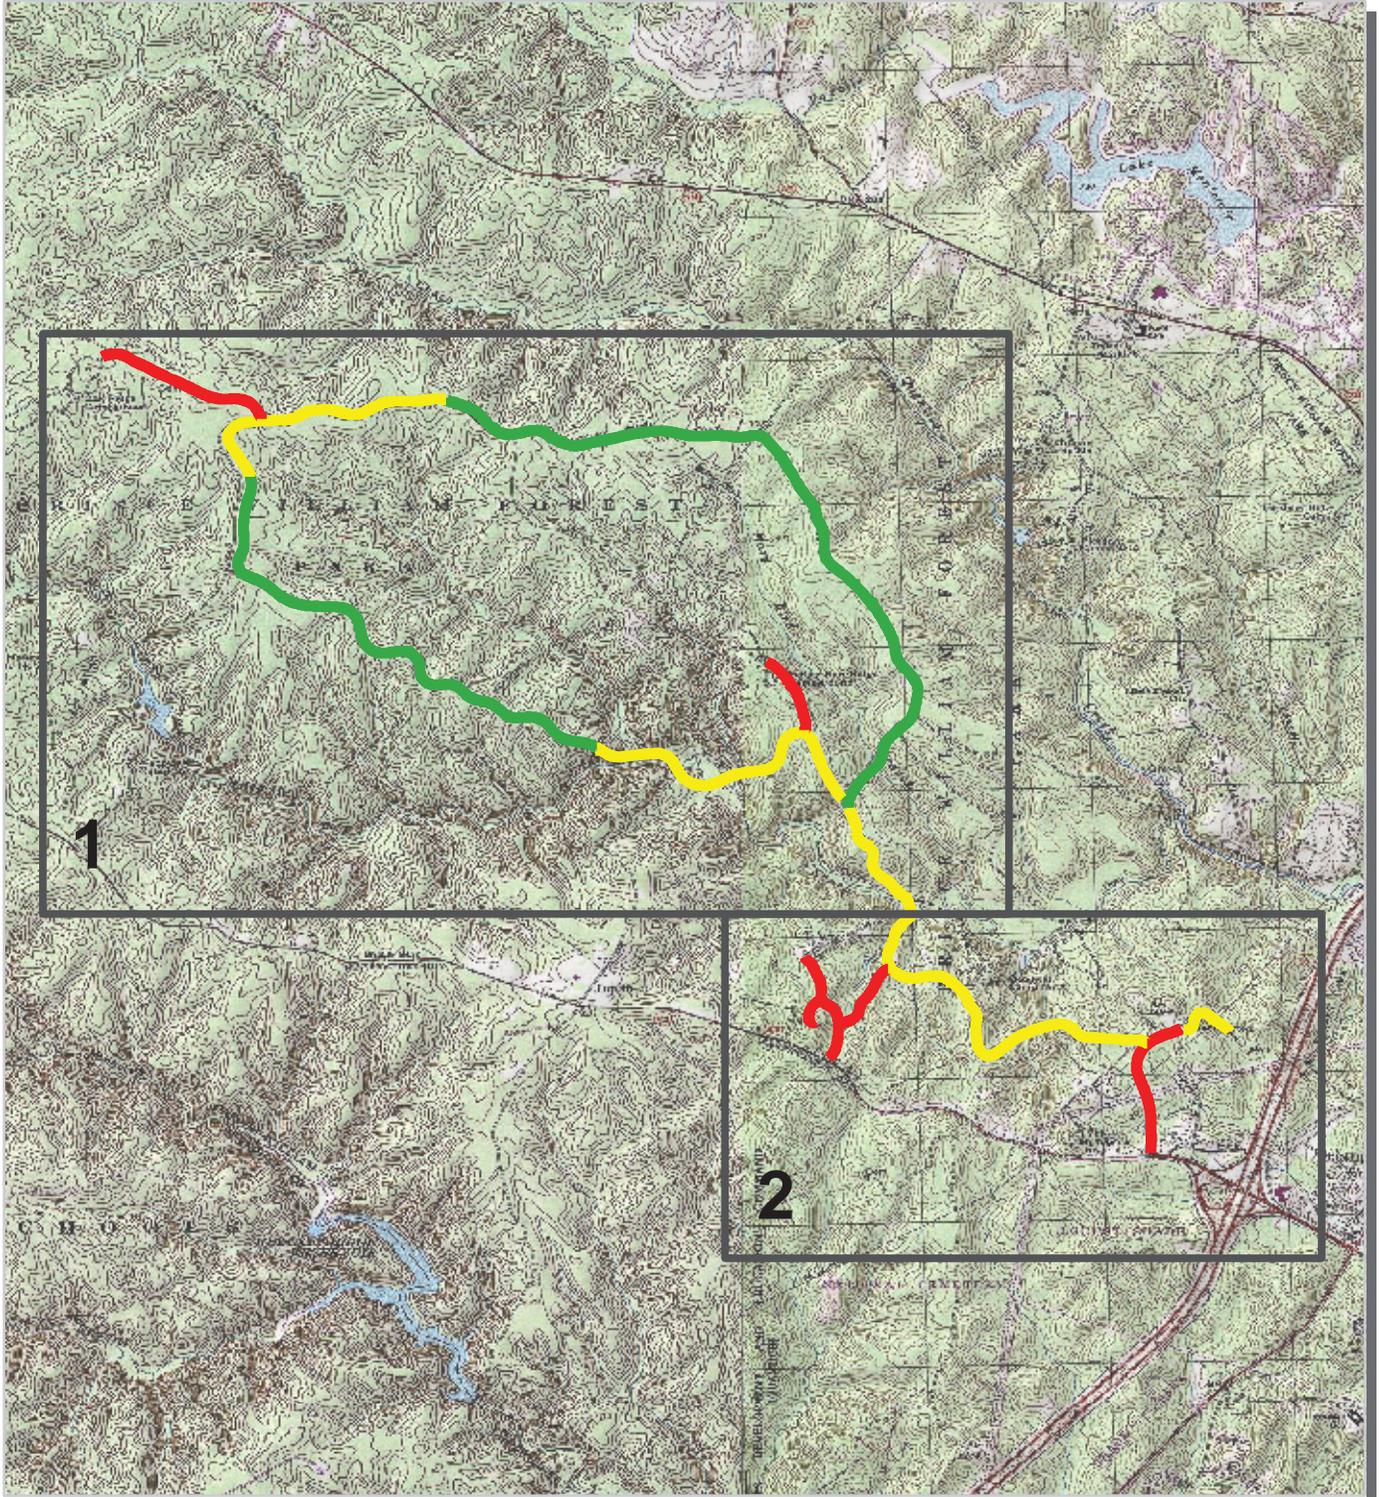
Prince William Forest Park Route Condition Key Map PCR - Mile by Mile

PCR	Poor

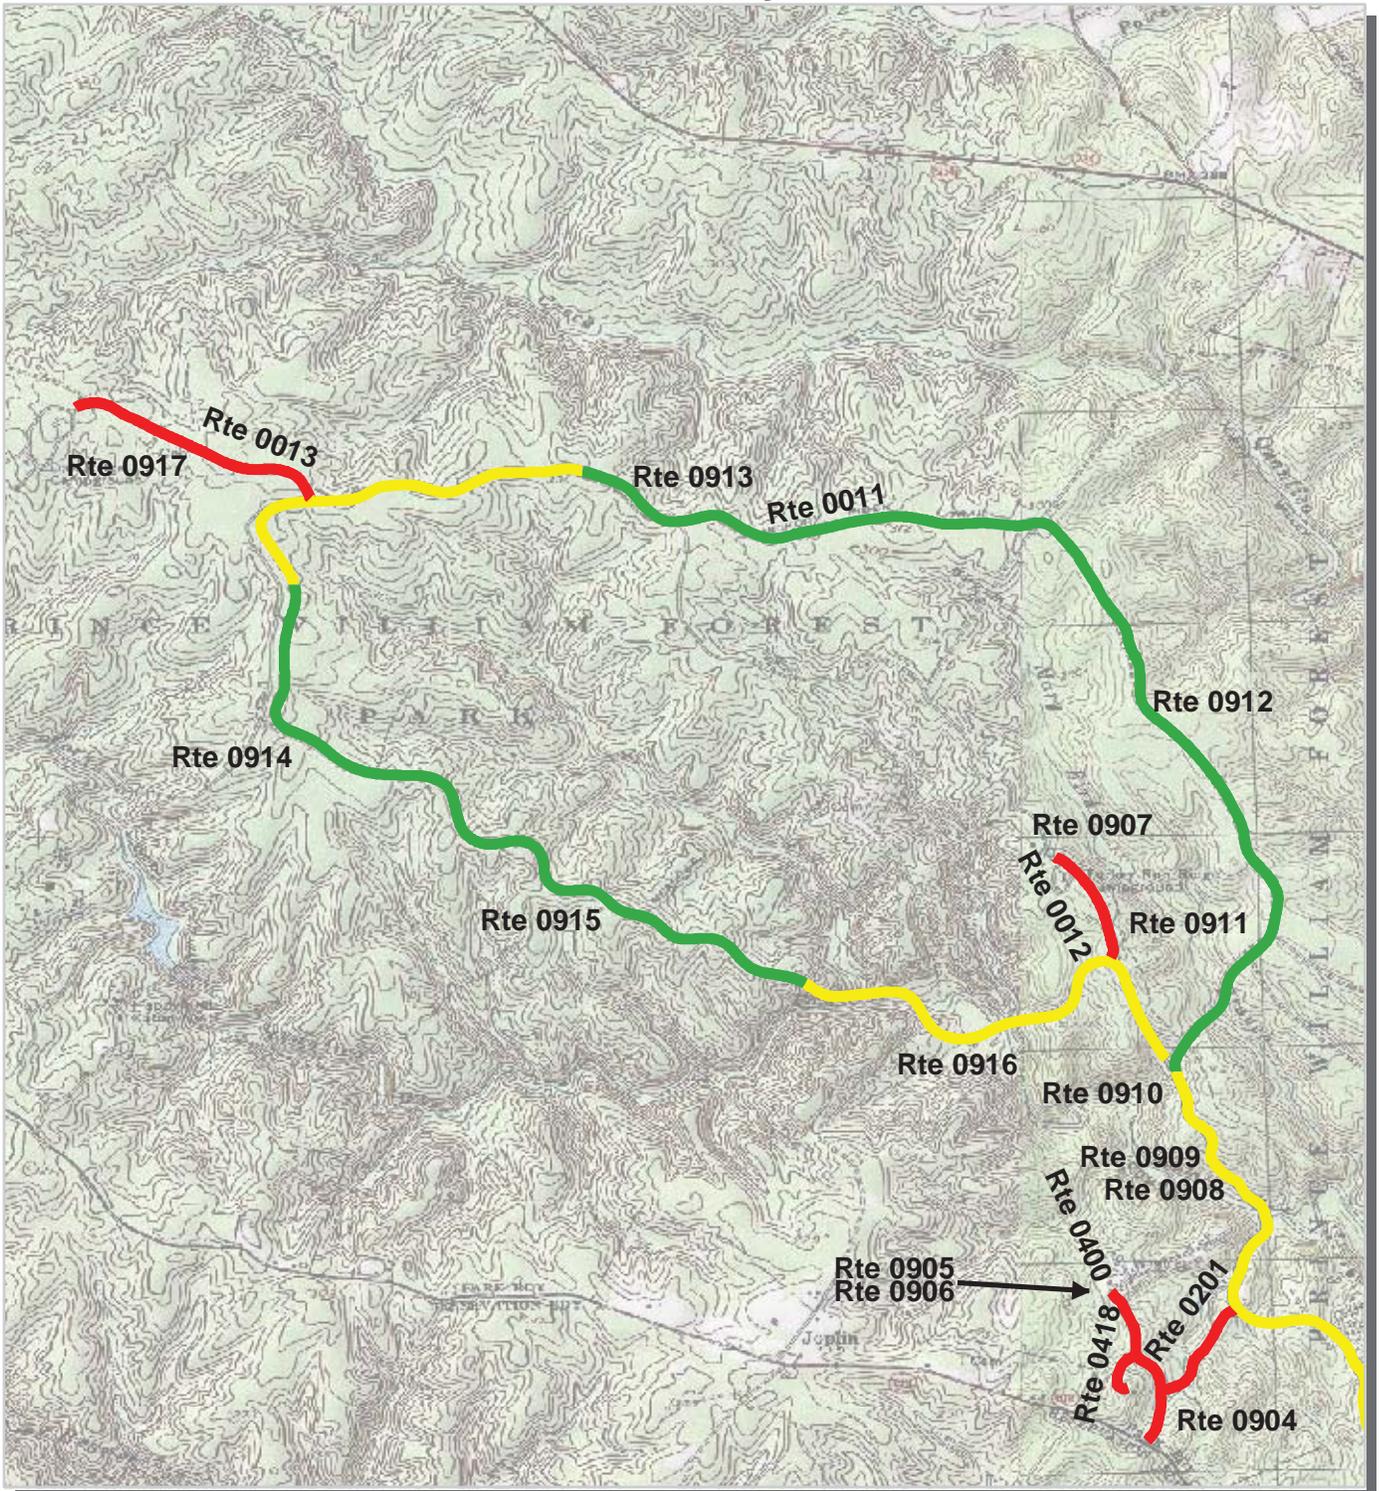
Prince William Forest Park Route Condition Area Map 1 PCR - Mile by Mile

PCR	Poor		Fair		Good		Excellent	
	(<=60)		(61 - 84)		(85 - 94)		(95 - 100)

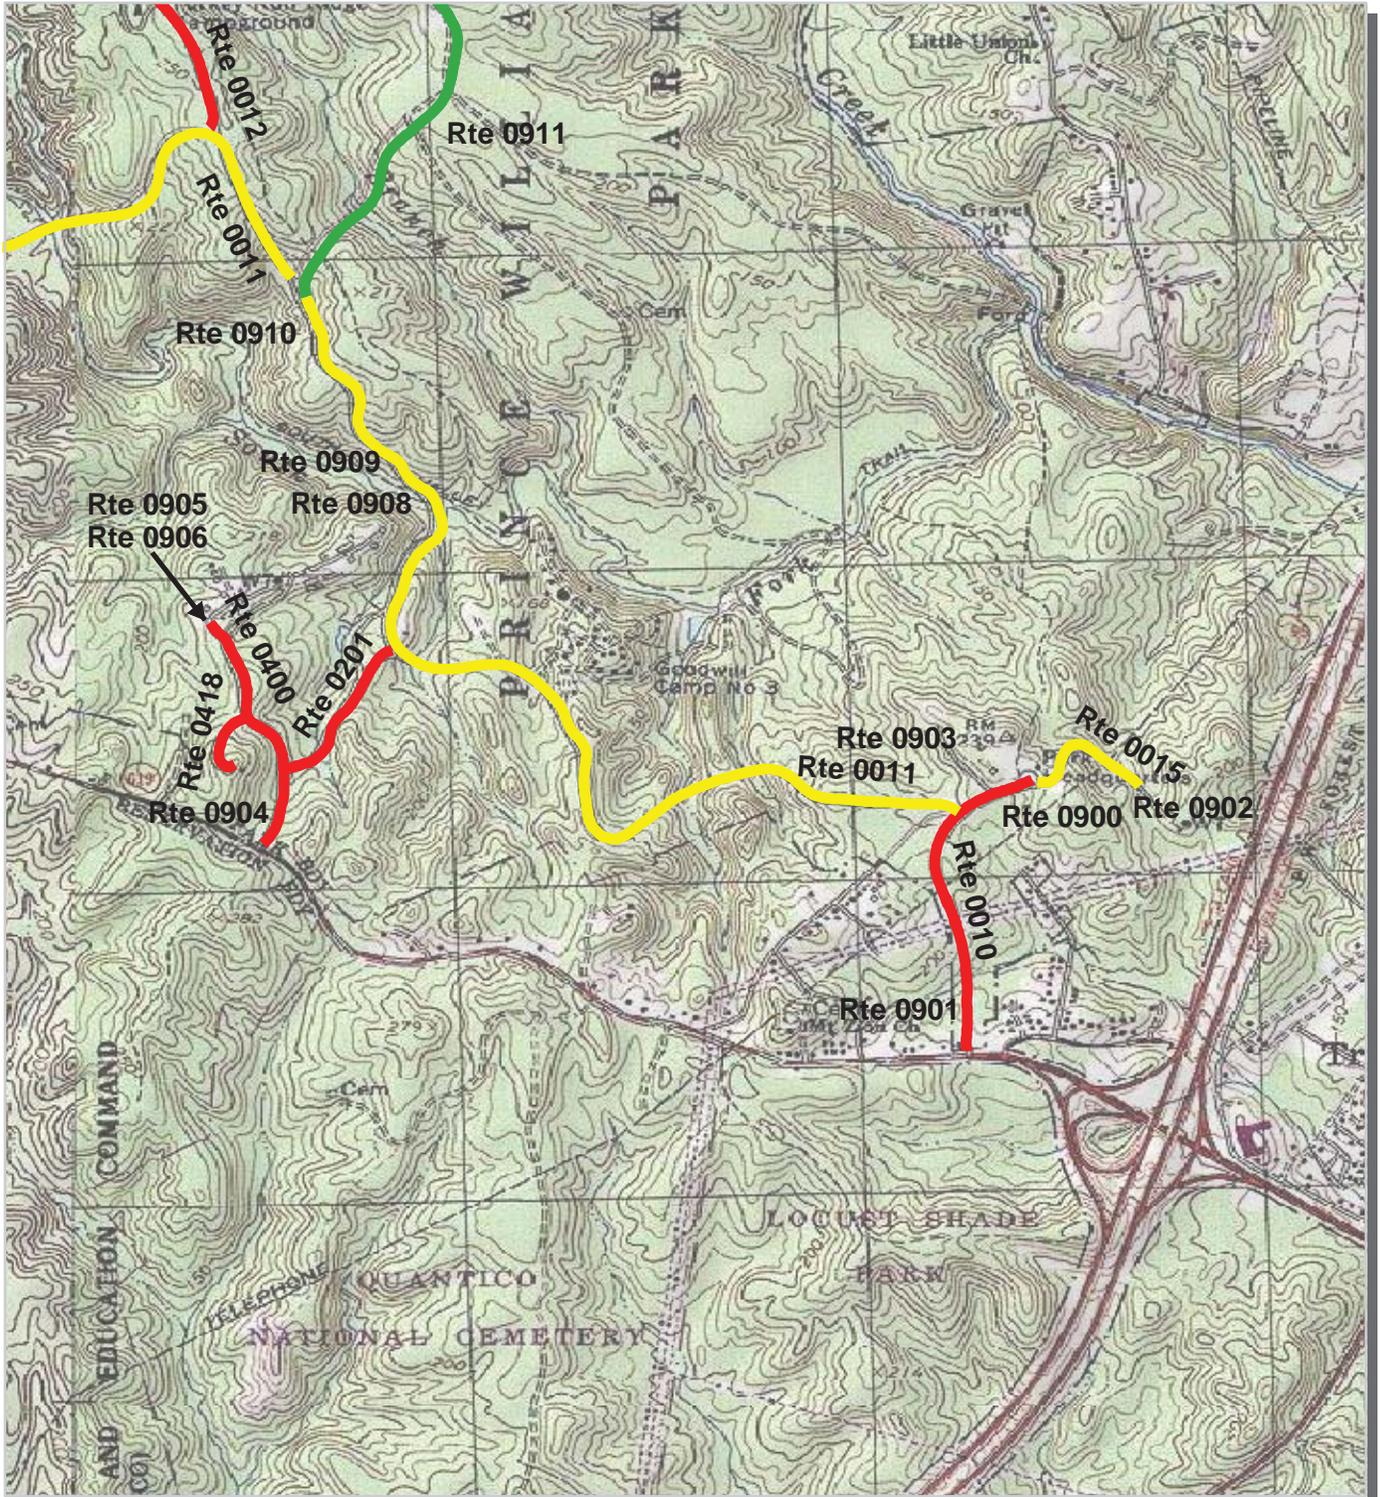
Prince William Forest Park Route Condition Area Map 2 PCR - Mile by Mile

PCR	Poor	Fair	Good	Excellent
	(≤ 60)	(61 - 84)	(85 - 94)	(95 - 100)

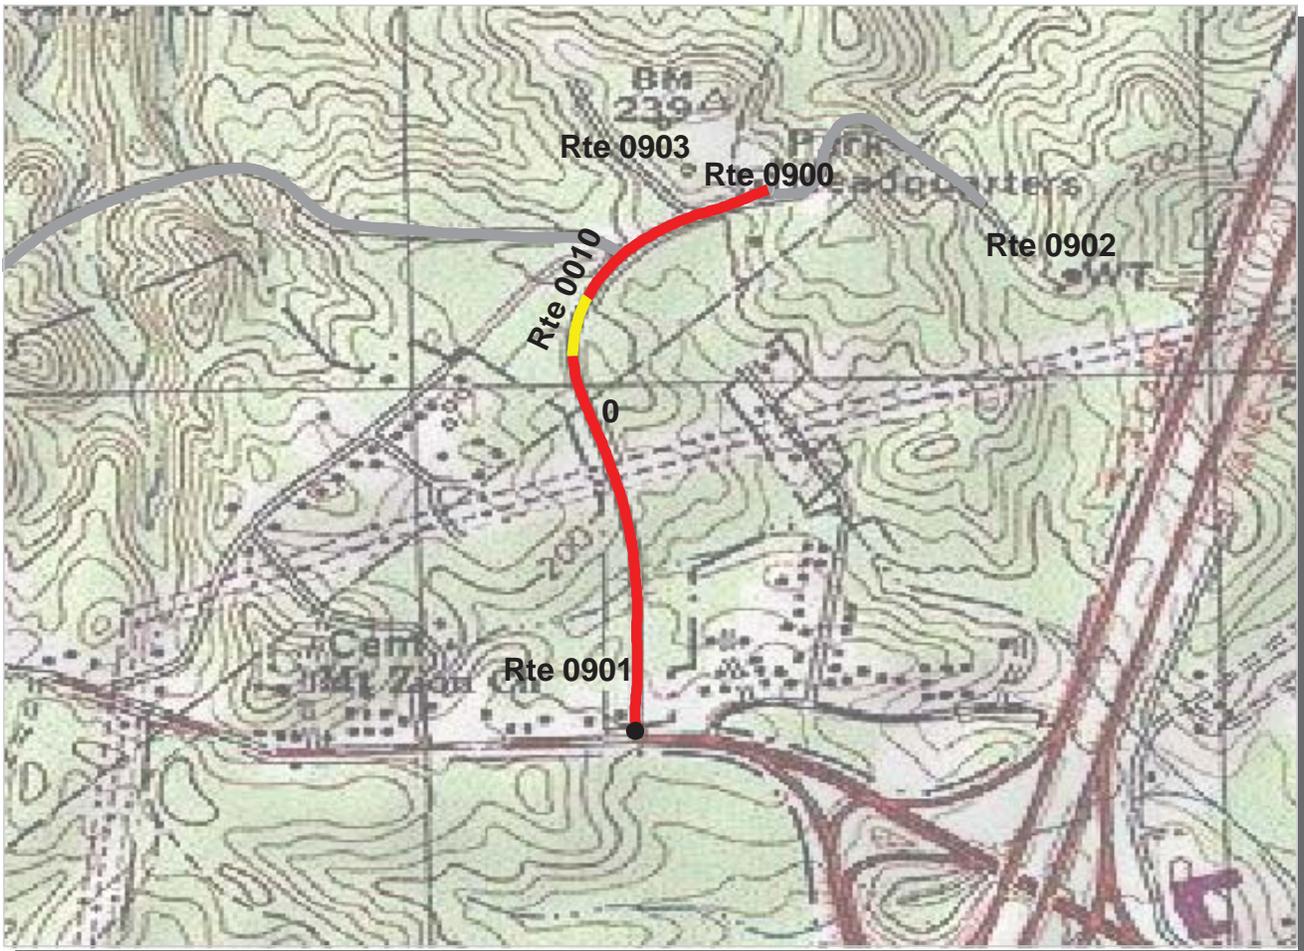
ROUTE: 0010 MAIN ENTRANCE ROAD **TOTAL LENGTH: 0.63 Miles**

Section Number	0				
Section Length (mi)	0.63				
AADT	**				
SADT	**				
ADT Date	**				
Cross Section Information					
Number of Lanes	2				
Paved Width (ft)	20				
Lane Width (ft)	10				
Shoulder Width (ft)	5				
Roadway Condition Information					
PCR (Pavement Condition Rating)	40				
RCI (Roughness Condition Index)	91				
SCR (Surface Condition Rating)	17				
Alligator Cracking Index	44				
Rutting Index	68				
Patching Index	99				
Transverse Cracking Index	90				
Longitudinal Cracking Index	94				
Shoulder Condition Rating	N/C				
Drainage Condition Rating	GOOD

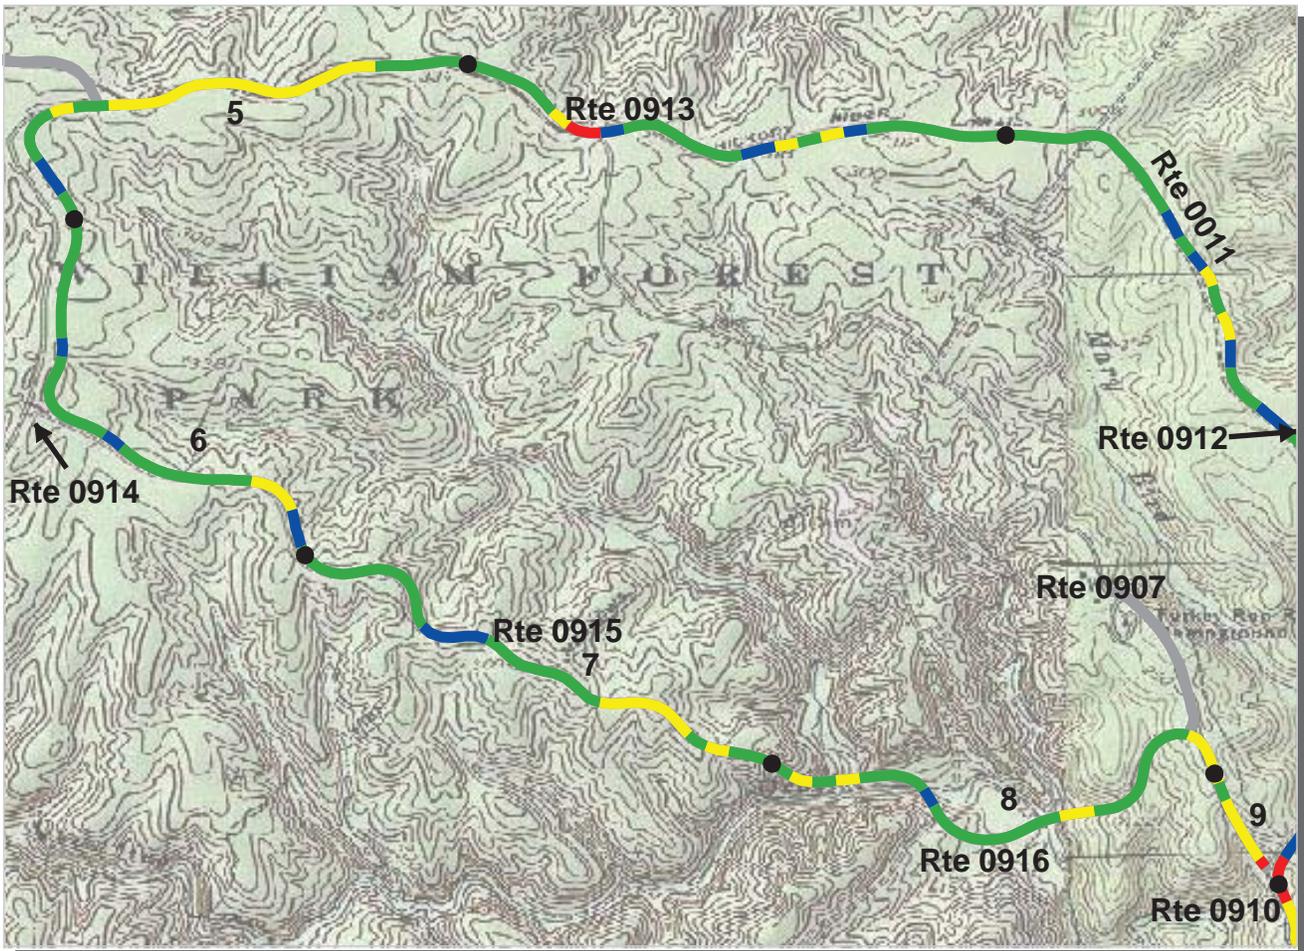
ROUTE: 0011 PARK SCENIC DRIVE TOTAL LENGTH: 9.24 Miles

Section Number	5	6	7	8	9
Section Length (mi)	1.00	1.00	1.00	1.00	0.24
AADT	**				
SADT	**				
ADT Date	**				
Cross Section Information					
Number of Lanes	1	2	2	2	2
Paved Width (ft)	21	21	20	21	22
Lane Width (ft)	10	10	10	11	9
Shoulder Width (ft)	7	5	6	0	0
Roadway Condition Information					
PCR (Pavement Condition Rating)	84	90	88	84	67
RCI (Roughness Condition Index)	92	99	99	92	84
SCR (Surface Condition Rating)	79	84	81	79	61
Alligator Cracking Index	100	100	100	98	94
Rutting Index	82	84	82	81	75
Patching Index	99	100	100	100	100
Transverse Cracking Index	98	99	99	99	96
Longitudinal Cracking Index	99	99	99	99	95
Shoulder Condition Rating	N/C	N/C	N/C	N/A	N/A
Drainage Condition Rating	GOOD	GOOD	GOOD	GOOD	GOOD

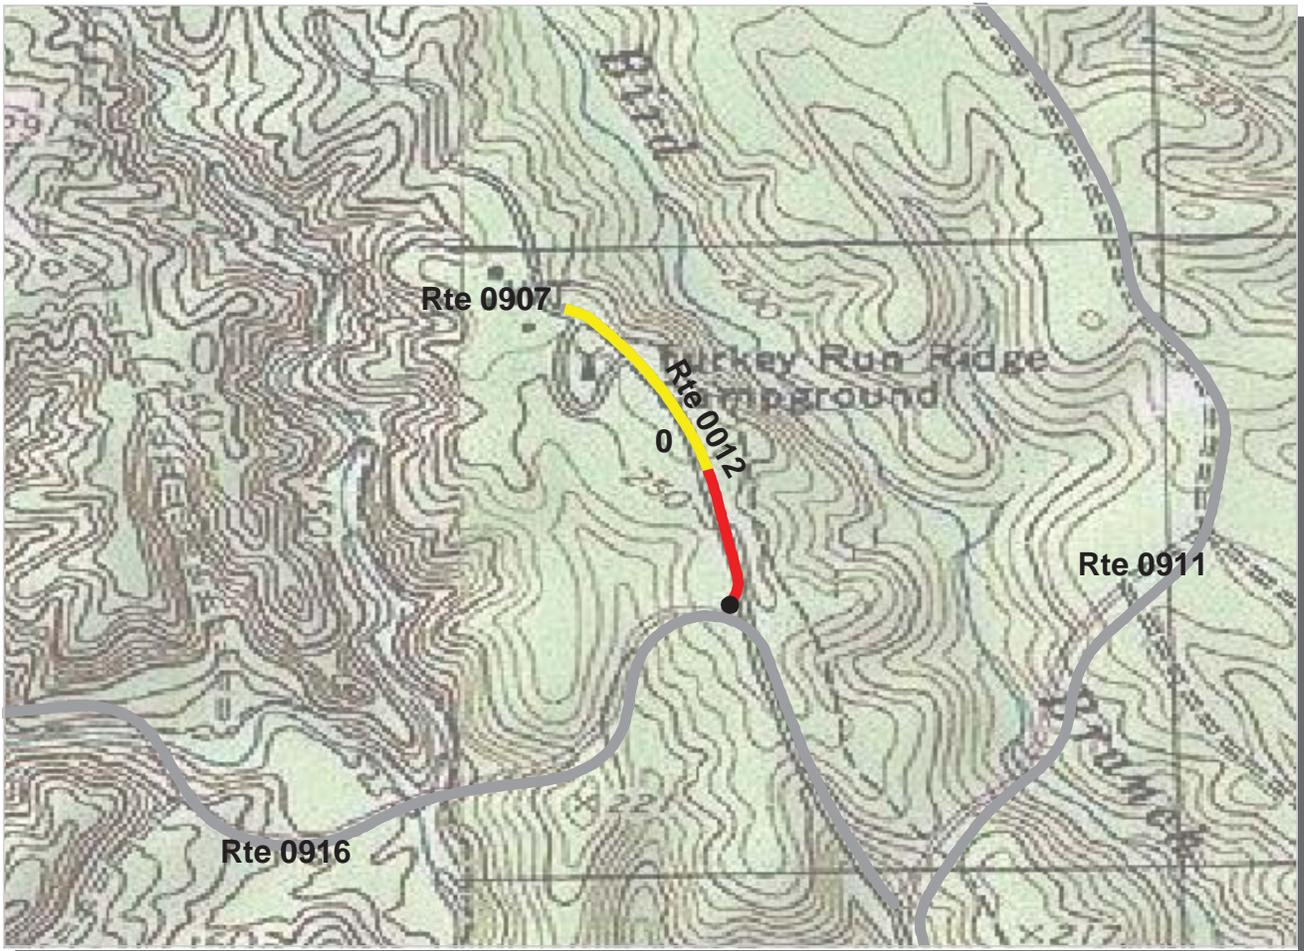
ROUTE: 0012 TURKEY RUN ACCESS ROAD TOTAL LENGTH: 0.35 Miles

Section Number	0				
Section Length (mi)	0.35				
AADT	**				
SADT	**				
ADT Date	**				
Cross Section Information					
Number of Lanes	2				
Paved Width (ft)	19				
Lane Width (ft)	10				
Shoulder Width (ft)	5				
Roadway Condition Information					
PCR (Pavement Condition Rating)	47				
RCI (Roughness Condition Index)	76				
SCR (Surface Condition Rating)	35				
Alligator Cracking Index	75				
Rutting Index	53				
Patching Index	100				
Transverse Cracking Index	96				
Longitudinal Cracking Index	97				
Shoulder Condition Rating	GOOD				
Drainage Condition Rating	GOOD

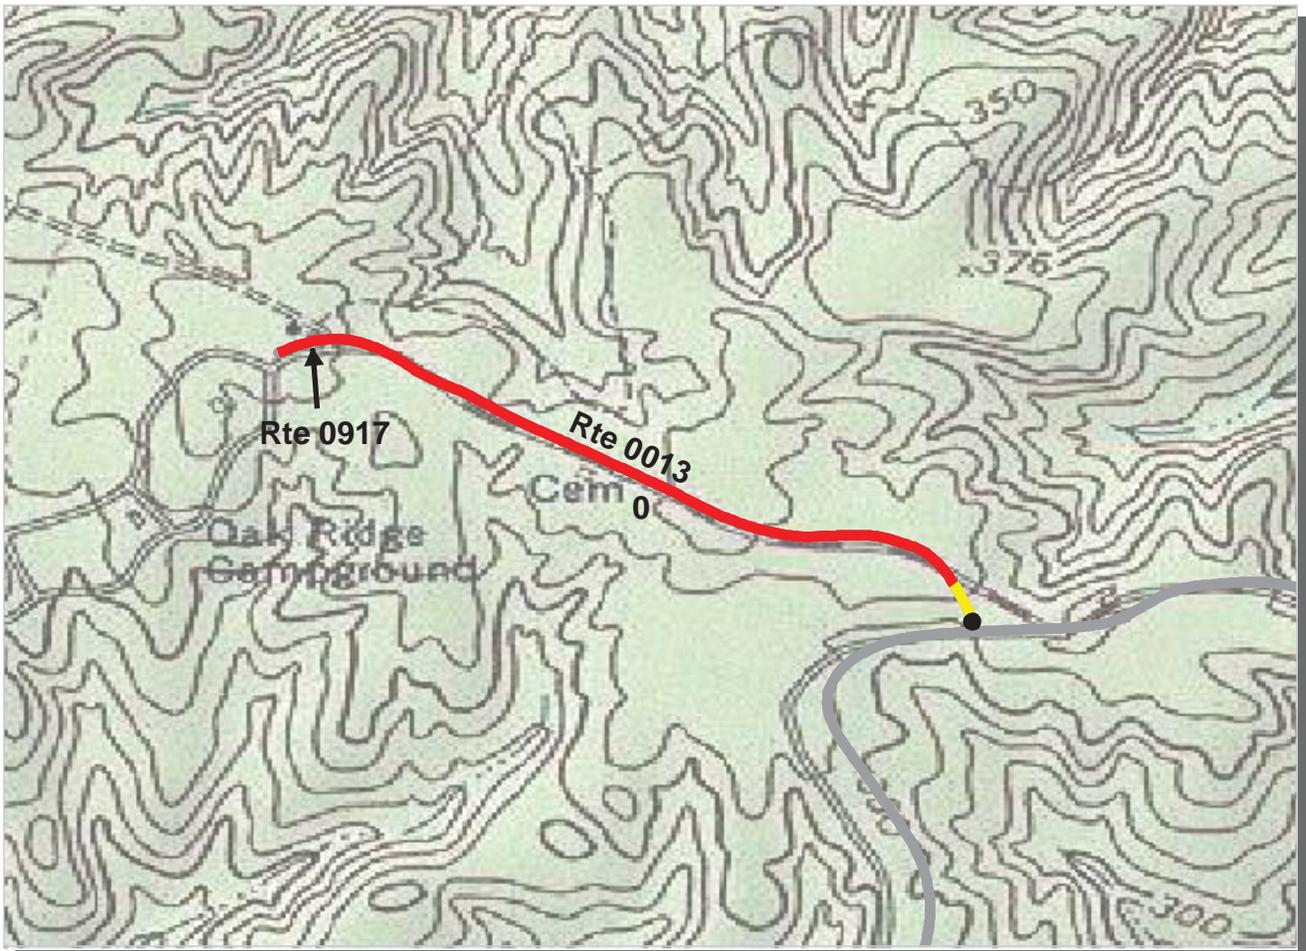
ROUTE: 0013 OAK RIDGE CAMP GROUND ACCESS ROAD TOTAL LENGTH: 0.65 Miles

Section Number	0				
Section Length (mi)	0.65				
AADT	**				
SADT	**				
ADT Date	**				
Cross Section Information					
Number of Lanes	2				
Paved Width (ft)	16				
Lane Width (ft)	8				
Shoulder Width (ft)	4				
Roadway Condition Information					
PCR (Pavement Condition Rating)	34				
RCI (Roughness Condition Index)	38				
SCR (Surface Condition Rating)	28				
Alligator Cracking Index	64				
Rutting Index	62				
Patching Index	100				
Transverse Cracking Index	97				
Longitudinal Cracking Index	94				
Shoulder Condition Rating	N/C				
Drainage Condition Rating	GOOD

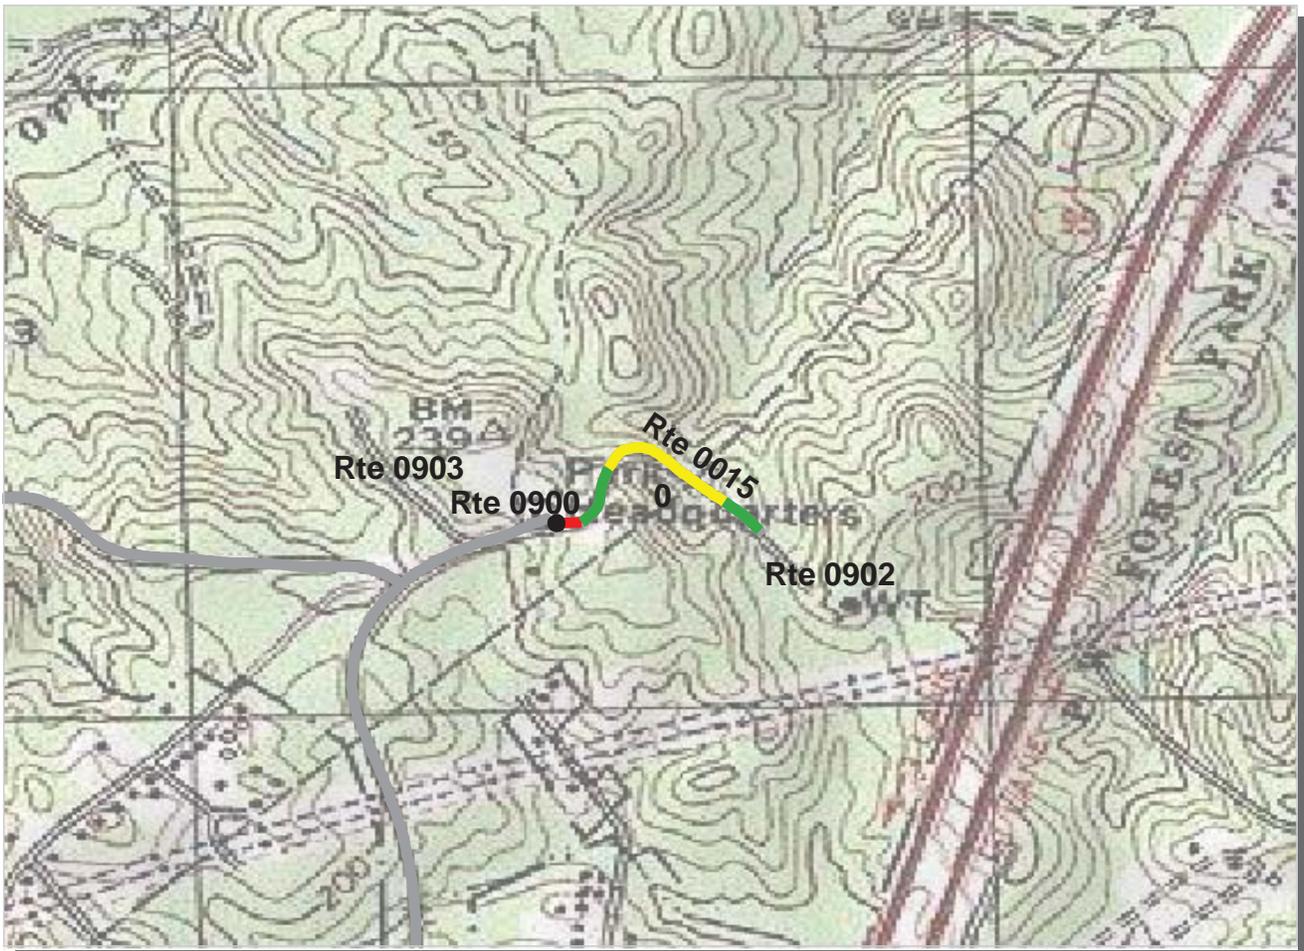
ROUTE: 0015 TELEGRAPH ROAD TOTAL LENGTH: 0.26 Miles

Section Number	0				
Section Length (mi)	0.26				
AADT	**				
SADT	**				
ADT Date	**				
Cross Section Information					
Number of Lanes	2				
Paved Width (ft)	21				
Lane Width (ft)	10				
Shoulder Width (ft)	7				
Roadway Condition Information					
PCR (Pavement Condition Rating)	79				
RCI (Roughness Condition Index)	87				
SCR (Surface Condition Rating)	79				
Alligator Cracking Index	96				
Rutting Index	83				
Patching Index	99				
Transverse Cracking Index	99				
Longitudinal Cracking Index	99				
Shoulder Condition Rating	N/C				
Drainage Condition Rating	GOOD

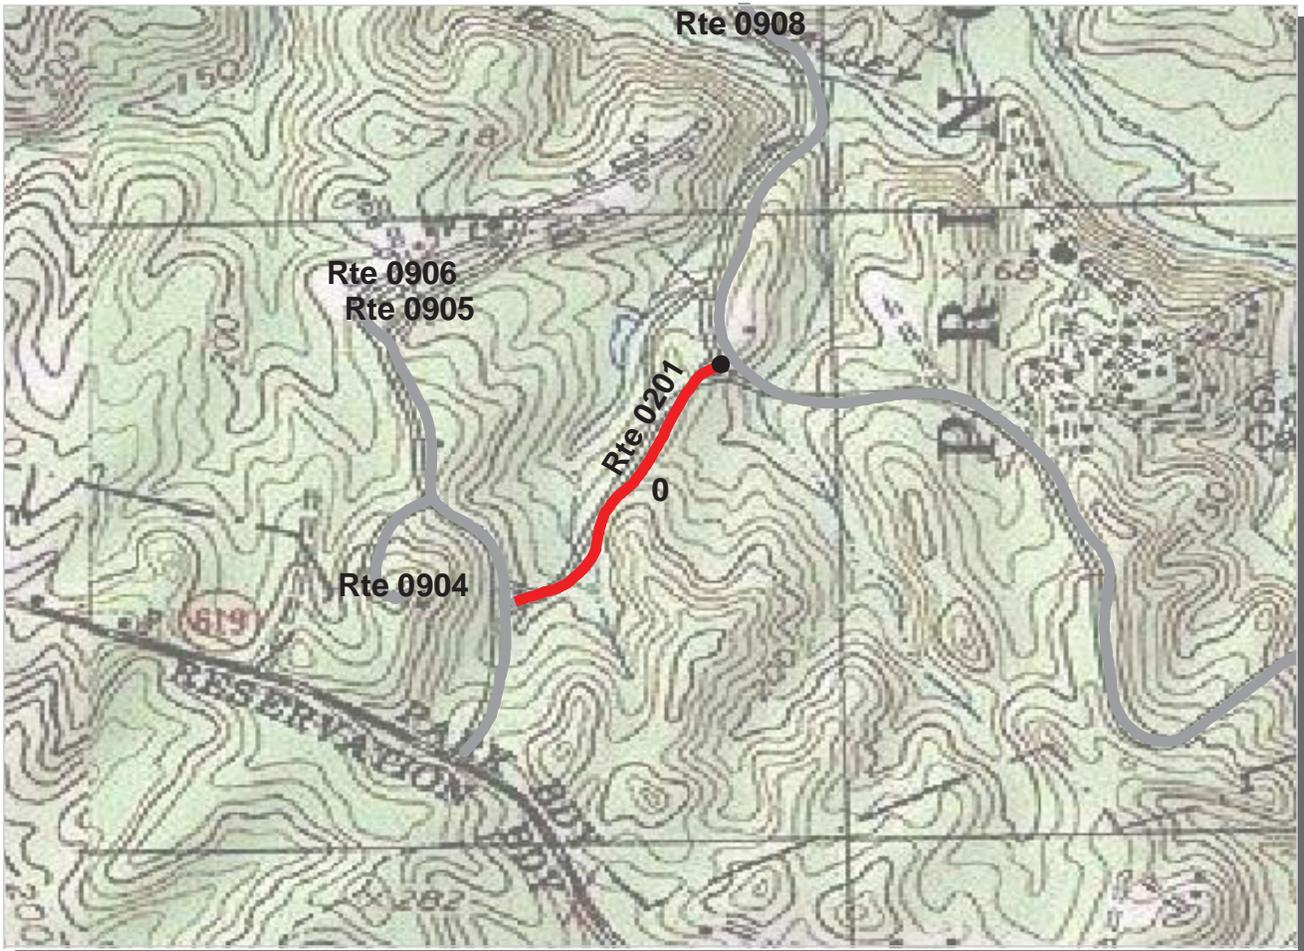
ROUTE: 0201 CARTER DAY CAMP ROAD TOTAL LENGTH: 0.31 Miles

Section Number	0				
Section Length (mi)	0.31				
AADT	**				
SADT	**				
ADT Date	**				
Cross Section Information					
Number of Lanes	2				
Paved Width (ft)	17				
Lane Width (ft)	8				
Shoulder Width (ft)	0				
Roadway Condition Information					
PCR (Pavement Condition Rating)	32				
RCI (Roughness Condition Index)	60				
SCR (Surface Condition Rating)	27				
Alligator Cracking Index	76				
Rutting Index	58				
Patching Index	99				
Transverse Cracking Index	86				
Longitudinal Cracking Index	96				
Shoulder Condition Rating	N/A				
Drainage Condition Rating	GOOD

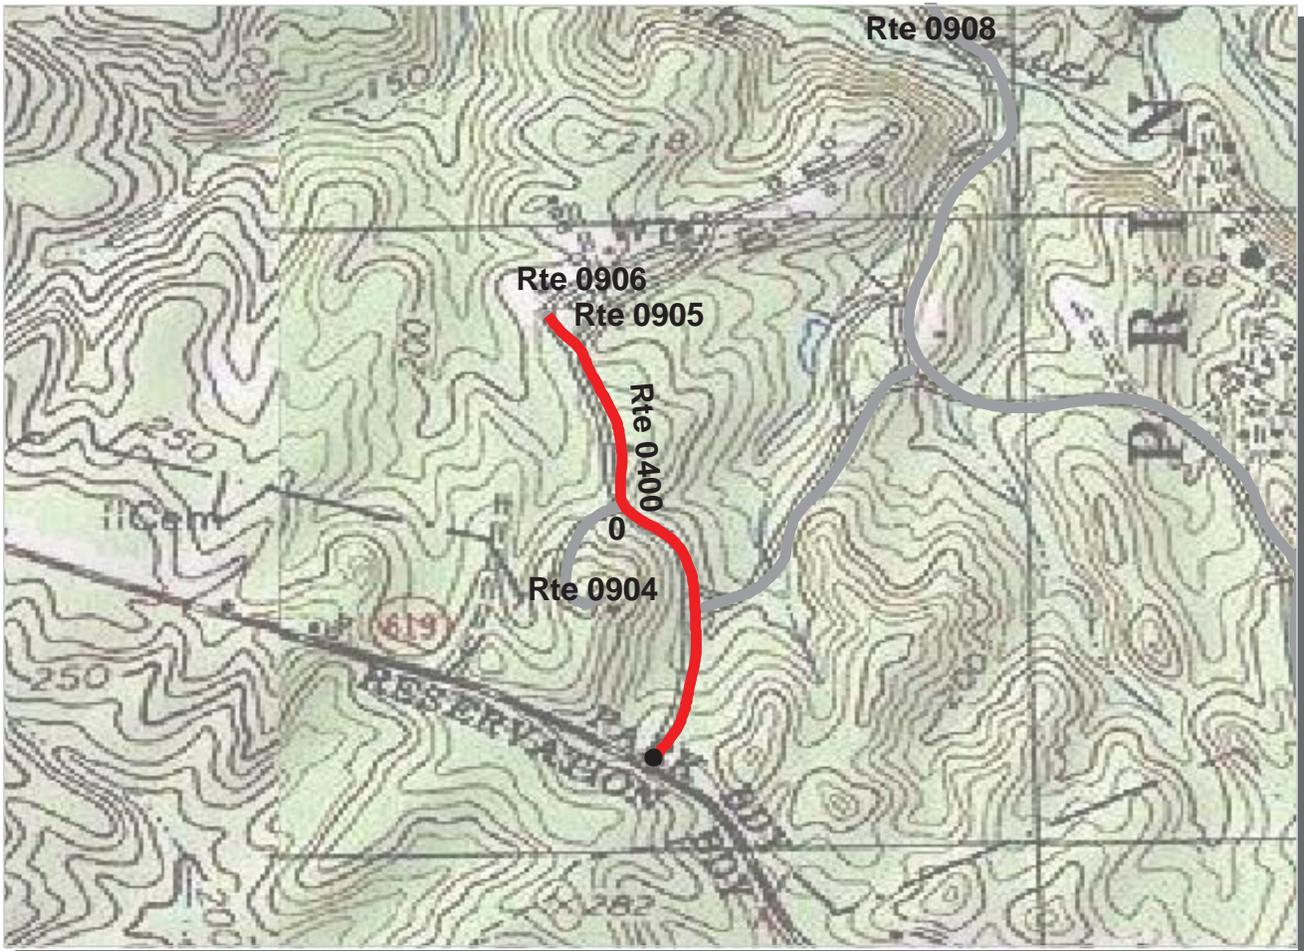
ROUTE: 0400 ADMINISTRATIVE SERVICE ROAD TOTAL LENGTH: 0.50 Miles

Section Number	0				
Section Length (mi)	0.50				
AADT	**				
SADT	**				
ADT Date	**				
Cross Section Information					
Number of Lanes	2				
Paved Width (ft)	16				
Lane Width (ft)	8				
Shoulder Width (ft)	4				
Roadway Condition Information					
PCR (Pavement Condition Rating)	41				
RCI (Roughness Condition Index)	67				
SCR (Surface Condition Rating)	31				
Alligator Cracking Index	84				
Rutting Index	49				
Patching Index	100				
Transverse Cracking Index	97				
Longitudinal Cracking Index	96				
Shoulder Condition Rating	N/C				
Drainage Condition Rating	GOOD

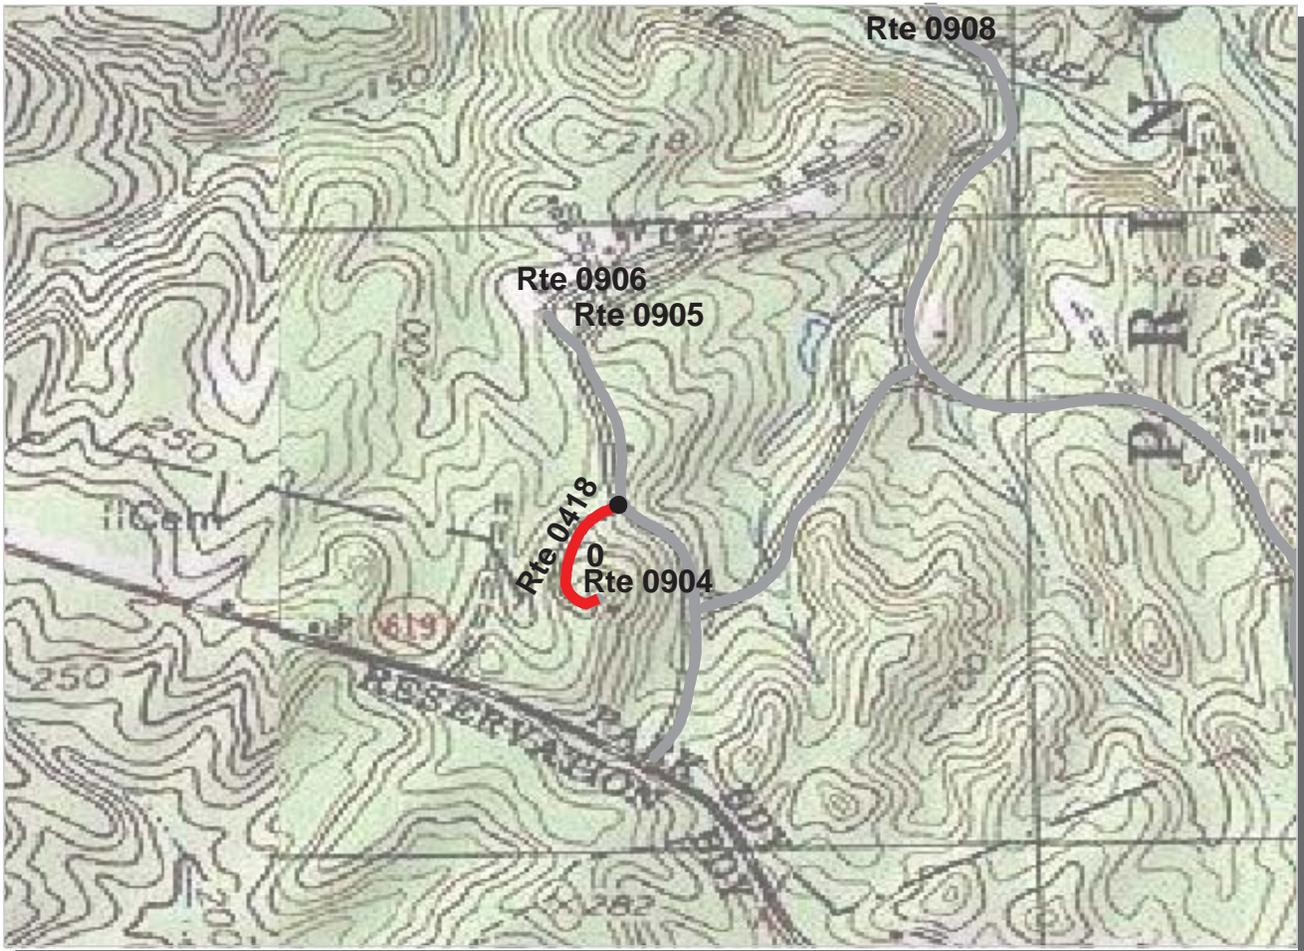
ROUTE: 0418 PARK HEADQUARTERS ROAD TOTAL LENGTH: 0.15 Miles

Section Number	0				
Section Length (mi)	0.15				
AADT	**				
SADT	**				
ADT Date	**				
Cross Section Information					
Number of Lanes	1				
Paved Width (ft)	10				
Lane Width (ft)	10				
Shoulder Width (ft)	6				
Roadway Condition Information					
PCR (Pavement Condition Rating)	40				
RCI (Roughness Condition Index)	29				
SCR (Surface Condition Rating)	40				
Alligator Cracking Index	97				
Rutting Index	59				
Patching Index	100				
Transverse Cracking Index	90				
Longitudinal Cracking Index	92				
Shoulder Condition Rating	N/C				
Drainage Condition Rating	GOOD

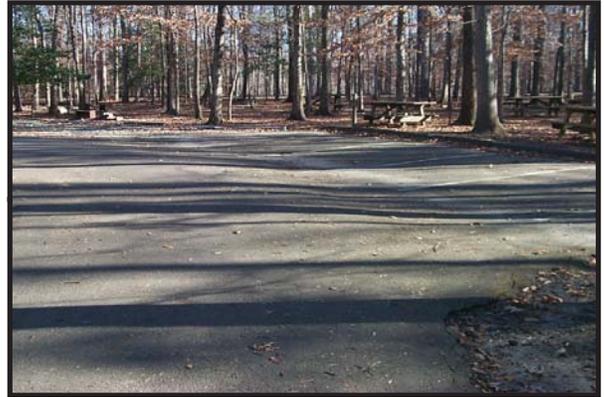
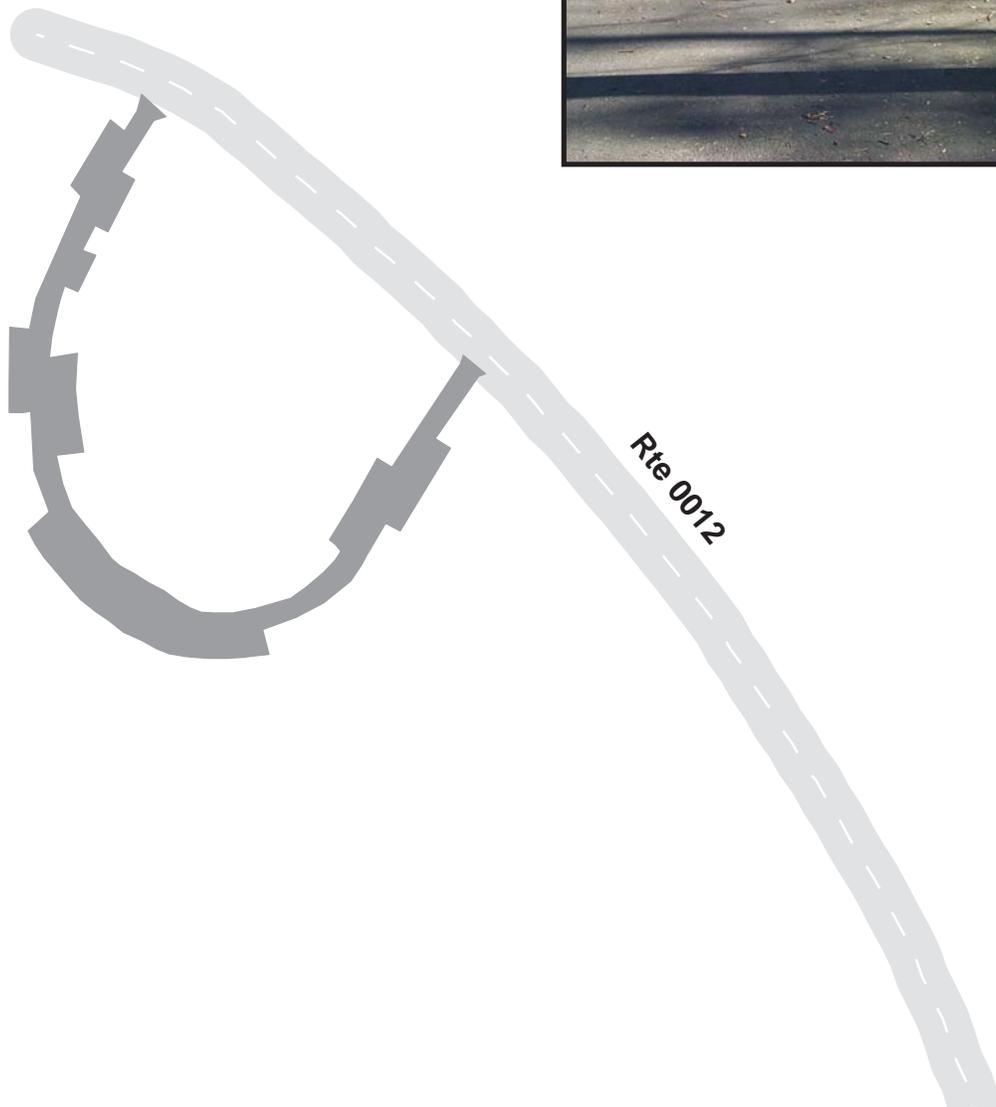
Route 0501

Route	Length (mi)	Width (ft)	Area (sq ft)	Lane Miles *	Condition / PCR	Surface Type
0501	1.11	10.00	58661	1.01	FAIR / 73	AS

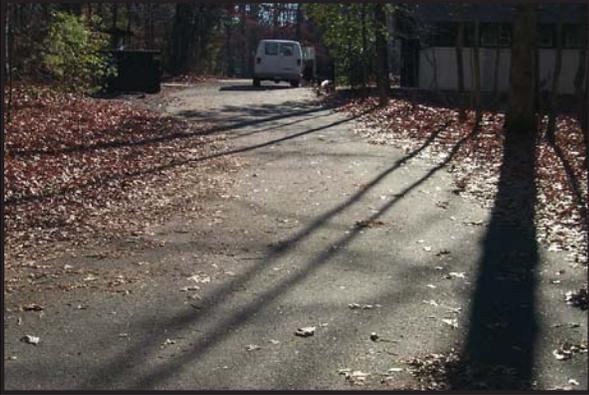
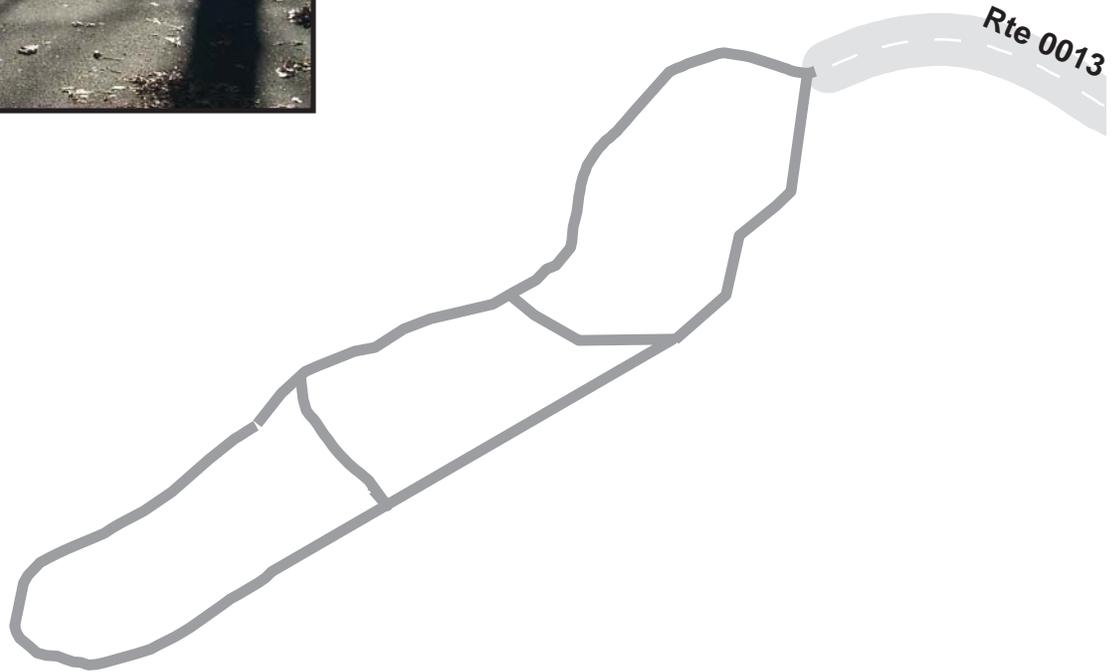
Route 0502

Route	Length (mi)	Width (ft)	Area (sq ft)	Lane Miles *	Condition / PCR	Surface Type
0502	1.78	10.00	93984	1.62	GOOD / 90	AS

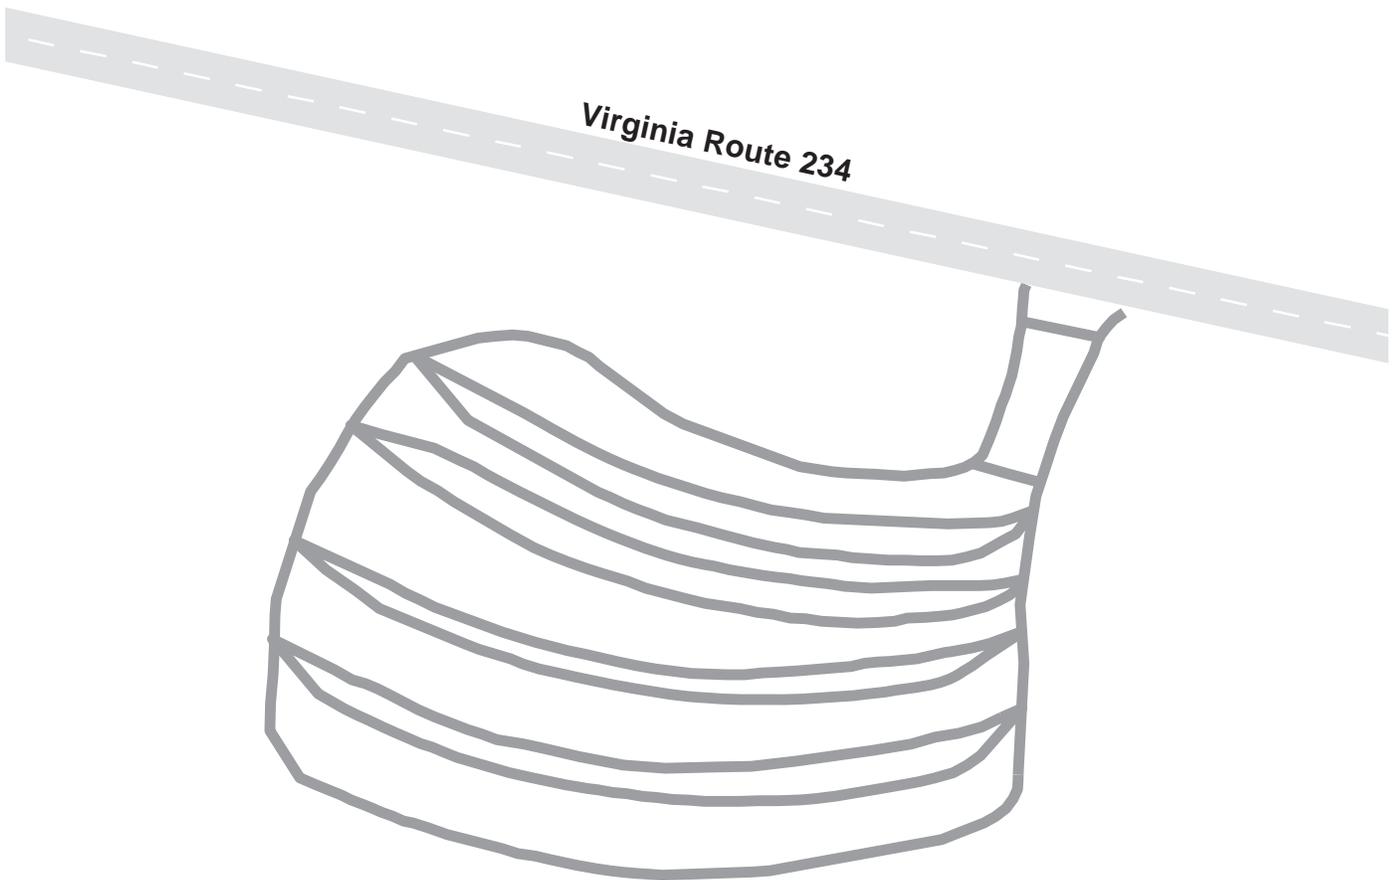
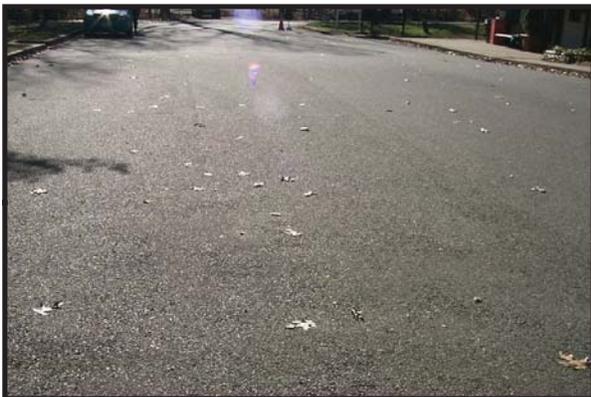
Route 0503

Route	Length (mi)	Width (ft)	Area (sq ft)	Lane Miles *	Condition / PCR	Surface Type
0503	0.06	10.00	3274	0.06	GOOD / 90	AS
