The Road Inventory of Prince William Forest Park PRWI – 3700

Road Inventory Program

Prepared By:
Federal Highway Administration
Eastern Federal Lands Highway Division
Cycle 3

Prince William Forest Park in Virginia

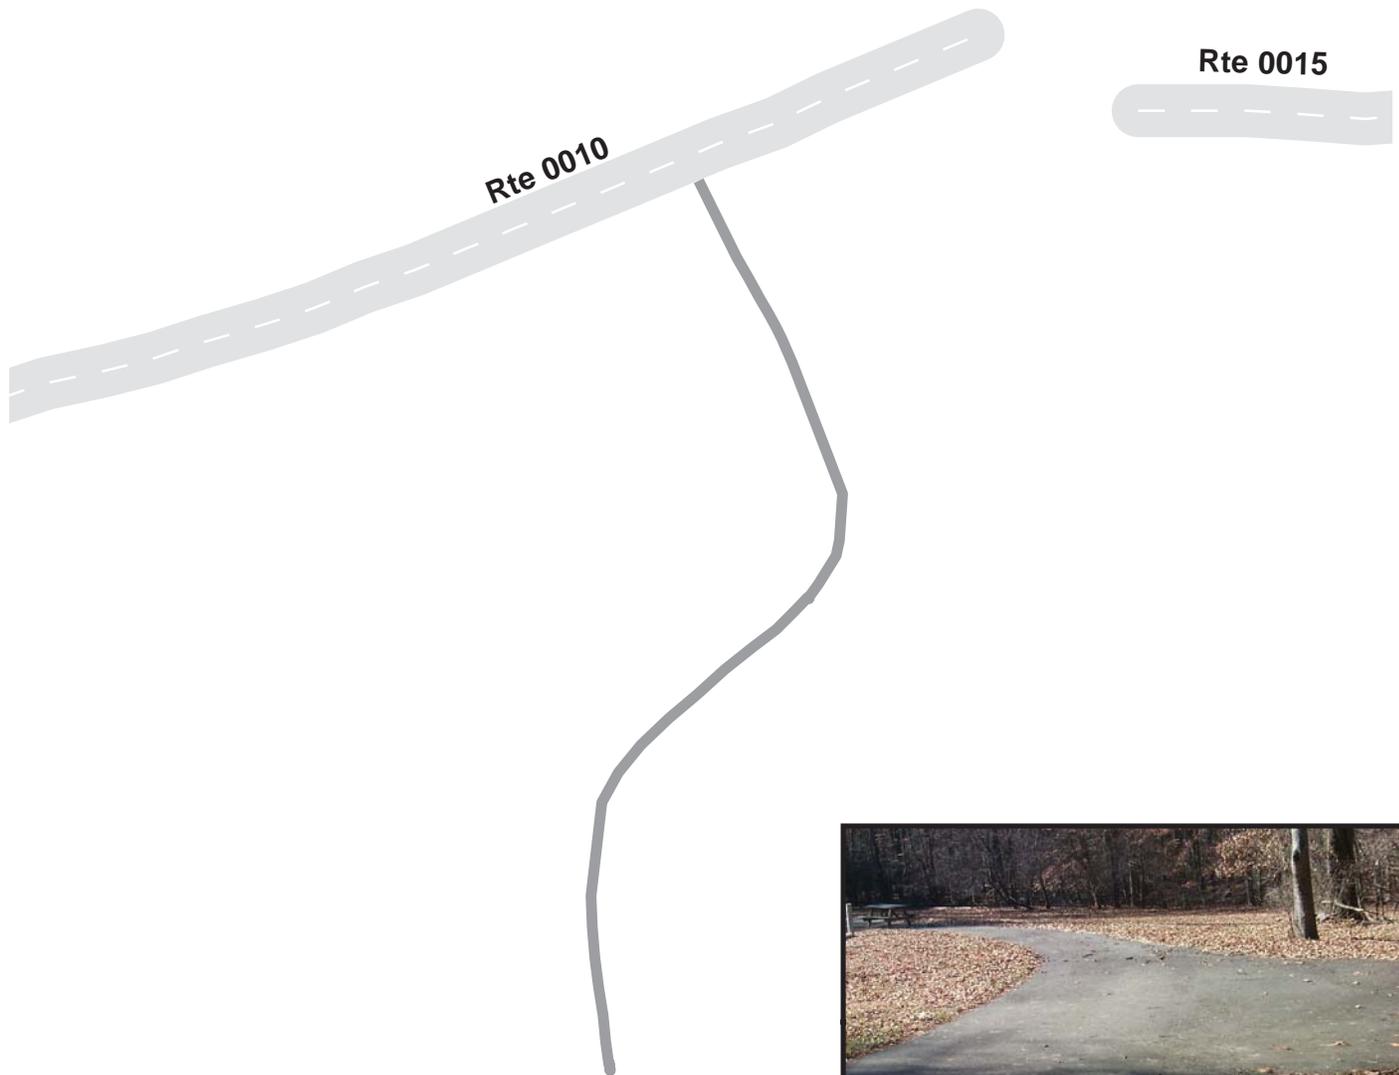
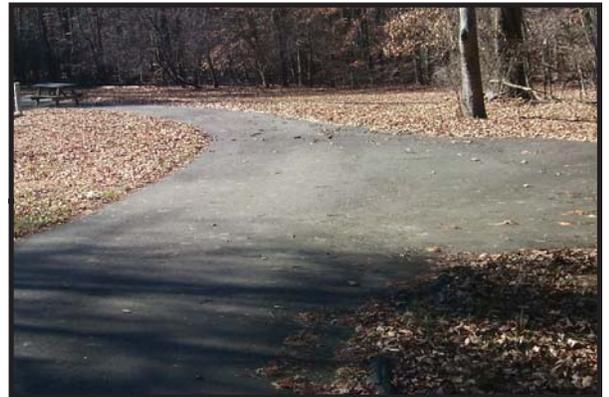
Route 0900

Route	Public / NonPublic	Date Visited	Area (sq ft)	Lane Miles *	Surface Type	Condition / PCR
0900	PUBLIC	12/12/2001	10798	0.19	AS	GOOD / 90

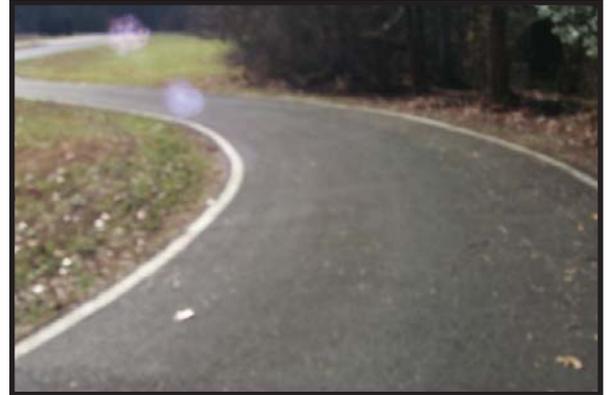
PRINCE WILLIAM FOREST PARK
Route 0902
 TELEGRAPH ROAD PICNIC AREA PARKING
 AT END OF ROUTE 0015

Route	Public / NonPublic	Date Visited	Area (sq ft)	Lane Miles *	Surface Type	Condition / PCR
0902	PUBLIC	12/12/2001	31224	0.54	AS	GOOD / 90

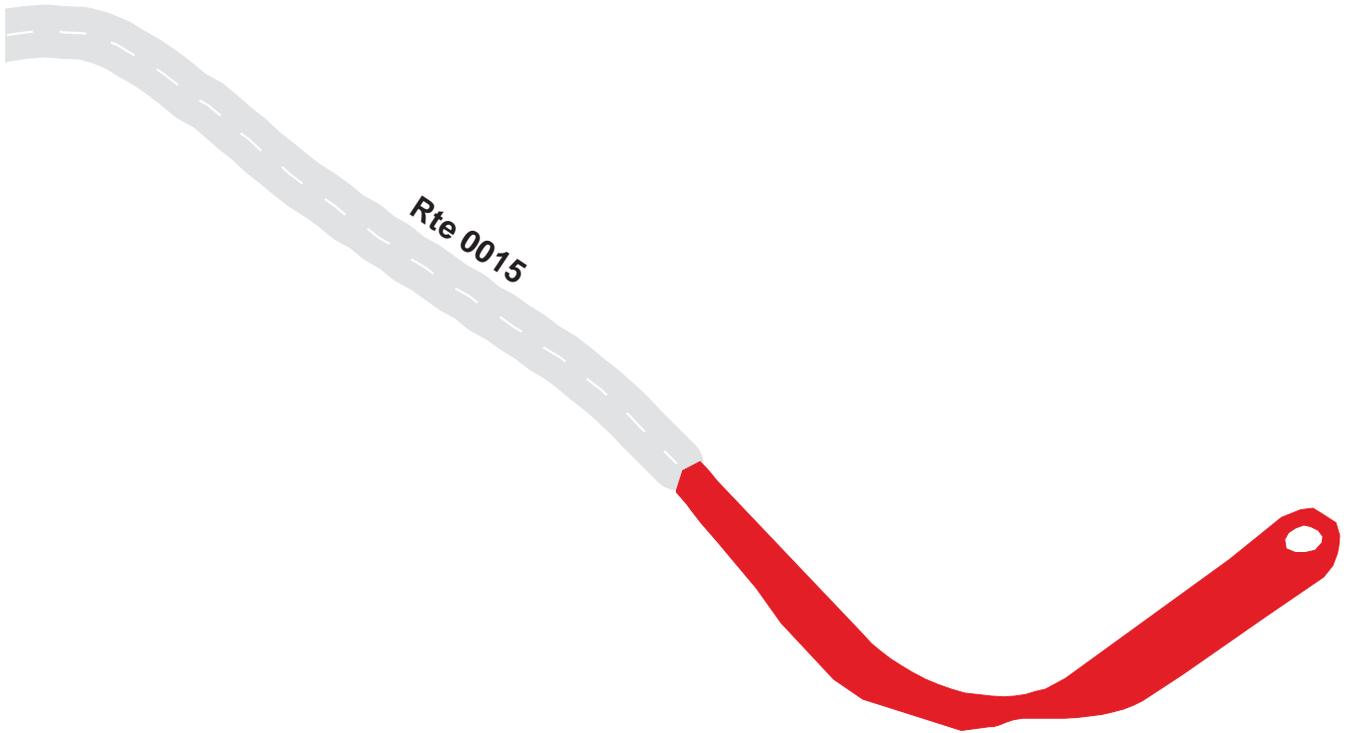
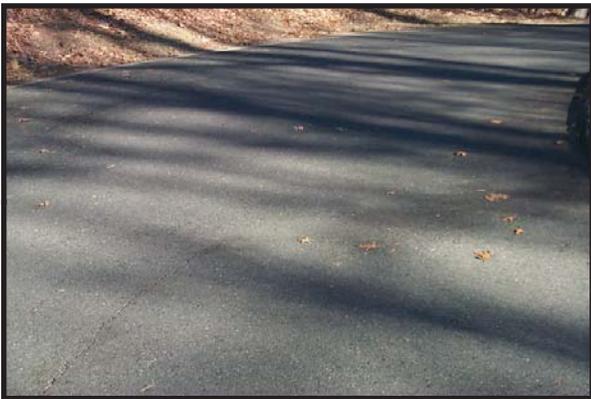
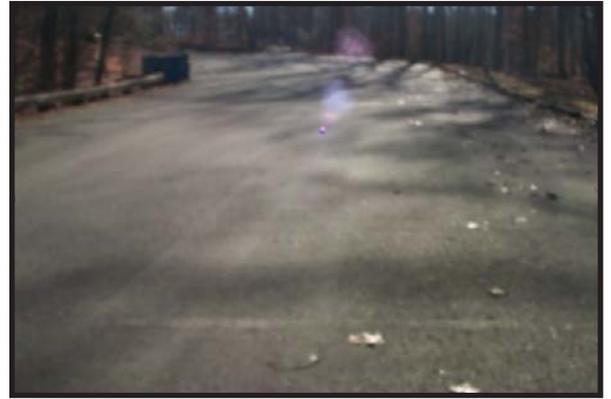
Route 0903

Route	Public / NonPublic	Date Visited	Area (sq ft)	Lane Miles *	Surface Type	Condition / PCR
0903	PUBLIC	12/12/2001	43790	0.75	AS	FAIR / 73

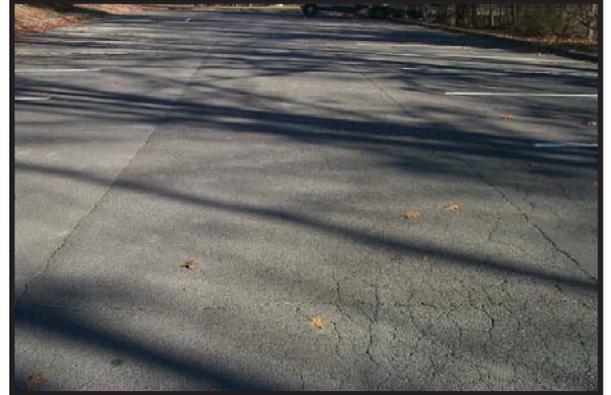
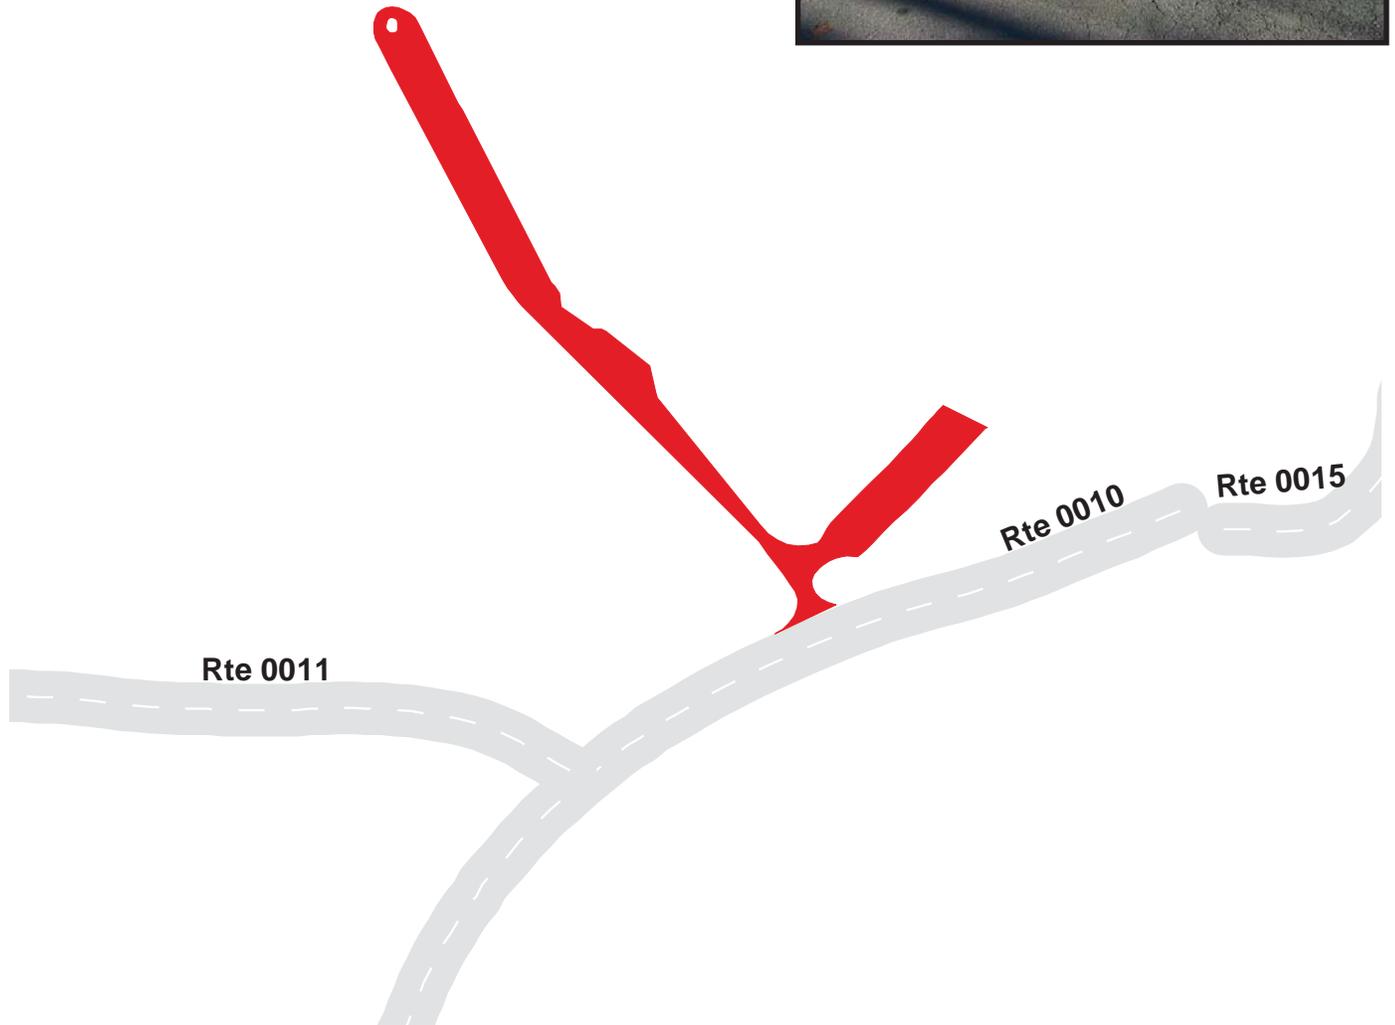
Route 0904

Route	Public / NonPublic	Date Visited	Area (sq ft)	Lane Miles *	Surface Type	Condition / PCR
0904	PUBLIC	12/12/2001	2959	0.05	AS	FAIR / 73

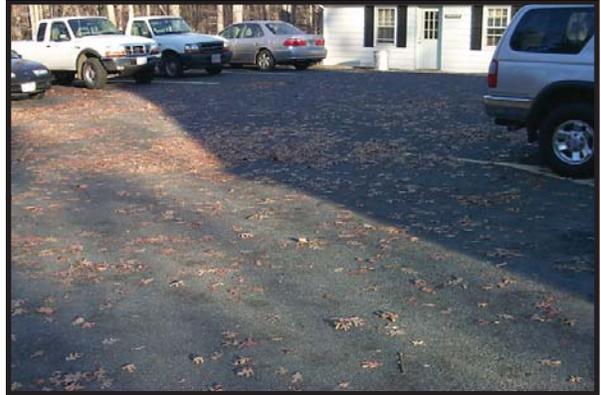
PRINCE WILLIAM FOREST PARK
Route 0905
 MAINTENANCE AREA EMPLOYEE PARKING
 FROM ROUTE 0400

Route	Public / NonPublic	Date Visited	Area (sq ft)	Lane Miles *	Surface Type	Condition / PCR
0905	NONPUBLIC	12/12/2001	12247	0.21	AS	FAIR / 73

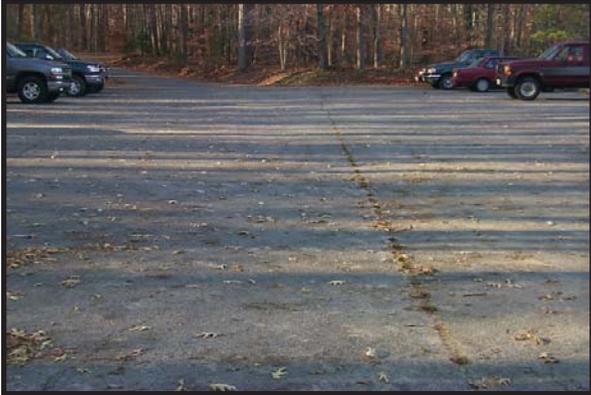
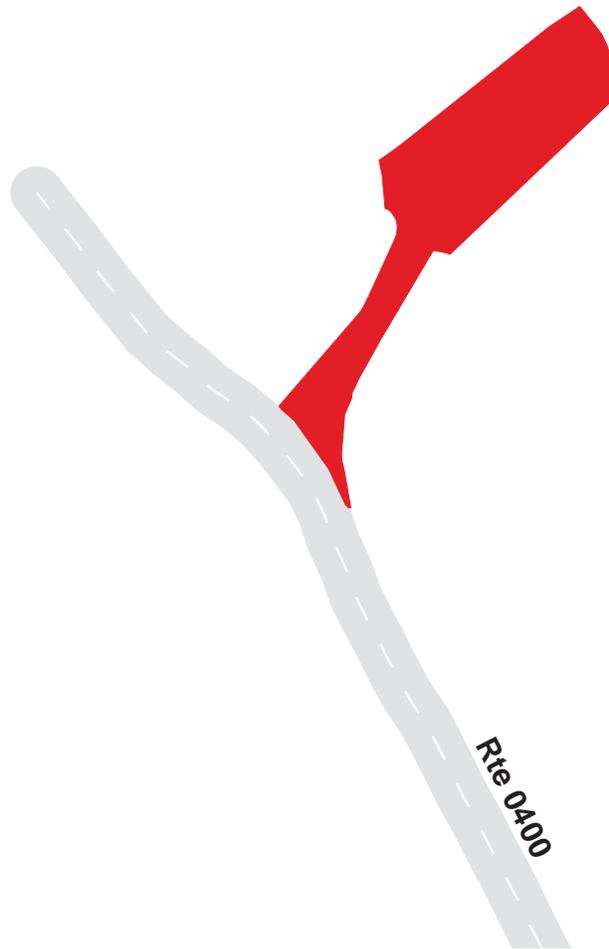
Route 0906

Route	Public / NonPublic	Date Visited	Area (sq ft)	Lane Miles *	Surface Type	Condition / PCR
0906	NONPUBLIC	12/12/2001	45058	0.78	AS	FAIR / 73

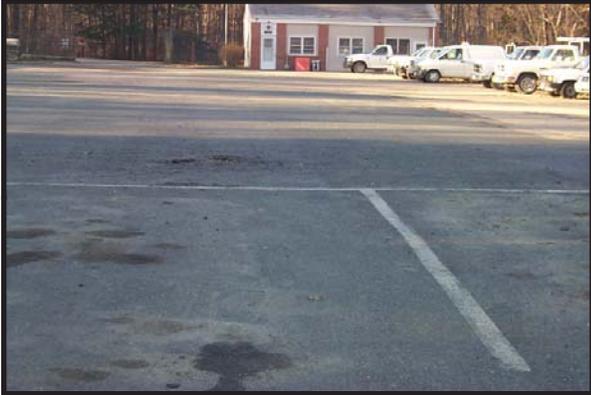
PRINCE WILLIAM FOREST PARK
Route 0907
NATURE CENTER/RESIDENCE PARKING
AT END ROUTE 0012

Route	Public / NonPublic	Date Visited	Area (sq ft)	Lane Miles *	Surface Type	Condition / PCR
0907	PUBLIC	12/12/2001	19463	0.34	AS	FAIR / 73

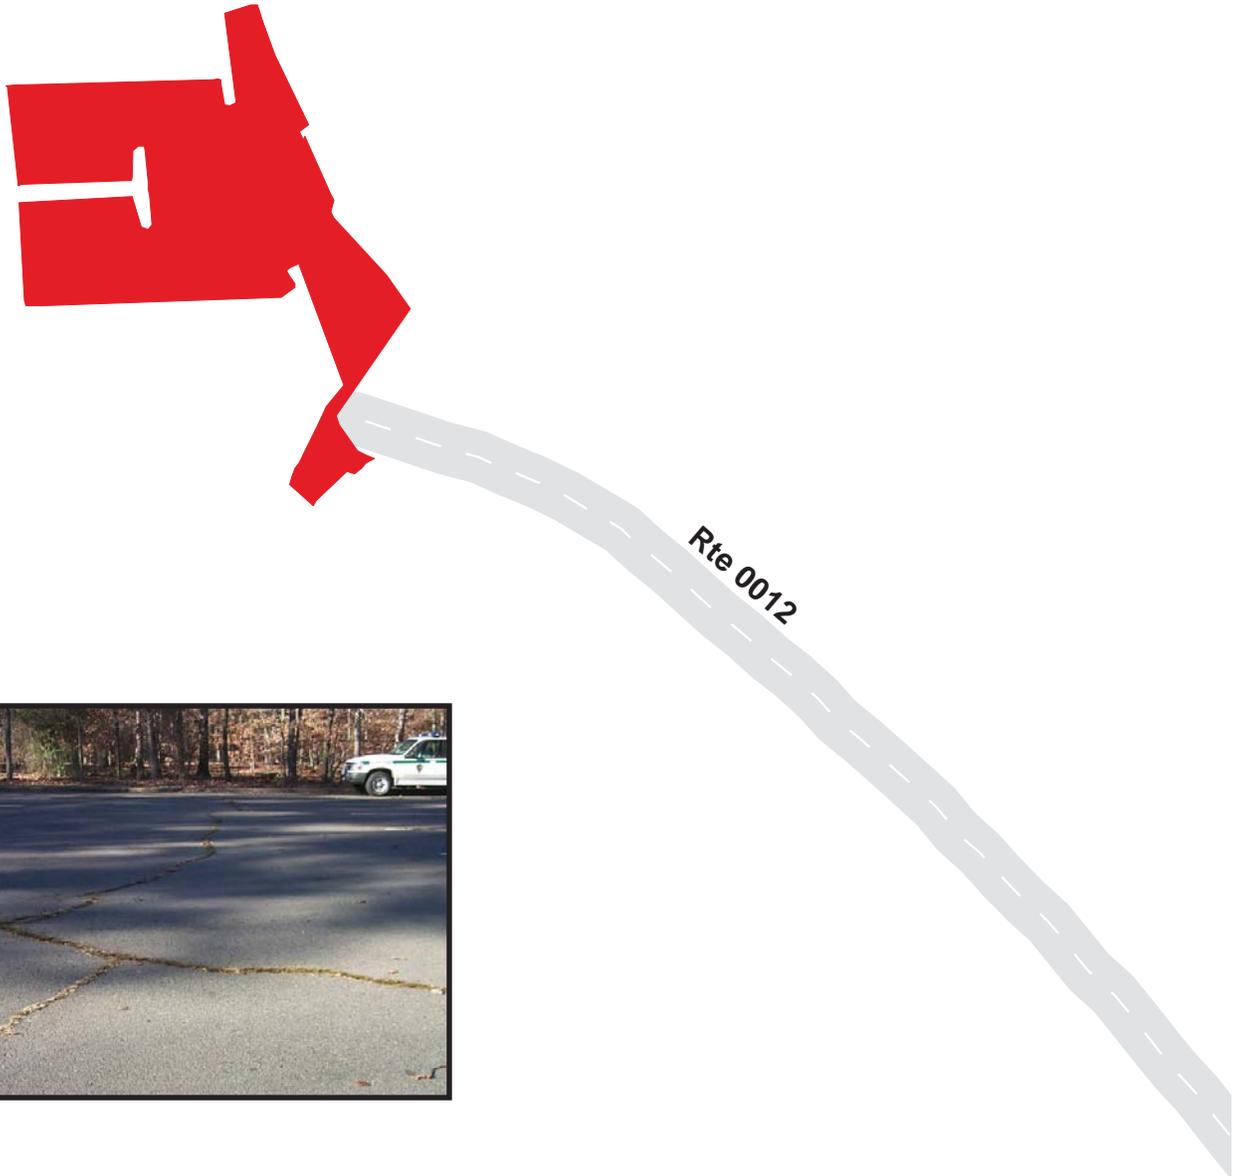
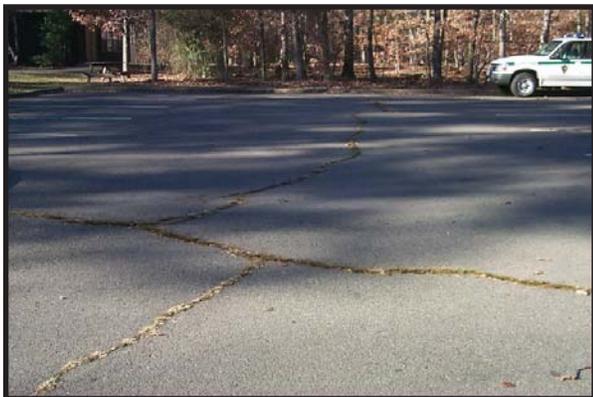
Route 0908

Route	Public / NonPublic	Date Visited	Area (sq ft)	Lane Miles *	Surface Type	Condition / PCR
0908	PUBLIC	12/12/2001	1994	0.03	AS	FAIR / 73

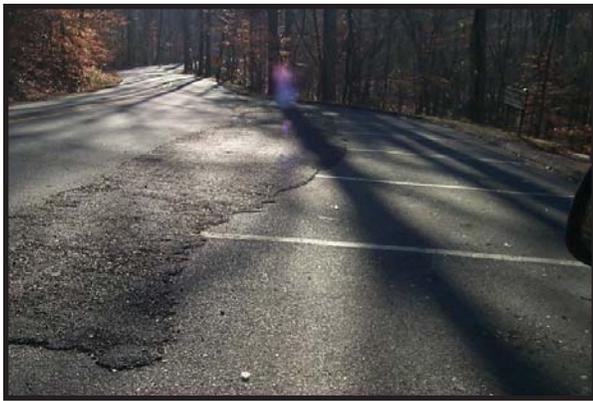
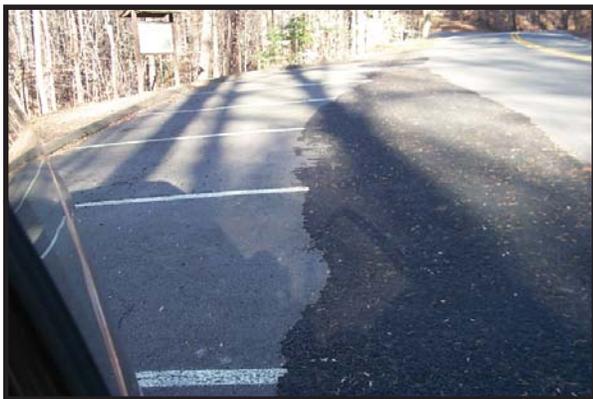
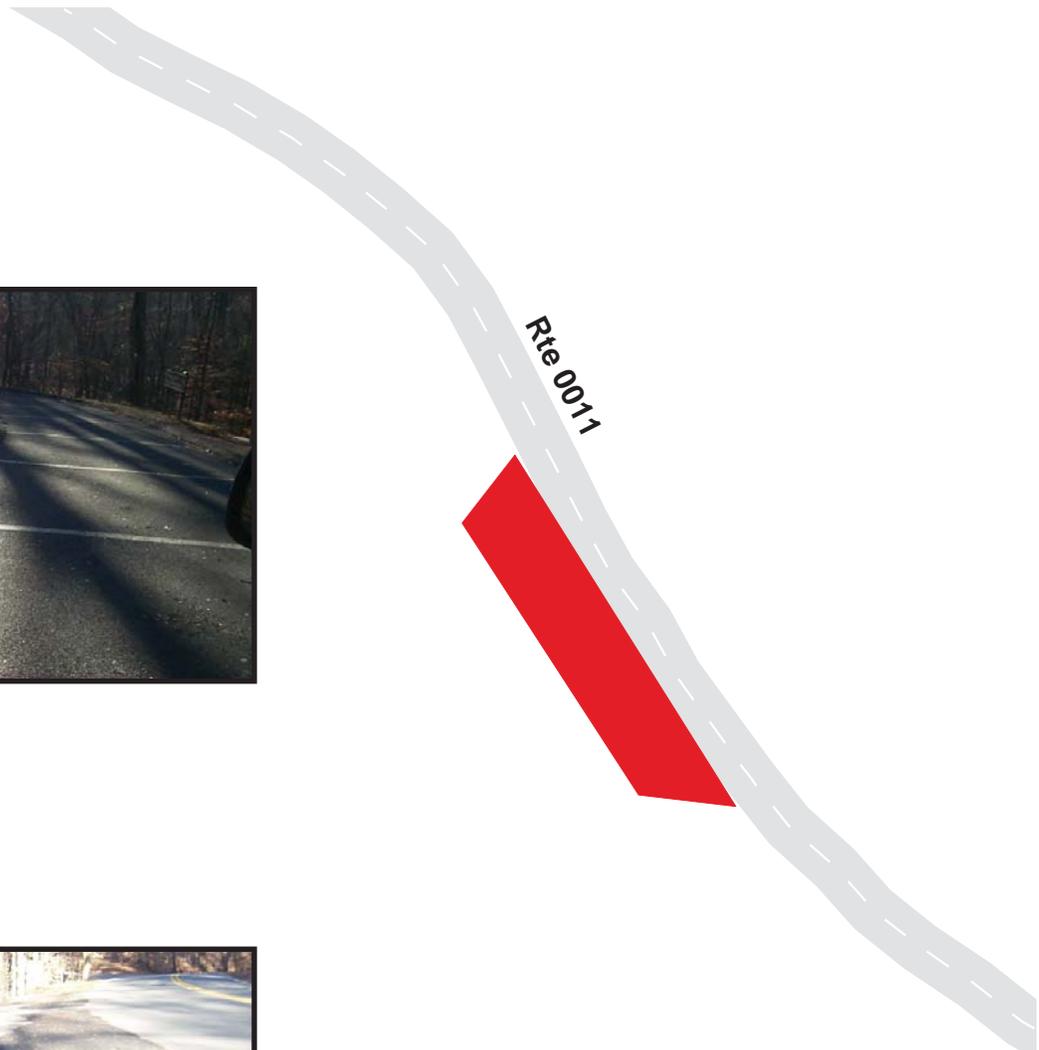
Route 0909

Route	Public / NonPublic	Date Visited	Area (sq ft)	Lane Miles *	Surface Type	Condition / PCR
0909	PUBLIC	12/12/2001	4793	0.08	AS	POOR / 45

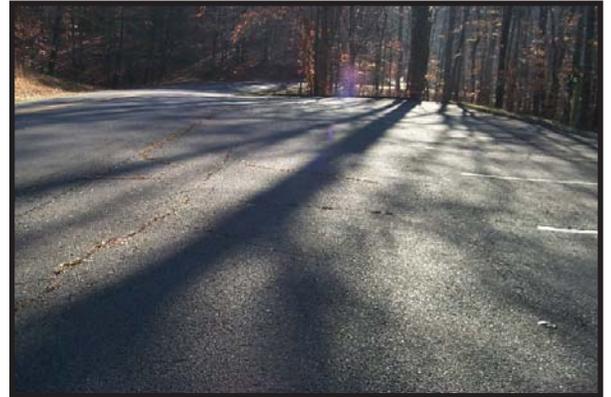
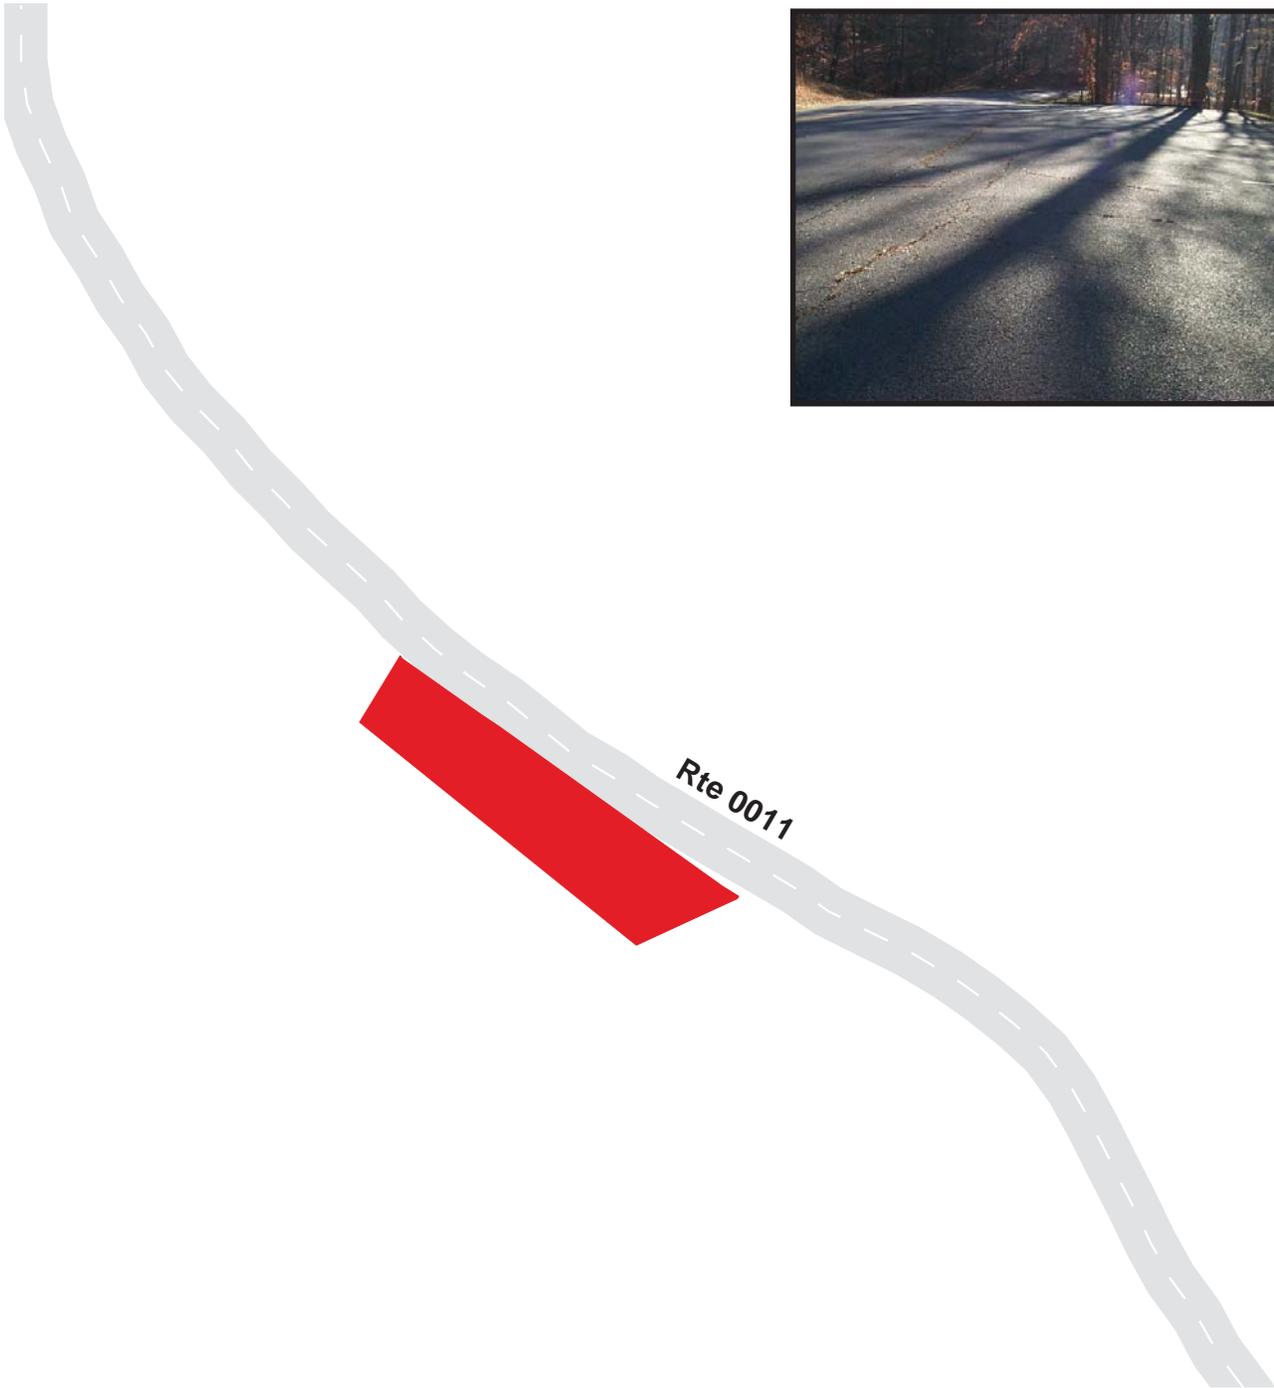
Route 0910

Route	Public / NonPublic	Date Visited	Area (sq ft)	Lane Miles *	Surface Type	Condition / PCR
0910	PUBLIC	12/12/2001	2163	0.04	AS	FAIR / 73

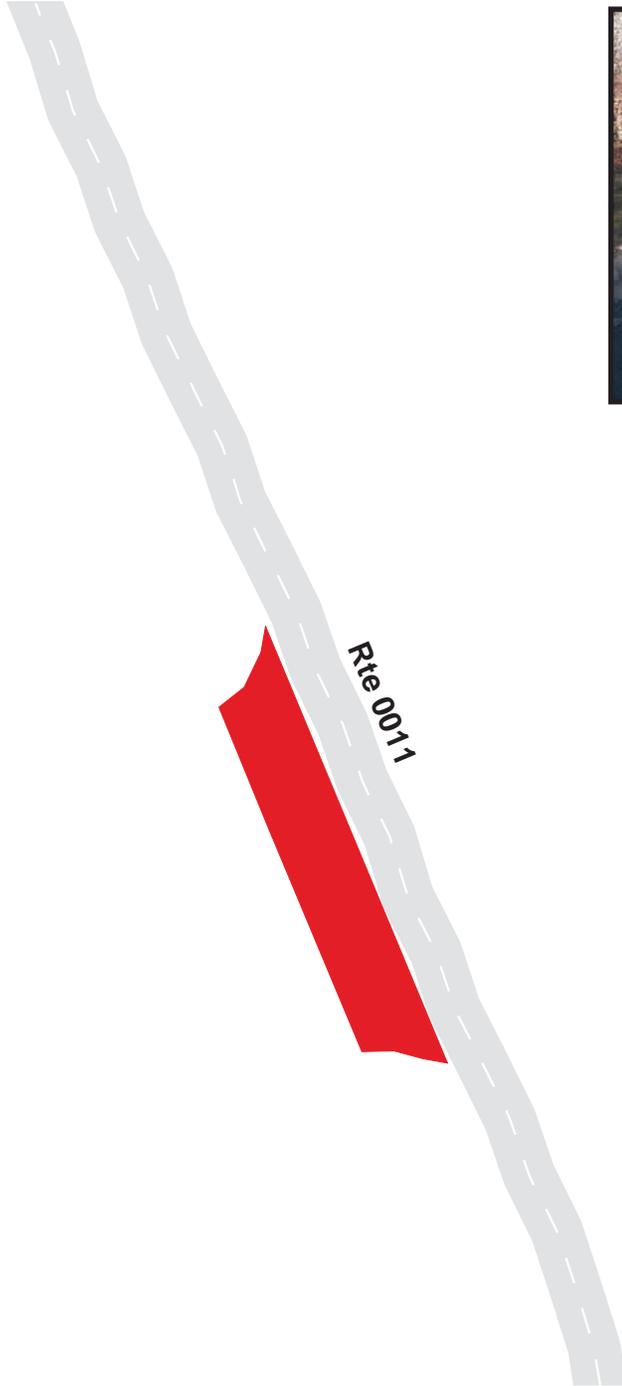
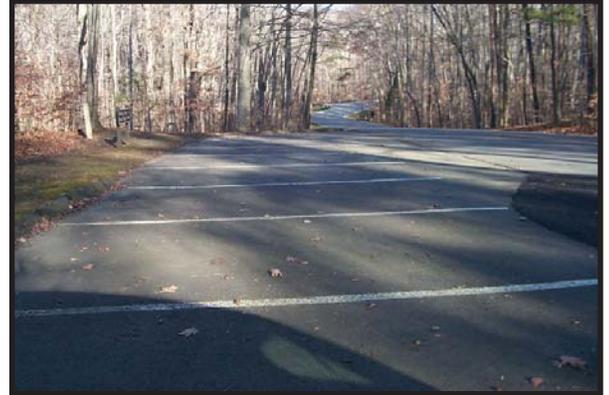
Route 0911

Route	Public / NonPublic	Date Visited	Area (sq ft)	Lane Miles *	Surface Type	Condition / PCR
0911	PUBLIC	12/12/2001	6004	0.10	OC	GOOD / 90

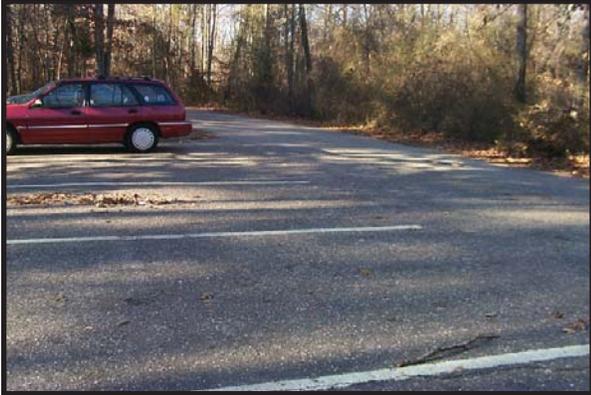
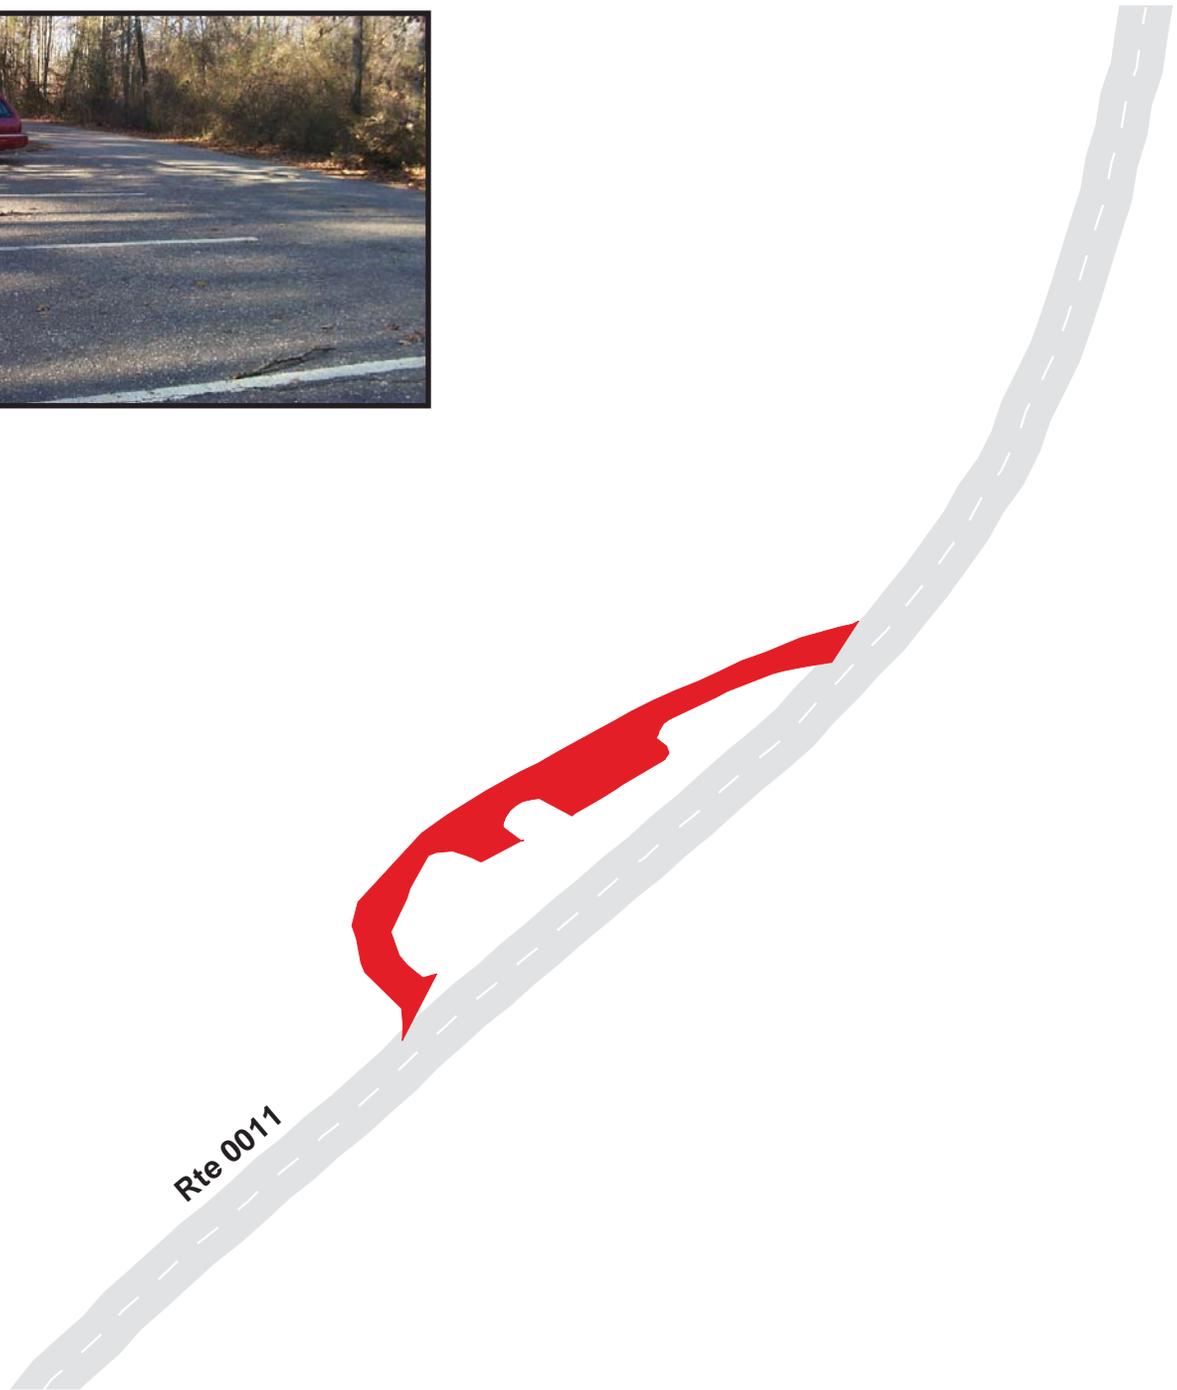
Route 0912

Route	Public / NonPublic	Date Visited	Area (sq ft)	Lane Miles *	Surface Type	Condition / PCR
0912	PUBLIC	12/12/2001	3921	0.07	OC	GOOD / 90

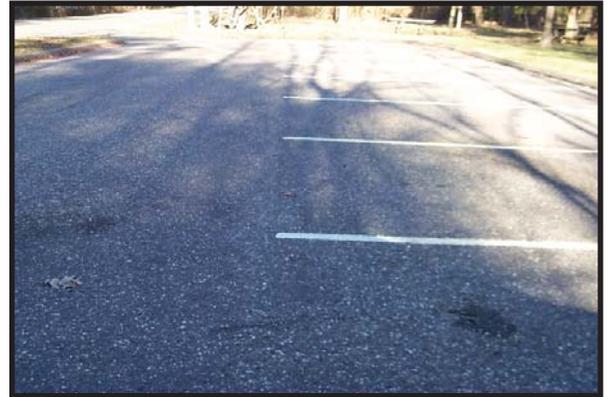
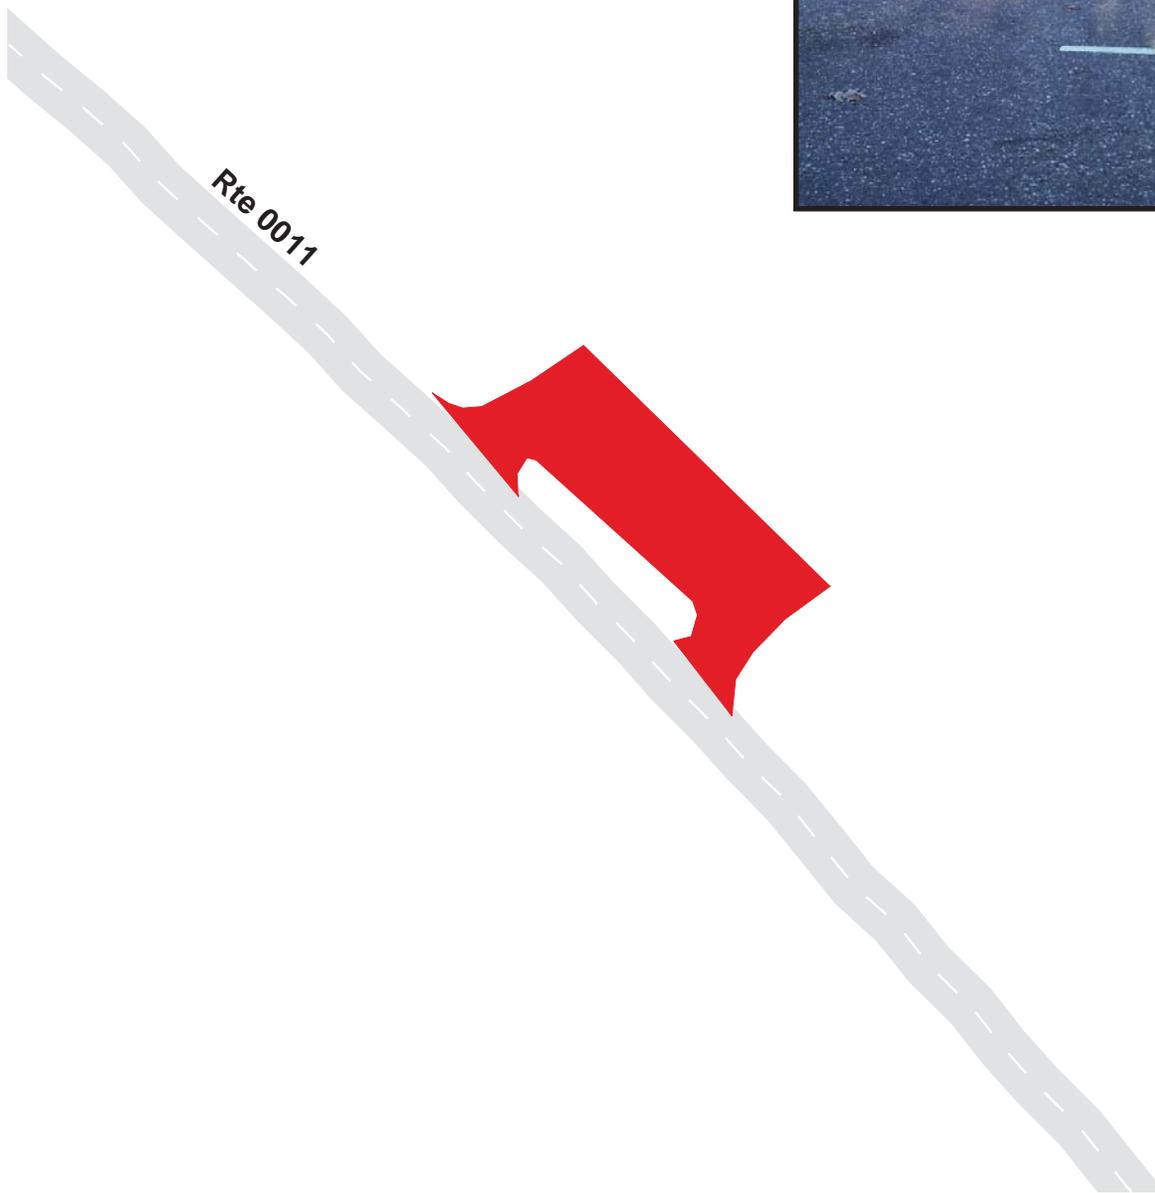
Route 0913

Route	Public / NonPublic	Date Visited	Area (sq ft)	Lane Miles *	Surface Type	Condition / PCR
0913	PUBLIC	12/12/2001	3327	0.06	OC	FAIR / 73

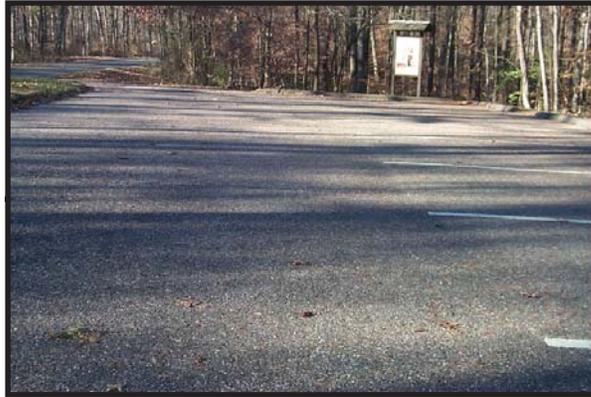
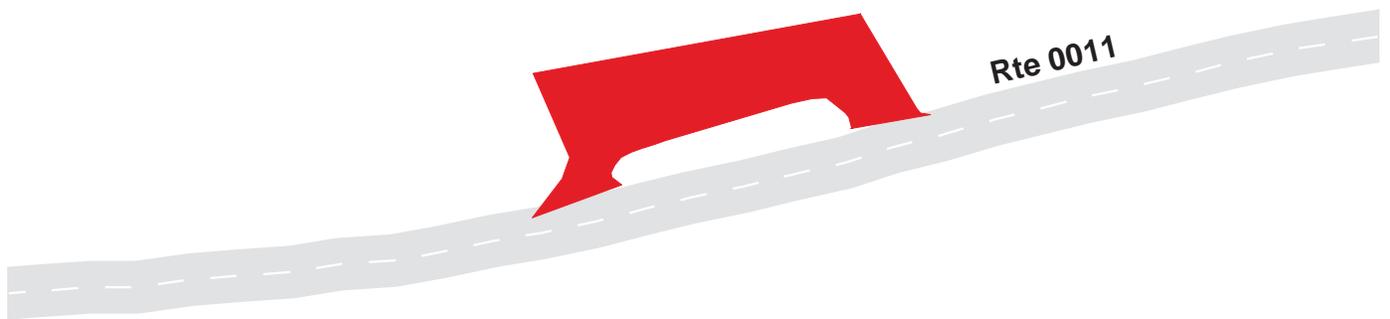
Route 0914

Route	Public / NonPublic	Date Visited	Area (sq ft)	Lane Miles *	Surface Type	Condition / PCR
0914	PUBLIC	12/12/2001	8110	0.14	AS	POOR / 45

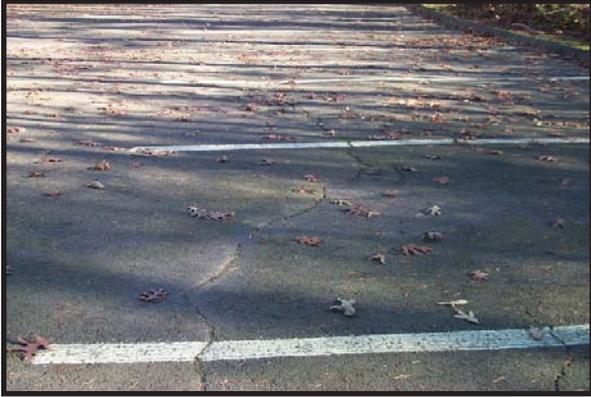
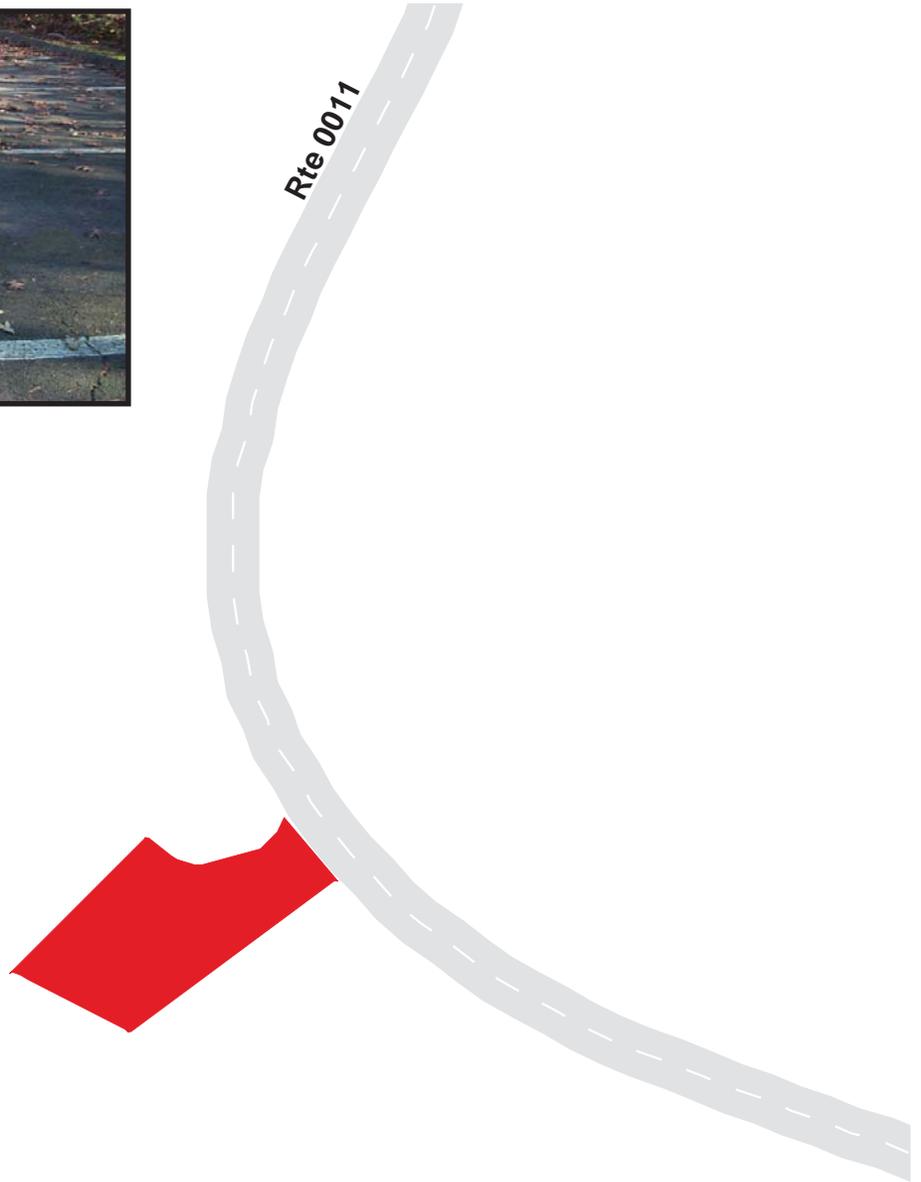
Route 0915

Route	Public / NonPublic	Date Visited	Area (sq ft)	Lane Miles *	Surface Type	Condition / PCR
0915	PUBLIC	12/12/2001	4239	0.07	OC	FAIR / 73

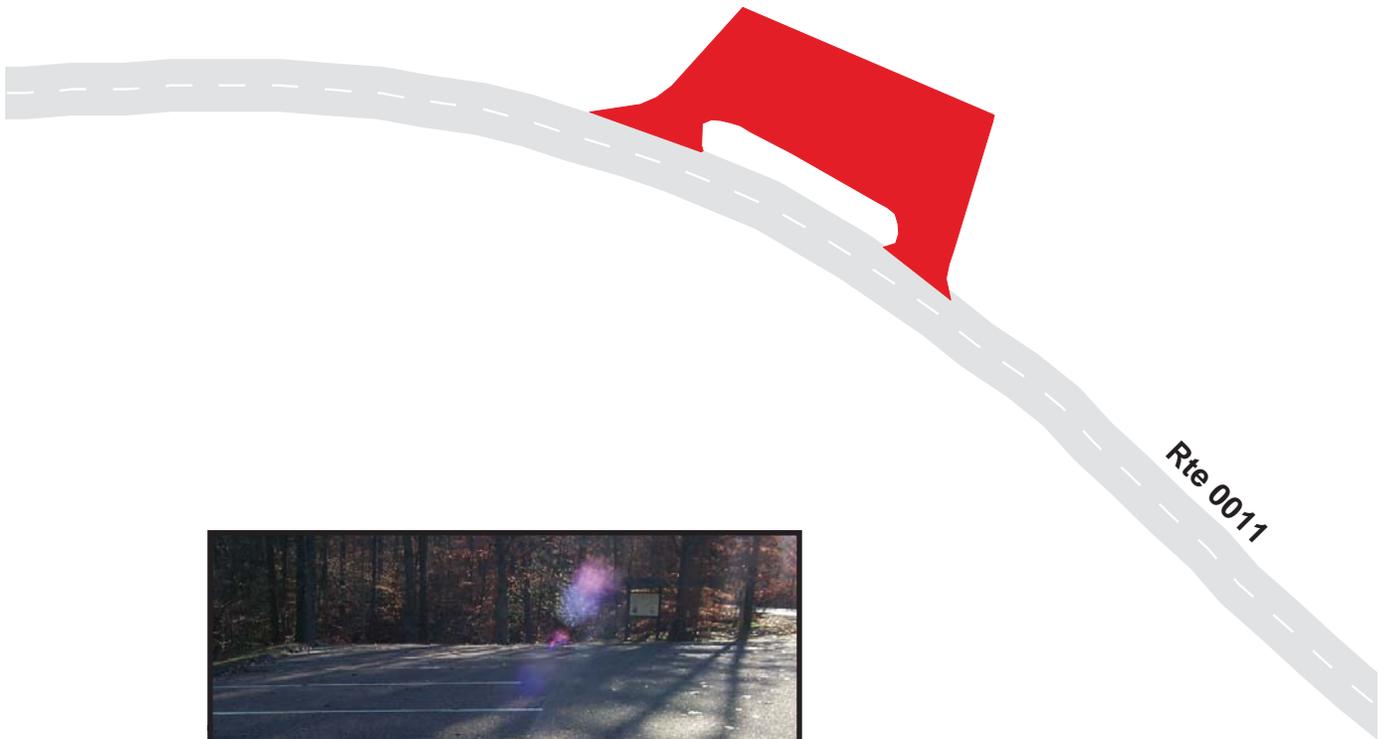
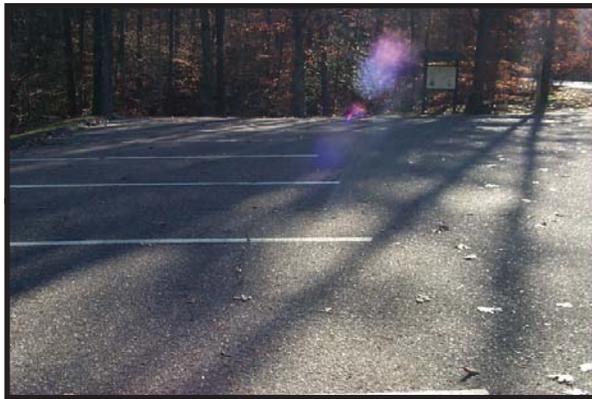
Route 0916

Route	Public / NonPublic	Date Visited	Area (sq ft)	Lane Miles *	Surface Type	Condition / PCR
0916	PUBLIC	12/12/2001	3854	0.07	AS	FAIR / 73

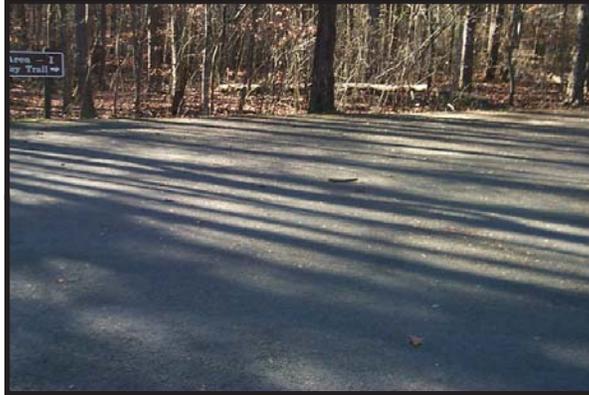
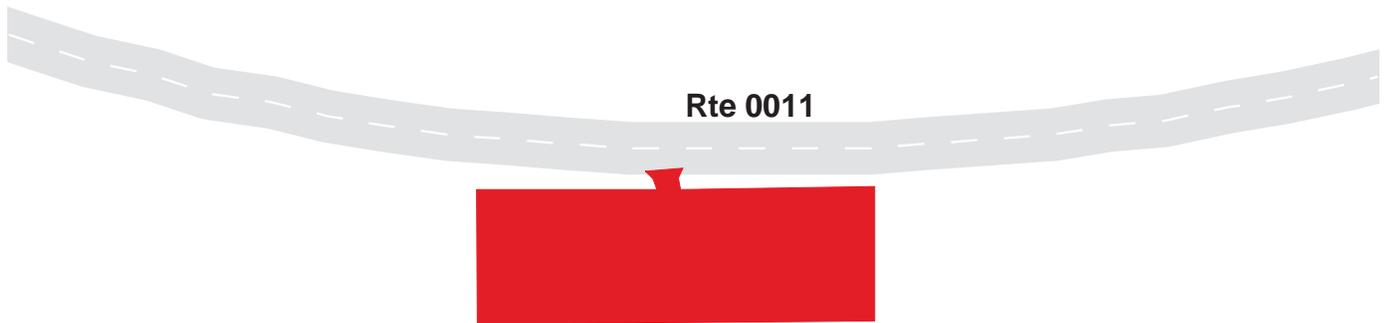
Route 0917

Route	Public / NonPublic	Date Visited	Area (sq ft)	Lane Miles *	Surface Type	Condition / PCR
0917	PUBLIC	12/12/2001	3432	0.06	AS	FAIR / 73
