# The Road Inventory of Puukohola Heiau National Historic Site PUHE - 8310

## Road Inventory Program

Prepared By:  
Federal Highway Administration  
Eastern Federal Lands Highway Division  
Cycle 3

# Puukohola Heiau National Historic Site in Hawaii

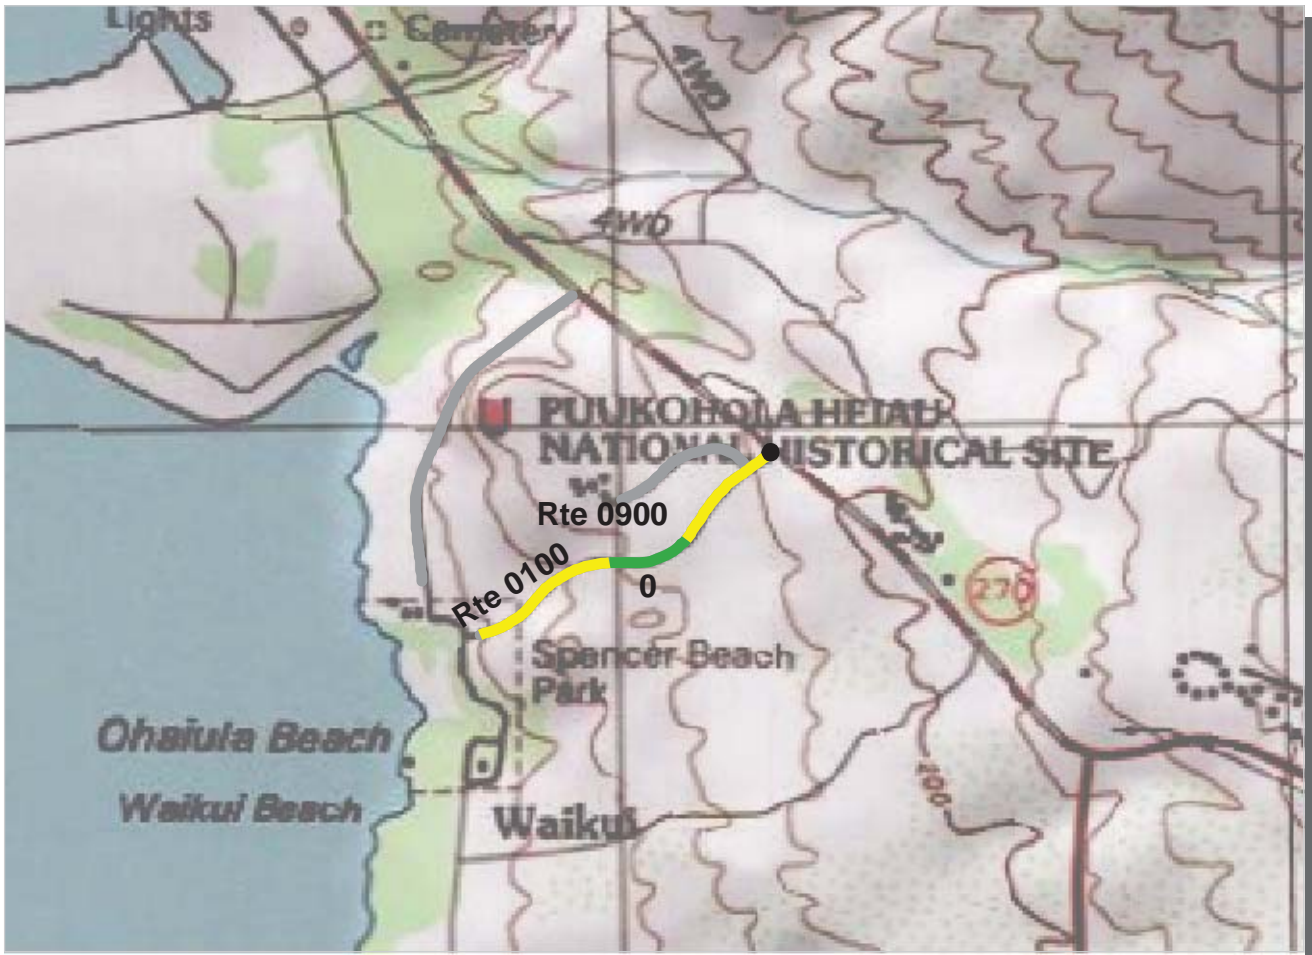
**ROUTE: 0100 New Spencer Beach Park Road** **TOTAL LENGTH: 0.36 Miles**

Section Number	0				
Section Length (mi)	0.36				
AADT	**				
SADT	**				
ADT Date	**				
<b>Cross Section Information</b>					
Number of Lanes	2				
Paved Width (ft)	21				
Lane Width (ft)	10				
Shoulder Width (ft)	4				
<b>Roadway Condition Information</b>					
PCR (Pavement Condition Rating)	78				
RCI (Roughness Condition Index)	95				
SCR (Surface Condition Rating)	71				
Alligator Cracking Index	100				
Rutting Index	71				
Patching Index	100				
Transverse Cracking Index	99				
Longitudinal Cracking Index	99				
Shoulder Condition Rating	N/C				
Drainage Condition Rating	N/C

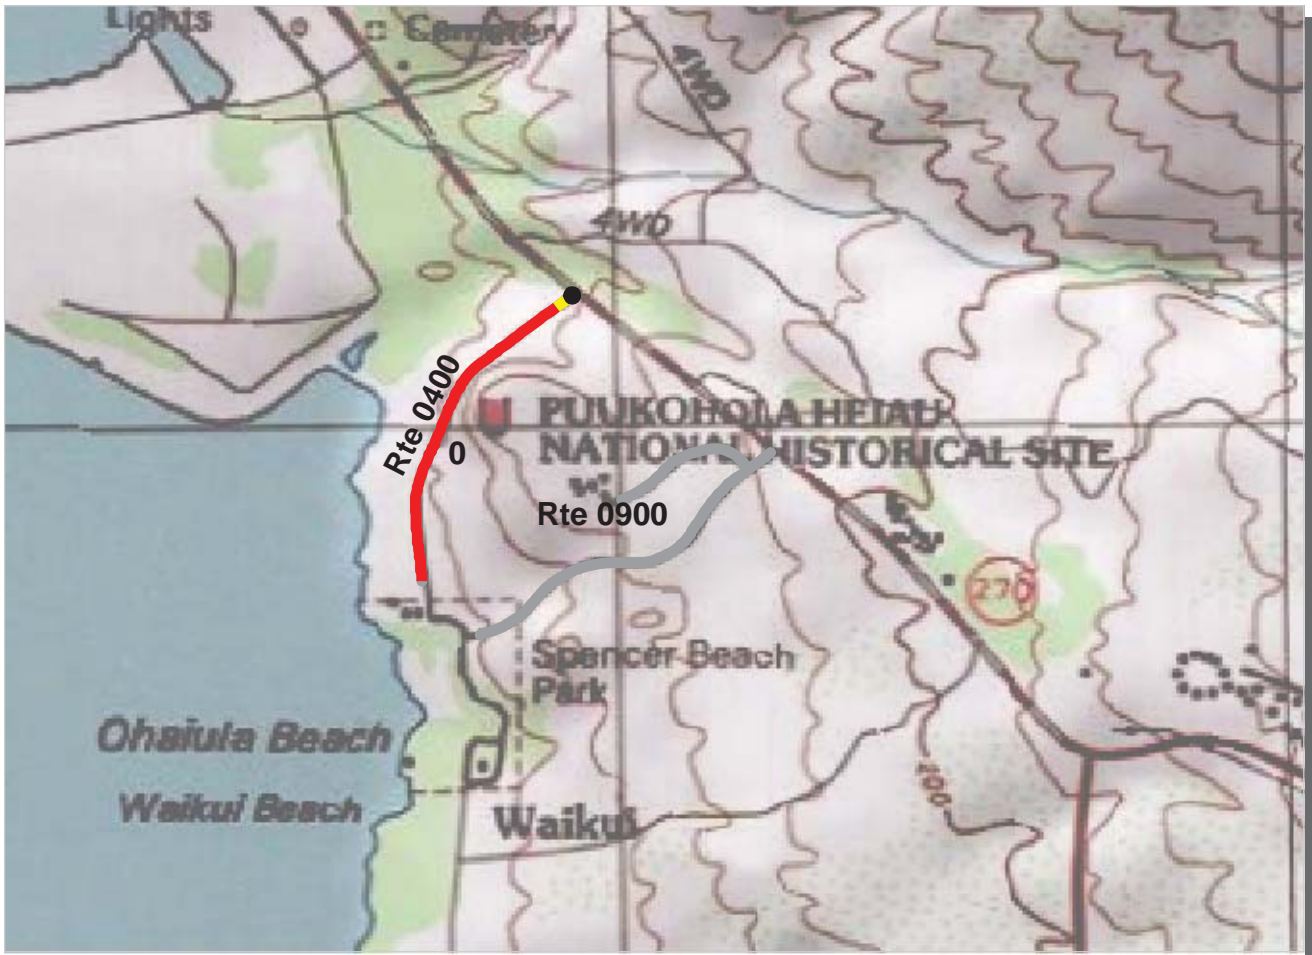
**ROUTE: 0400 Old Spencer Beach Park Road** **TOTAL LENGTH: 0.36 Miles**

Section Number	0				
Section Length (mi)	0.36				
AADT	**				
SADT	**				
ADT Date	**				
<b>Cross Section Information</b>					
Number of Lanes	2				
Paved Width (ft)	21				
Lane Width (ft)	10				
Shoulder Width (ft)	0				
<b>Roadway Condition Information</b>					
PCR (Pavement Condition Rating)	4				
RCI (Roughness Condition Index)	NC				
SCR (Surface Condition Rating)	4				
Alligator Cracking Index	5				
Rutting Index	62				
Patching Index	100				
Transverse Cracking Index	90				
Longitudinal Cracking Index	97				
Shoulder Condition Rating	N/A				
Drainage Condition Rating	N/C
