**The Road Inventory
of
Pu'uhonua o Honaunau National Historical Park
PUHO - 8280**

Road Inventory Program

Prepared By:
Federal Highway Administration
Eastern Federal Lands Highway Division
Cycle 3

Pu'uhonua o Honaunau National Historical Park in Hawaii

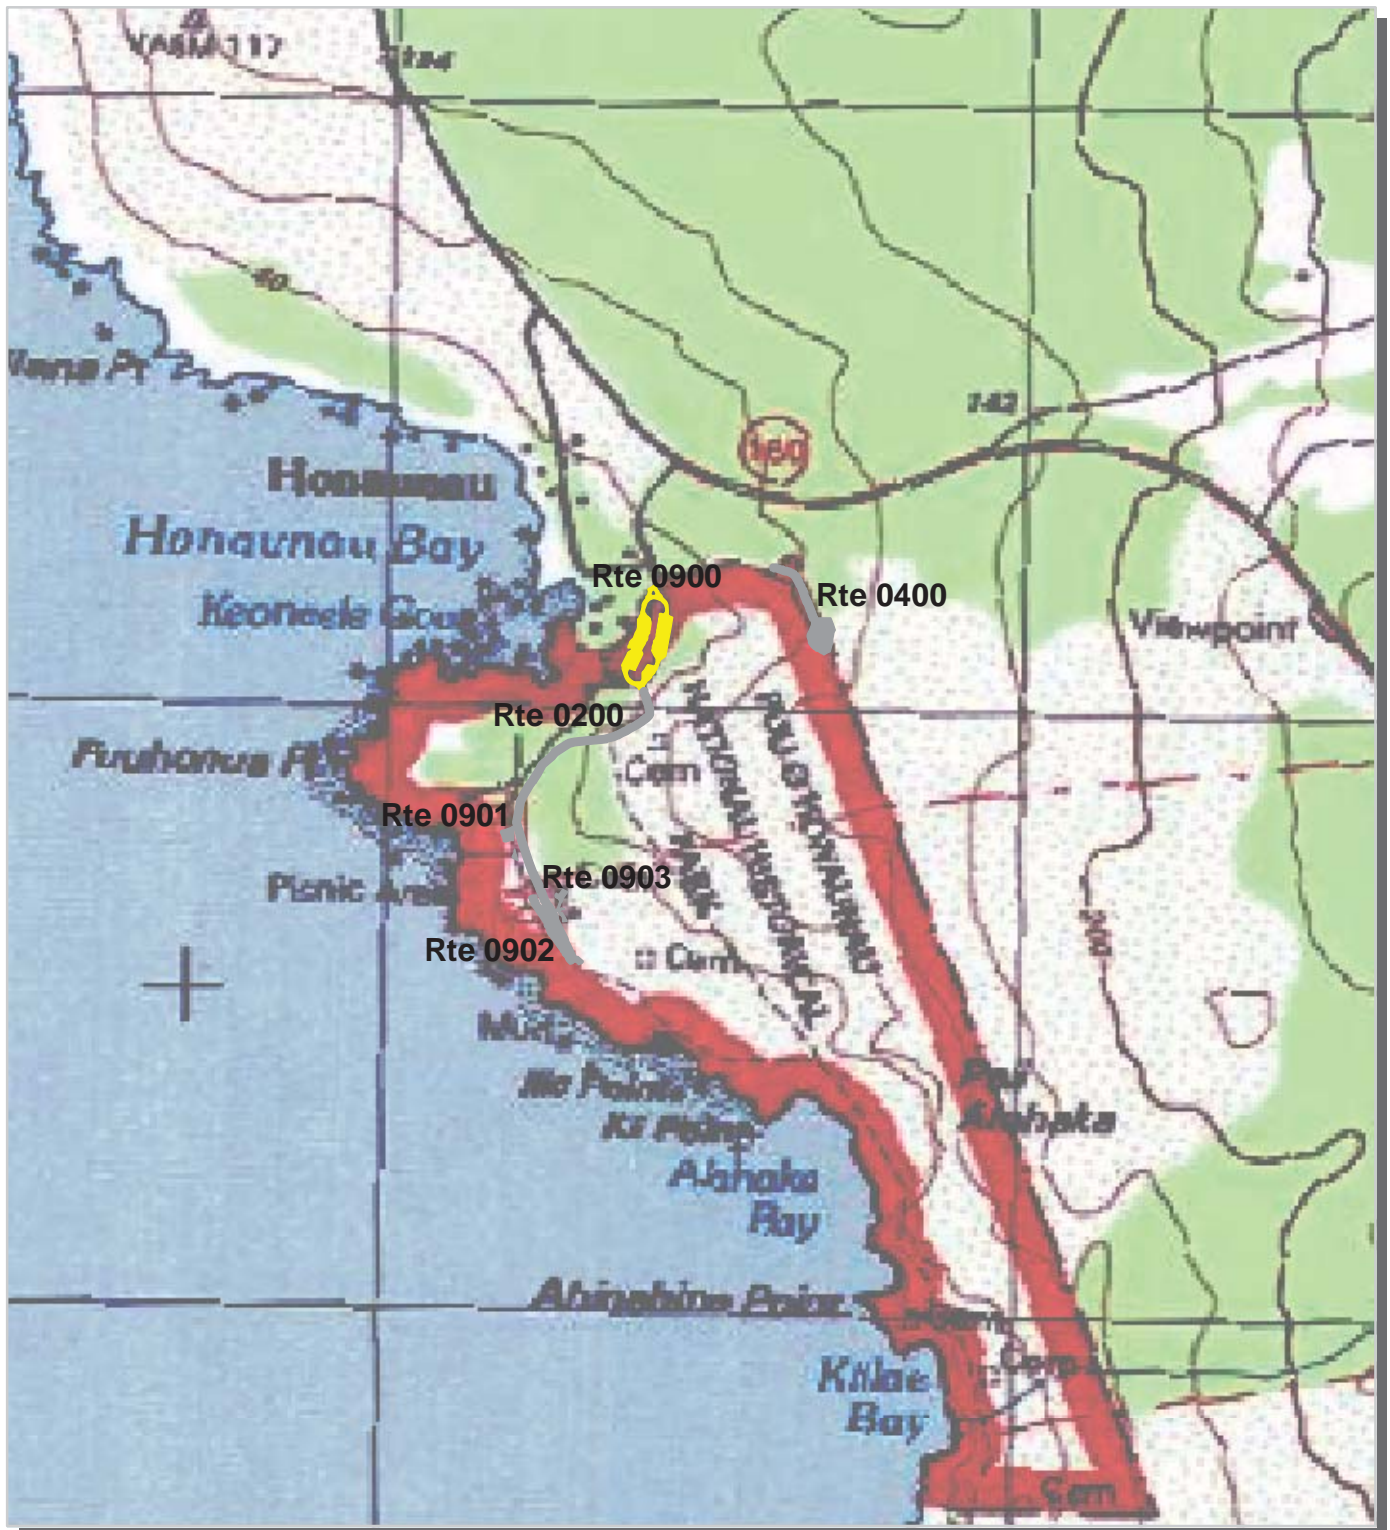
Route Condition Key Map

PCR - Mile by Mile

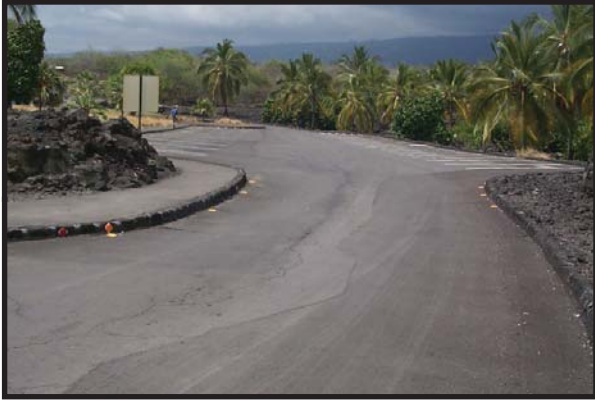
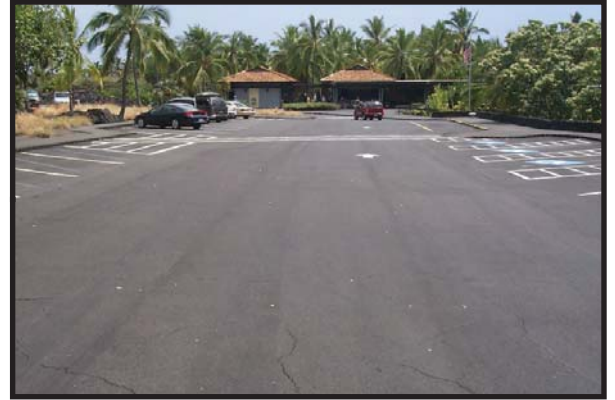
Route 0900

Visitor Center Parking
From North Park Boundary

Route	Public / NonPublic	Date Visited	Area (sq ft)	Lane Miles *	Surface Type	Condition / PCR
0900	Public	5/11/2001	51294	0.88	AS	FAIR / 73

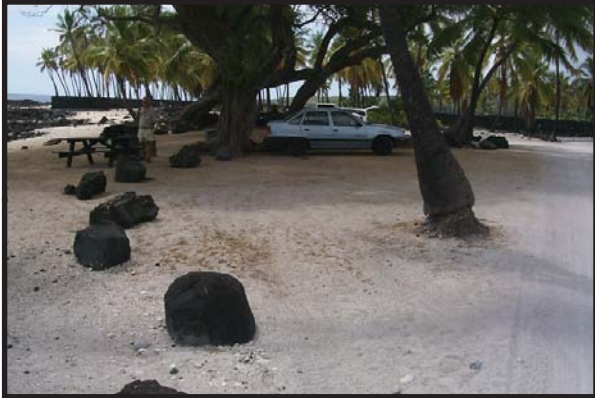
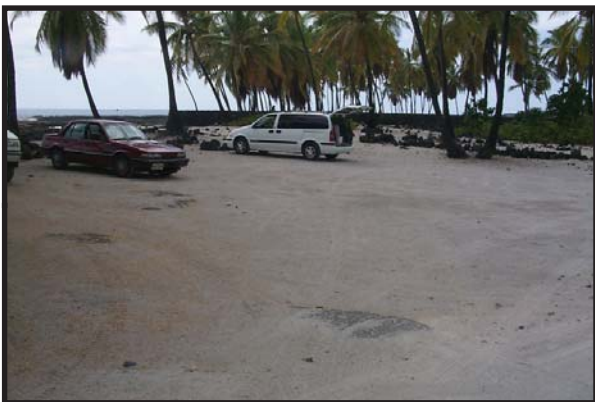
Route 0901

Roadside Picnic Parking
Adjacent to Route 0200

Route	Public / NonPublic	Date Visited	Area (sq ft)	Lane Miles *	Surface Type	Condition / PCR
0901	Public	5/11/2001	4570	0.08	DT	NC / -1

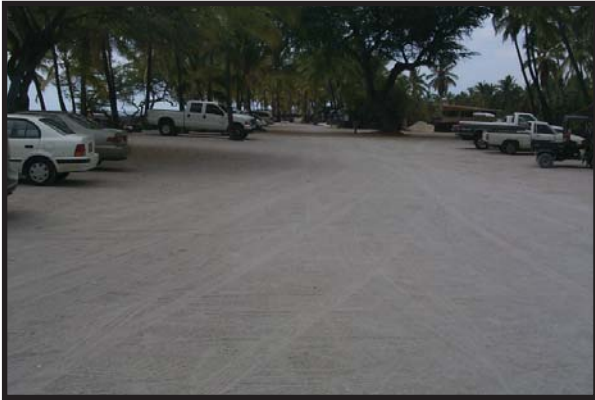
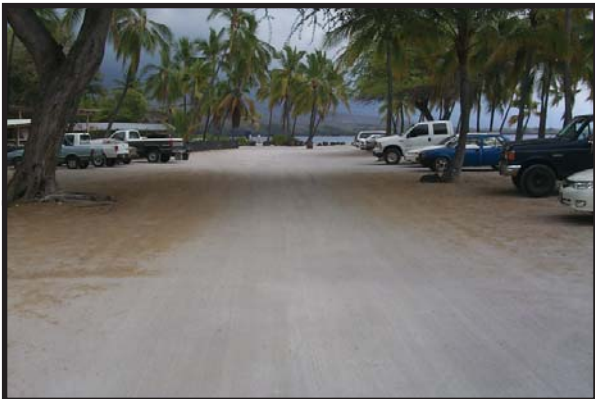
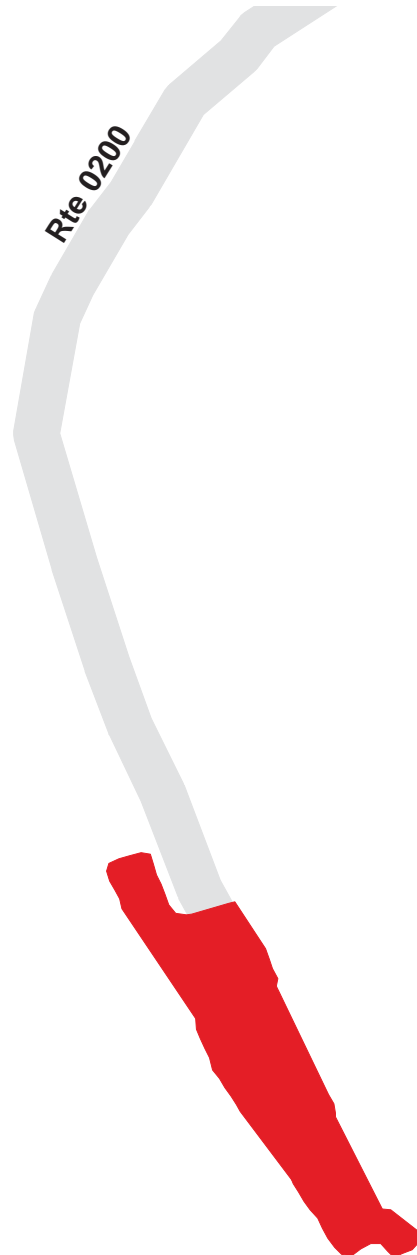
Route 0902

Picnic Area Parking
At End of Route 0200

Route	Public / NonPublic	Date Visited	Area (sq ft)	Lane Miles *	Surface Type	Condition / PCR
0902	Public	5/11/2001	27409	0.47	DT	NC / -1

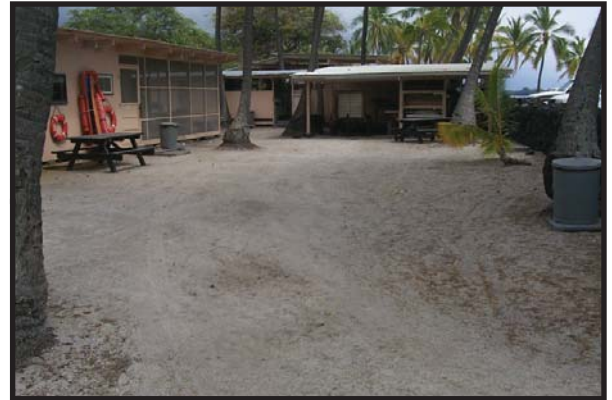
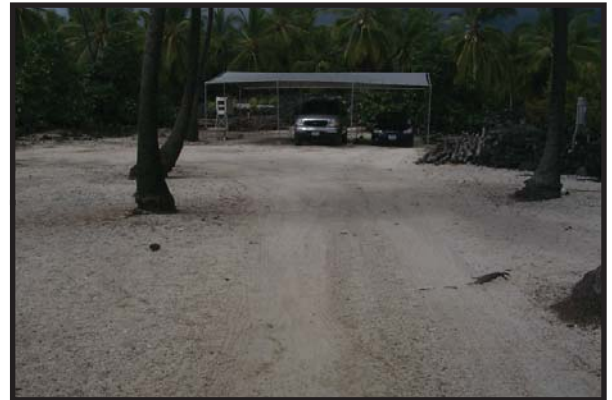
Route 0903

Administrative Parking
Adjacent to Route 0902

Route	Public / NonPublic	Date Visited	Area (sq ft)	Lane Miles *	Surface Type	Condition / PCR
0903	NonPublic	5/11/2001	3620	0.06	DT	NC / -1
