**The Road Inventory
of
Redwood National Park
REDW - 8480**

Road Inventory Program

Prepared By:
Federal Highway Administration
Eastern Federal Lands Highway Division
Cycle 3

Redwood National Park in California

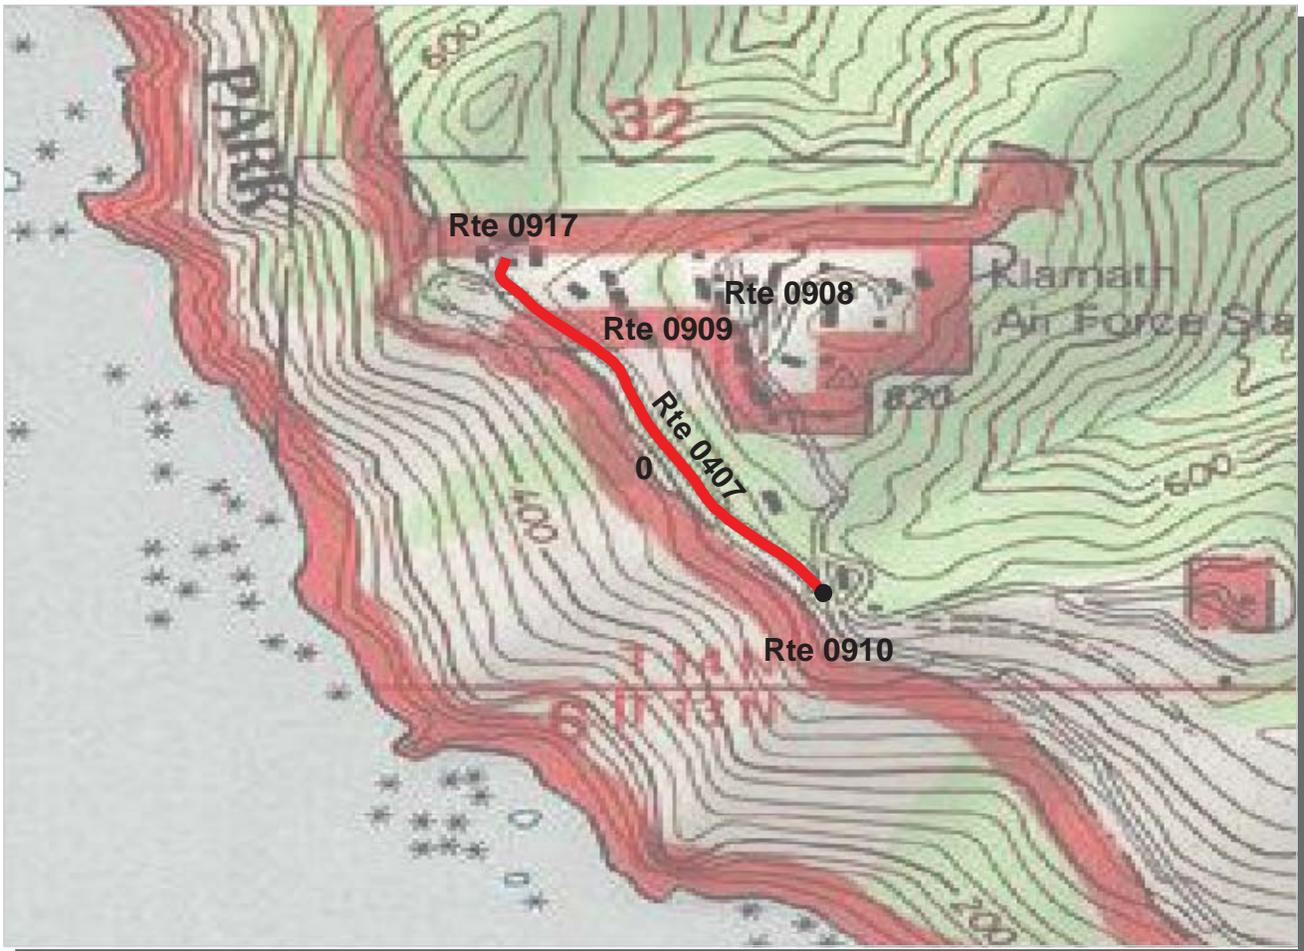
ROUTE: 0407 Residence Road **TOTAL LENGTH: 0.41 Miles**

Section Number	0				
Section Length (mi)	0.41				
AADT	**				
SADT	**				
ADT Date	**				
Cross Section Information					
Number of Lanes	2				
Paved Width (ft)	20				
Lane Width (ft)	10				
Shoulder Width (ft)	0				
Roadway Condition Information					
PCR (Pavement Condition Rating)	26				
RCI (Roughness Condition Index)	60				
SCR (Surface Condition Rating)	21				
Alligator Cracking Index	88				
Rutting Index	33				
Patching Index	97				
Transverse Cracking Index	98				
Longitudinal Cracking Index	96				
Shoulder Condition Rating	N/A				
Drainage Condition Rating	N/A

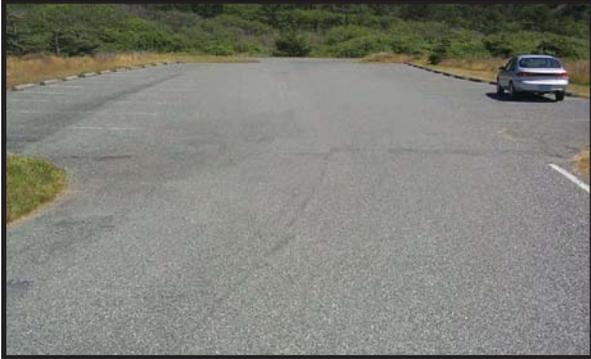
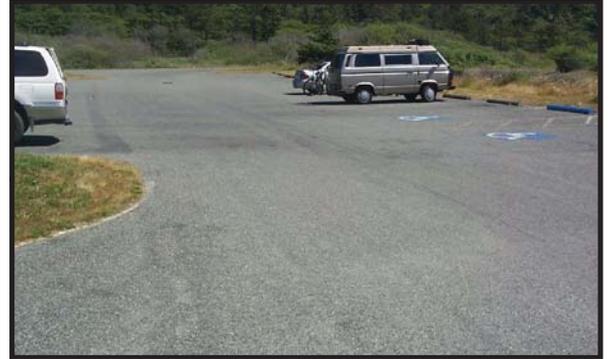
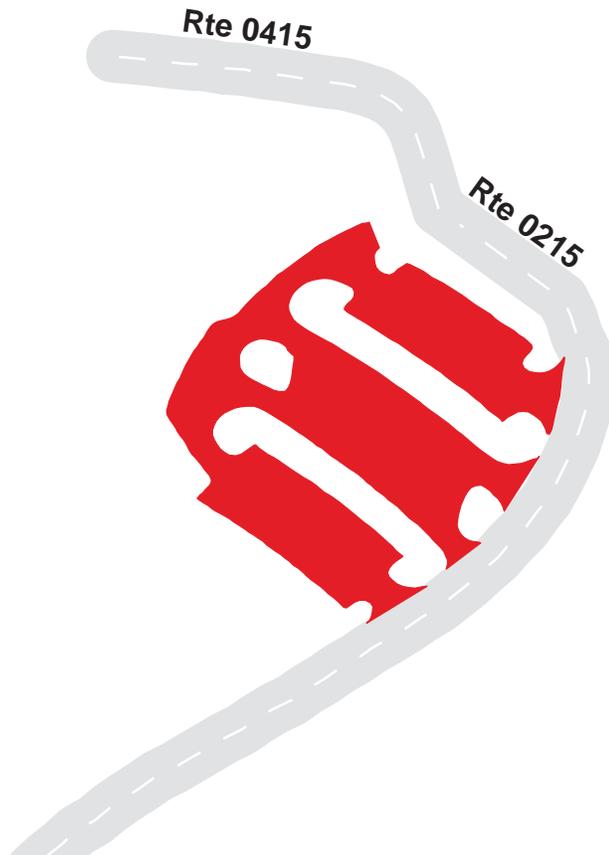
Redwood National Park
Route 0901
 REDWOOD CREEK PICNIC AREA PARKING
 FROM ROUTE 0215

Route	Public / NonPublic	Date Visited	Area (sq ft)	Lane Miles *	Surface Type	Condition / PCR
0901	Public	6/13/2001	25648	0.44	AS	GOOD / 90

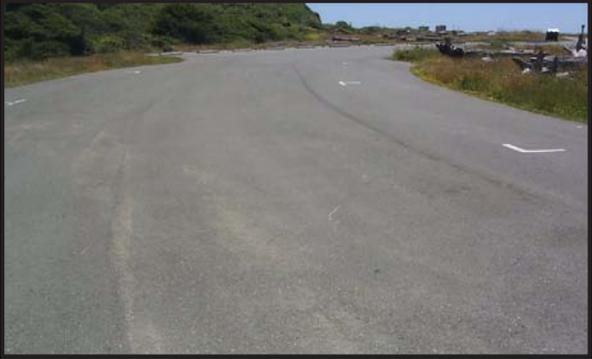
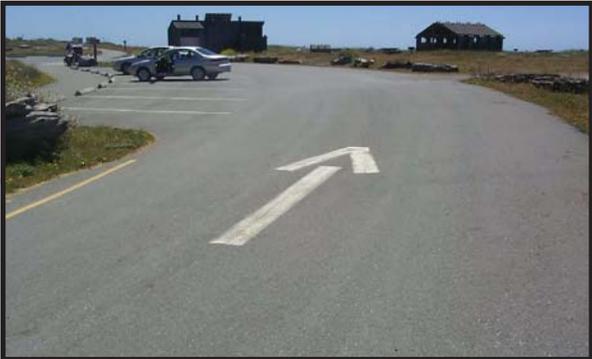
Redwood National Park
Route 0902
 PARK HEADQUARTERS PARKING
 FROM 3RD STREET IN CRESENT CITY

Route	Public / NonPublic	Date Visited	Area (sq ft)	Lane Miles *	Surface Type	Condition / PCR
0902	Public	6/12/2001	11770	0.20	AS	GOOD / 90

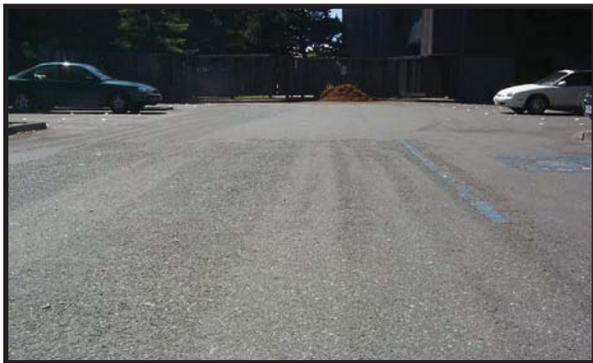
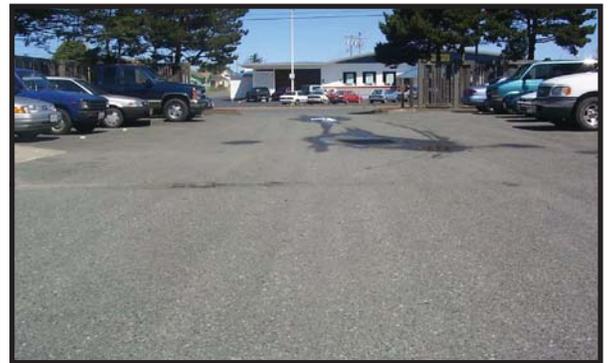
Redwood National Park
Route 0903
 HIOUCHI INFORMATION CENTER PARKING
 FROM US 199

Route	Public / NonPublic	Date Visited	Area (sq ft)	Lane Miles *	Surface Type	Condition / PCR
0903	Public	6/12/2001	29914	0.52	AS	EXCELLENT / 97

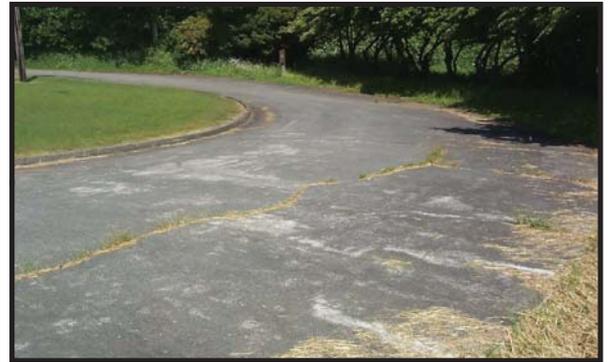
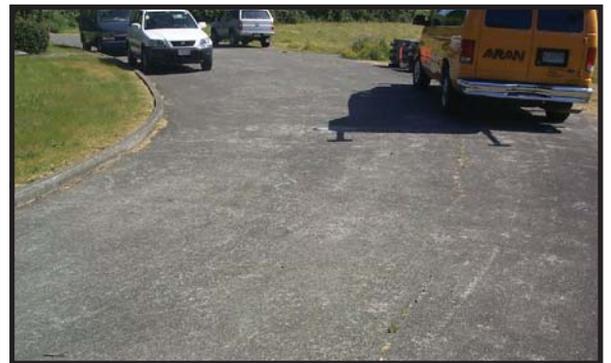
Redwood National Park
Route 0912
DOUGLAS BRIDGE PARKING
FROM ROUTE 0102

Route	Public / NonPublic	Date Visited	Area (sq ft)	Lane Miles *	Surface Type	Condition / PCR
0912	Public	6/14/2001	9990	0.17	AS	FAIR / 73

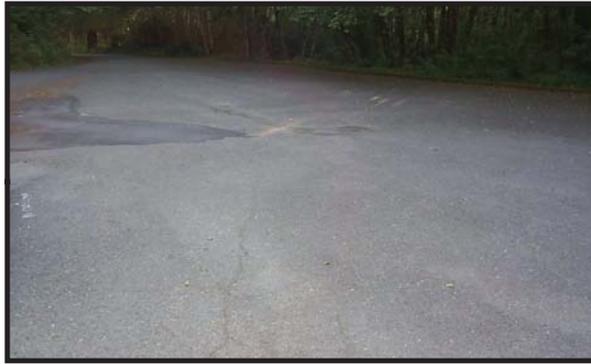
Redwood National Park
Route 0913
ELK MEADOW DAY USE AREA PARKING
FROM ROUTE 0115

Route	Public / NonPublic	Date Visited	Area (sq ft)	Lane Miles *	Surface Type	Condition / PCR
0913	Public	6/14/2001	45118	0.78	AS	EXCELLENT / 97

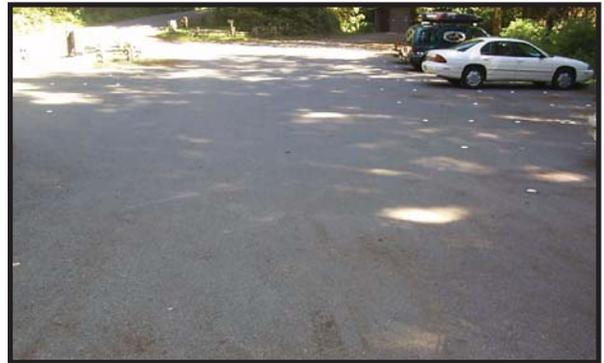
Redwood National Park
Route 0915
 REDWOOD CREEK TRAILHEAD PARKING
 FROM ROUTE 0210

Route	Public / NonPublic	Date Visited	Area (sq ft)	Lane Miles *	Surface Type	Condition / PCR
0915	Public	6/13/2001	23359	0.40	OC	GOOD / 90

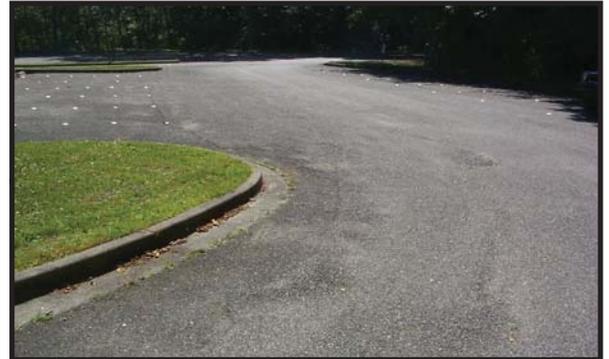
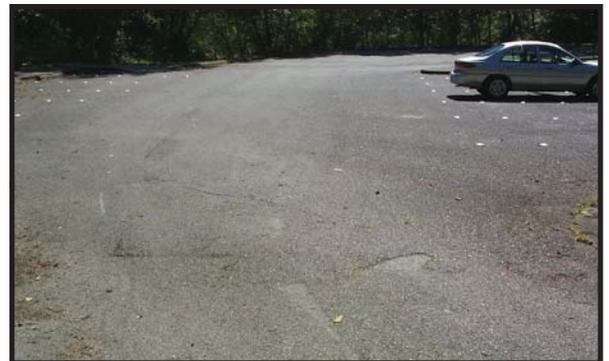
Redwood National Park
Route 0916
REDWOOD CREEK OVERLOOK PARKING
FROM BALD HILLS ROAD

Route	Public / NonPublic	Date Visited	Area (sq ft)	Lane Miles *	Surface Type	Condition / PCR
0916	Public	6/14/2001	4121	0.07	AS	GOOD / 90

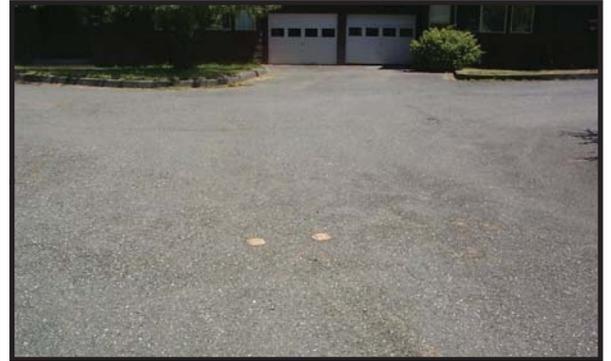
Redwood National Park
Route 0918
 HIOUCHI TRAILER PARKING
 FROM US 199

Route	Public / NonPublic	Date Visited	Area (sq ft)	Lane Miles *	Surface Type	Condition / PCR
0918	NonPublic	6/12/2001	9515	0.16	AS	GOOD / 90

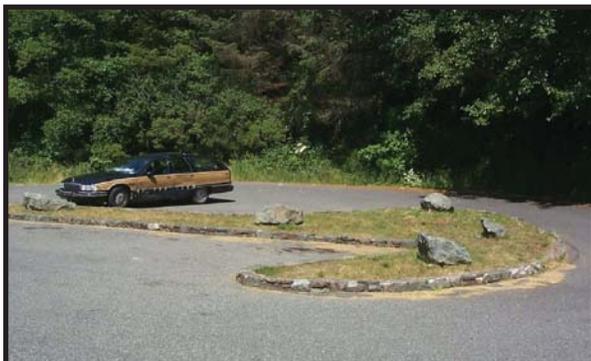
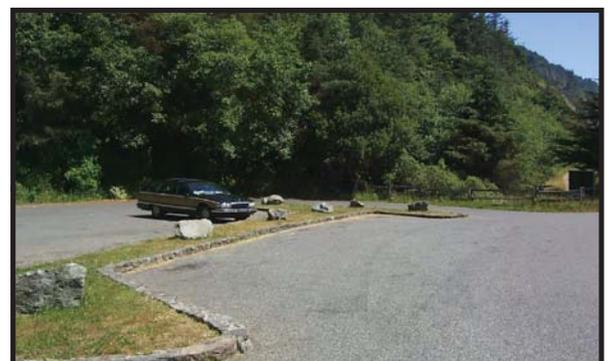
Redwood National Park
Route 0920
 FALSE KLAMATH COVE PARKING
 FROM US 101

Route	Public / NonPublic	Date Visited	Area (sq ft)	Lane Miles *	Surface Type	Condition / PCR
0920	Public	6/14/2001	9657	0.17	AS	EXCELLENT / 97

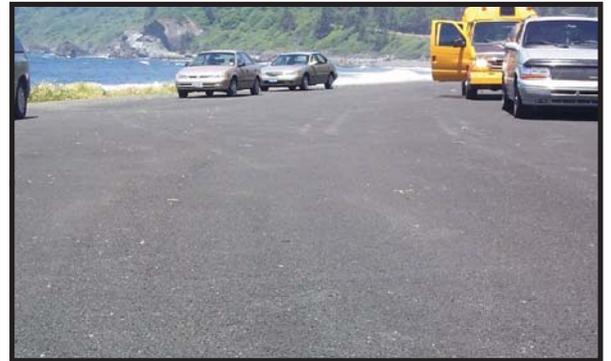
Redwood National Park
Route 0921A
DAVISON ROAD ELK VIEWING PARKING A
FROM ROUTE 0115

Route	Public / NonPublic	Date Visited	Area (sq ft)	Lane Miles *	Surface Type	Condition / PCR
0921A	Public	6/14/2001	2990	0.05	AS	EXCELLENT / 97

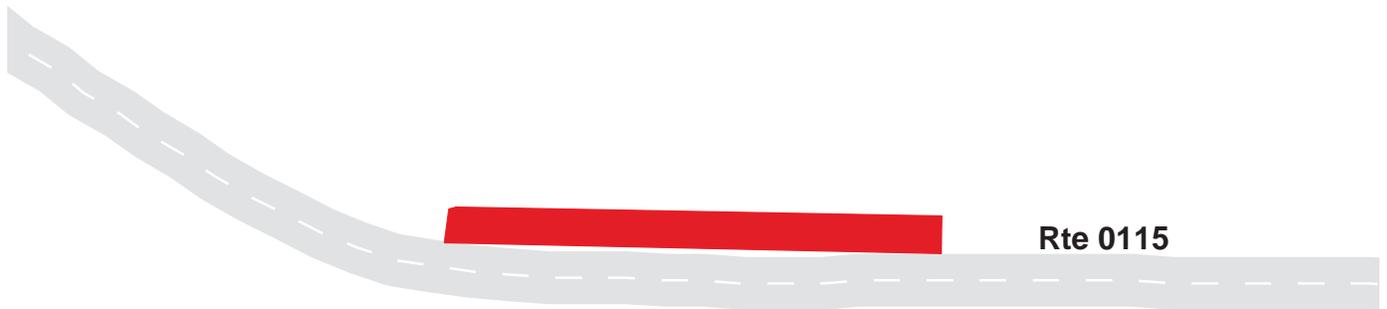
Redwood National Park
Route 0921B
DAVISON ROAD ELK VIEWING PARKING B
FROM ROUTE 0115

Route	Public / NonPublic	Date Visited	Area (sq ft)	Lane Miles *	Surface Type	Condition / PCR
0921B	Public	6/14/2001	4226	0.07	AS	EXCELLENT / 97
