# The Road Inventory of Richmond National Battlefield Park RICH - 4800

## Road Inventory Program

Prepared By:  
Federal Highway Administration  
Eastern Federal Lands Highway Division  
Cycle 3

# Richmond National Battlefield Park in Virginia

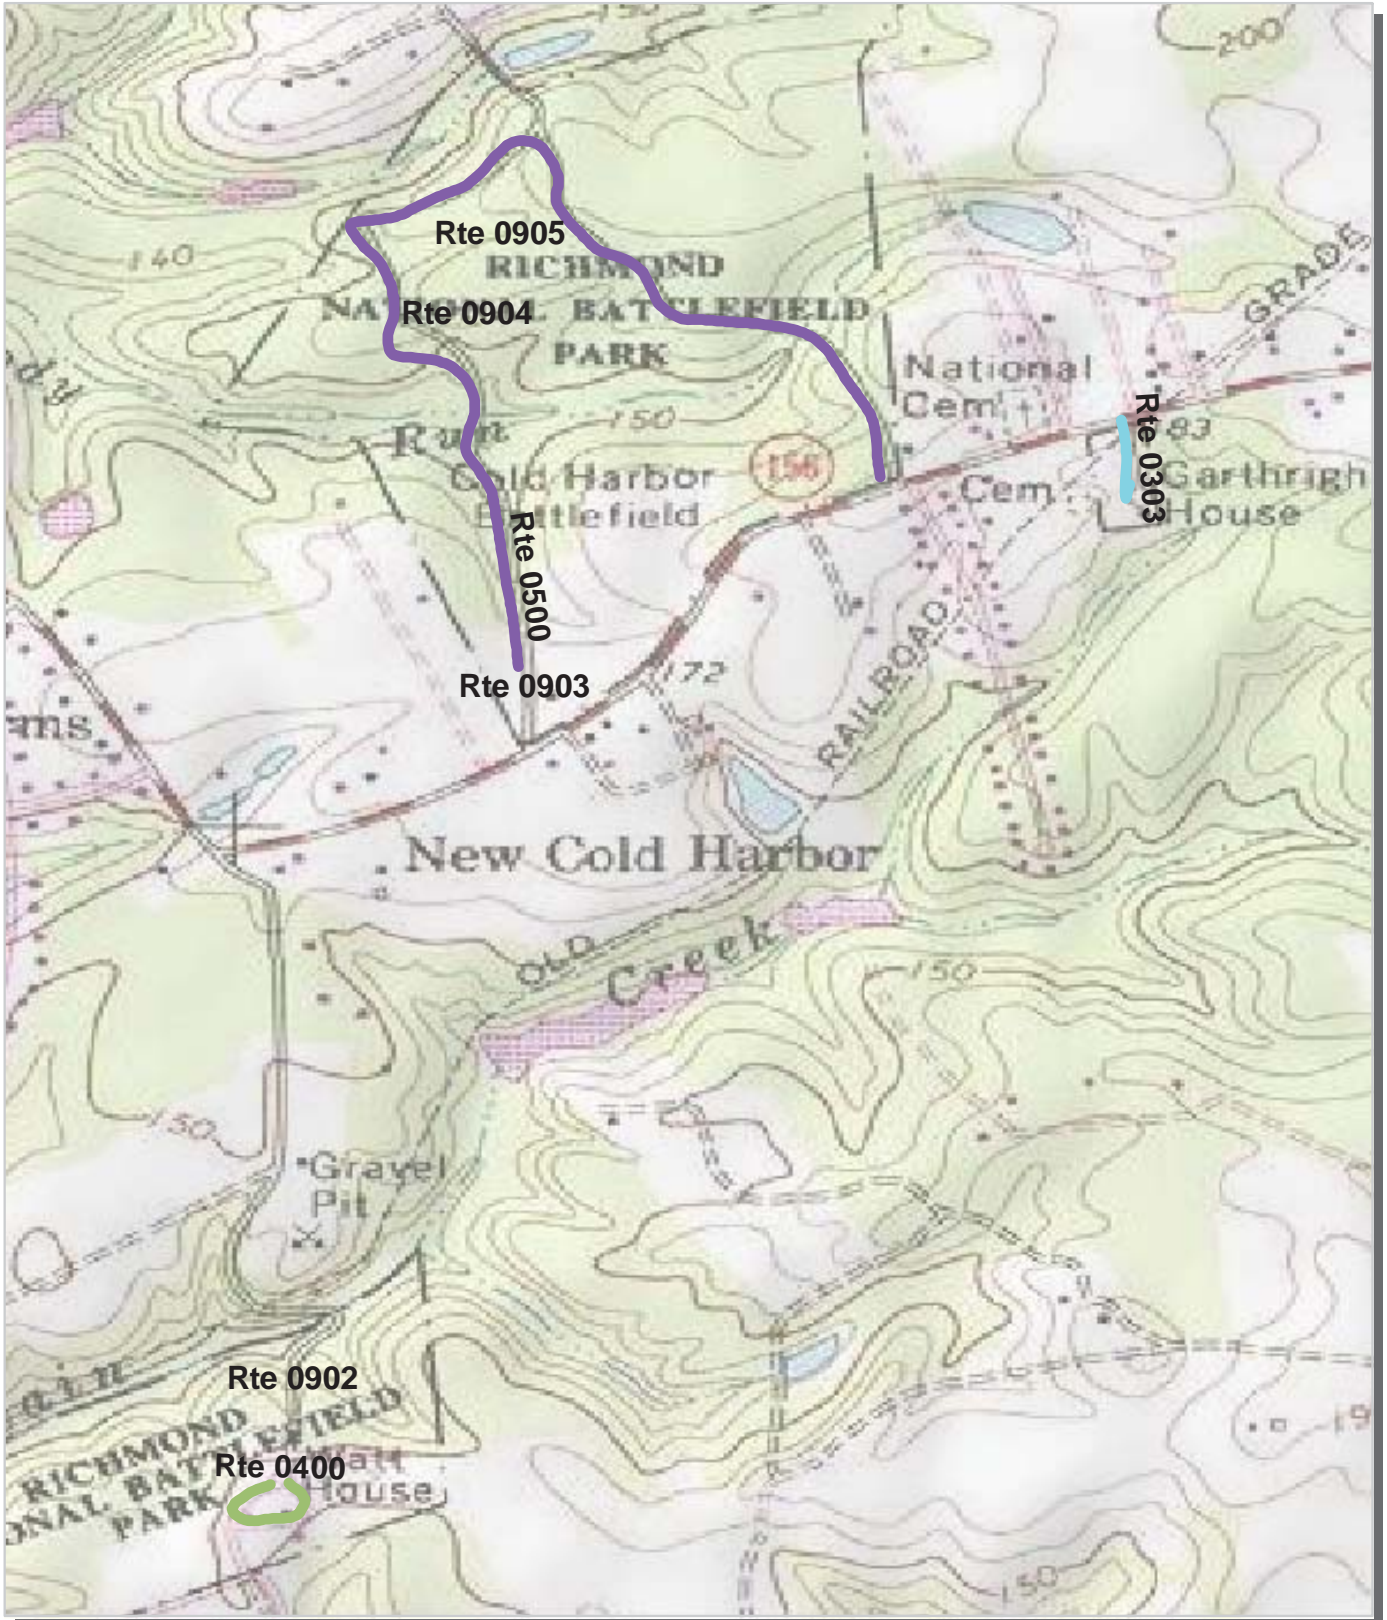
# Richmond National Battlefield Park Route Location Area Map 1

Unique colors used to differentiate routes

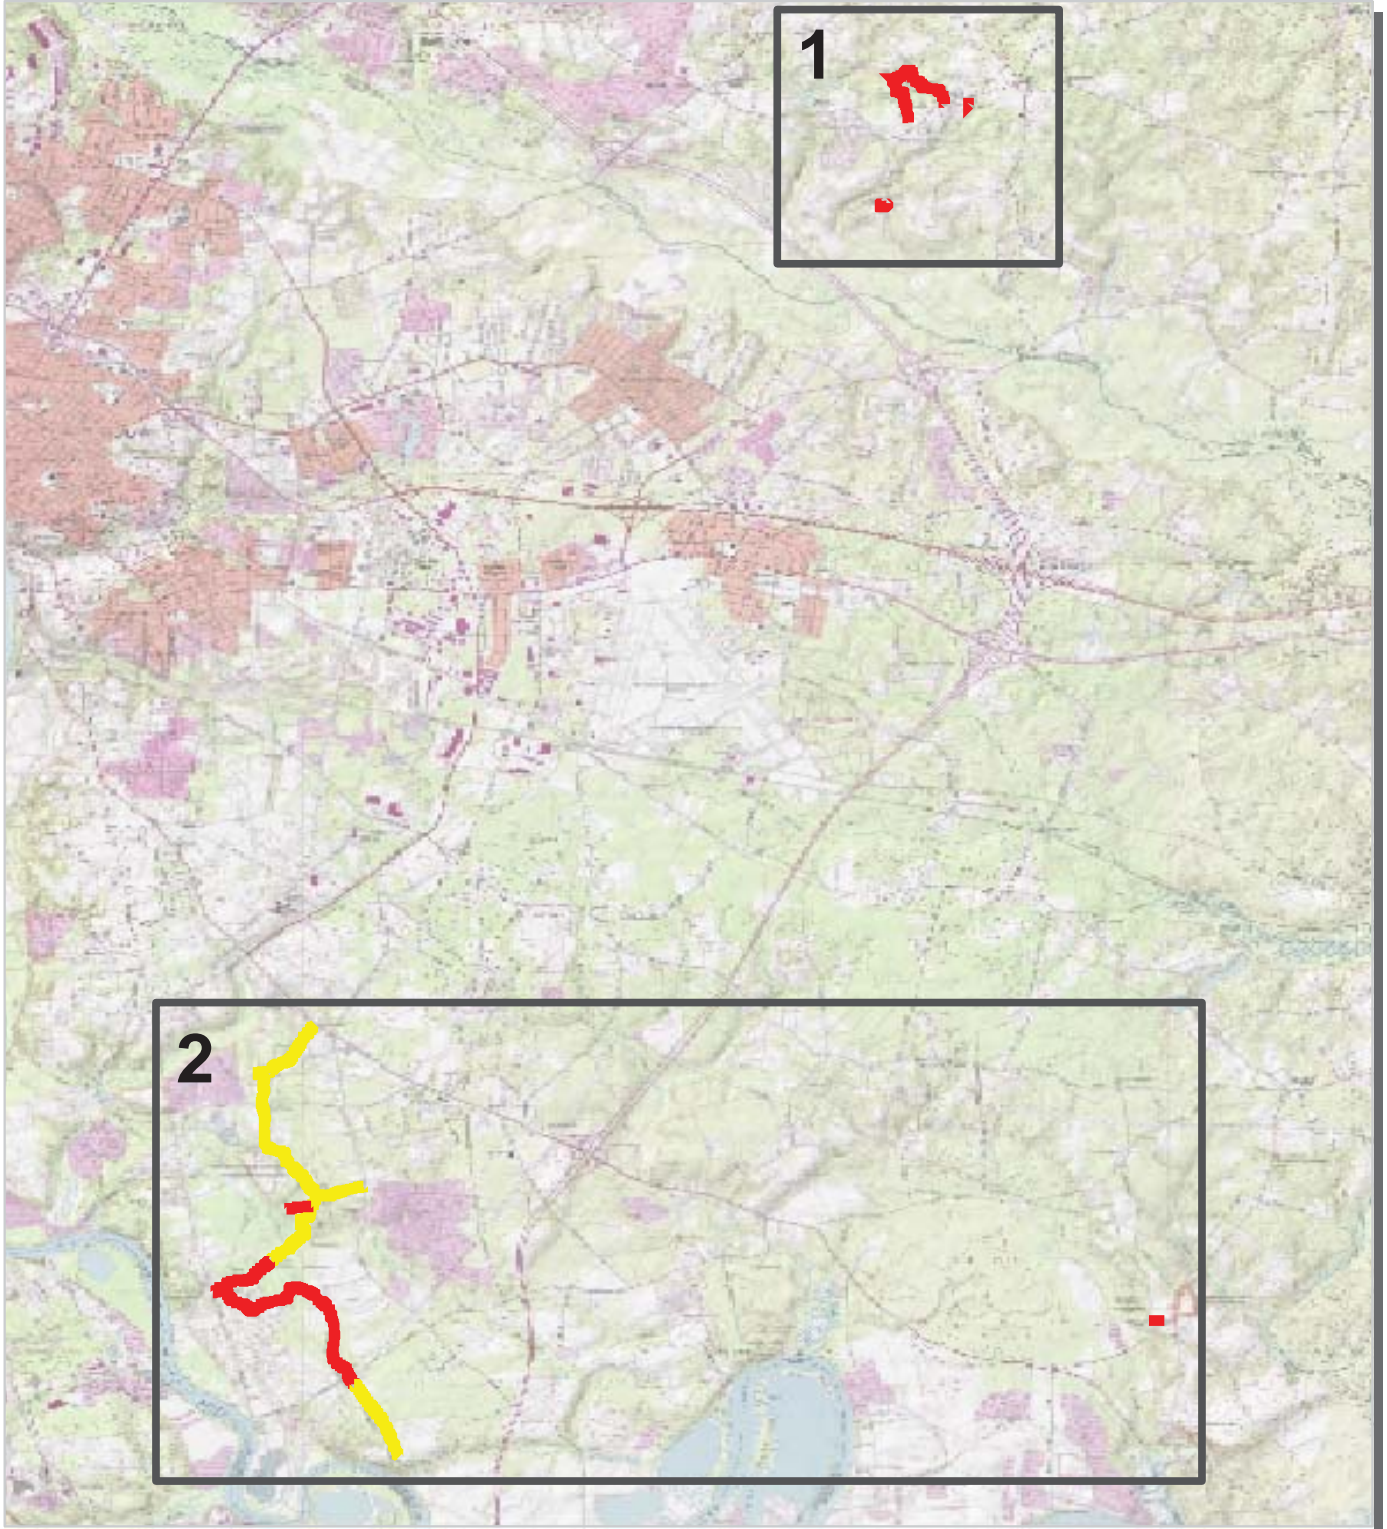
# Richmond National Battlefield Park Route Condition Key Map PCR - Mile by Mile

| PCR | Poor | | Fair | | Good | | Excellent | |
| | | (<=60) | | (61 - 84) | | (85 - 94) | | (95 - 100) |

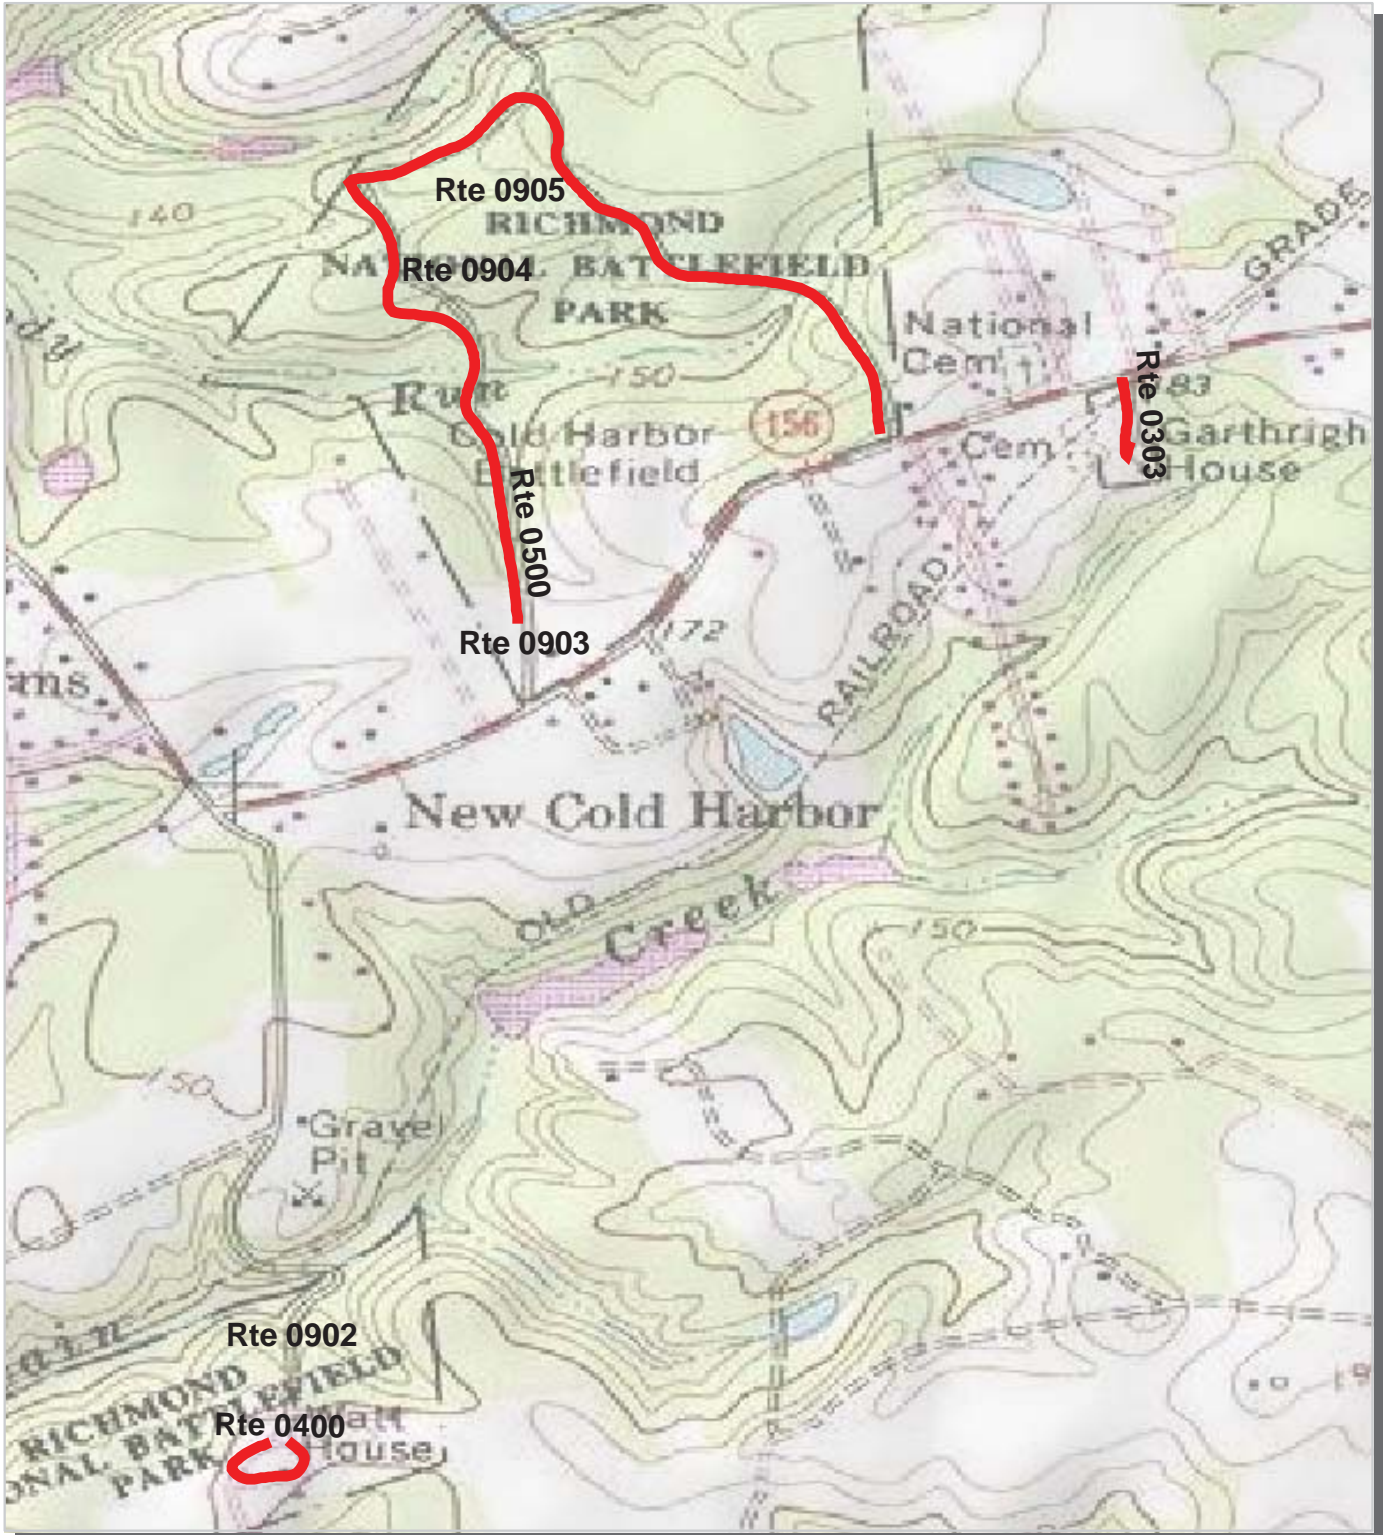
# Richmond National Battlefield Park Route Condition Area Map 1 PCR - Mile by Mile

| PCR | Poor | Fair | Good | Excellent |
| | (<=60) | (61 - 84) | (85 - 94) | (95 - 100) |

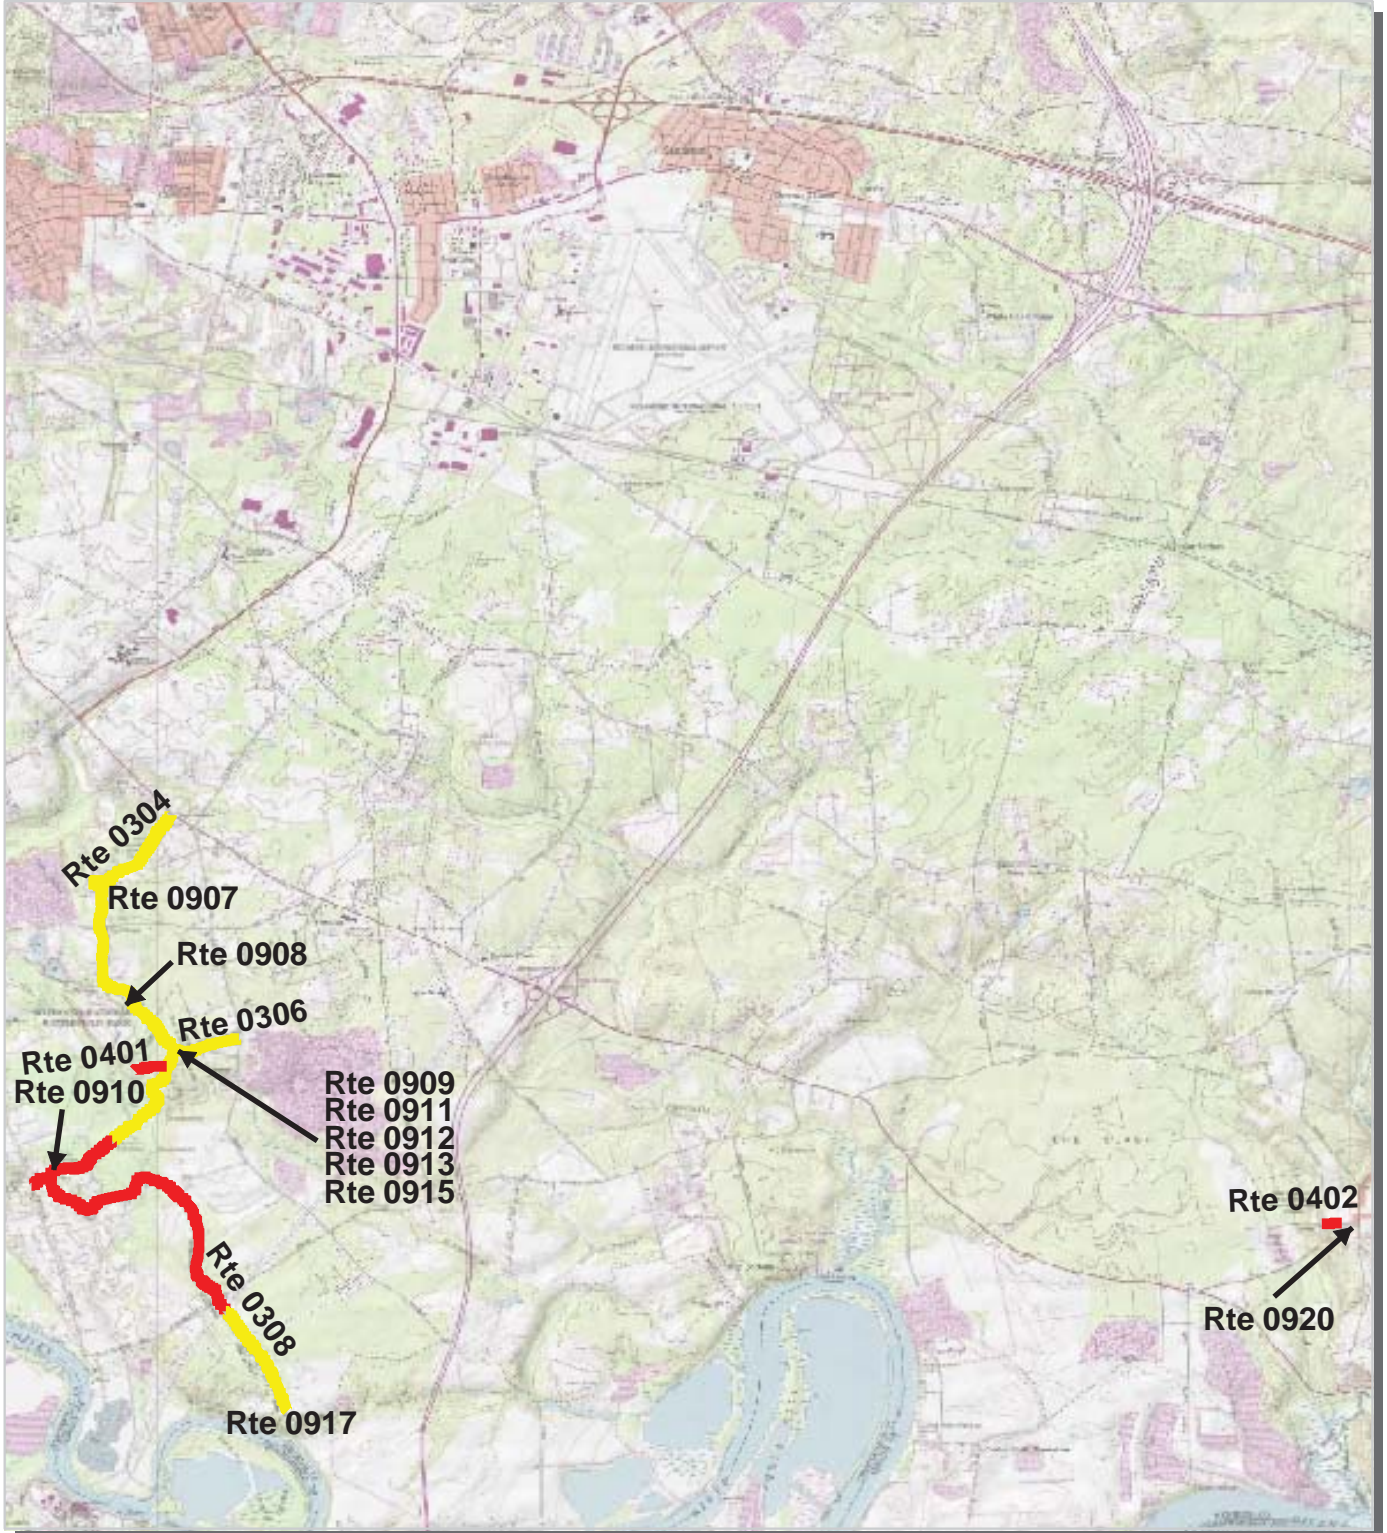
## Route Condition Area Map 2

| PCR | Poor | <span style="color: red;">■</span> | Fair | <span style="color: yellow;">■</span> | Good | <span style="color: green;">■</span> | Excellent | <span style="color: blue;">■</span> |
| | | (<=60) | | (61 - 84) | | (85 - 94) | | (95 - 100) |

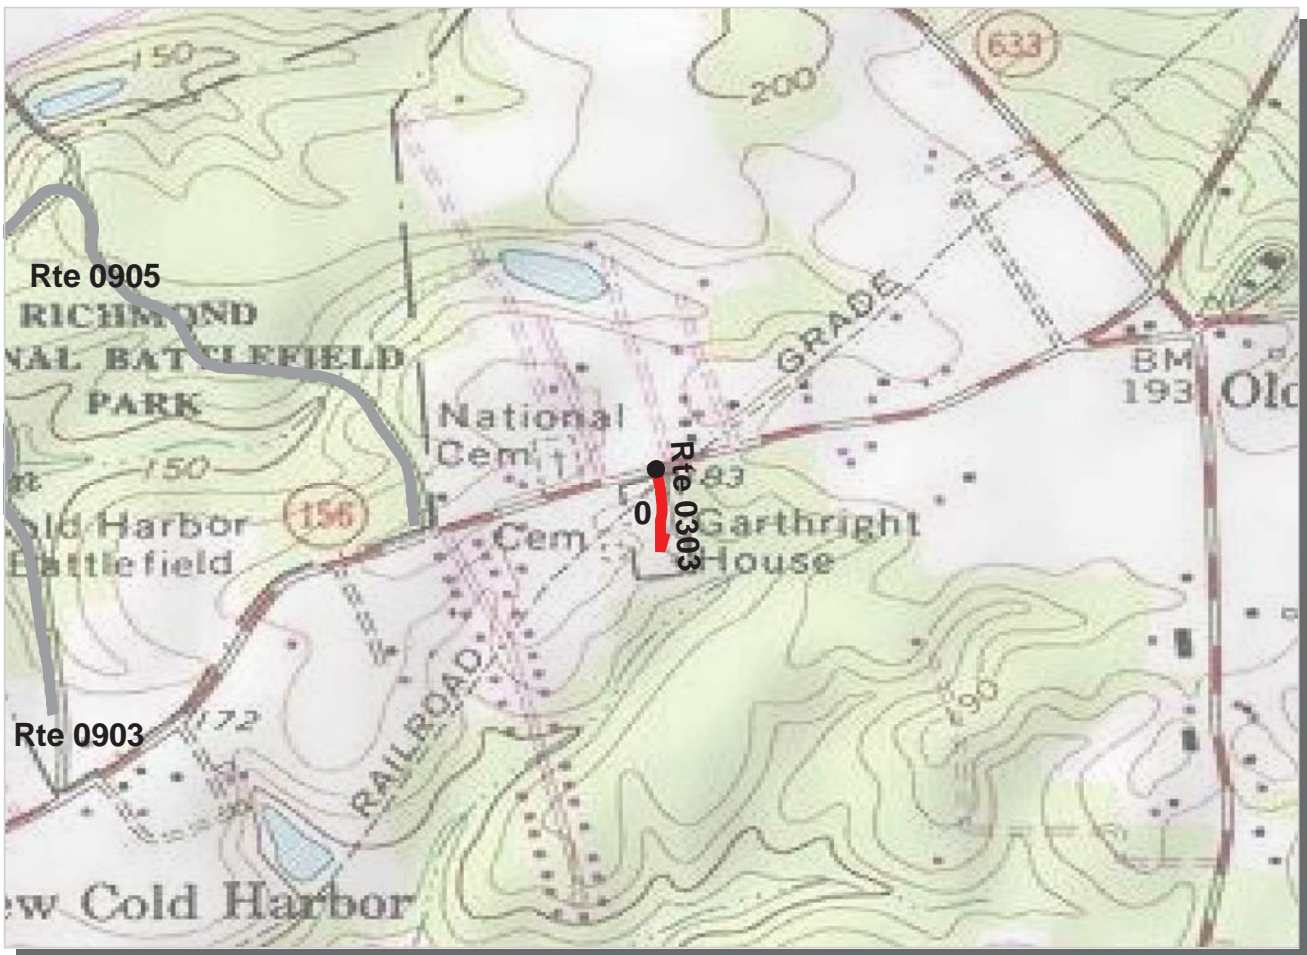
ROUTE: 0303 Garthright House Road

| PCR (Pavement Condition Rating) | 14 | | | | |
| SCR (Surface Condition Rating) | 14 | | | | |
| Shoulder Condition Rating | GOOD | | | | |
| Drainage Condition Rating | GOOD | | | | |

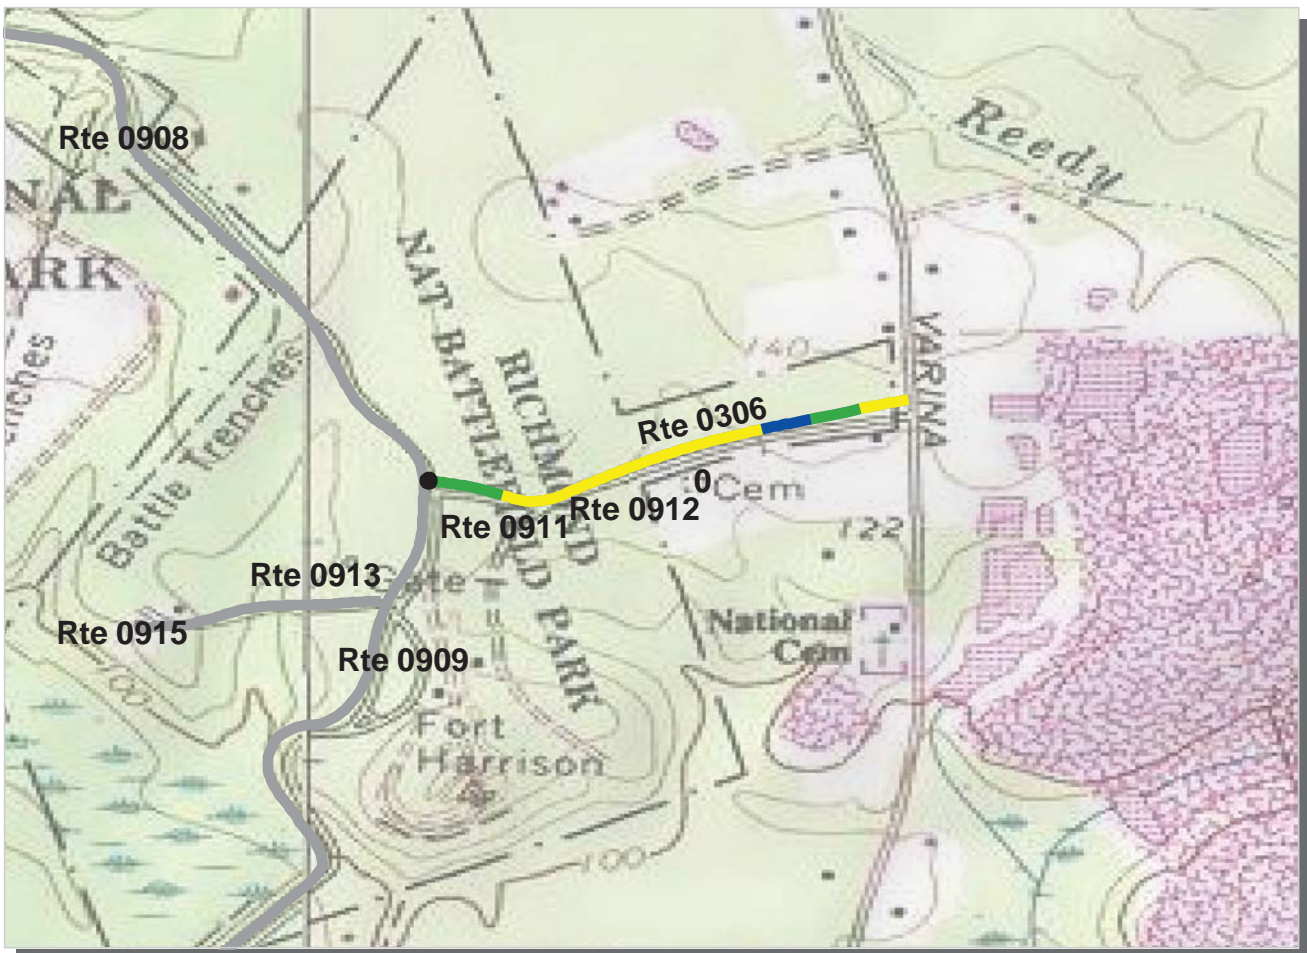
**ROUTE: 0306 Picnic Road** **TOTAL LENGTH: 0.41 Miles**

| PCR (Pavement Condition Rating) | 75 | | | |
| RCI (Roughness Condition Index) | 80 | | | |
| SCR (Surface Condition Rating) | 73 | | | |
| Shoulder Condition Rating | GOOD | | | |
| Drainage Condition Rating | GOOD | | | |

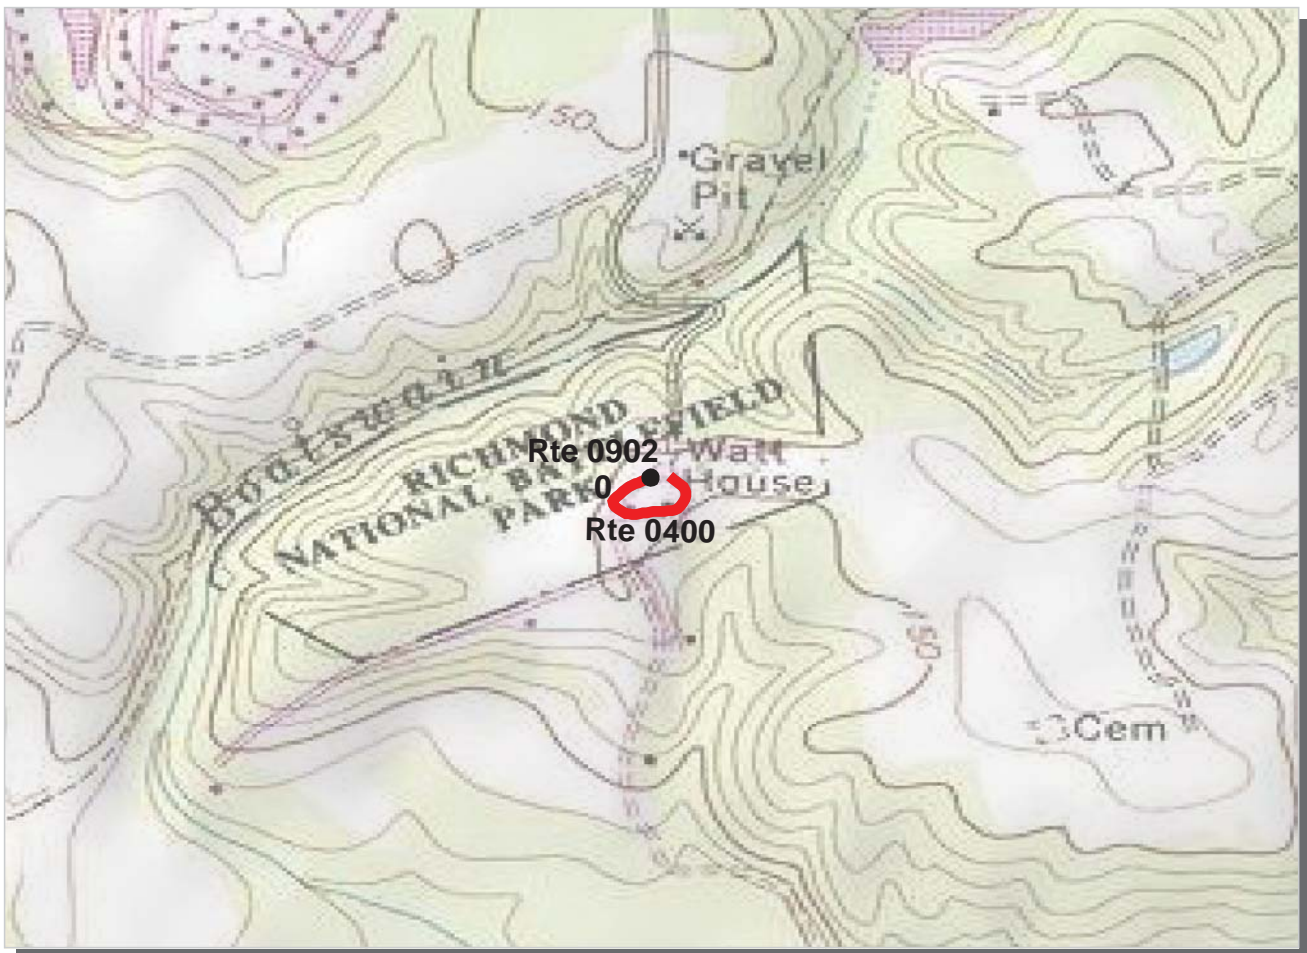
**ROUTE: 0400 Watt House Loop Road**

| PCR (Pavement Condition Rating) | 10 | | | | |
| SCR (Surface Condition Rating) | 10 | | | | |
| Shoulder Condition Rating | GOOD | | | | |
| Drainage Condition Rating | GOOD | | | | |

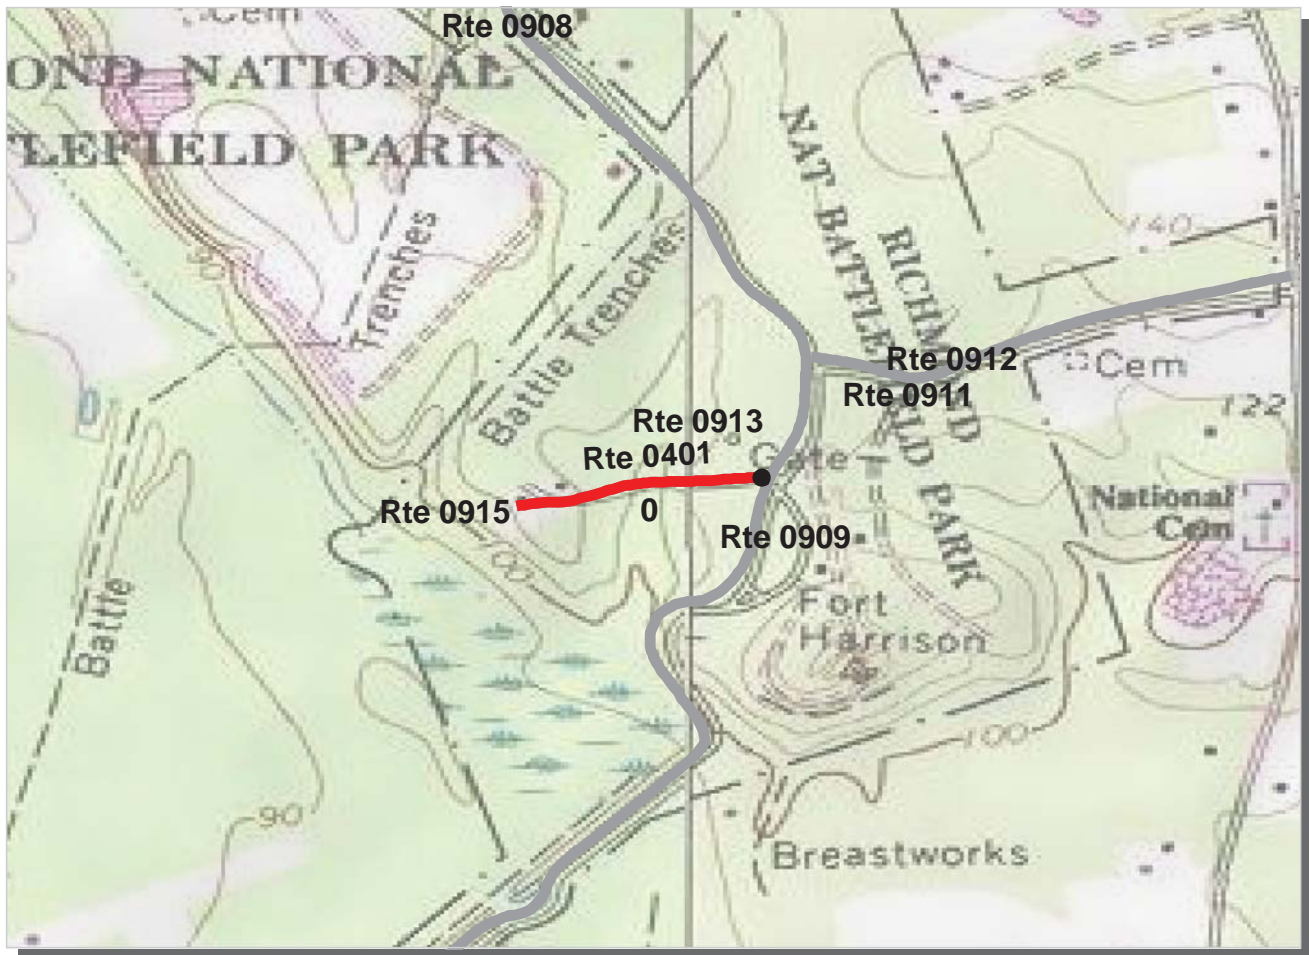
| PCR (Pavement Condition Rating) | 24 | | | | |
| RCI (Roughness Condition Index) | 29 | | | | |
| SCR (Surface Condition Rating) | 22 | | | | |
| Drainage Condition Rating | POOR | | | | |

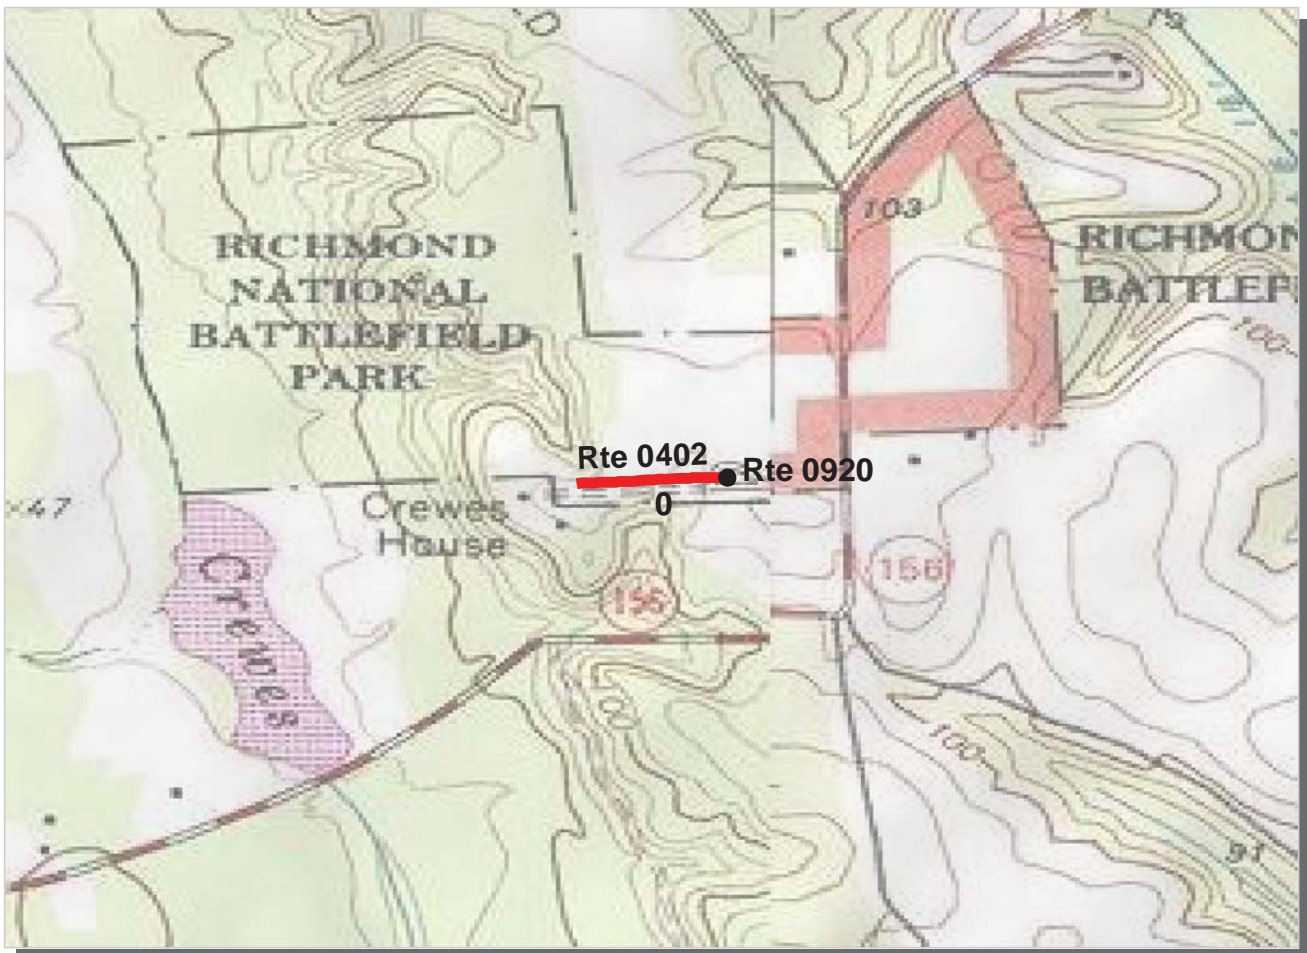
ROUTE: 0402 Malvern Hill Residence Road

| PCR (Pavement Condition Rating) | 6 | | | | |
| RCI (Roughness Condition Index) | 25 | | | | |
| SCR (Surface Condition Rating) | 3 | | | | |

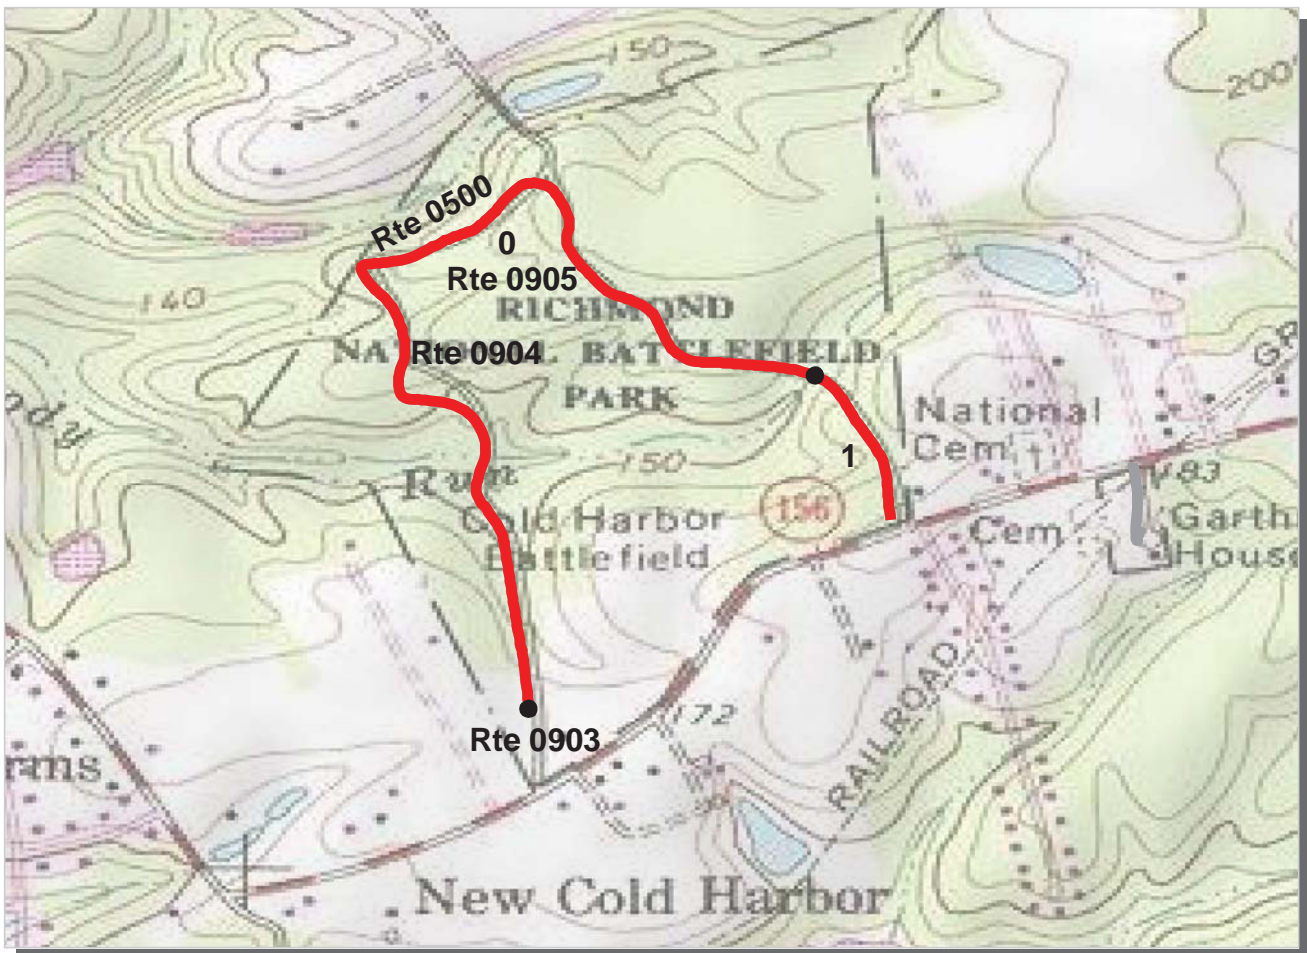
| Section Number | 0 | 1 | | | |
|---|---|---|--|--|--|
| PCR (Pavement Condition Rating) | 36 | 33 | | | |
| RCI (Roughness Condition Index) | 43 | 44 | | | |
| SCR (Surface Condition Rating) | 34 | 31 | | | |

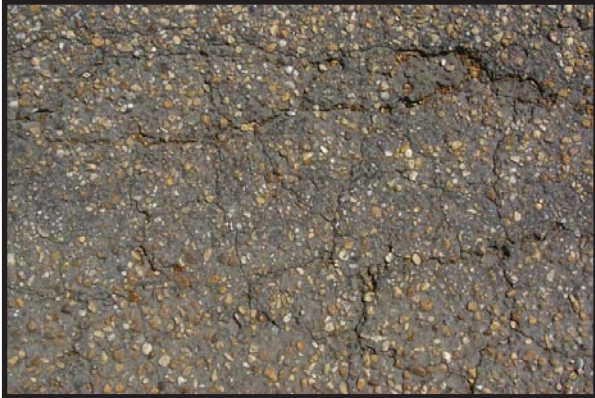
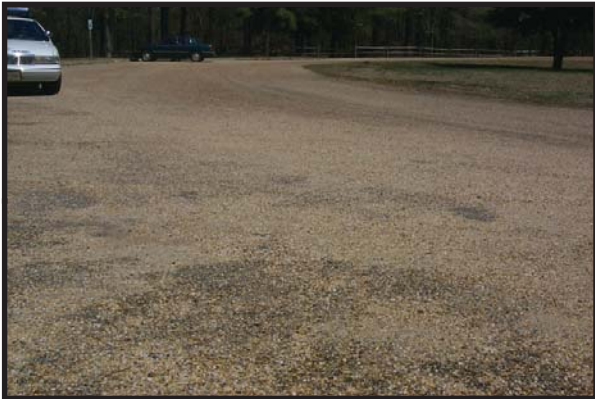
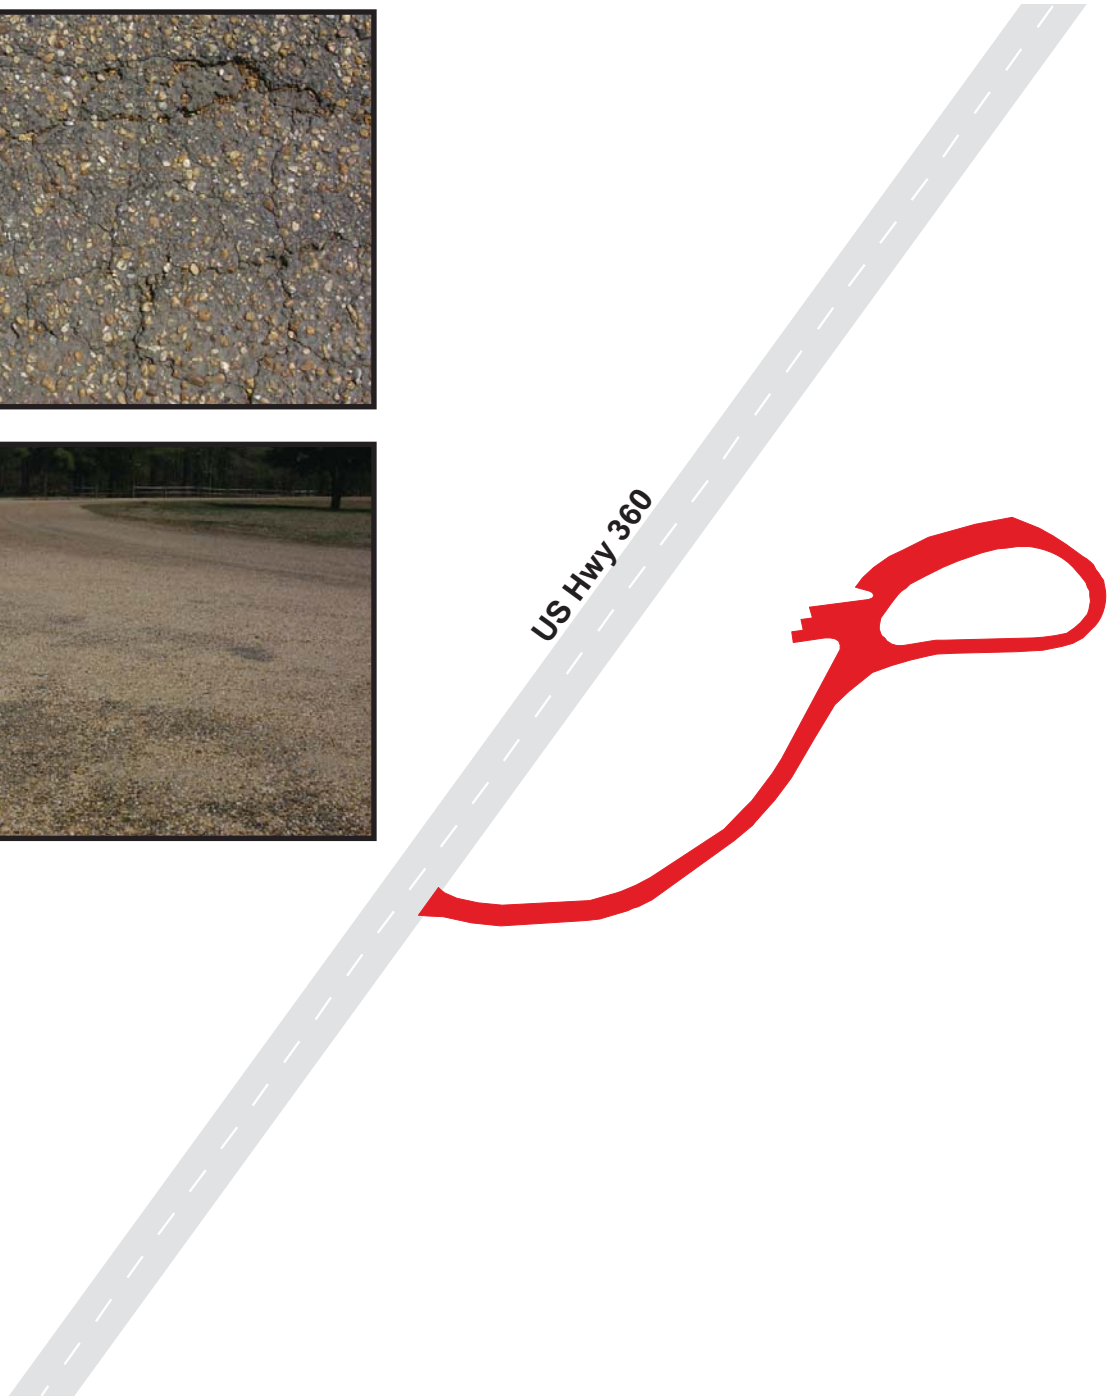
| Route | Public / NonPublic | Date Visited | Area (sq ft) | Lane Miles * | Surface Type | Condition / PCR |
|---|---|---|---|---|---|---|
| 0900 | Public | 4/11/2002 | 24752 | 0.43 | OC | FAIR / 73 |

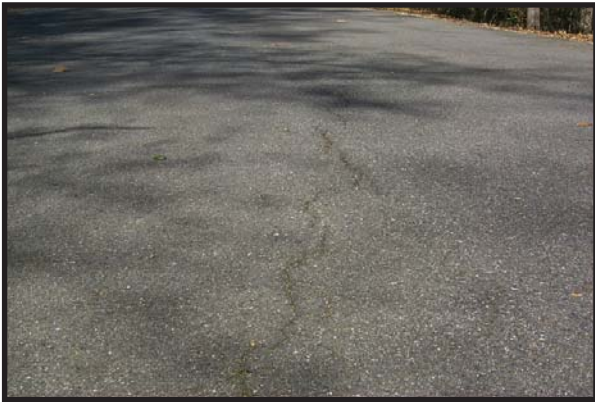
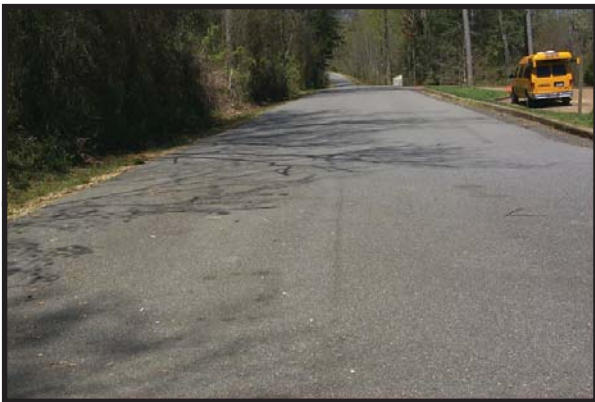
| Route | Public / NonPublic | Date Visited | Area (sq ft) | Lane Miles * | Surface Type | Condition / PCR |
|---|---|---|---|---|---|---|
| 0901A | Public | 4/11/2002 | 23305 | 0.40 | AS | GOOD / 90 |

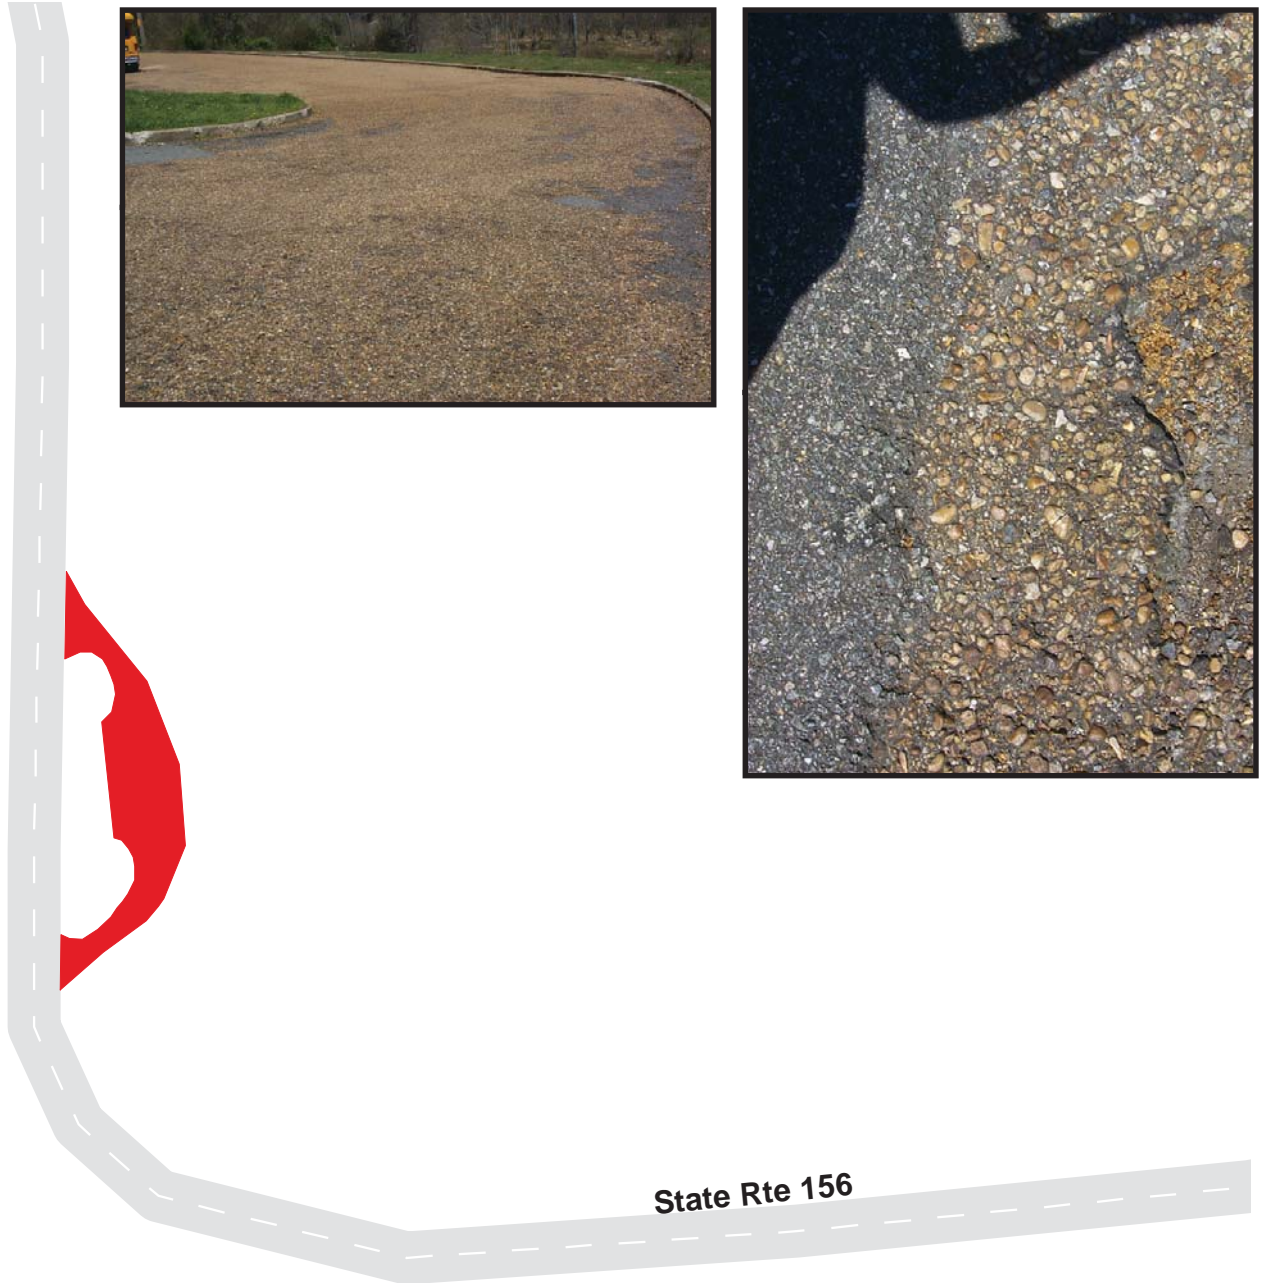
| Route | Public / NonPublic | Date Visited | Area (sq ft) | Lane Miles * | Surface Type | Condition / PCR |
|---|---|---|---|---|---|---|
| 0901B | Public | 4/11/2002 | 4792 | 0.08 | OC | FAIR / 73 |

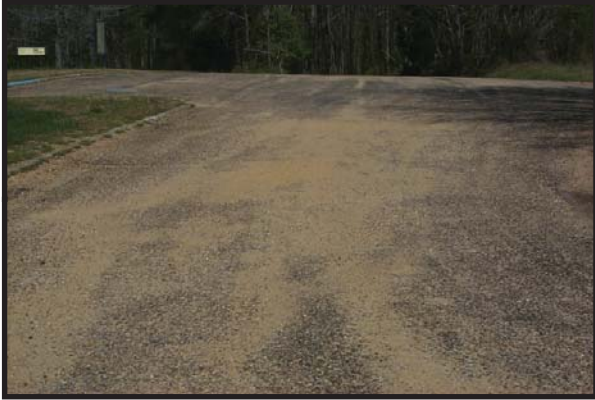
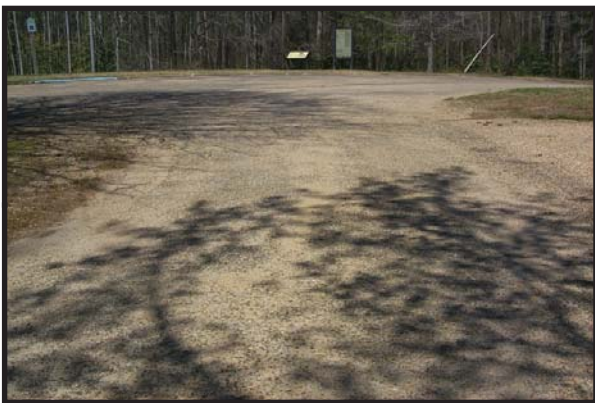
| Route | Public / NonPublic | Date Visited | Area (sq ft) | Lane Miles * | Surface Type | Condition / PCR |
|---|---|---|---|---|---|---|
| 0902 | Public | 4/11/2002 | 19016 | 0.33 | OC | GOOD / 90 |

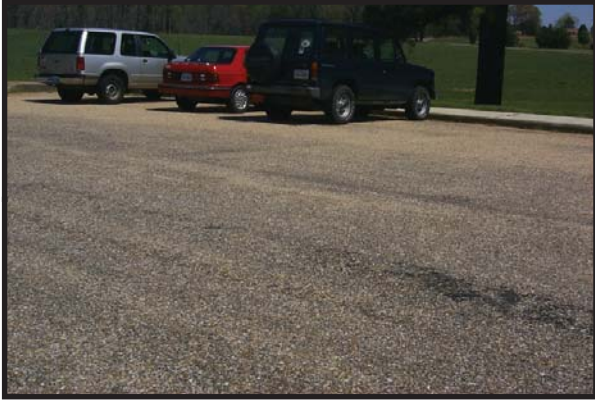
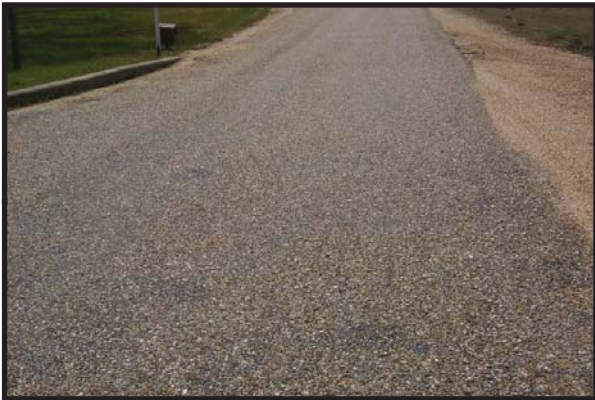
**Richmond National Battlefield Park**  
**Route 0903**  
 COLD HARBOR VISITOR CENTER PARKING  
 From State Route 156

| Route | Public / NonPublic | Date Visited | Area (sq ft) | Lane Miles * | Surface Type | Condition / PCR |
|---|---|---|---|---|---|---|
| 0903 | Public | 4/11/2002 | 10550 | 0.18 | OC | GOOD / 90 |

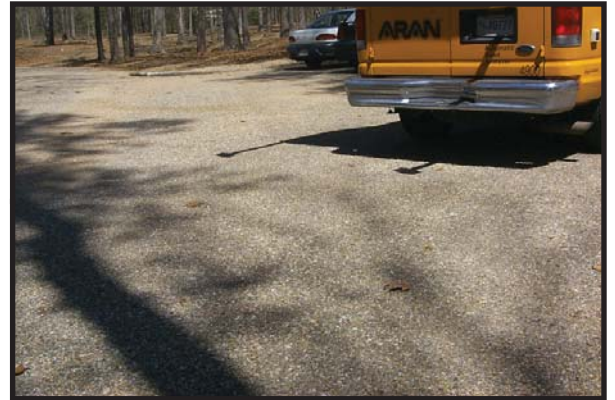
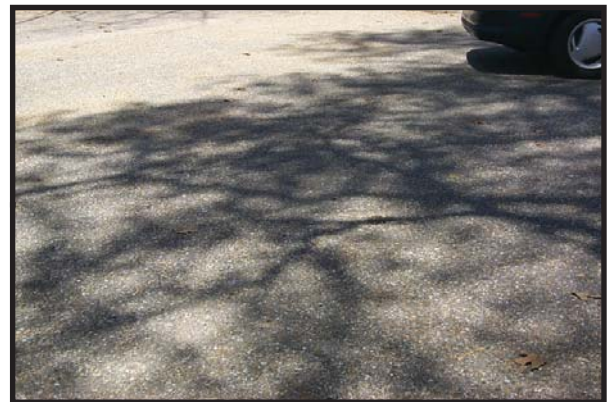
| Route | Public / NonPublic | Date Visited | Area (sq ft) | Lane Miles * | Surface Type | Condition / PCR |
|---|---|---|---|---|---|---|
| 0904 | Public | 4/11/2002 | 1553 | 0.03 | OC | GOOD / 90 |

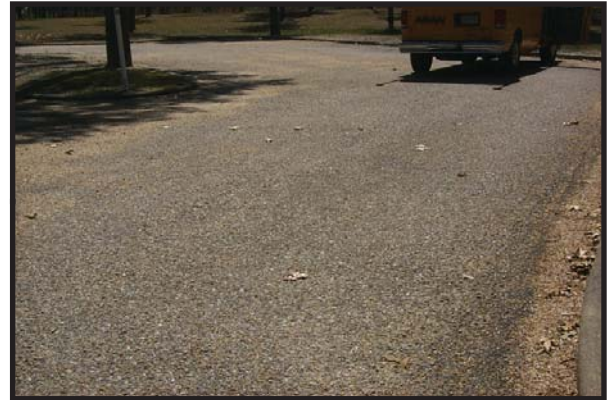
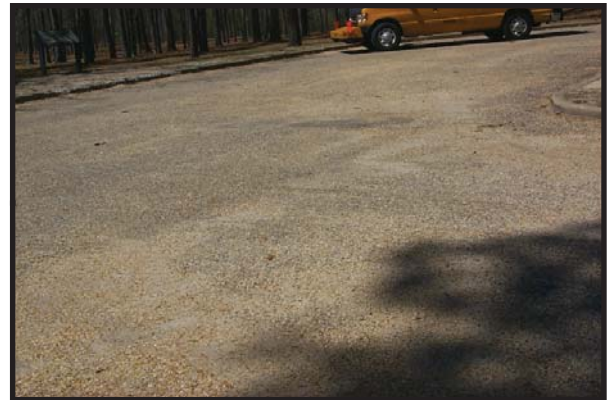
| Route | Public / NonPublic | Date Visited | Area (sq ft) | Lane Miles * | Surface Type | Condition / PCR |
|---|---|---|---|---|---|---|
| 0905 | Public | 4/11/2002 | 4435 | 0.08 | OC | GOOD / 90 |
