# The Road Inventory of Richmond National Battlefield Park RICH - 4800

## Road Inventory Program

Prepared By:  
Federal Highway Administration  
Eastern Federal Lands Highway Division  
Cycle 3

# Richmond National Battlefield Park in Virginia

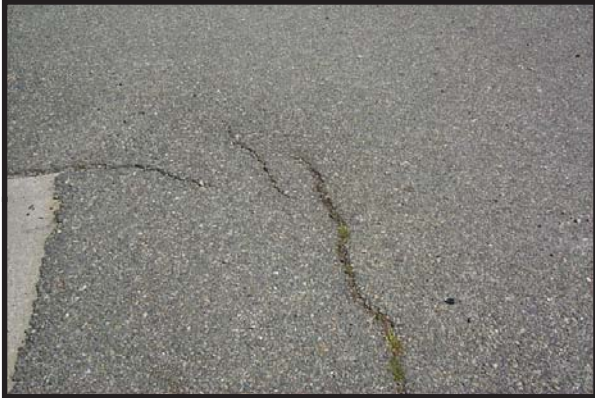
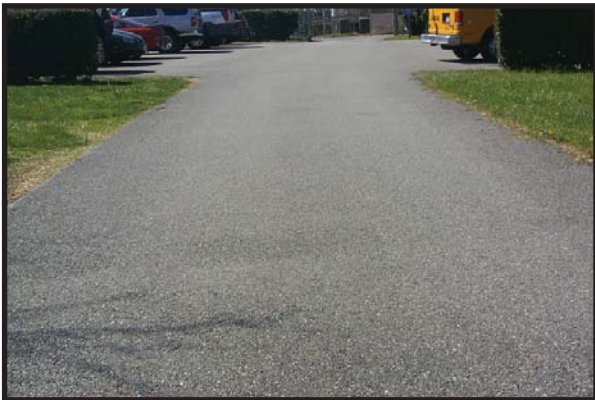
| Route | Public / NonPublic | Date Visited | Area (sq ft) | Lane Miles * | Surface Type | Condition / PCR |
|---|---|---|---|---|---|---|
| 0906 | NonPublic | 4/11/2002 | 4673 | 0.08 | AS | GOOD / 90 |

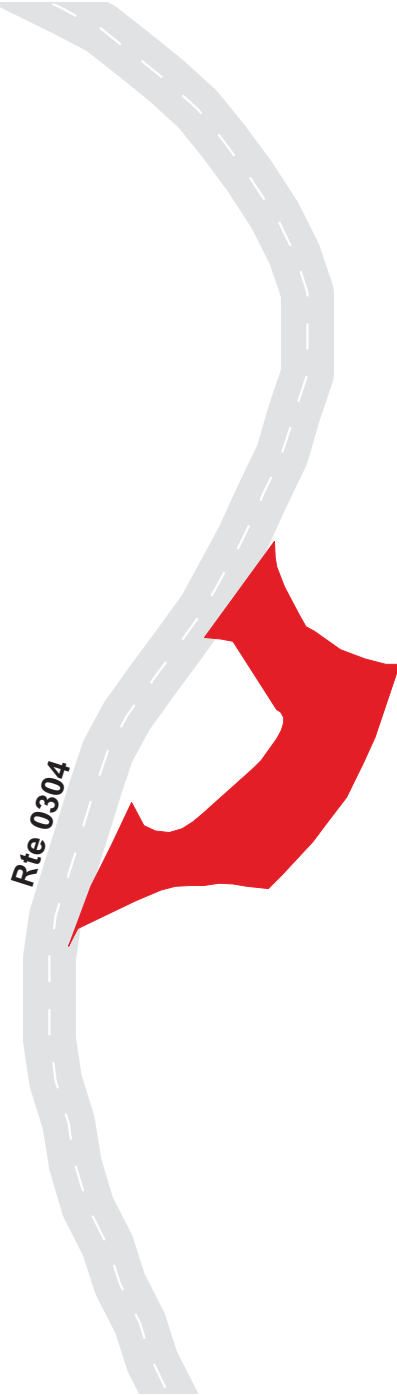
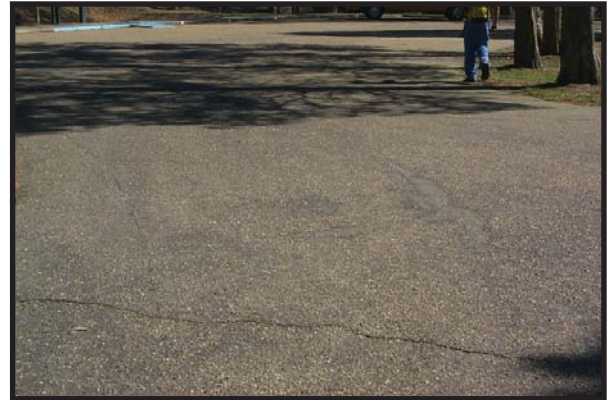
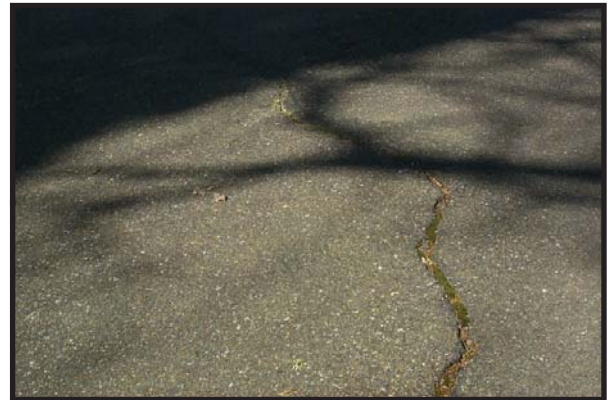
| Route | Public / NonPublic | Date Visited | Area (sq ft) | Lane Miles * | Surface Type | Condition / PCR |
|---|---|---|---|---|---|---|
| 0907 | Public | 4/11/2002 | 5904 | 0.10 | OC | FAIR / 73 |

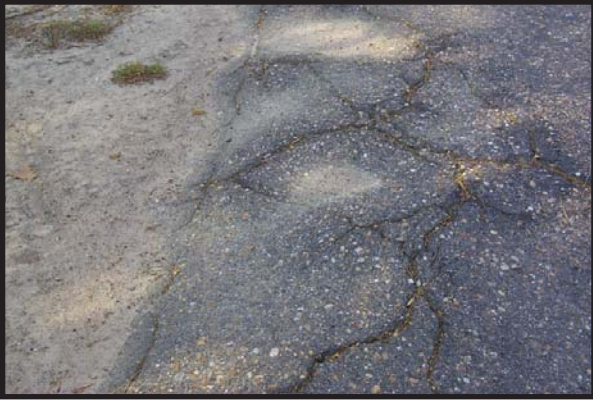
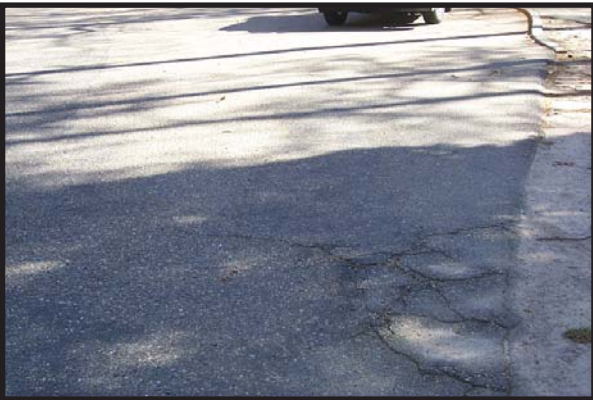
| Route | Public / NonPublic | Date Visited | Area (sq ft) | Lane Miles * | Surface Type | Condition / PCR |
|---|---|---|---|---|---|---|
| 0908 | Public | 4/11/2002 | 4232 | 0.07 | OC | FAIR / 73 |

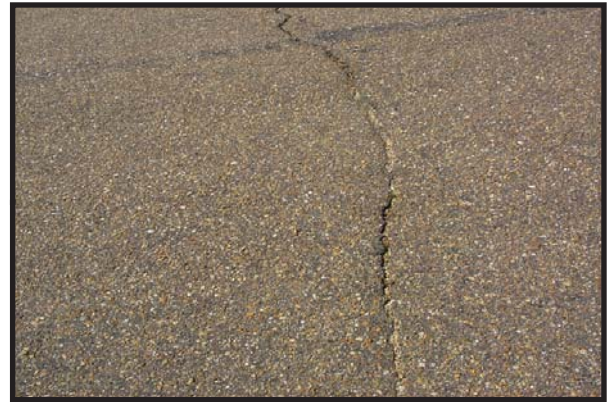
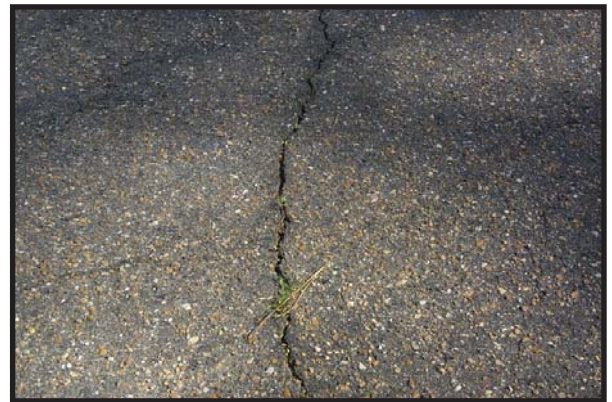
| Route | Public / NonPublic | Date Visited | Area (sq ft) | Lane Miles * | Surface Type | Condition / PCR |
|---|---|---|---|---|---|---|
| 0909 | Public | 4/11/2002 | 24612 | 0.42 | OC | FAIR / 73 |

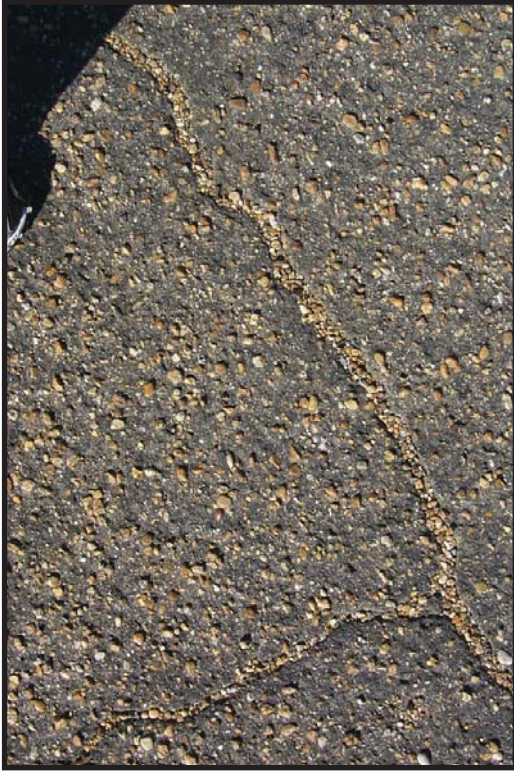
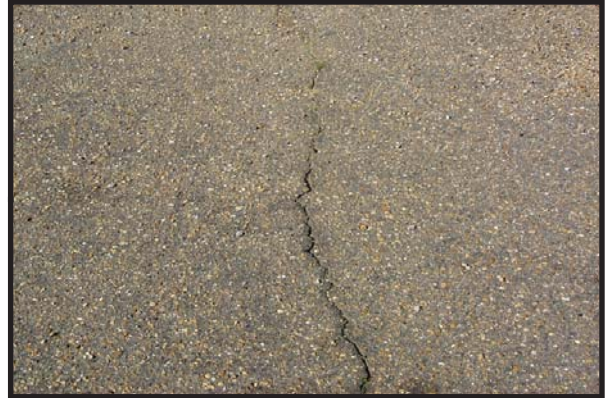
| Route | Public / NonPublic | Date Visited | Area (sq ft) | Lane Miles * | Surface Type | Condition / PCR |
|---|---|---|---|---|---|---|
| 0910 | Public | 4/11/2002 | 3788 | 0.07 | OC | FAIR / 73 |

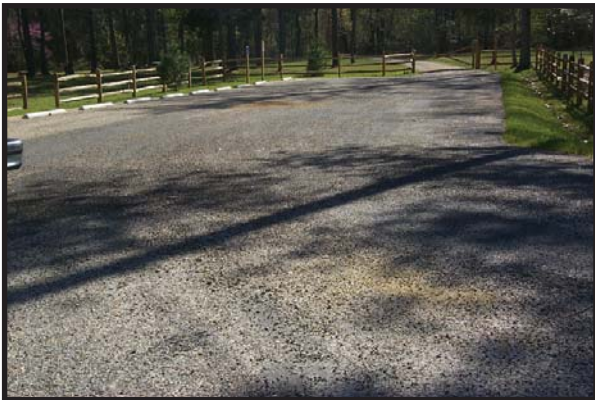
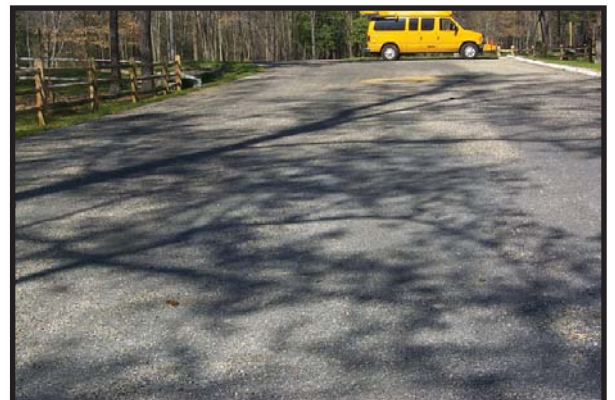
| Route | Public / NonPublic | Date Visited | Area (sq ft) | Lane Miles * | Surface Type | Condition / PCR |
|---|---|---|---|---|---|---|
| 0911 | Public | 4/11/2002 | 5646 | 0.10 | OC | GOOD / 90 |

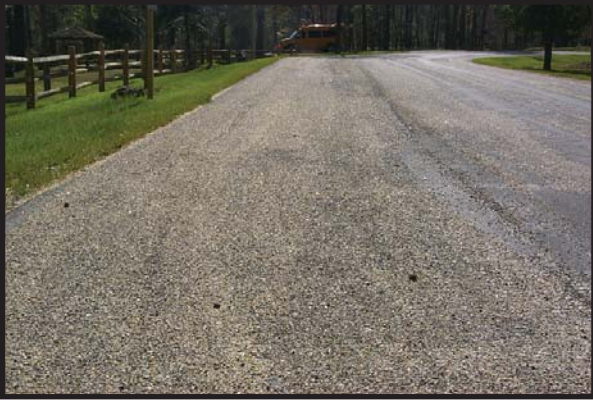
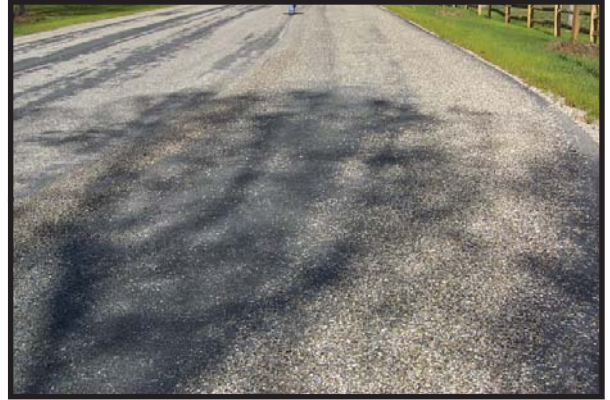
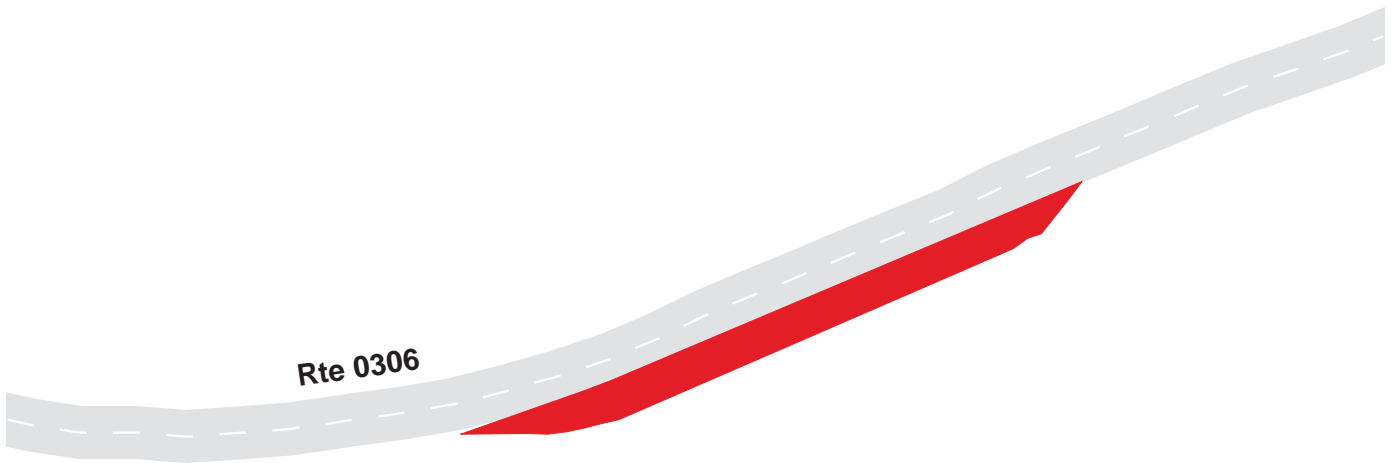
| Route | Public / NonPublic | Date Visited | Area (sq ft) | Lane Miles * | Surface Type | Condition / PCR |
|---|---|---|---|---|---|---|
| 0912 | Public | 4/11/2002 | 2019 | 0.03 | OC | GOOD / 90 |

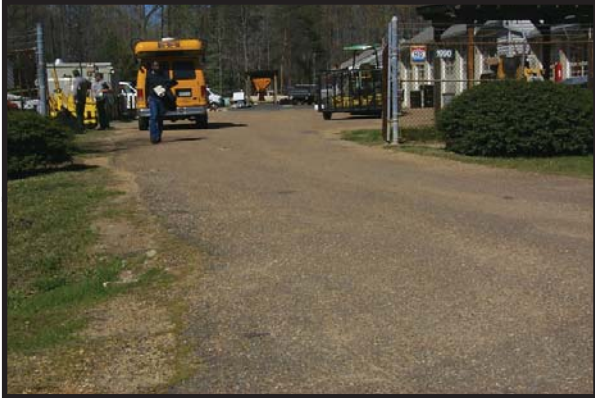
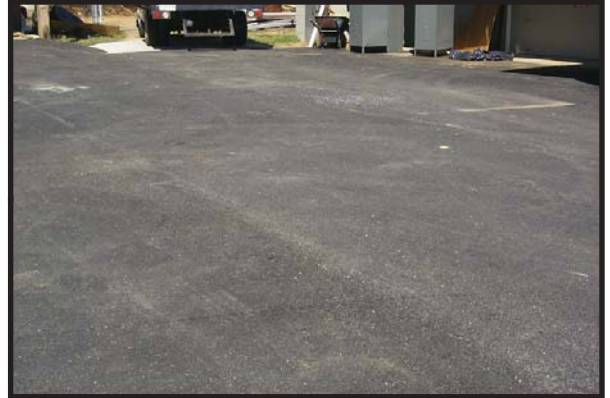
| Route | Public / NonPublic | Date Visited | Area (sq ft) | Lane Miles * | Surface Type | Condition / PCR |
|---|---|---|---|---|---|---|
| 0913 | NonPublic | 4/11/2002 | 9616 | 0.17 | OC | FAIR / 73 |

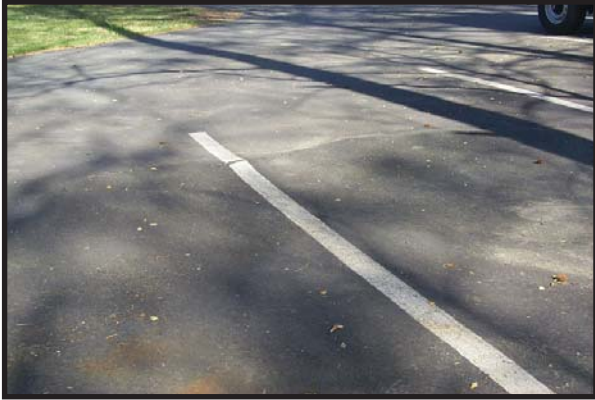
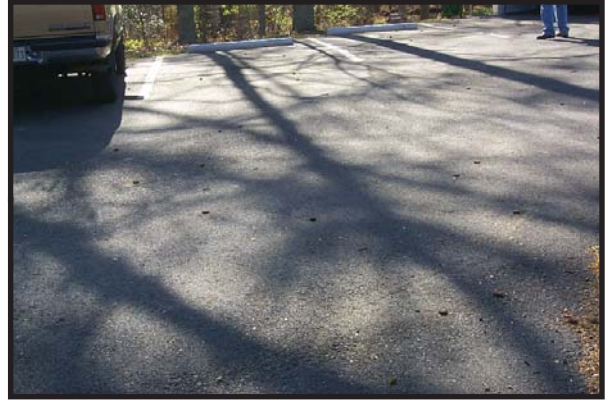
## Route 0917

| Route | Public / NonPublic | Date Visited | Area (sq ft) | Lane Miles * | Surface Type | Condition / PCR |
|---|---|---|---|---|---|---|
| 0917 | Public | 4/11/2002 | 6002 | 0.10 | OC | POOR / 45 |

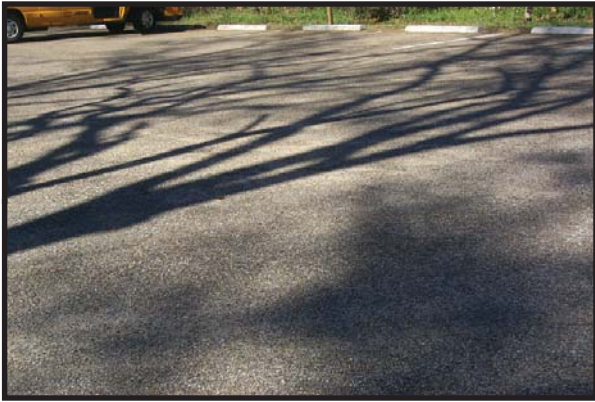
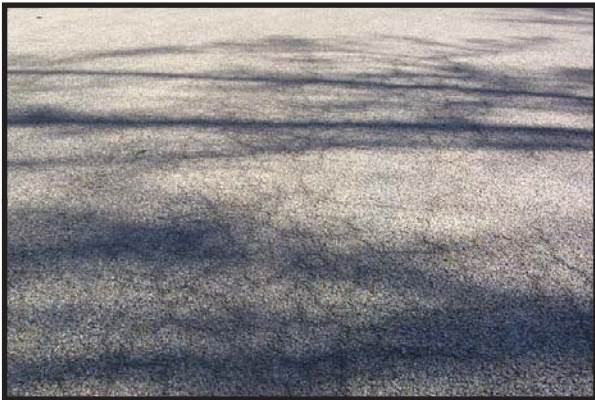
## Route 0918

| Route | Public / NonPublic | Date Visited | Area (sq ft) | Lane Miles * | Surface Type | Condition / PCR |
|---|---|---|---|---|---|---|
| 0918 | Public | 4/11/2002 | 42968 | 0.74 | OC | GOOD / 90 |

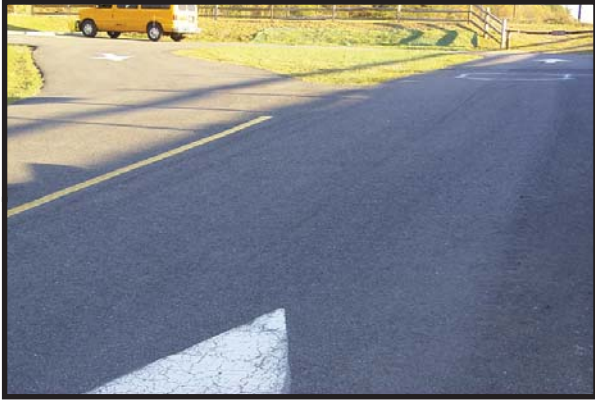
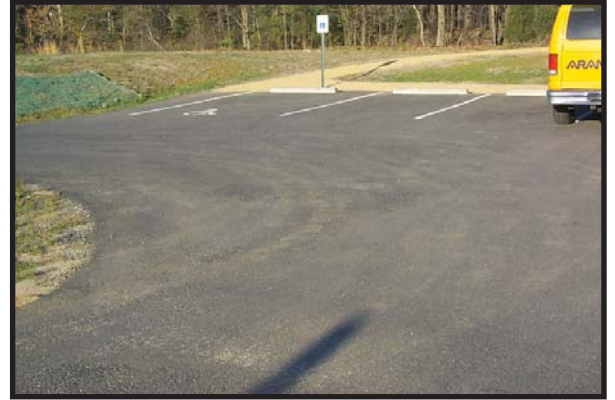
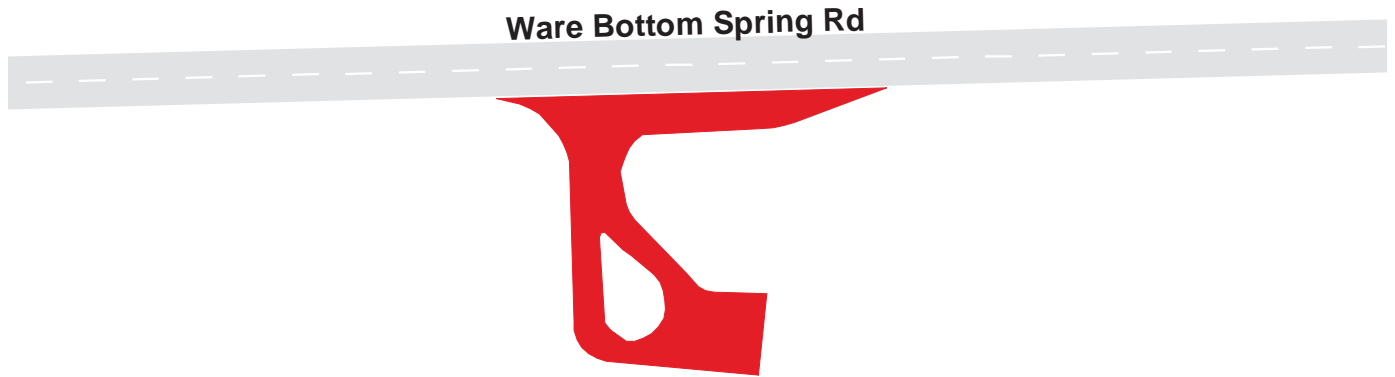
| Route | Public / NonPublic | Date Visited | Area (sq ft) | Lane Miles * | Surface Type | Condition / PCR |
|---|---|---|---|---|---|---|
| 0919 | Public | 4/11/2002 | 7538 | 0.13 | AS | GOOD / 90 |
