# The Road Inventory of Rock Creek Park ROCR - 3450

## Road Inventory Program

Prepared By:  
Federal Highway Administration  
Eastern Federal Lands Highway Division  
Cycle 3

# Rock Creek Park in Washington DC

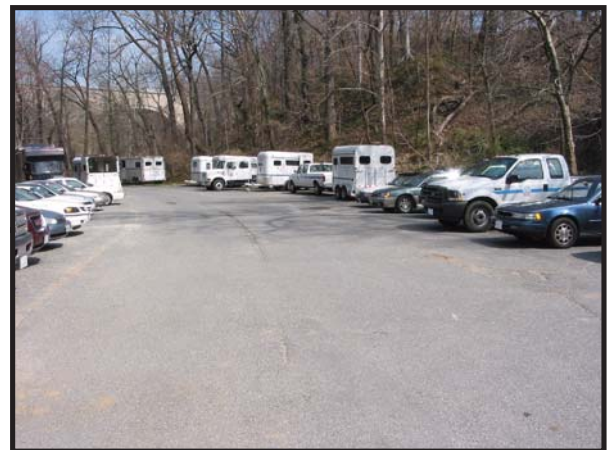
## Route 0910

Route	Public / NonPublic	Date Visited	Area (sq ft)	Lane Miles *	Surface Type	Condition / PCR
0910	NonPublic	3/24/2004	18044	0.31	AS	POOR / 45

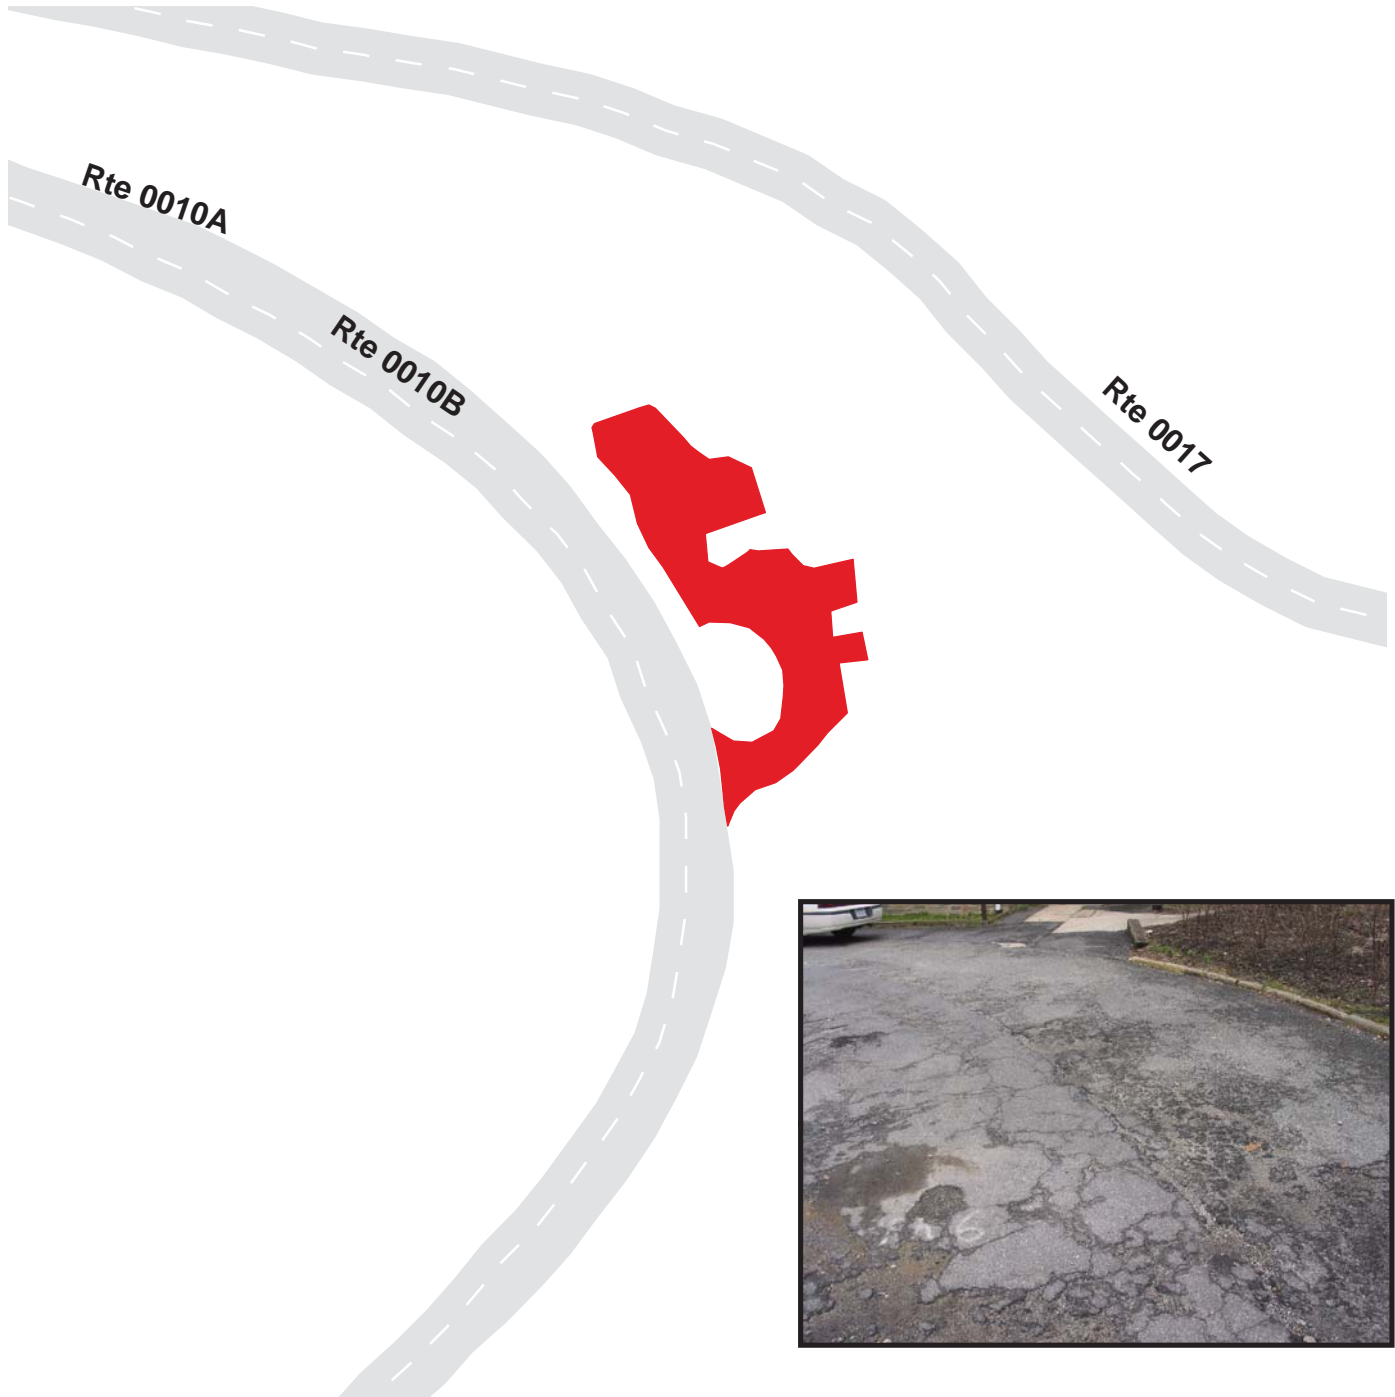
## Route 0912A

Route	Public / NonPublic	Date Visited	Area (sq ft)	Lane Miles *	Surface Type	Condition / PCR
0912A	NonPublic	3/18/2004	4939	0.09	AS	POOR / 45

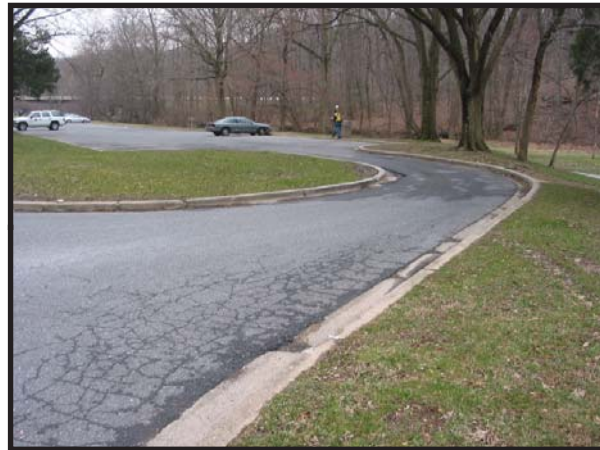
**Rock Creek Park**  
**Route 0913**  
 Picnic Parking Area #6  
 Adjacent To Route 0010A

Route	Public / NonPublic	Date Visited	Area (sq ft)	Lane Miles *	Surface Type	Condition / PCR
0913	Public	3/17/2004	22625	0.39	AS	GOOD / 90

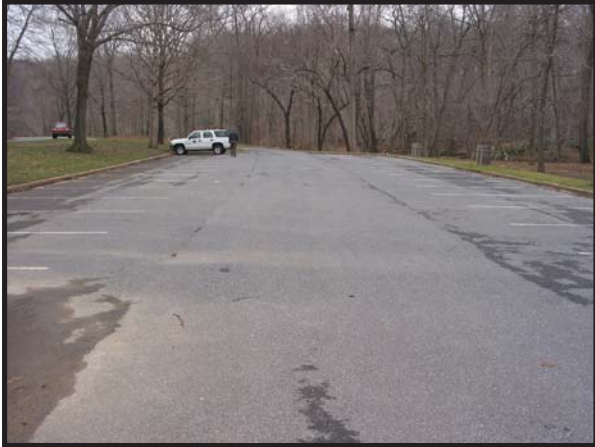
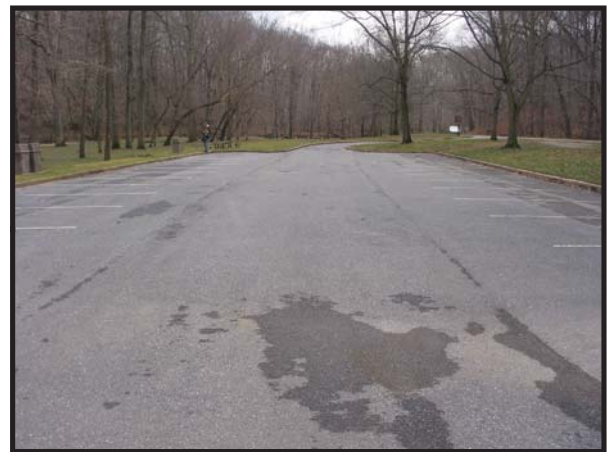
**Rock Creek Park**  
**Route 0915**  
 Picnic Parking Area # 8  
 Adjacent To Route 0010A

Route	Public / NonPublic	Date Visited	Area (sq ft)	Lane Miles *	Surface Type	Condition / PCR
0915	Public	3/17/2004	12324	0.21	AS	GOOD / 90

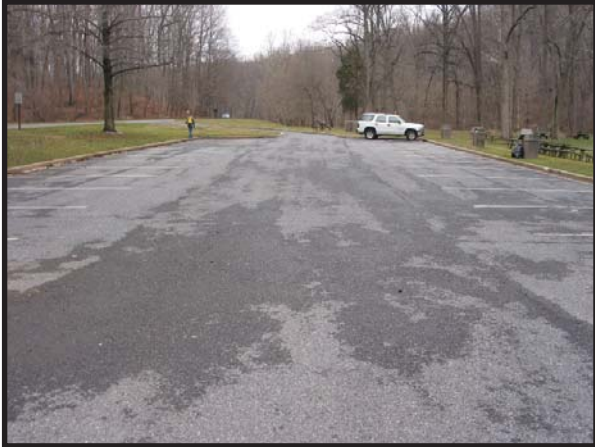
**Rock Creek Park**  
**Route 0916**  
 Picnic Parking Area #9  
 Adjacent To Route 0010A

Route	Public / NonPublic	Date Visited	Area (sq ft)	Lane Miles *	Surface Type	Condition / PCR
0916	Public	3/17/2004	10889	0.19	AS	GOOD / 90

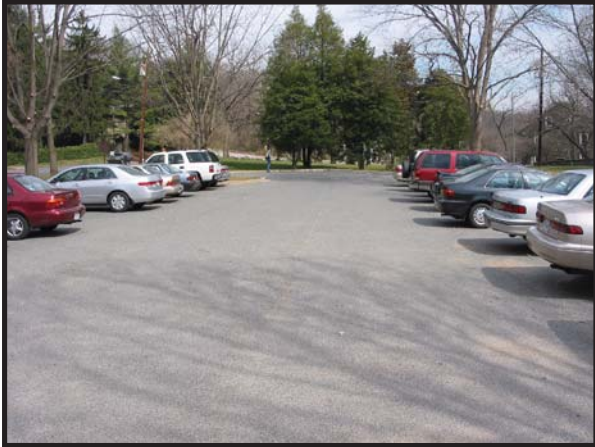
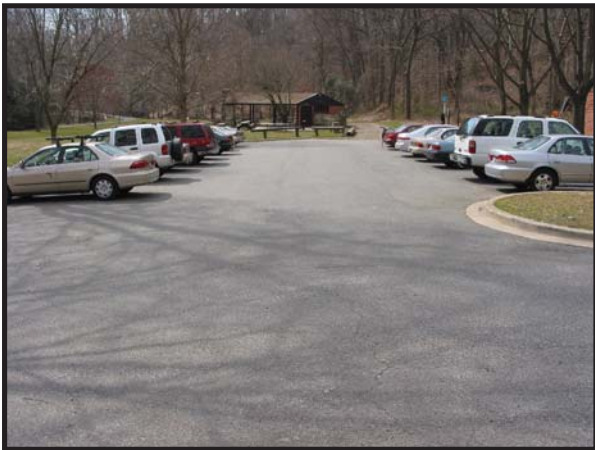
**Rock Creek Park**  
**Route 0918**  
 Picnic Parking Area #1  
 From Shoemaker Street

Route	Public / NonPublic	Date Visited	Area (sq ft)	Lane Miles *	Surface Type	Condition / PCR
0918	Public	3/24/2004	9176	0.16	AS	FAIR / 73

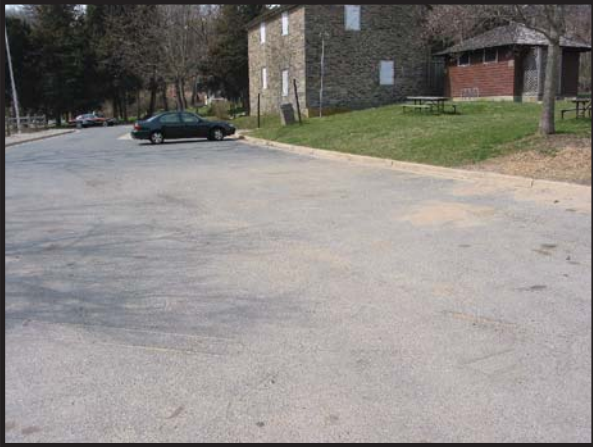
## Route 0919

Route	Public / NonPublic	Date Visited	Area (sq ft)	Lane Miles *	Surface Type	Condition / PCR
0919	Public	3/24/2004	5564	0.10	AS	FAIR / 73

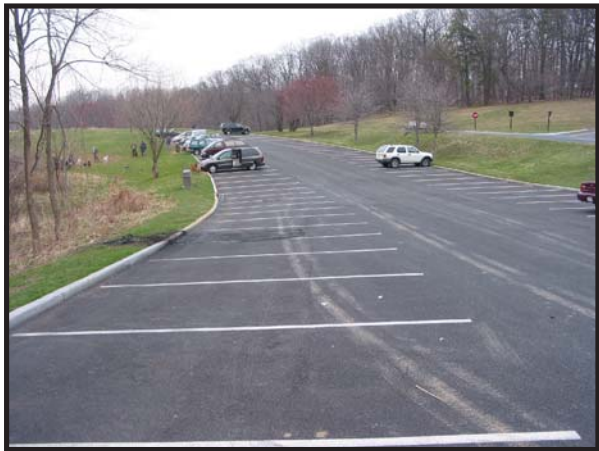
## Route 0923

Route	Public / NonPublic	Date Visited	Area (sq ft)	Lane Miles *	Surface Type	Condition / PCR
0923	Public	3/18/2004	23198	0.40	AS	GOOD / 90

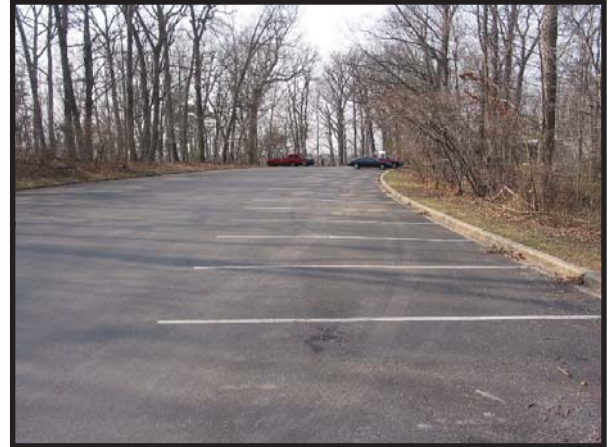
## Route 0924A

Route	Public / NonPublic	Date Visited	Area (sq ft)	Lane Miles *	Surface Type	Condition / PCR
0924A	Public	3/18/2004	5424	0.09	AS	GOOD / 90

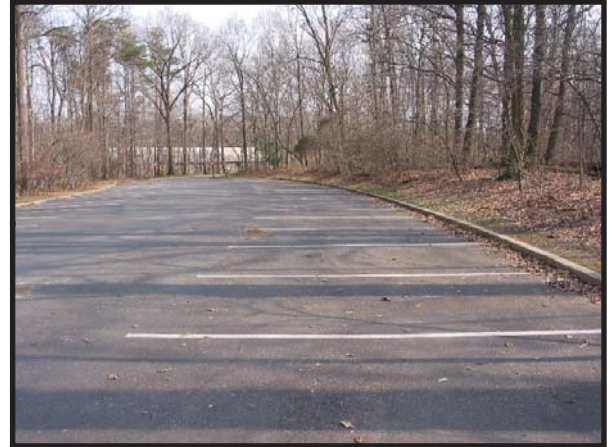
## Route 0924B

Route	Public / NonPublic	Date Visited	Area (sq ft)	Lane Miles *	Surface Type	Condition / PCR
0924B	Public	3/18/2004	4633	0.08	AS	GOOD / 90

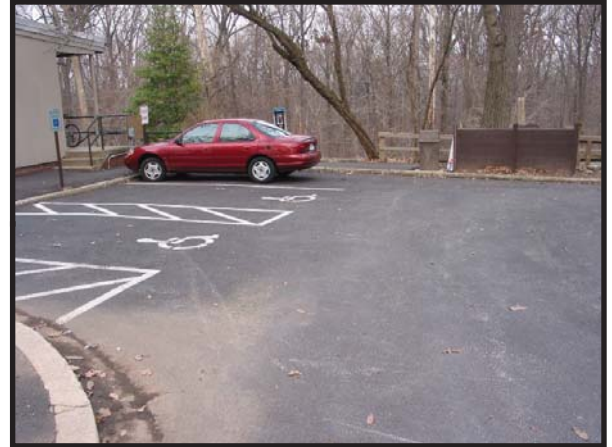
## Route 0924C

Route	Public / NonPublic	Date Visited	Area (sq ft)	Lane Miles *	Surface Type	Condition / PCR
0924C	Public	3/18/2004	1935	0.03	AS	GOOD / 90

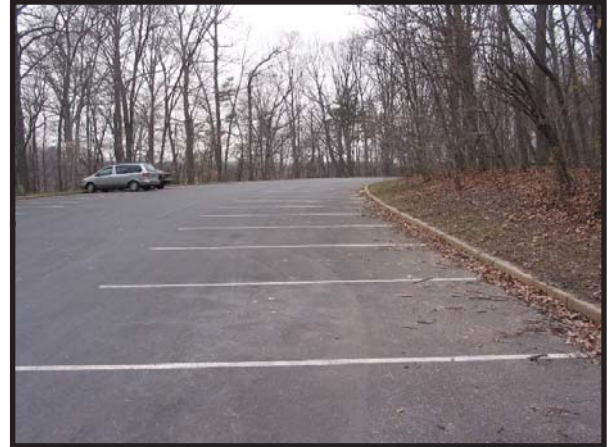
## Route 0924D

Route	Public / NonPublic	Date Visited	Area (sq ft)	Lane Miles *	Surface Type	Condition / PCR
0924D	Public	3/18/2004	5888	0.10	AS	GOOD / 90

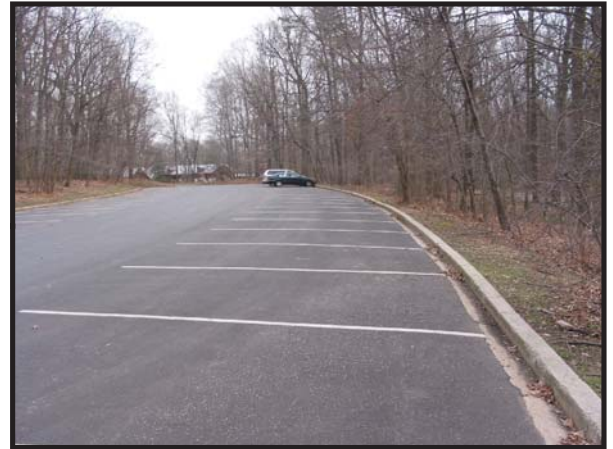
## Route 0924E

Route	Public / NonPublic	Date Visited	Area (sq ft)	Lane Miles *	Surface Type	Condition / PCR
0924E	Public	3/18/2004	7057	0.12	AS	GOOD / 90

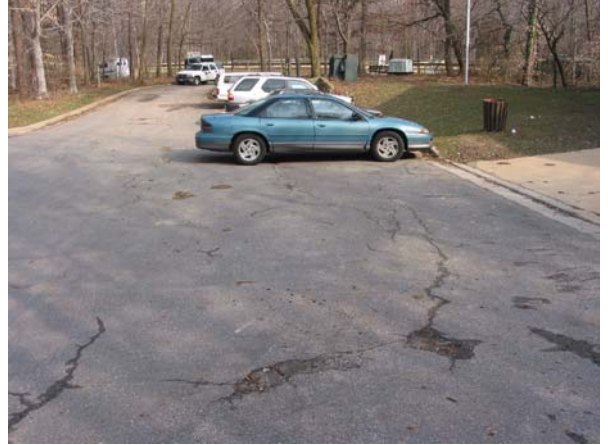
## Route 0925C

Route	Public / NonPublic	Date Visited	Area (sq ft)	Lane Miles *	Surface Type	Condition / PCR
0925C	Public	3/18/2004	2628	0.05	AS	FAIR / 73

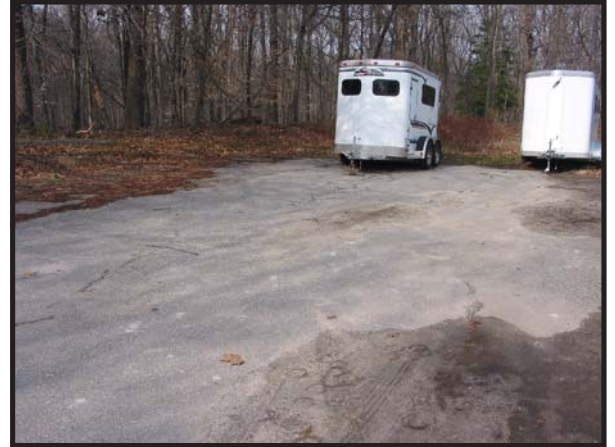
## Route 0925D

Route	Public / NonPublic	Date Visited	Area (sq ft)	Lane Miles *	Surface Type	Condition / PCR
0925D	Public	3/18/2004	3146	0.05	AS	FAIR / 73

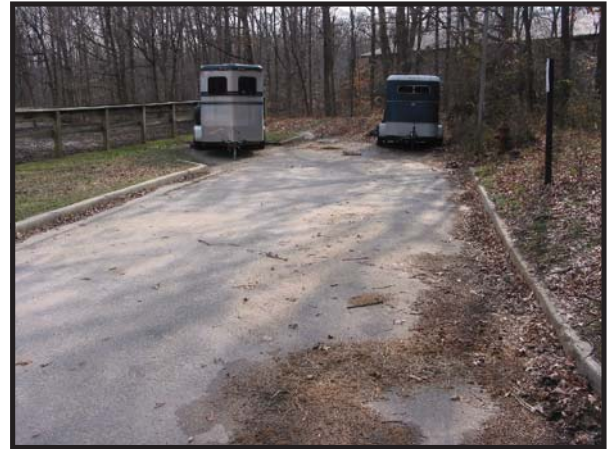
## Route 0925E

Route	Public / NonPublic	Date Visited	Area (sq ft)	Lane Miles *	Surface Type	Condition / PCR
0925E	Public	3/18/2004	1649	0.03	AS	GOOD / 90

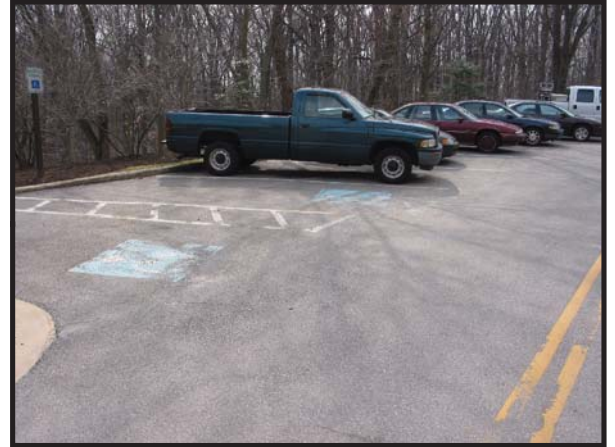
**Rock Creek Park**  
**Route 0926A**  
 Headquarters Parking  
 Adjacent To Route 0403

Route	Public / NonPublic	Date Visited	Area (sq ft)	Lane Miles *	Surface Type	Condition / PCR
0926A	Public	3/18/2004	1973	0.03	AS	GOOD / 90

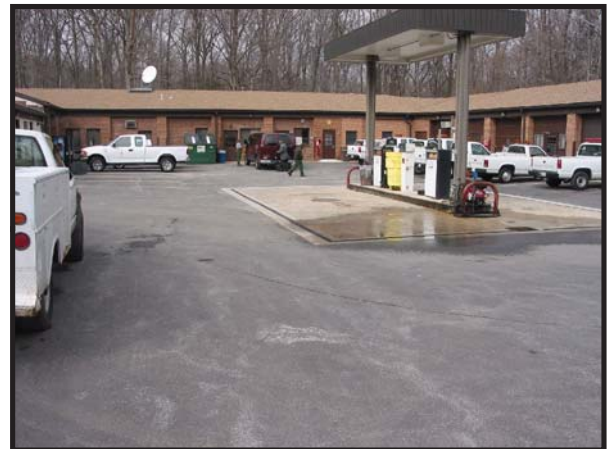
**Rock Creek Park**  
**Route 0927**  
 Pincnic Parking Area #20  
 Adjacent To Route 0016

Route	Public / NonPublic	Date Visited	Area (sq ft)	Lane Miles *	Surface Type	Condition / PCR
0927	Public	3/18/2004	998	0.02	AS	FAIR / 73

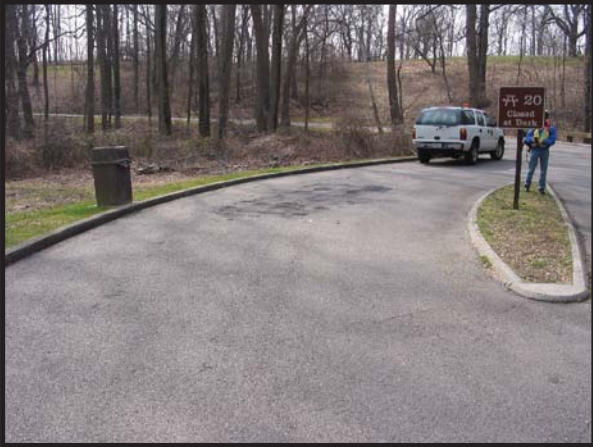
**Rock Creek Park**  
**Route 0928**  
 Picnic Parking Area #20A  
 Adjacent To Route 0016

Route	Public / NonPublic	Date Visited	Area (sq ft)	Lane Miles *	Surface Type	Condition / PCR
0928	Public	3/18/2004	2309	0.04	AS	GOOD / 90

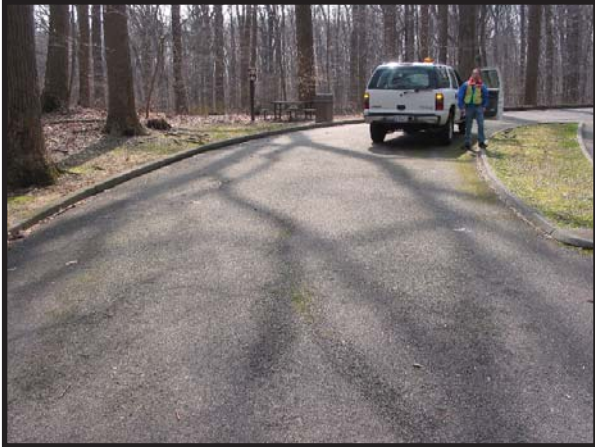
## Route 0929

Route	Public / NonPublic	Date Visited	Area (sq ft)	Lane Miles *	Surface Type	Condition / PCR
0929	Public	3/18/2004	1269	0.02	AS	GOOD / 90

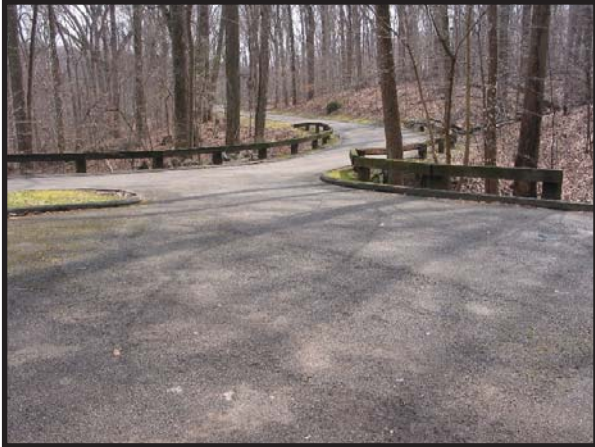
## Route 0930

Route	Public / NonPublic	Date Visited	Area (sq ft)	Lane Miles *	Surface Type	Condition / PCR
0930	Public	3/18/2004	692	0.01	AS	FAIR / 73

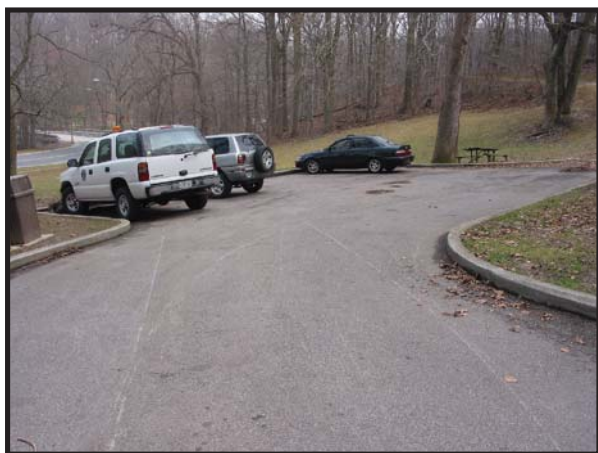
## Route 0932

Route	Public / NonPublic	Date Visited	Area (sq ft)	Lane Miles *	Surface Type	Condition / PCR
0932	Public	3/20/2004	35701	0.61	AS	POOR / 45

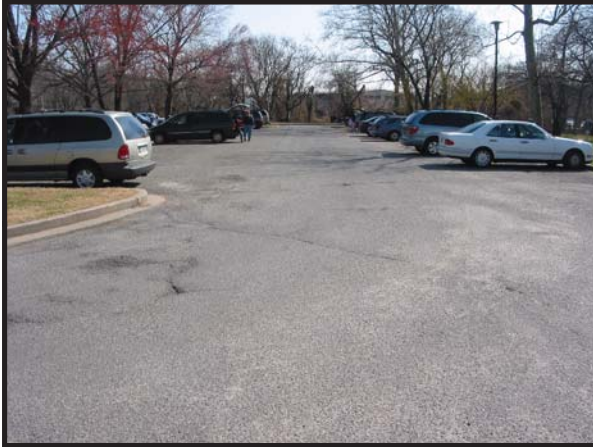
## Route 0933

Route	Public / NonPublic	Date Visited	Area (sq ft)	Lane Miles *	Surface Type	Condition / PCR
0933	Public	3/17/2004	3370	0.06	AS	GOOD / 90

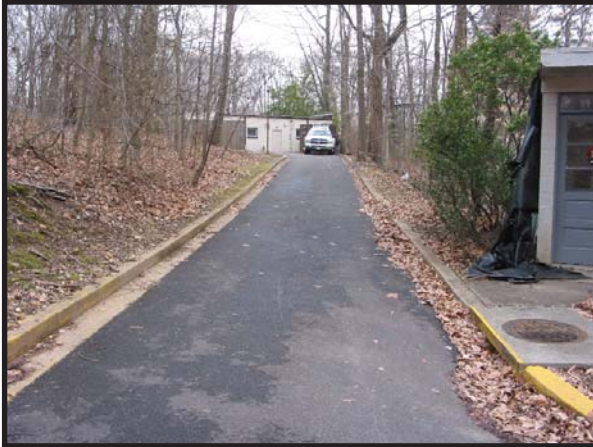
## Route 0934

Route	Public / NonPublic	Date Visited	Area (sq ft)	Lane Miles *	Surface Type	Condition / PCR
0934	Public	3/18/2004	2559	0.04	AS	GOOD / 90

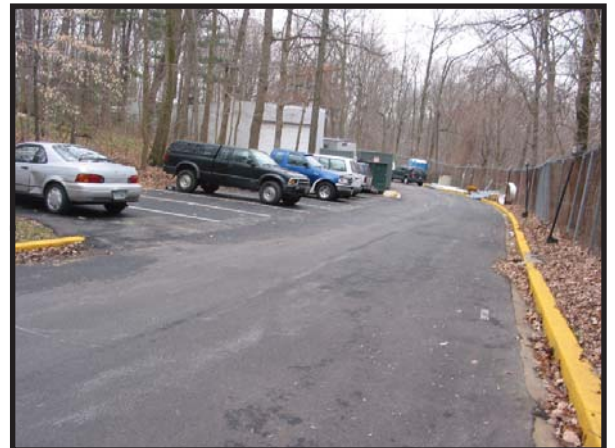
## Route 0935

Route	Public / NonPublic	Date Visited	Area (sq ft)	Lane Miles *	Surface Type	Condition / PCR
0935	NonPublic	3/17/2004	5519	0.10	AS	POOR / 45

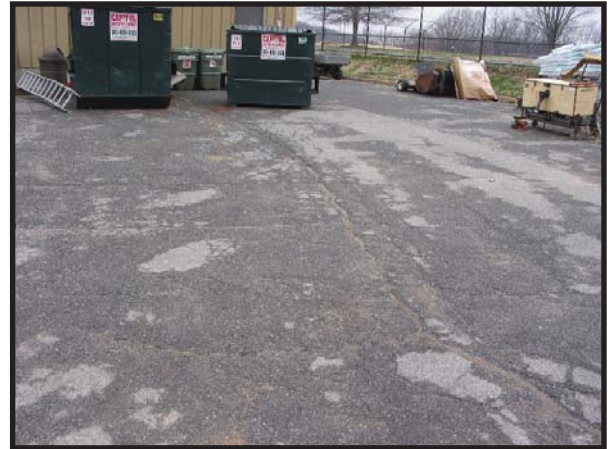
**Rock Creek Park**  
**Route 0936**  
 Picnic Parking Area #11  
 Adjacent To Route 0014

Route	Public / NonPublic	Date Visited	Area (sq ft)	Lane Miles *	Surface Type	Condition / PCR
0936	Public	3/18/2004	2949	0.05	AS	GOOD / 90

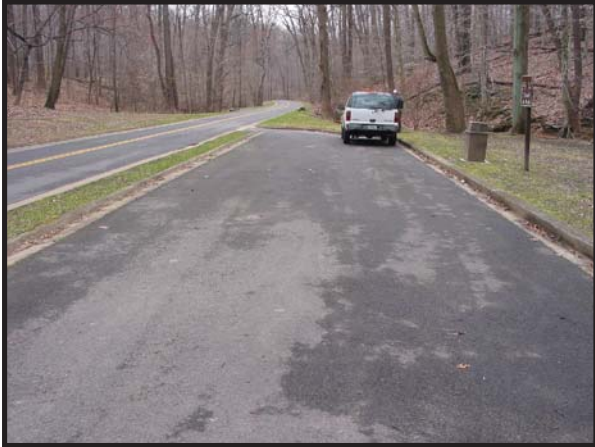
## Route 0937

Route	Public / NonPublic	Date Visited	Area (sq ft)	Lane Miles *	Surface Type	Condition / PCR
0937	Public	3/18/2004	3485	0.06	AS	FAIR / 73

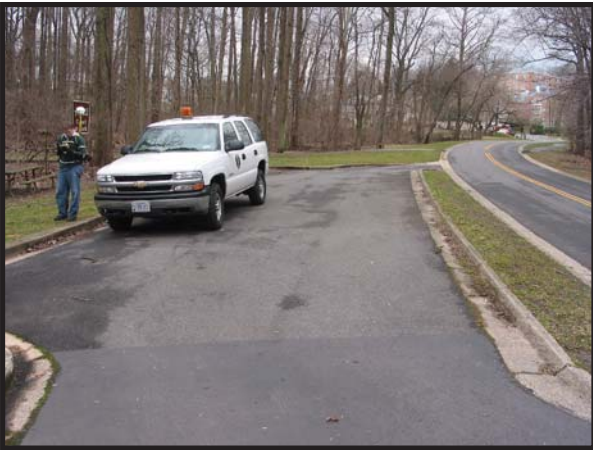
## Route 0938A

Route	Public / NonPublic	Date Visited	Area (sq ft)	Lane Miles *	Surface Type	Condition / PCR
0938A	NonPublic	3/24/2004	5957	0.10	AS	GOOD / 90

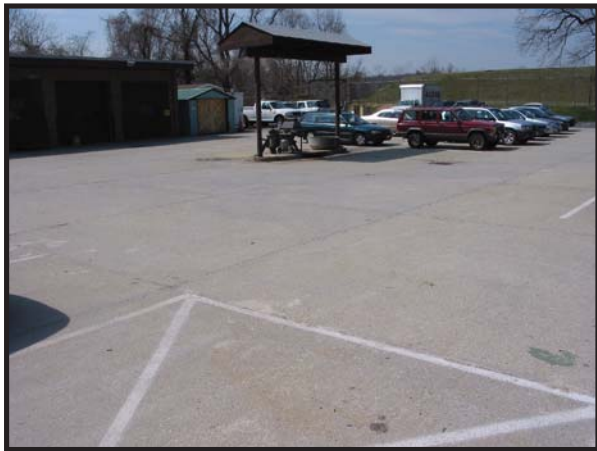
## Route 0938B

Route	Public / NonPublic	Date Visited	Area (sq ft)	Lane Miles *	Surface Type	Condition / PCR
0938B	NonPublic	3/24/2004	12425	0.21	CO	GOOD / 90
