# The Road Inventory of Rocky Mountain National Park ROMO - 1520

Prepared By:  
Federal Highway Administration  
Eastern Federal Lands Highway Division  
Cycle 3

# Rocky Mountain National Park in Colorado

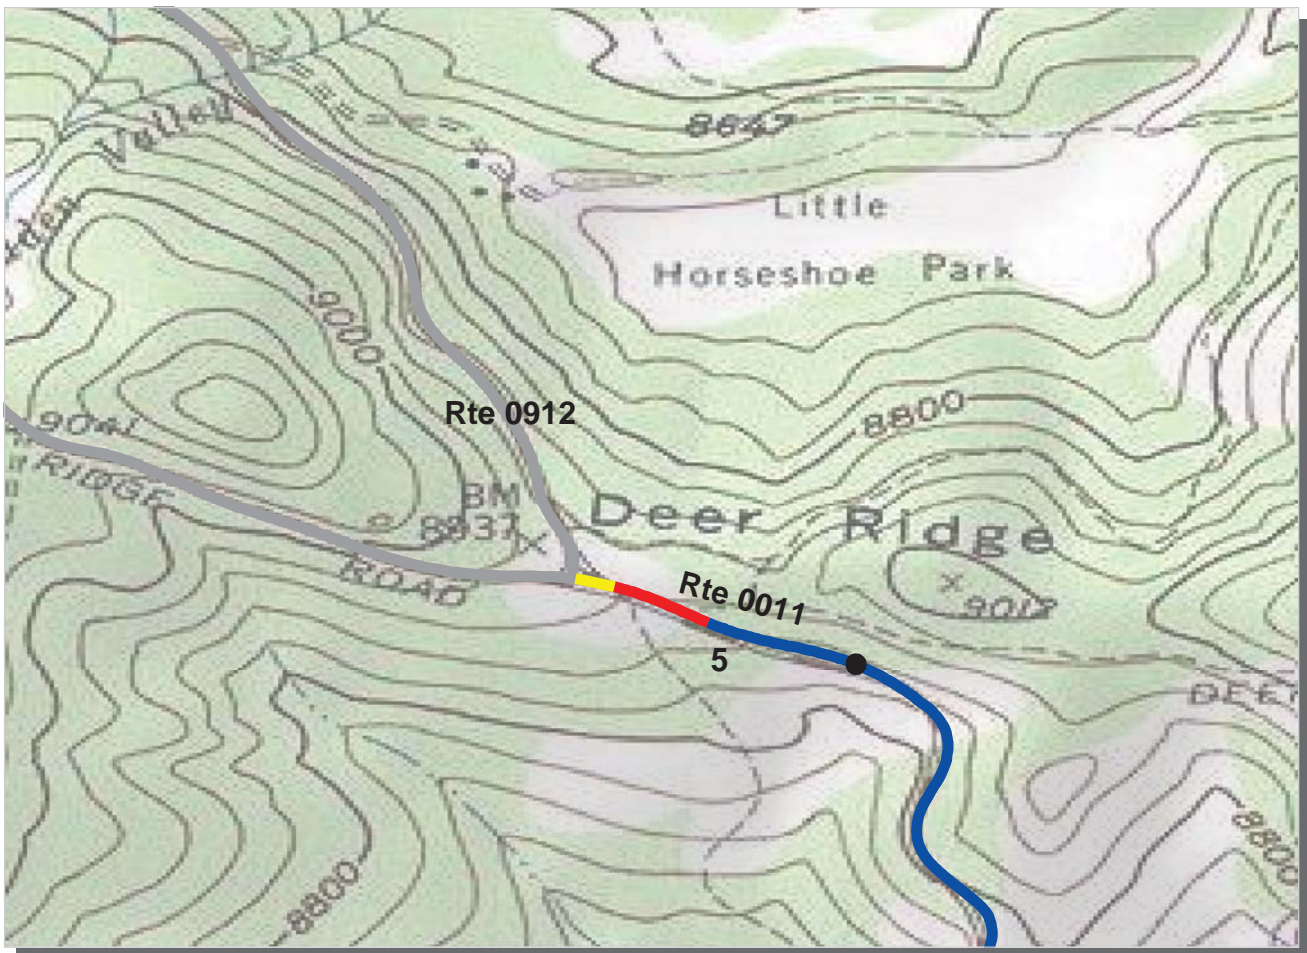
**ROUTE: 0011 Beaver Meadows Road**

Section Number	0	1	2	3	4
Section Length (mi)	1.00	1.00	1.00	1.00	1.00
AADT	**				
SADT	**				
ADT Date	**				
<b>Cross Section Information</b>					
Number of Lanes	2	2	2	2	2
Paved Width (ft)	18	24	27	22	22
Lane Width (ft)	10	13	15	11	11
Shoulder Width (ft)	0	4	0	5	3
<b>Roadway Condition Information</b>					
PCR (Pavement Condition Rating)	88	93	91	99	98
RCI (Roughness Condition Index)	96	98	91	99	97
SCR (Surface Condition Rating)	86	90	92	99	99
Alligator Cracking Index	99	100	100	100	100
Rutting Index	90	90	93	99	99
Patching Index	99	100	99	100	100
Transverse Cracking Index	98	99	99	100	100
Longitudinal Cracking Index	99	99	99	100	100
Shoulder Condition Rating	N/A	GOOD	N/A	GOOD	GOOD
Drainage Condition Rating	GOOD	GOOD	GOOD	GOOD	GOOD

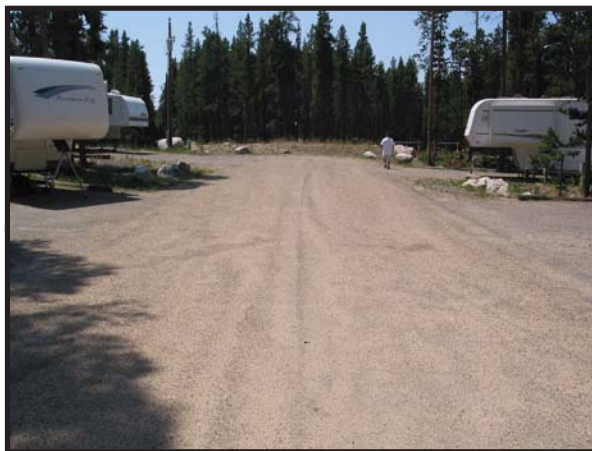
Route	Length (mi)	Width (ft)	Area (sq ft)	Lane Miles *	Condition / PCR	Surface Type
0422	0.03	21.50	2424	0.04	POOR / 45	OC

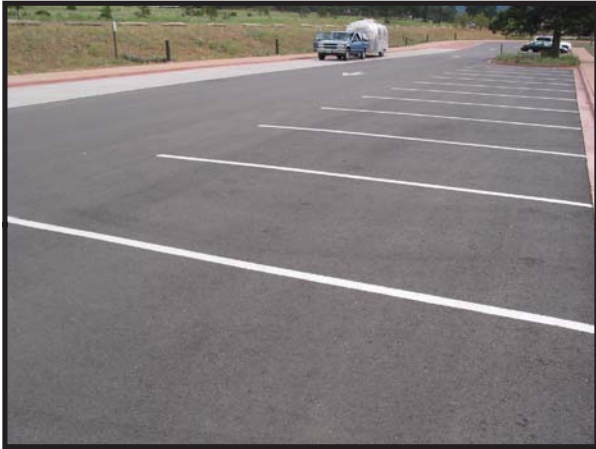
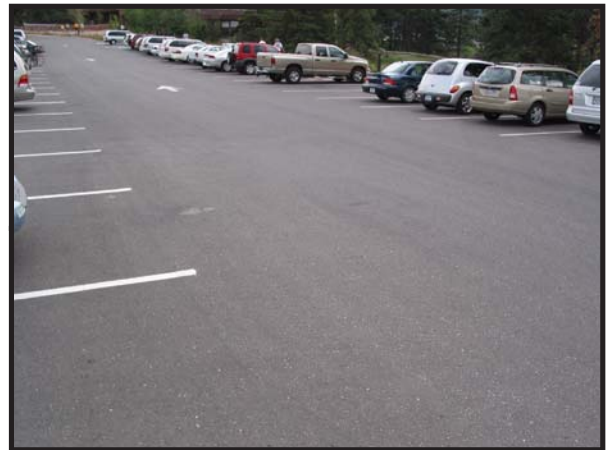
## Route 0900

Route	Public / NonPublic	Date Visited	Area (sq ft)	Lane Miles *	Surface Type	Condition / PCR
0900	Public	7/15/2003	59020	1.02	AS	EXCELLENT / 97

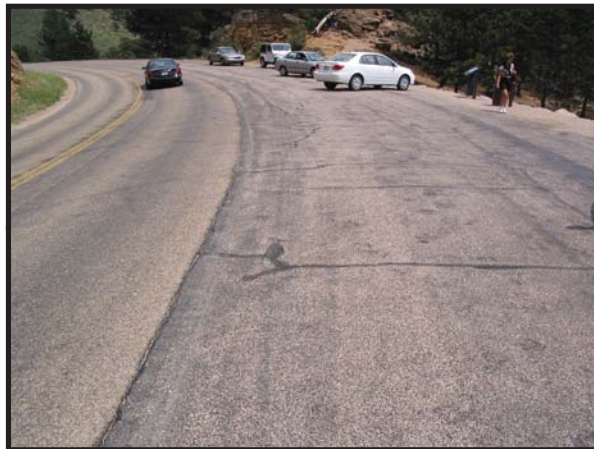
## Route 0901

Route	Public / NonPublic	Date Visited	Area (sq ft)	Lane Miles *	Surface Type	Condition / PCR
0901	Public	7/23/1999	6613	0.11	OC	FAIR / 73

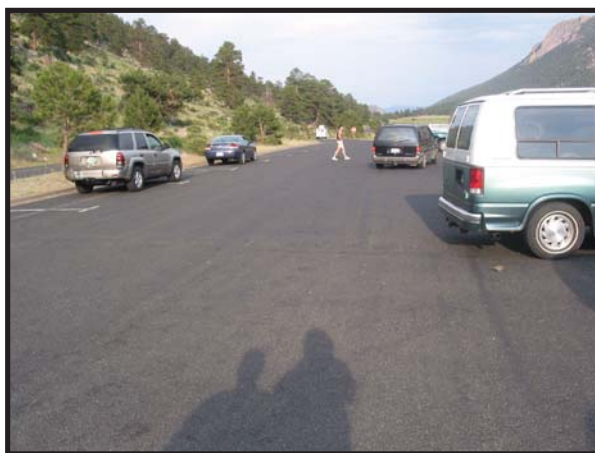
## Route 0904

Route	Public / NonPublic	Date Visited	Area (sq ft)	Lane Miles *	Surface Type	Condition / PCR
0904	Public	7/21/1999	16689	0.29	NC	EXCELLENT / 97

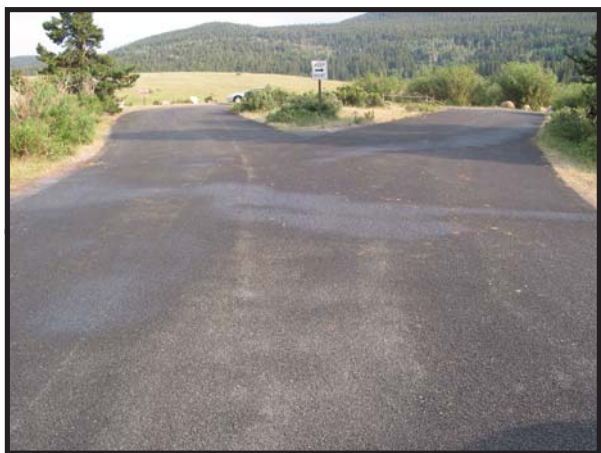
## Route 0905

Route	Public / NonPublic	Date Visited	Area (sq ft)	Lane Miles *	Surface Type	Condition / PCR
0905	Public	7/21/1999	8506	0.15	NC	EXCELLENT / 97

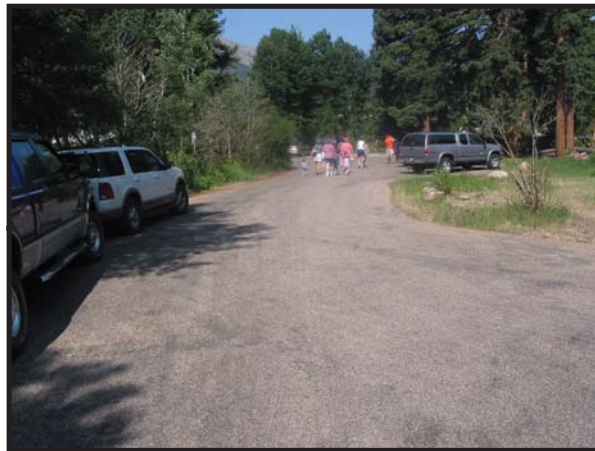
## Route 0908

Route	Public / NonPublic	Date Visited	Area (sq ft)	Lane Miles *	Surface Type	Condition / PCR
0908	Public	7/21/1999	11352	0.20	NC	GOOD / 90

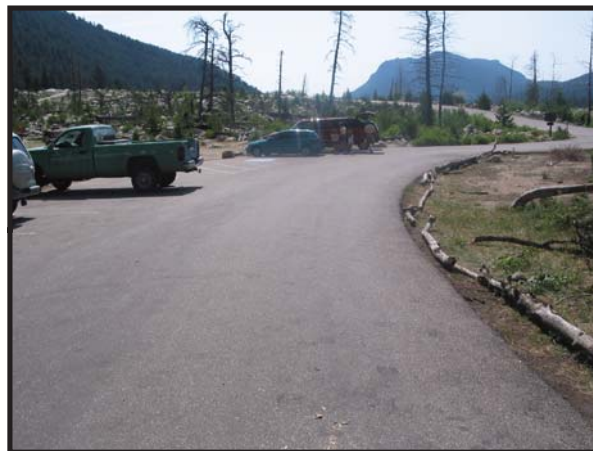
## Route 0909

Route	Public / NonPublic	Date Visited	Area (sq ft)	Lane Miles *	Surface Type	Condition / PCR
0909	Public	7/21/1999	17572	0.30	NC	GOOD / 90

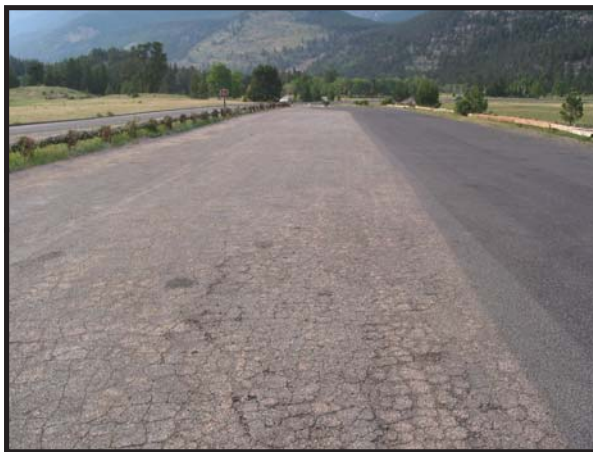
## Route 0910

Route	Public / NonPublic	Date Visited	Area (sq ft)	Lane Miles *	Surface Type	Condition / PCR
0910	Public	7/21/1999	20821	0.36	NC	POOR / 45

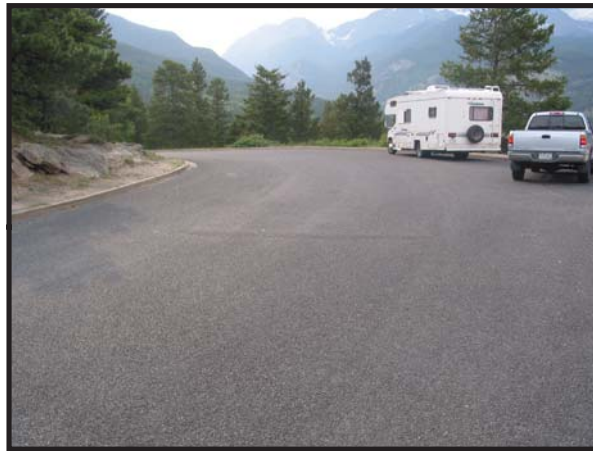
## Route 0911

Route	Public / NonPublic	Date Visited	Area (sq ft)	Lane Miles *	Surface Type	Condition / PCR
0911	Public	7/21/1999	13072	0.23	NC	EXCELLENT / 97

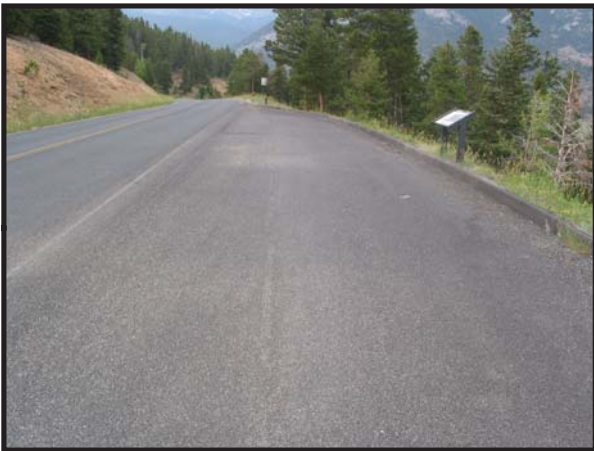
## Route 0912

Route	Public / NonPublic	Date Visited	Area (sq ft)	Lane Miles *	Surface Type	Condition / PCR
0912	Public	7/21/1999	3322	0.06	NC	EXCELLENT / 97

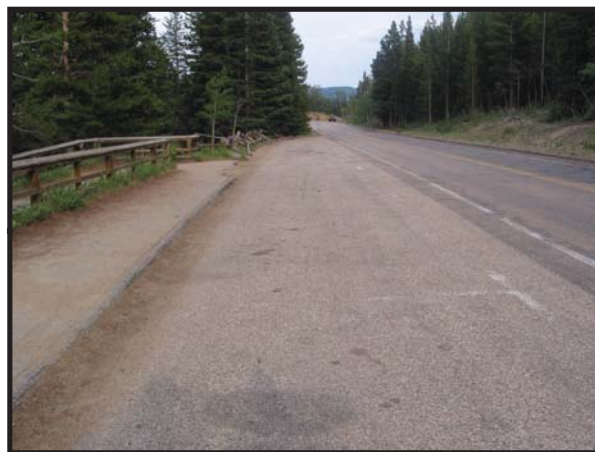
## Route 0913

Route	Public / NonPublic	Date Visited	Area (sq ft)	Lane Miles *	Surface Type	Condition / PCR
0913	Public	7/21/1999	3204	0.06	AS	GOOD / 90

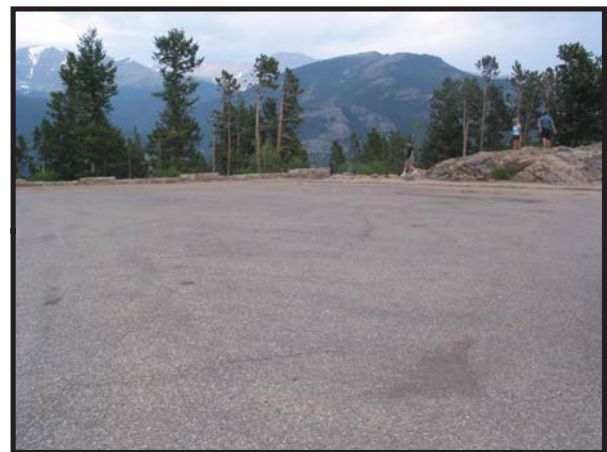
## Route 0915

Route	Public / NonPublic	Date Visited	Area (sq ft)	Lane Miles *	Surface Type	Condition / PCR
0915	Public	7/21/1999	6982	0.12	AS	GOOD / 90

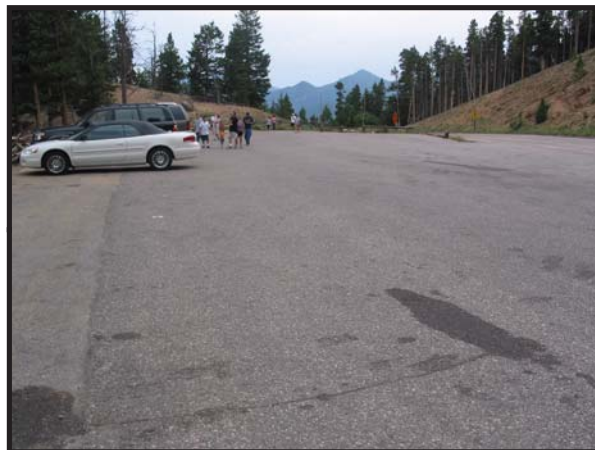
## Route 0916

Route	Public / NonPublic	Date Visited	Area (sq ft)	Lane Miles *	Surface Type	Condition / PCR
0916	Public	7/21/1999	12581	0.22	AS	GOOD / 90

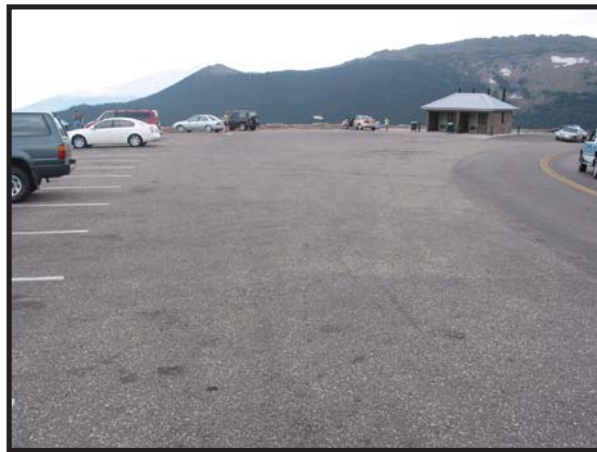
## Route 0917

Route	Public / NonPublic	Date Visited	Area (sq ft)	Lane Miles *	Surface Type	Condition / PCR
0917	Public	7/21/1999	23938	0.41	AS	GOOD / 90

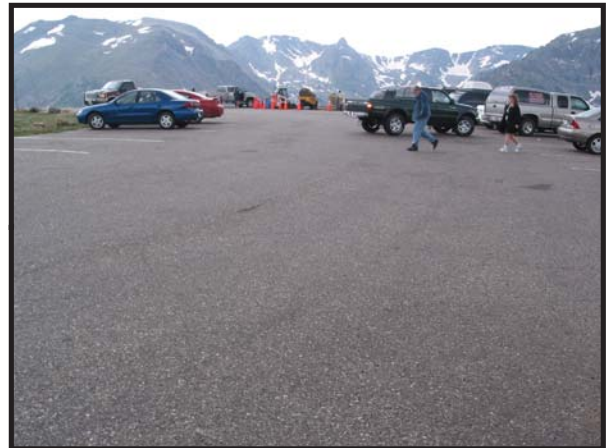
## Route 0918

Route	Public / NonPublic	Date Visited	Area (sq ft)	Lane Miles *	Surface Type	Condition / PCR
0918	Public	7/21/1999	17999	0.31	AS	FAIR / 73

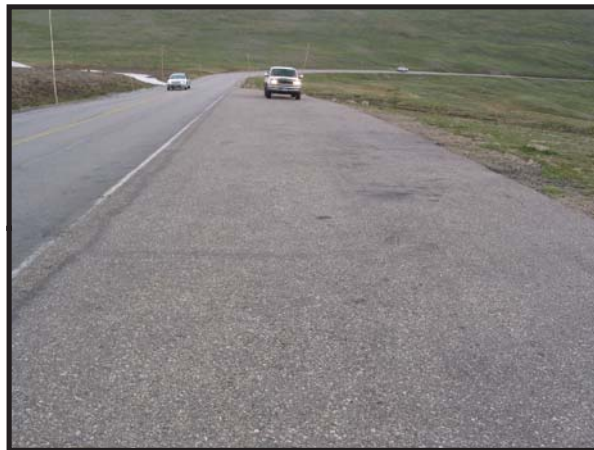
## Route 0919

Route	Public / NonPublic	Date Visited	Area (sq ft)	Lane Miles *	Surface Type	Condition / PCR
0919	Public	7/21/1999	4213	0.07	AS	GOOD / 90

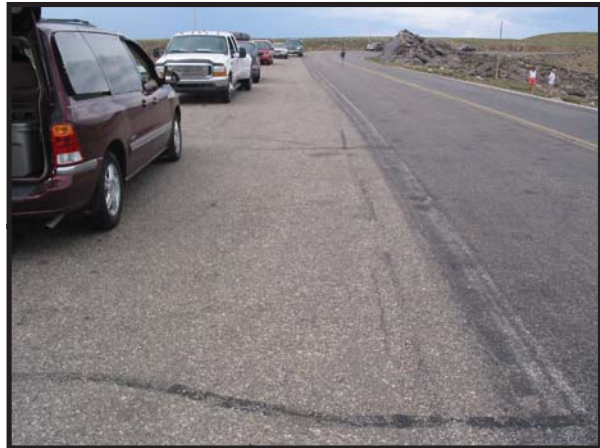
## Route 0921

Route	Public / NonPublic	Date Visited	Area (sq ft)	Lane Miles *	Surface Type	Condition / PCR
0921	Public	7/16/2003	5137	0.09	AS	FAIR / 73

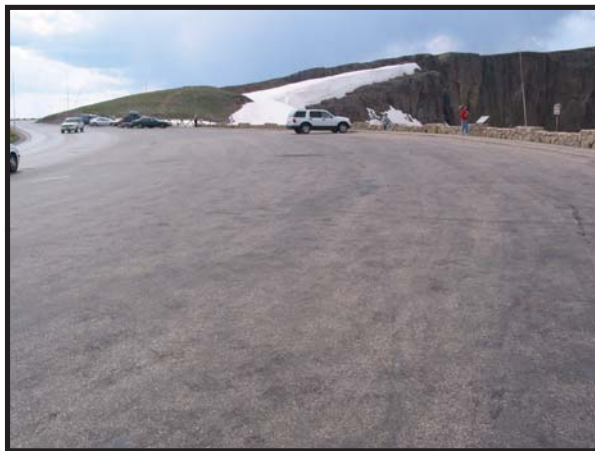
## Route 0922

Route	Public / NonPublic	Date Visited	Area (sq ft)	Lane Miles *	Surface Type	Condition / PCR
0922	Public	7/16/2003	20209	0.35	OC	FAIR / 73

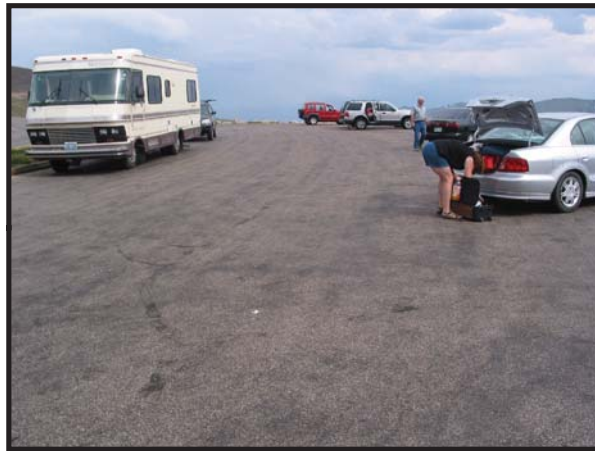
## Route 0923

Route	Public / NonPublic	Date Visited	Area (sq ft)	Lane Miles *	Surface Type	Condition / PCR
0923	Public	7/16/2003	11734	0.20	OC	GOOD / 90

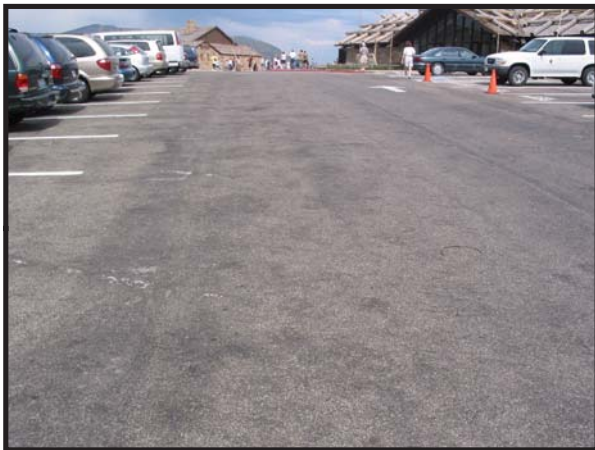
## Route 0924

Route	Public / NonPublic	Date Visited	Area (sq ft)	Lane Miles *	Surface Type	Condition / PCR
0924	Public	7/16/2003	82907	1.43	OC	GOOD / 90

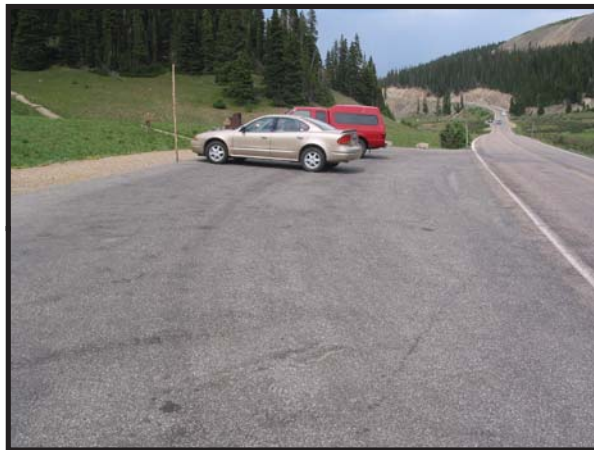
## Route 0927

Route	Public / NonPublic	Date Visited	Area (sq ft)	Lane Miles *	Surface Type	Condition / PCR
0927	Public	7/23/1999	2866	0.05	OC	GOOD / 90

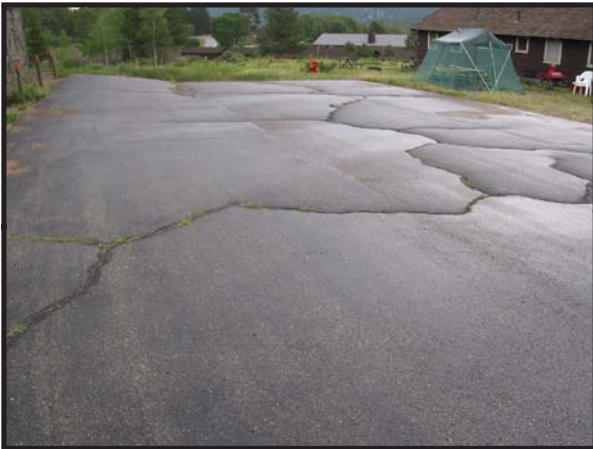
## Route 0965A

Route	Public / NonPublic	Date Visited	Area (sq ft)	Lane Miles *	Surface Type	Condition / PCR
0965A	Public	7/15/2003	1047	0.02	OC	FAIR / 73

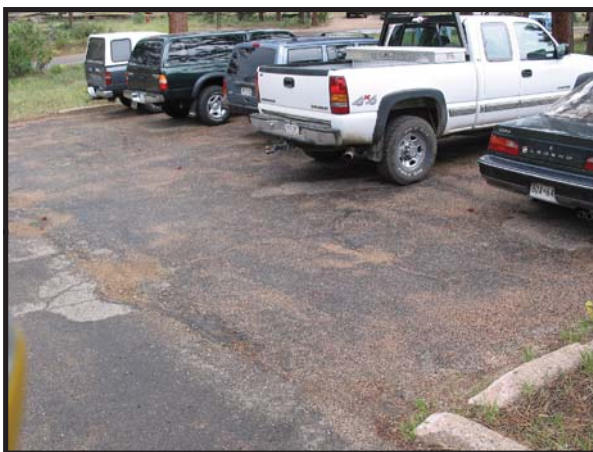
## Route 0965B

Route	Public / NonPublic	Date Visited	Area (sq ft)	Lane Miles *	Surface Type	Condition / PCR
0965B	NonPublic	7/15/2003	1546	0.03	OC	POOR / 45

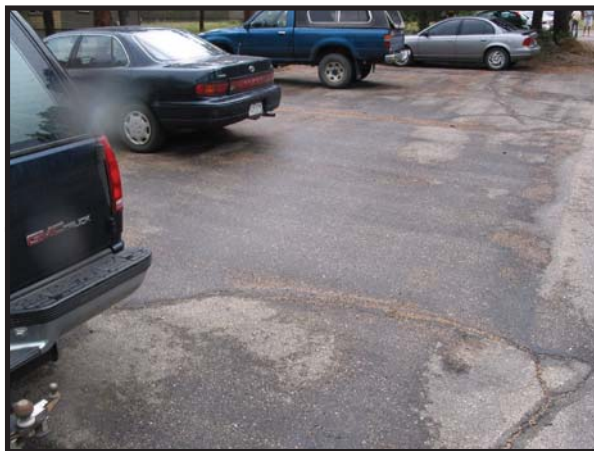
## Route 0965C

Route	Public / NonPublic	Date Visited	Area (sq ft)	Lane Miles *	Surface Type	Condition / PCR
0965C	NonPublic	7/15/2003	2067	0.04	OC	POOR / 45

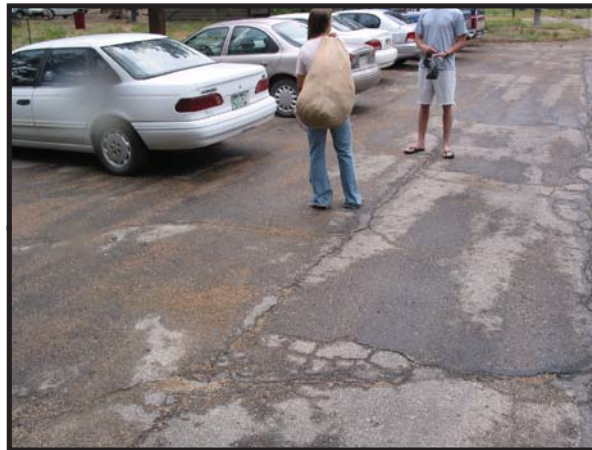
## Route 0965D

Route	Public / NonPublic	Date Visited	Area (sq ft)	Lane Miles *	Surface Type	Condition / PCR
0965D	NonPublic	7/15/2003	955	0.02	OC	FAIR / 73

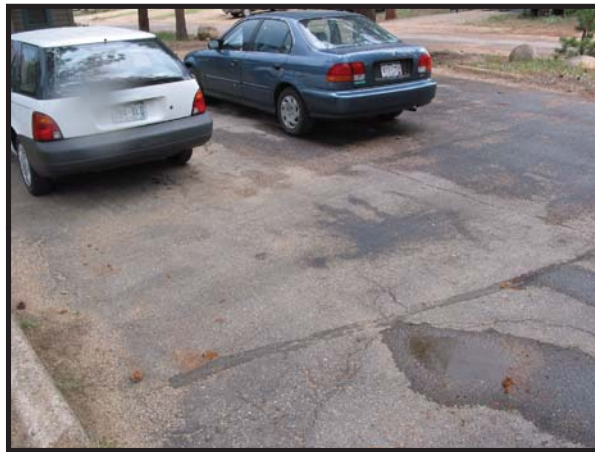
## Route 0965E

Route	Public / NonPublic	Date Visited	Area (sq ft)	Lane Miles *	Surface Type	Condition / PCR
0965E	NonPublic	7/15/2003	530	0.01	OC	POOR / 45

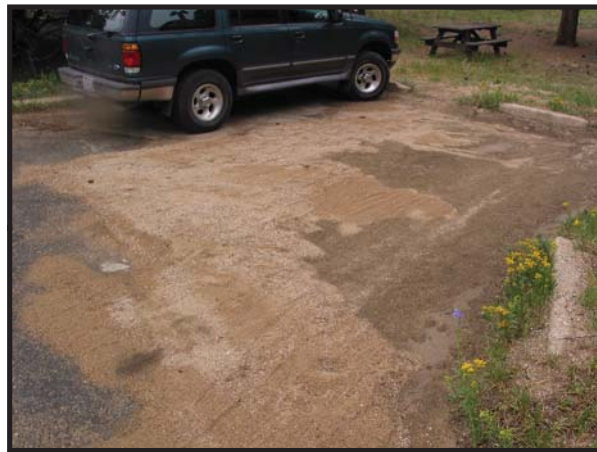
## Route 0966

Route	Public / NonPublic	Date Visited	Area (sq ft)	Lane Miles *	Surface Type	Condition / PCR
0966	NonPublic	7/15/2003	440	0.01	OC	POOR / 45

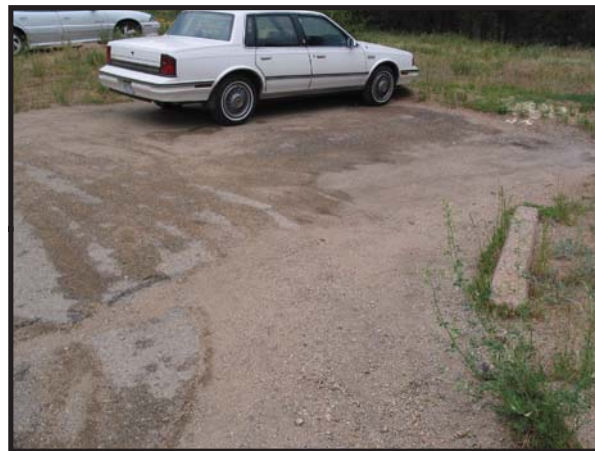
## Route 0967A

Route	Public / NonPublic	Date Visited	Area (sq ft)	Lane Miles *	Surface Type	Condition / PCR
0967A	Public	7/16/2003	7197	0.12	OC	GOOD / 90

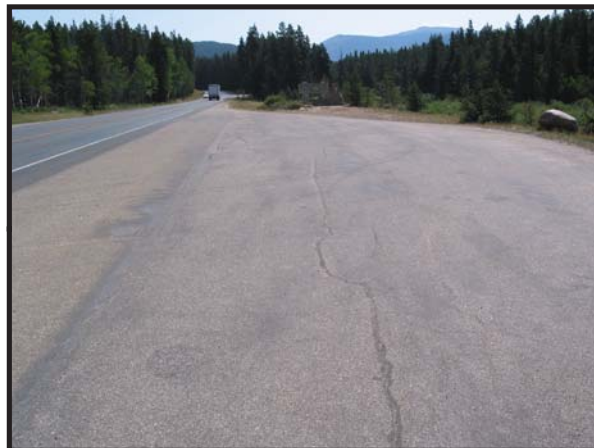
## Route 0967B

Route	Public / NonPublic	Date Visited	Area (sq ft)	Lane Miles *	Surface Type	Condition / PCR
0967B	Public	7/16/2003	3684	0.06	OC	FAIR / 73

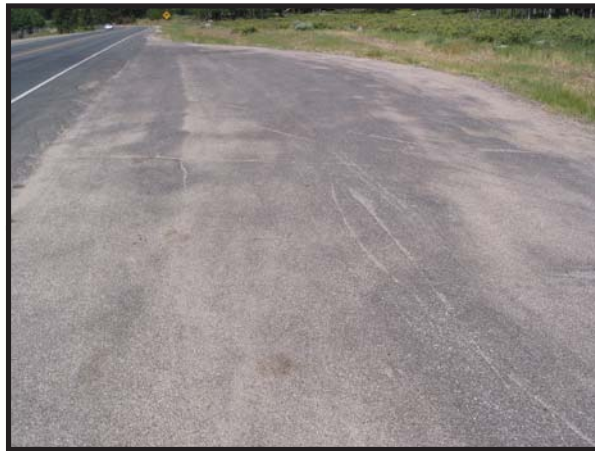
## Route 0968A

Route	Public / NonPublic	Date Visited	Area (sq ft)	Lane Miles *	Surface Type	Condition / PCR
0968A	NonPublic	7/16/2003	5589	0.10	OC	POOR / 45

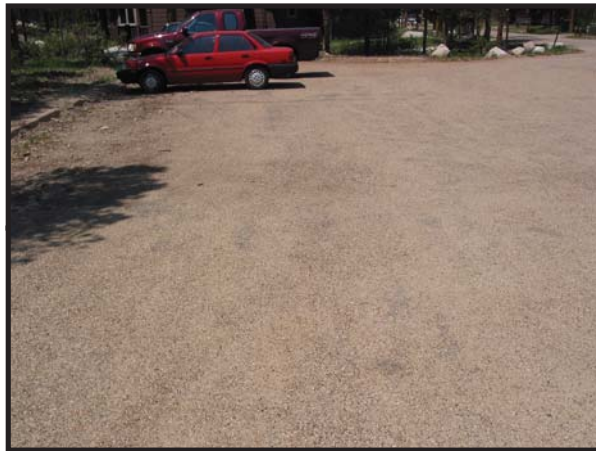
## Route 0968B

Route	Public / NonPublic	Date Visited	Area (sq ft)	Lane Miles *	Surface Type	Condition / PCR
0968B	NonPublic	7/16/2003	1346	0.02	OC	POOR / 45

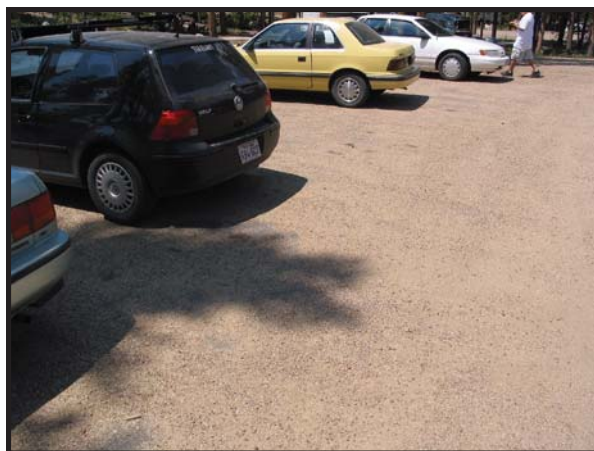
## Route 0970

Route	Public / NonPublic	Date Visited	Area (sq ft)	Lane Miles *	Surface Type	Condition / PCR
0970	Public	7/16/2003	2272	0.04	OC	GOOD / 90

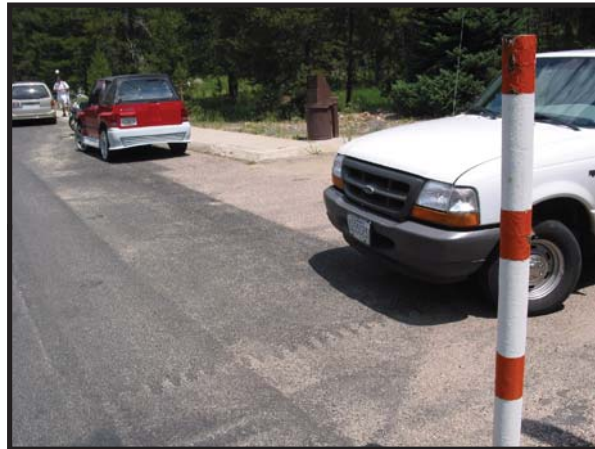
## Route 0972A

Route	Public / NonPublic	Date Visited	Area (sq ft)	Lane Miles *	Surface Type	Condition / PCR
0972A	Public	7/16/2003	1065	0.02	AS	GOOD / 90

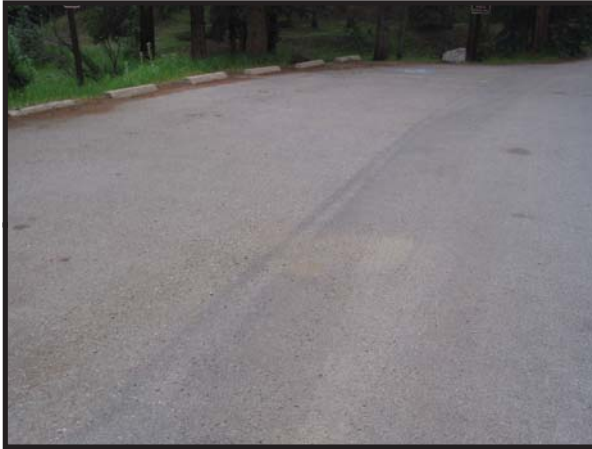
## Route 0972B

Route	Public / NonPublic	Date Visited	Area (sq ft)	Lane Miles *	Surface Type	Condition / PCR
0972B	Public	7/16/2003	2035	0.04	AS	FAIR / 73

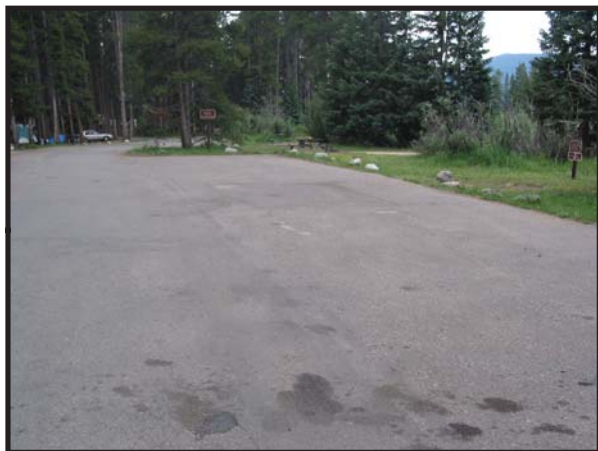
## Route 0973

Route	Public / NonPublic	Date Visited	Area (sq ft)	Lane Miles *	Surface Type	Condition / PCR
0973	Public	7/16/2003	2611	0.04	OC	GOOD / 90

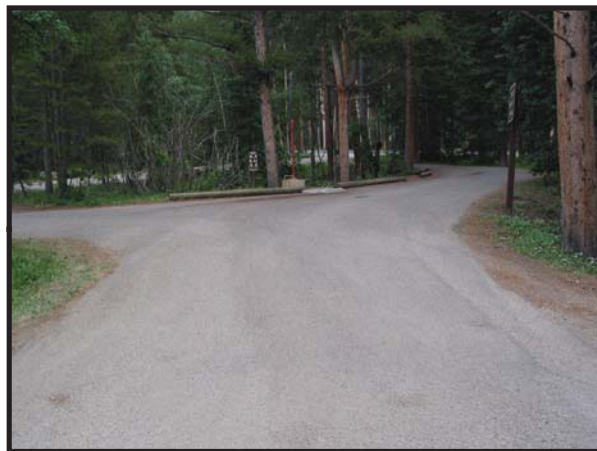
## Route 0974

Route	Public / NonPublic	Date Visited	Area (sq ft)	Lane Miles *	Surface Type	Condition / PCR
0974	NonPublic	7/16/2003	3427	0.06	OC	GOOD / 90

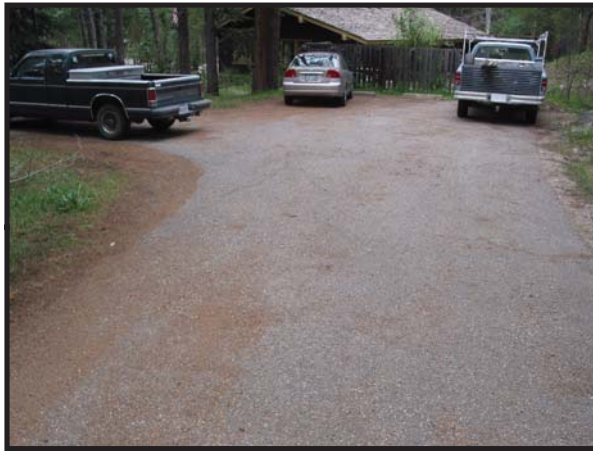
## Route 0977

Route	Public / NonPublic	Date Visited	Area (sq ft)	Lane Miles *	Surface Type	Condition / PCR
0977	Public	7/16/2003	866	0.01	AS	POOR / 45

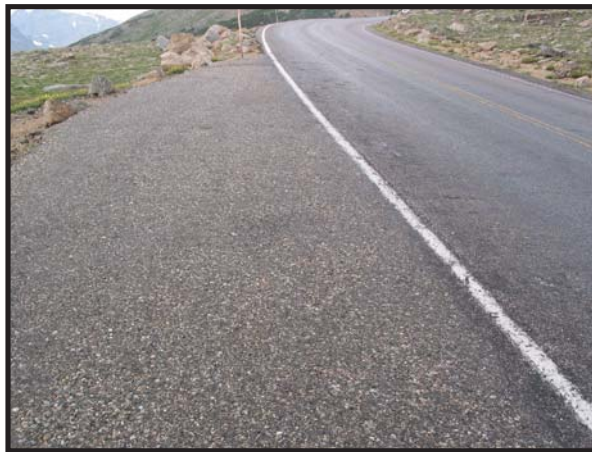
## Route 0980

Route	Public / NonPublic	Date Visited	Area (sq ft)	Lane Miles *	Surface Type	Condition / PCR
0980	Public	7/17/2003	997	0.02	NC	FAIR / 73

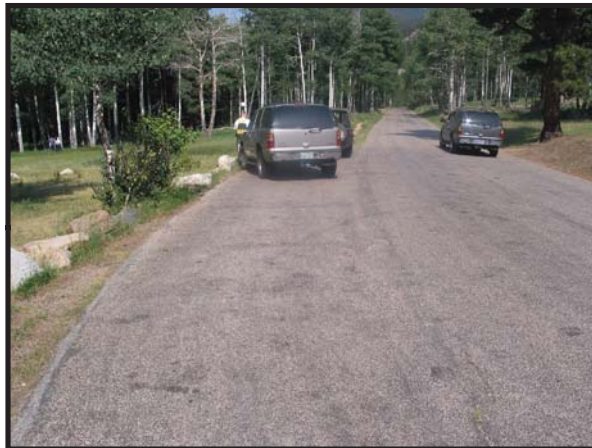
## Route 0981

Route	Public / NonPublic	Date Visited	Area (sq ft)	Lane Miles *	Surface Type	Condition / PCR
0981	Public	7/17/2003	415	0.01	AS	GOOD / 90

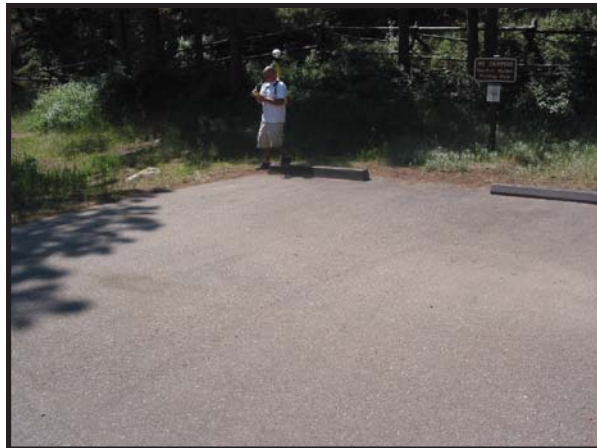
## Route 0982

Route	Public / NonPublic	Date Visited	Area (sq ft)	Lane Miles *	Surface Type	Condition / PCR
0982	Public	7/17/2003	2116	0.04	AS	FAIR / 73

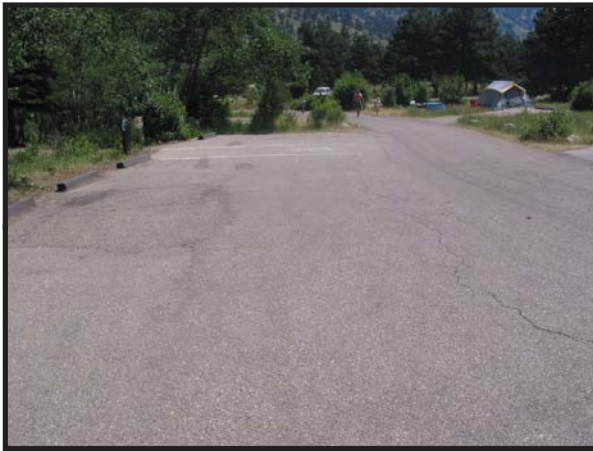
## Route 0983

Route	Public / NonPublic	Date Visited	Area (sq ft)	Lane Miles *	Surface Type	Condition / PCR
0983	Public	7/17/2003	1771	0.03	AS	GOOD / 90

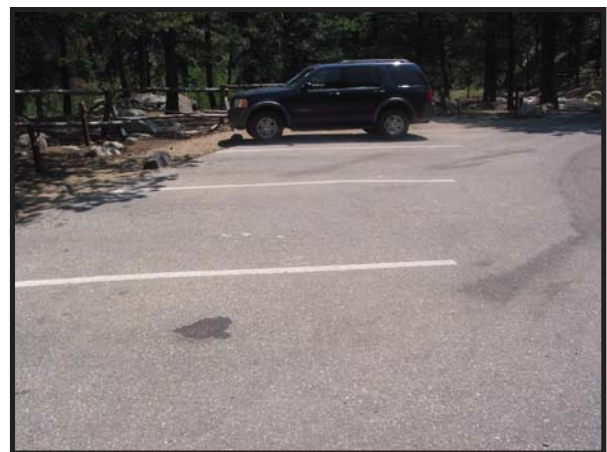
## Route 0984

Route	Public / NonPublic	Date Visited	Area (sq ft)	Lane Miles *	Surface Type	Condition / PCR
0984	Public	7/17/2003	2810	0.05	AS	FAIR / 73

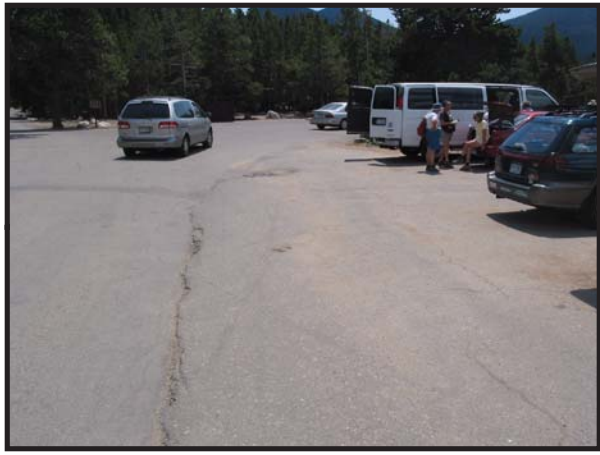
## Route 0985

Route	Public / NonPublic	Date Visited	Area (sq ft)	Lane Miles *	Surface Type	Condition / PCR
0985	Public	7/17/2003	4069	0.07	AS	POOR / 45

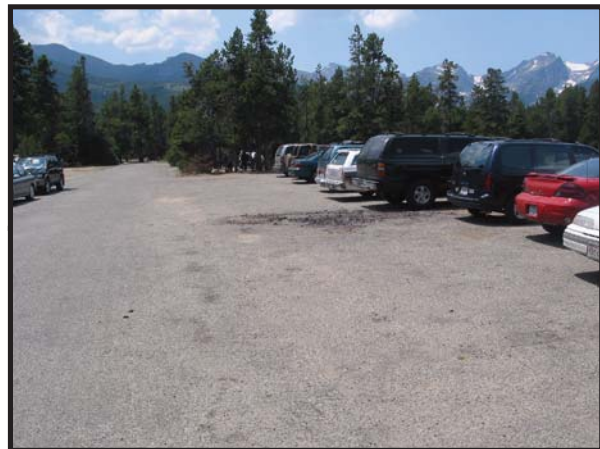
## Route 0989

Route	Public / NonPublic	Date Visited	Area (sq ft)	Lane Miles *	Surface Type	Condition / PCR
0989	Public	7/16/2003	2870	0.05	OC	GOOD / 90

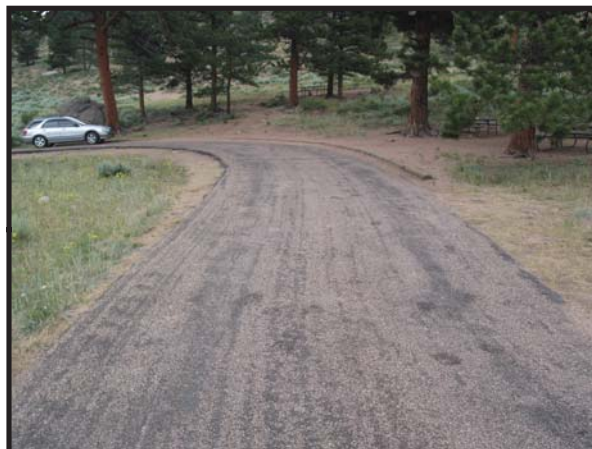
## Route 0990

Route	Public / NonPublic	Date Visited	Area (sq ft)	Lane Miles *	Surface Type	Condition / PCR
0990	Public	7/16/2003	463	0.01	AS	FAIR / 73

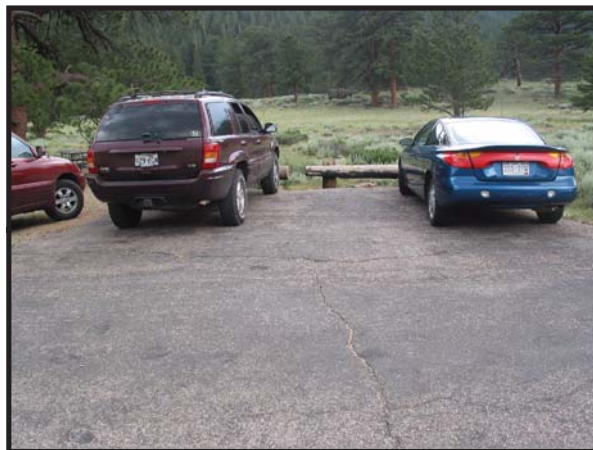
## Route 0991

Route	Public / NonPublic	Date Visited	Area (sq ft)	Lane Miles *	Surface Type	Condition / PCR
0991	Public	7/16/2003	2250	0.04	AS	FAIR / 73

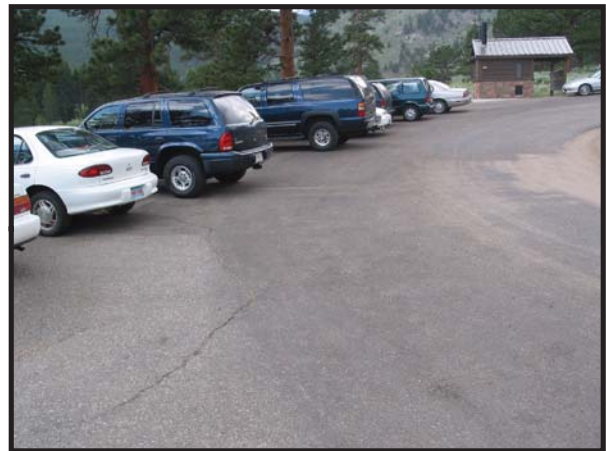
## Route 0994

Route	Public / NonPublic	Date Visited	Area (sq ft)	Lane Miles *	Surface Type	Condition / PCR
0994	Public	7/17/2003	2985	0.05	OC	GOOD / 90

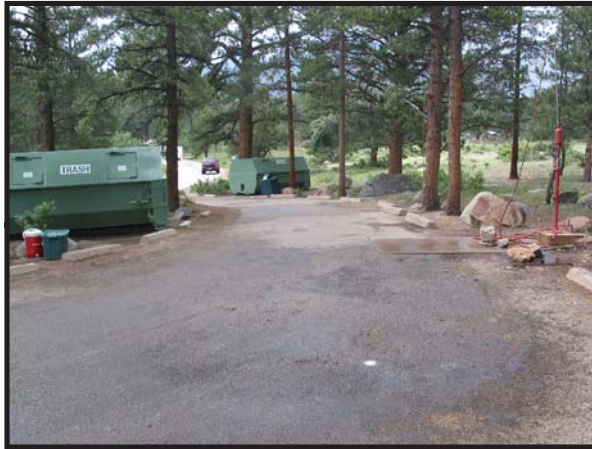
## Route 0995

Route	Public / NonPublic	Date Visited	Area (sq ft)	Lane Miles *	Surface Type	Condition / PCR
0995	Public	7/17/2003	1332	0.02	OC	GOOD / 90

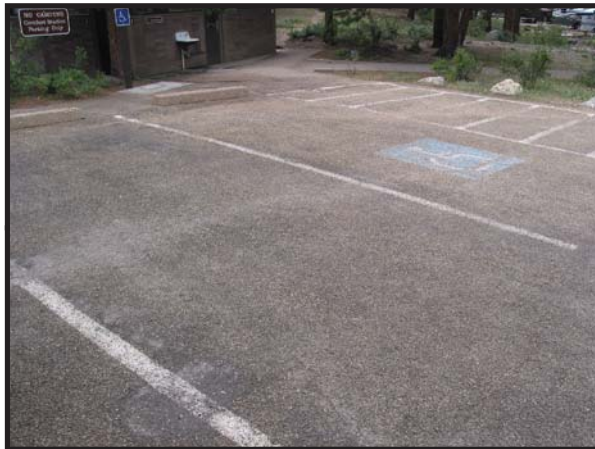
## Route 0996

Route	Public / NonPublic	Date Visited	Area (sq ft)	Lane Miles *	Surface Type	Condition / PCR
0996	Public	7/17/2003	1073	0.02	OC	FAIR / 73

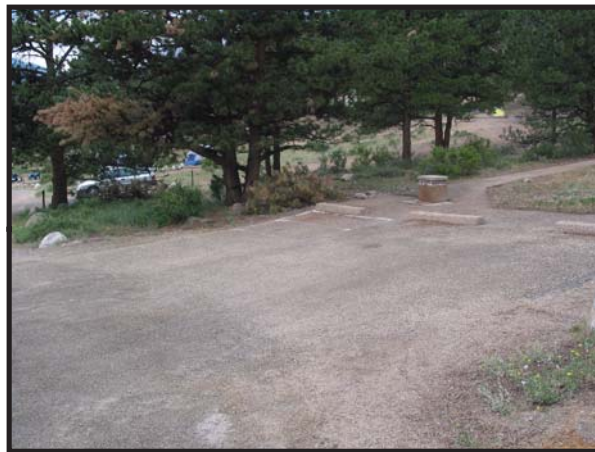
## Route 0998

Route	Public / NonPublic	Date Visited	Area (sq ft)	Lane Miles *	Surface Type	Condition / PCR
0998	Public	7/17/2003	1445	0.02	OC	FAIR / 73

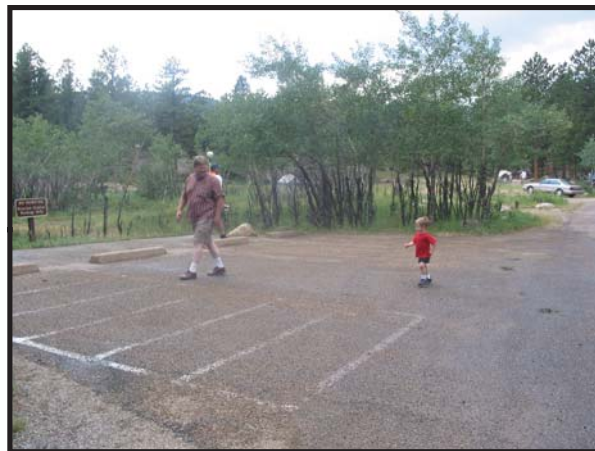
## Route 0999

Route	Public / NonPublic	Date Visited	Area (sq ft)	Lane Miles *	Surface Type	Condition / PCR
0999	Public	7/17/2003	849	0.01	OC	FAIR / 73

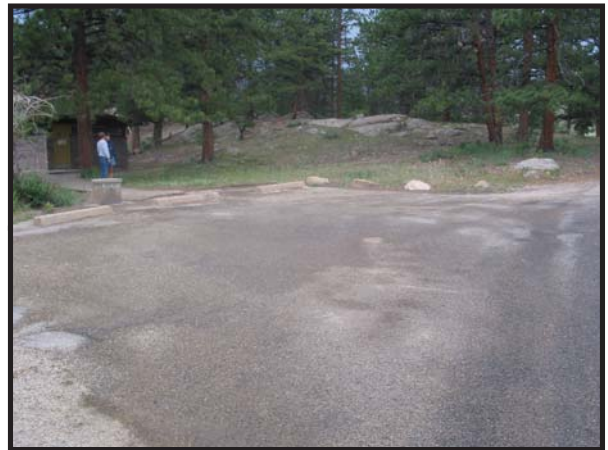
## Route 1000A

Route	Public / NonPublic	Date Visited	Area (sq ft)	Lane Miles *	Surface Type	Condition / PCR
1000A	Public	7/17/2003	3119	0.05	OC	FAIR / 73

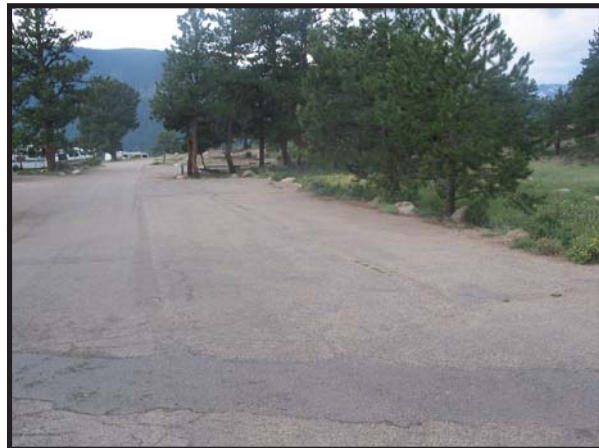
## Route 1000B

Route	Public / NonPublic	Date Visited	Area (sq ft)	Lane Miles *	Surface Type	Condition / PCR
1000B	Public	7/17/2003	1578	0.03	OC	FAIR / 73

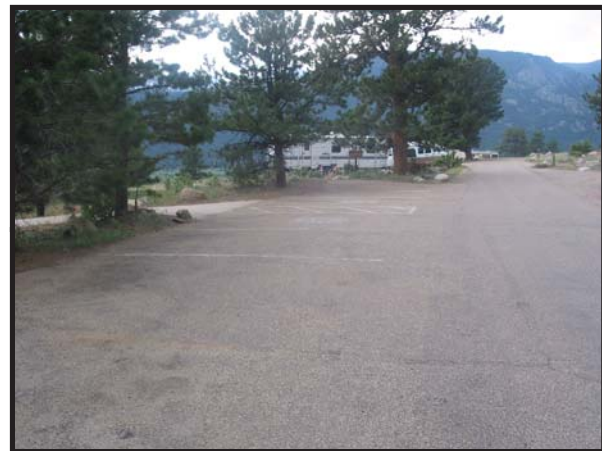
## Route 1004

Route	Public / NonPublic	Date Visited	Area (sq ft)	Lane Miles *	Surface Type	Condition / PCR
1004	Public	7/17/2003	6656	0.11	AS	GOOD / 90
