# The Road Inventory of Roger Williams National Memorial ROWI - 1860

Prepared By:  
Federal Highway Administration  
Eastern Federal Lands Highway Division  
Cycle 3

# Roger Williams National Memorial in Rhode Island

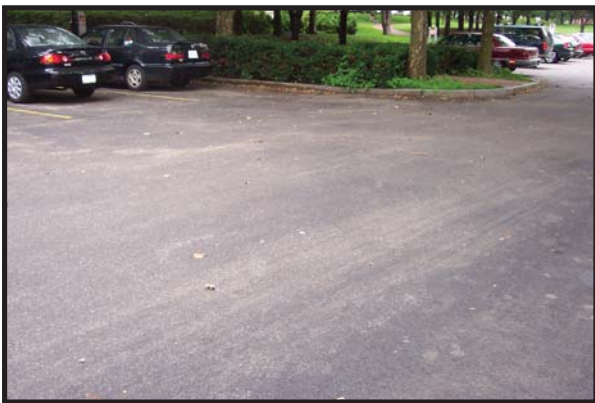
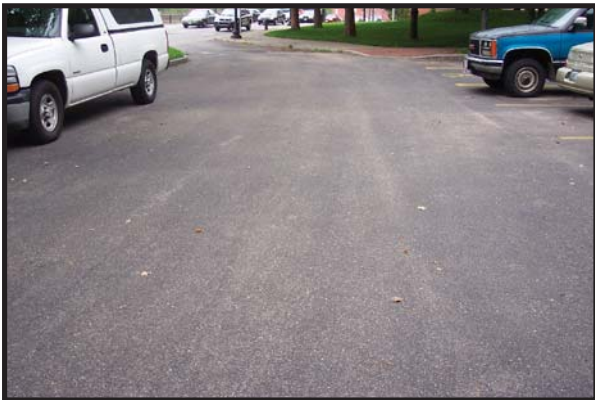
## Route 0900

Visitor Center Parking  
From Canal Street

Route	Public / NonPublic	Date Visited	Area (sq ft)	Lane Miles *	Surface Type	Condition / PCR
0900	Public	7/14/2004	9761	0.17	AS	GOOD / 90
