The Road Inventory of Russell Cave National Monument RUCA – 5660

Road Inventory Program

Prepared By:
Federal Highway Administration
Eastern Federal Lands Highway Division
Cycle 3

Russell Cave National Monument in Alabama

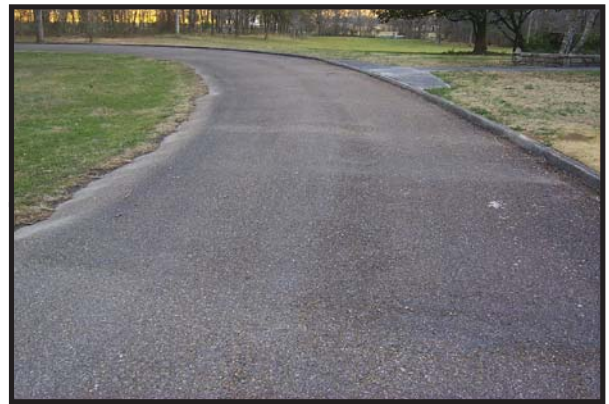
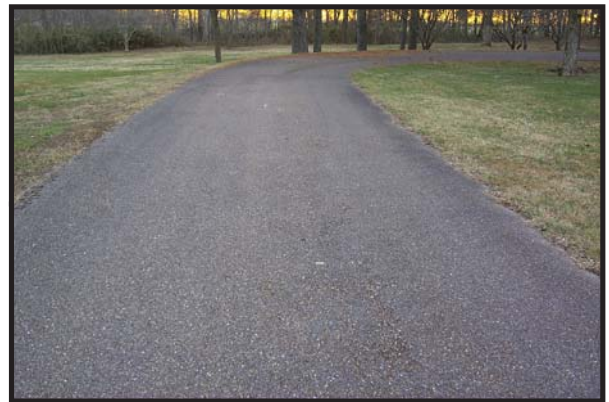
Russell Cave National Monument
Route 0901
 VISITOR CENTER LOOP TURNAROUND
 From Route 0010

Route	Public / NonPublic	Date Visited	Area (sq ft)	Lane Miles *	Surface Type	Condition / PCR
0901	Public	1/25/2002	7504	0.13	AS	GOOD / 90

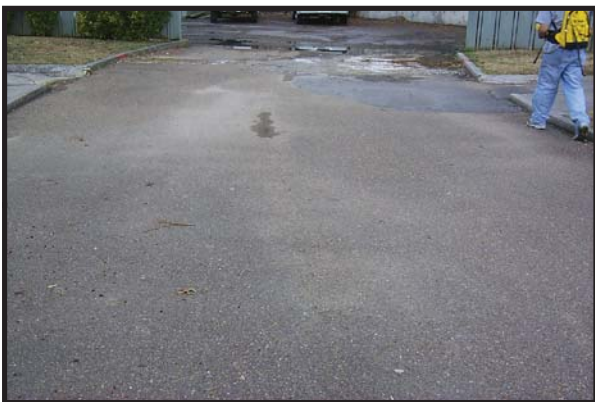
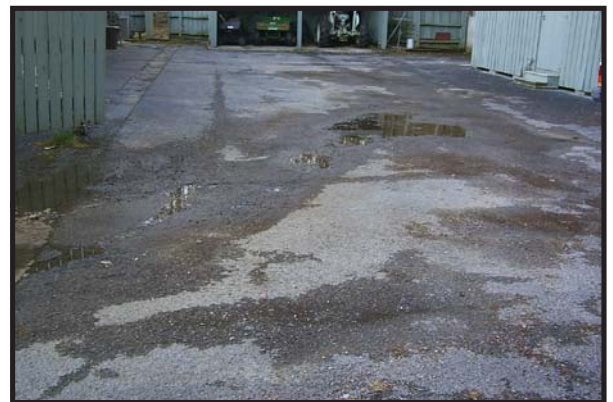
Route 0902

Route	Public / NonPublic	Date Visited	Area (sq ft)	Lane Miles *	Surface Type	Condition / PCR
0902	NonPublic	1/25/2002	4928	0.08	AS	POOR / 45

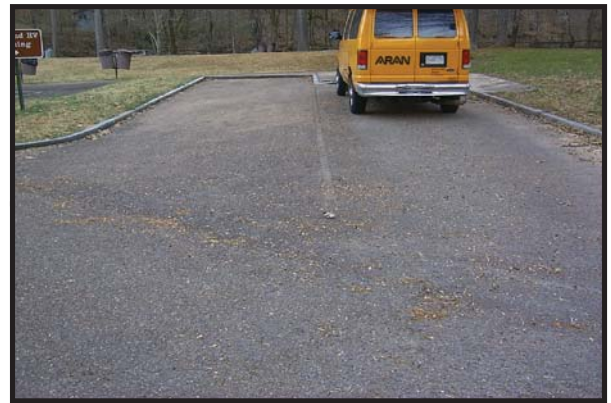
Route 0903

Route	Public / NonPublic	Date Visited	Area (sq ft)	Lane Miles *	Surface Type	Condition / PCR
0903	Public	1/25/2002	1330	0.02	AS	GOOD / 90

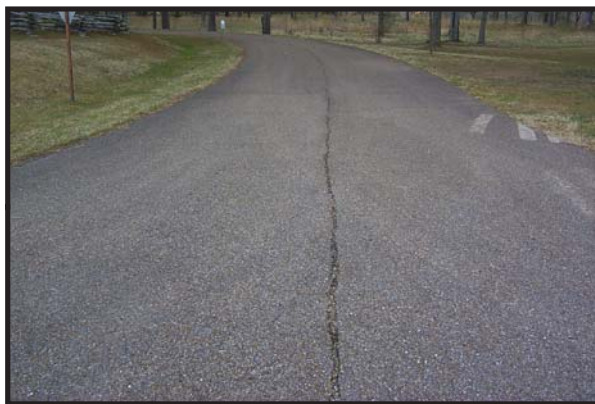
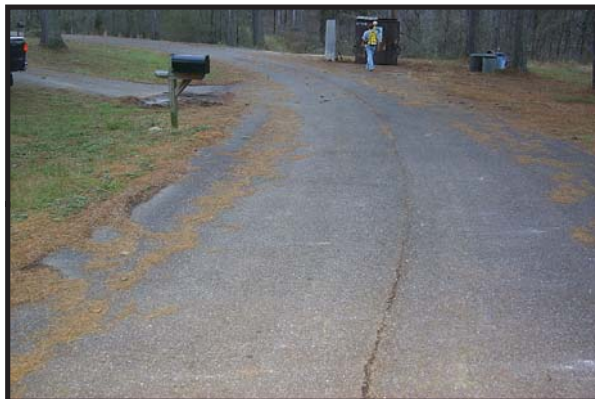
Route 0904

Route	Public / NonPublic	Date Visited	Area (sq ft)	Lane Miles *	Surface Type	Condition / PCR
0904	NonPublic	1/25/2002	8851	0.15	AS	FAIR / 73
