**The Road Inventory
of
San Antonio Missions National Historical
Park
SAAN - 7600**

Road Inventory Program

Prepared By:
Federal Highway Administration
Eastern Federal Lands Highway Division
Cycle 3

San Antonio Missions National Historical Park in Texas

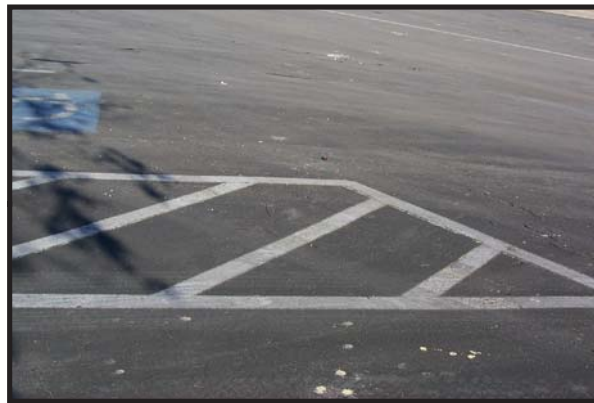
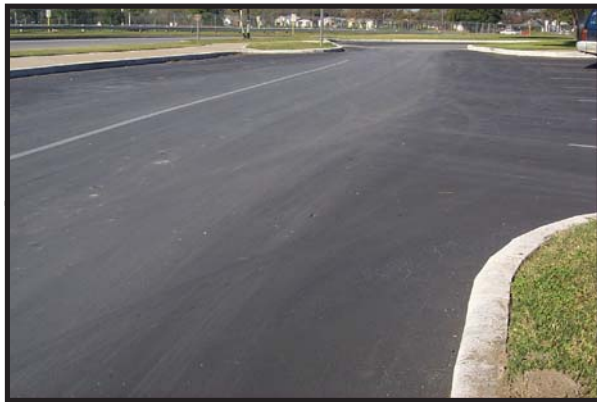
Route	Public / NonPublic	Date Visited	Area (sq ft)	Lane Miles *	Surface Type	Condition / PCR
0900	Public	12/20/2001	19988	0.34	AS	FAIR / 73

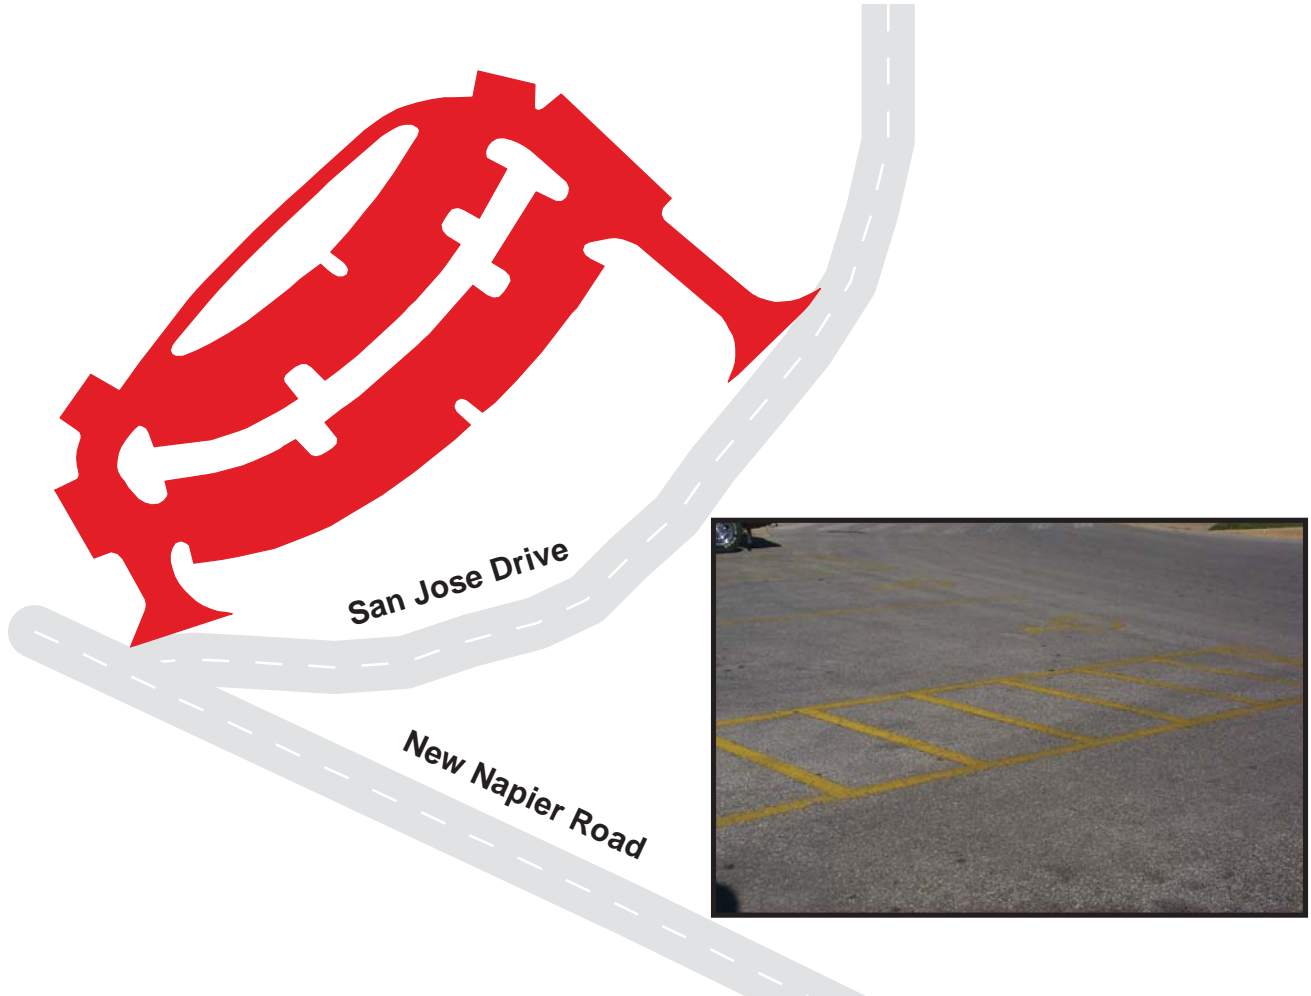
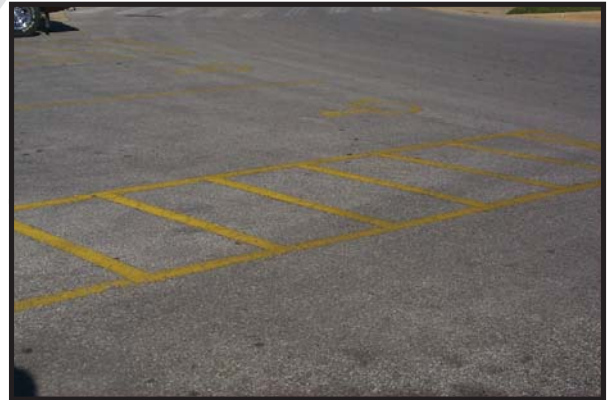
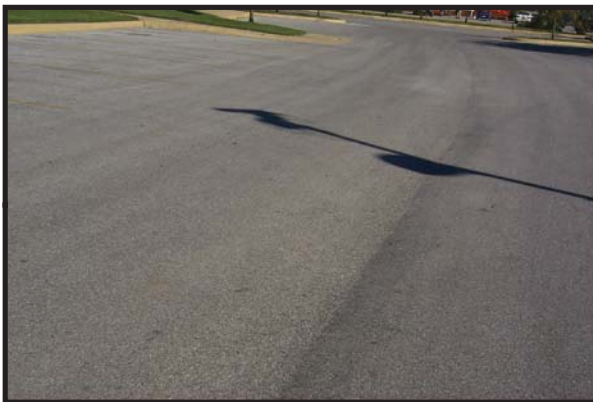
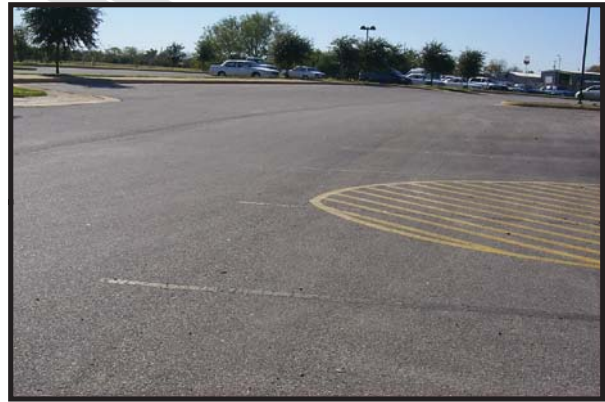
Route 0901

Route	Public / NonPublic	Date Visited	Area (sq ft)	Lane Miles *	Surface Type	Condition / PCR
0901	Public	12/20/2001	51265	0.88	AS	GOOD / 90

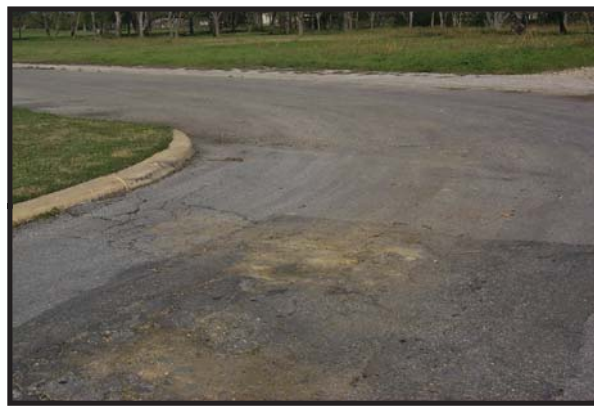
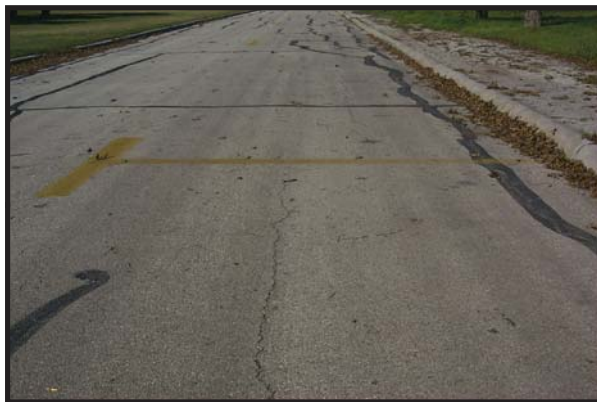
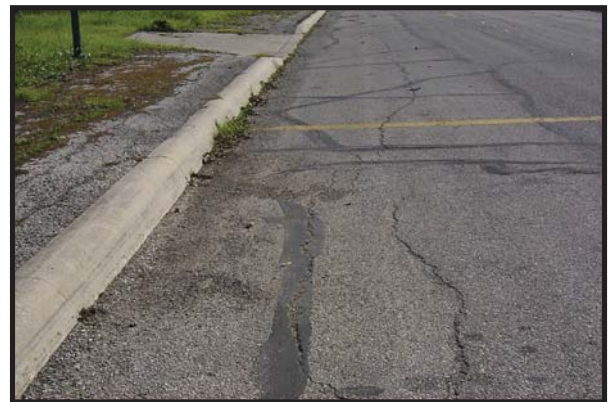
Route 0902

Route	Public / NonPublic	Date Visited	Area (sq ft)	Lane Miles *	Surface Type	Condition / PCR
0902	Public	12/20/2001	22082	0.38	AS	POOR / 45

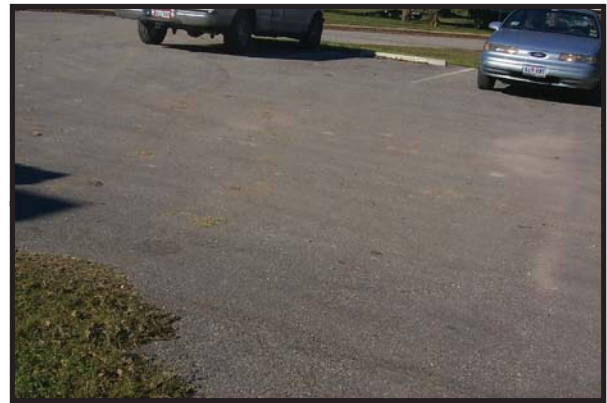
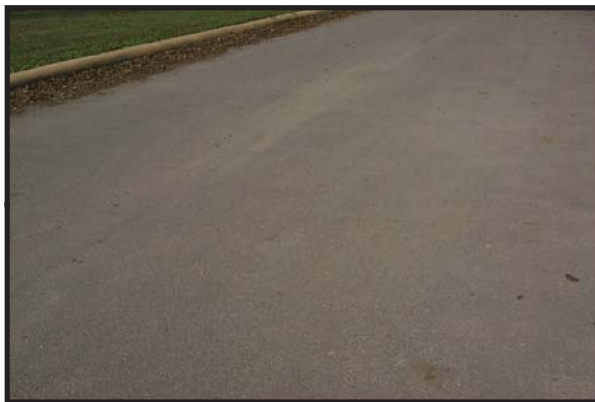
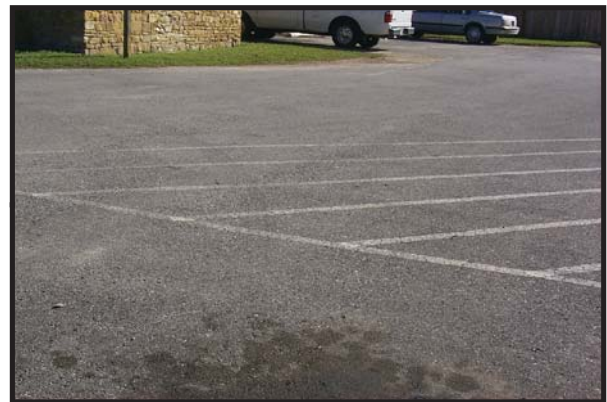
Route 0903

Route	Public / NonPublic	Date Visited	Area (sq ft)	Lane Miles *	Surface Type	Condition / PCR
0903	NonPublic	12/20/2001	17226	0.30	AS	FAIR / 73

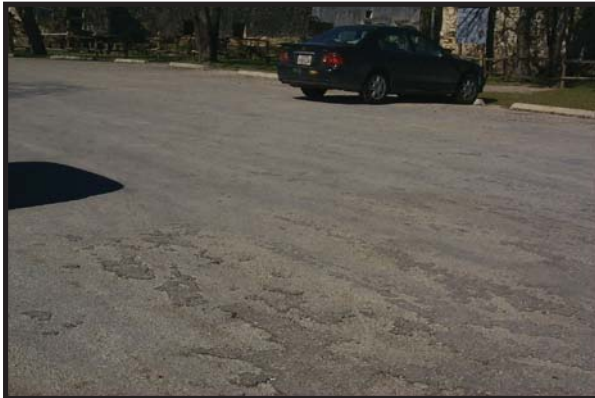
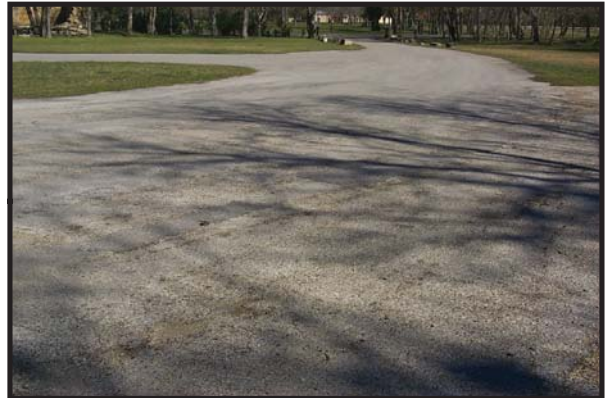
Route 0904

Route	Public / NonPublic	Date Visited	Area (sq ft)	Lane Miles *	Surface Type	Condition / PCR
0904	Public	12/20/2001	23510	0.40	AS	POOR / 45

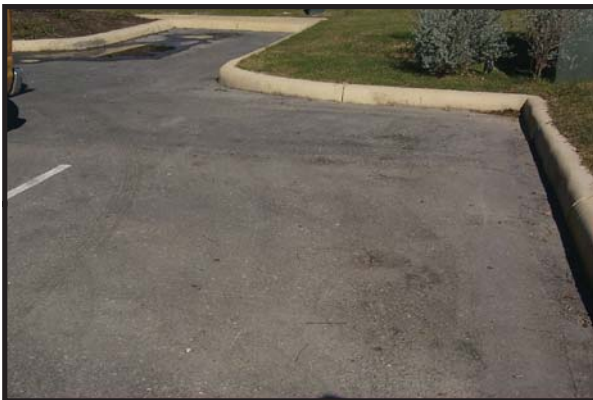
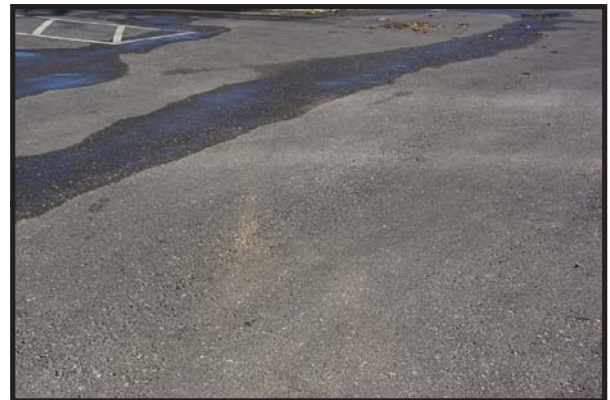
Route 0905

Route	Public / NonPublic	Date Visited	Area (sq ft)	Lane Miles *	Surface Type	Condition / PCR
0905	Public	12/20/2001	4292	0.07	AS	GOOD / 90

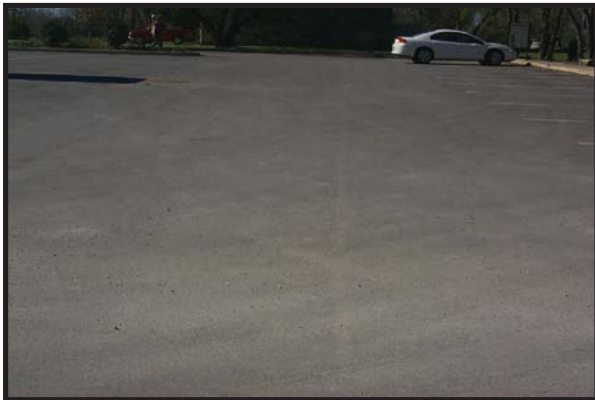
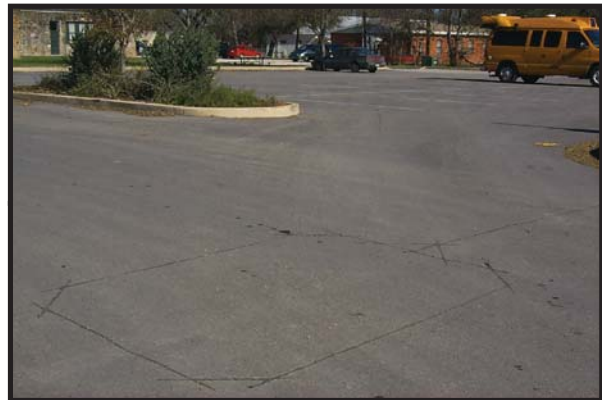
Route 0906

Route	Public / NonPublic	Date Visited	Area (sq ft)	Lane Miles *	Surface Type	Condition / PCR
0906	Public	12/20/2001	16101	0.28	AS	GOOD / 90

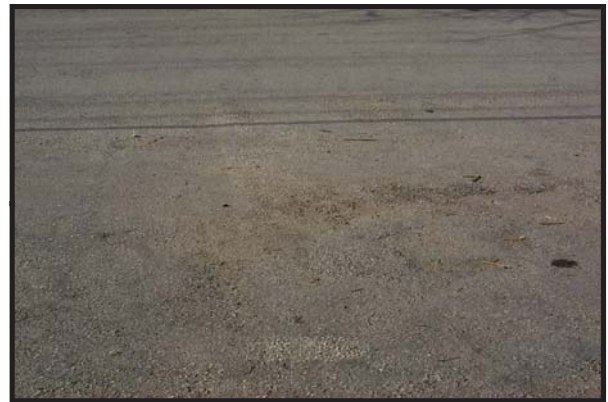
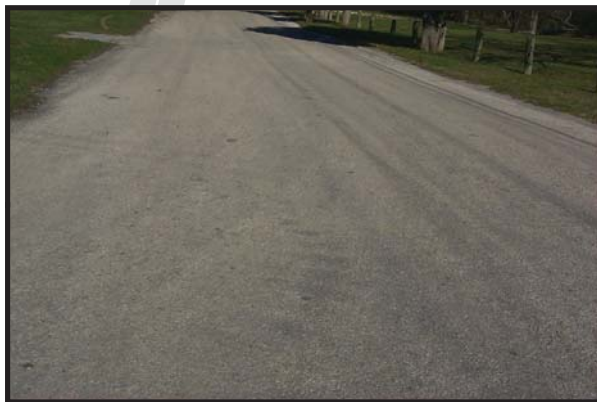
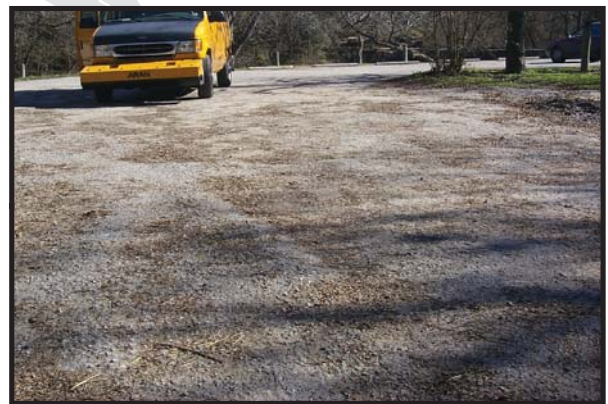
Route 0908

Route	Public / NonPublic	Date Visited	Area (sq ft)	Lane Miles *	Surface Type	Condition / PCR
0908	Public	12/20/2001	14555	0.25	AS	FAIR / 73
