**The Road Inventory
of
Saint Croix/Lower St. Croix National
(Wild/Scenic) River (Way)
SACN – 6590**

Road Inventory Program

Prepared By:
Federal Highway Administration
Eastern Federal Lands Highway Division
Cycle 3

Saint Croix/Lower St. Croix National (Wild/Scenic) River (Way) in Wisconsin

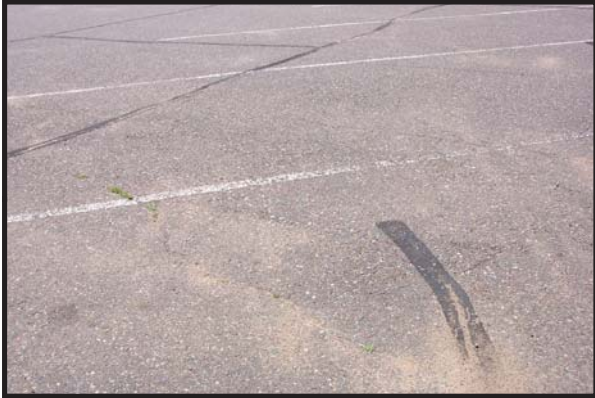
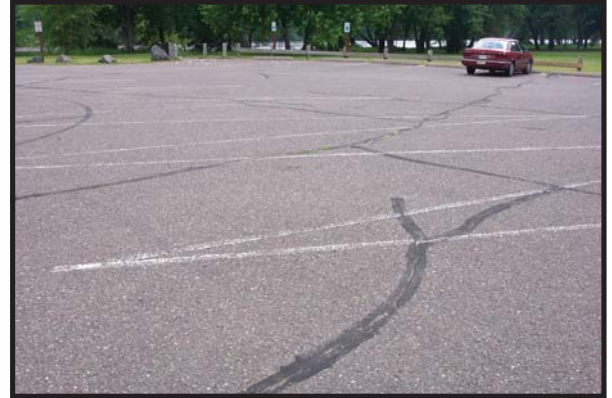
Route	Public / NonPublic	Date Visited	Area (sq ft)	Lane Miles *	Surface Type	Condition / PCR
0900	Public	6/26/2003	52859	0.91	AS	FAIR / 73

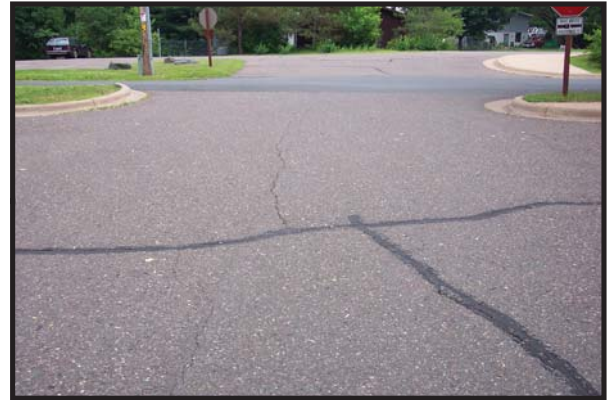
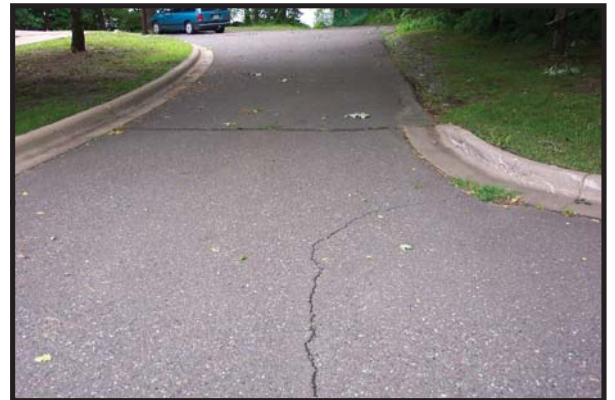
Route 0901

Route	Public / NonPublic	Date Visited	Area (sq ft)	Lane Miles *	Surface Type	Condition / PCR
0901	Public	6/26/2003	9737	0.17	AS	FAIR / 73

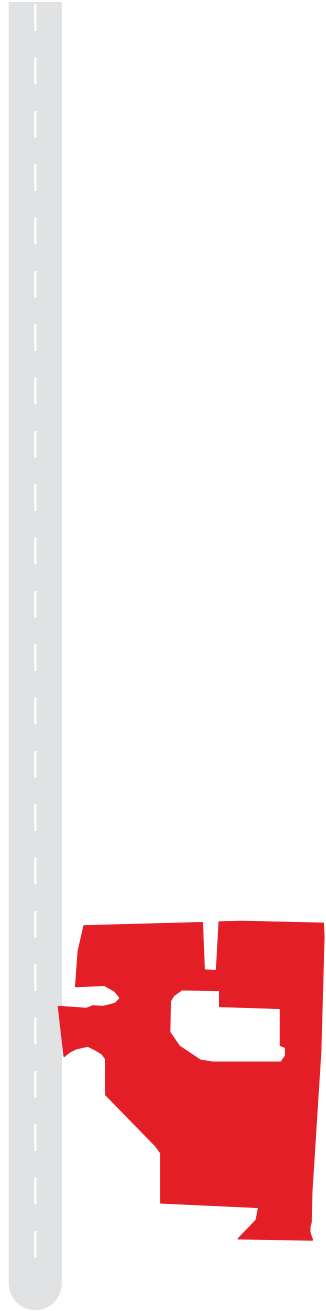
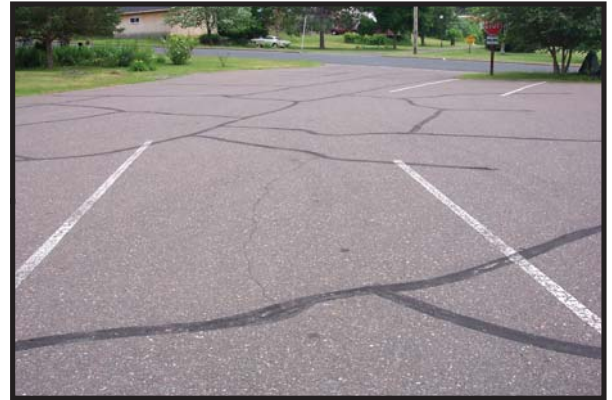
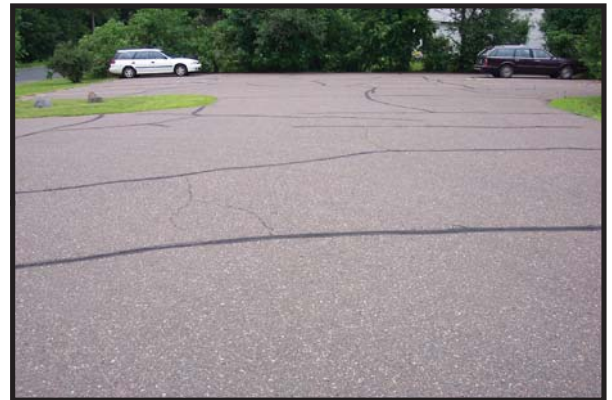
Route 0902

Route	Public / NonPublic	Date Visited	Area (sq ft)	Lane Miles *	Surface Type	Condition / PCR
0902	Public	6/26/2003	24599	0.42	AS	FAIR / 73

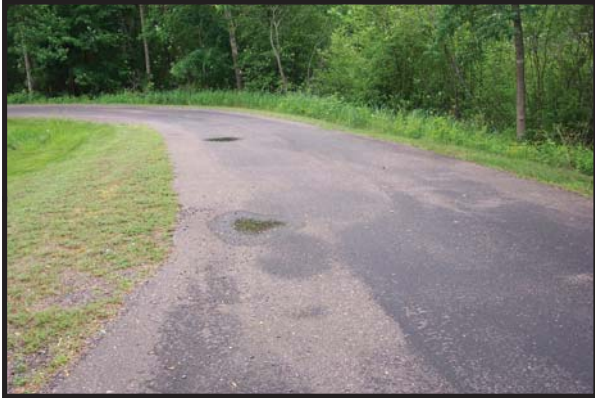
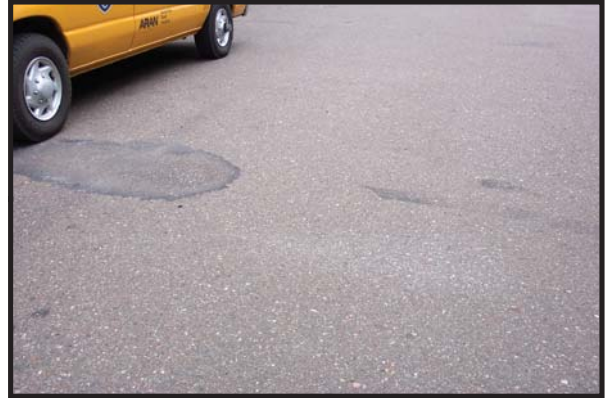
Route 0903

Route	Public / NonPublic	Date Visited	Area (sq ft)	Lane Miles *	Surface Type	Condition / PCR
0903	Public	6/26/2003	35881	0.62	AS	FAIR / 73

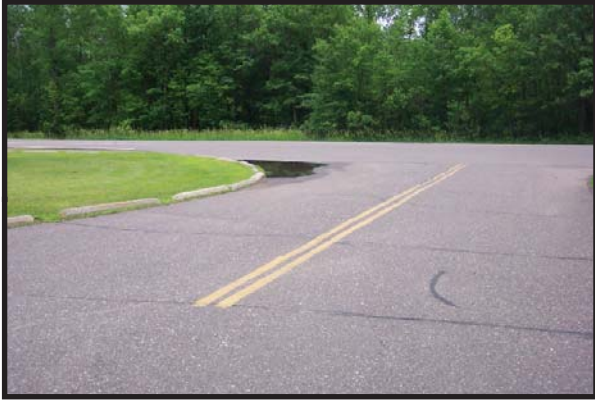
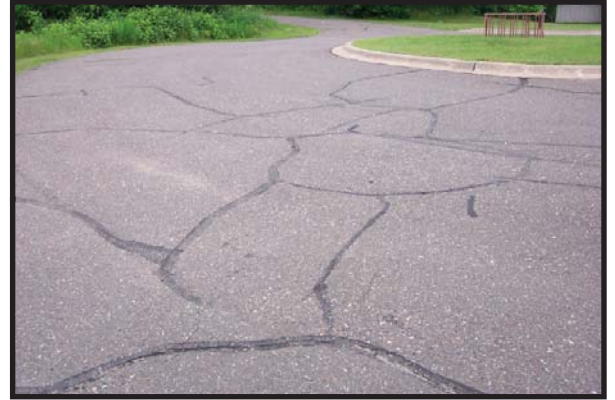
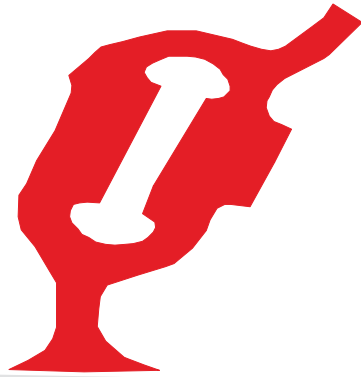
Route 0904

Route	Public / NonPublic	Date Visited	Area (sq ft)	Lane Miles *	Surface Type	Condition / PCR
0904	Public	6/26/2003	23789	0.41	AS	FAIR / 73

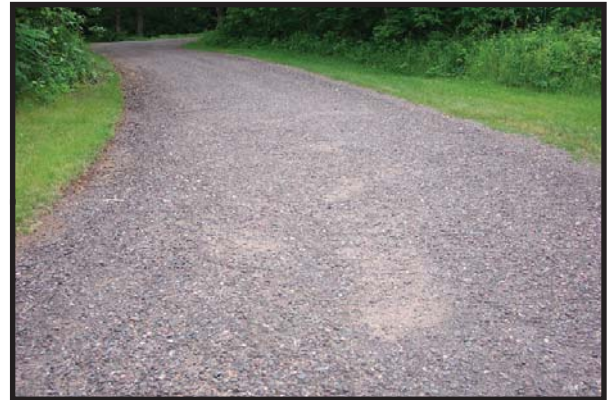
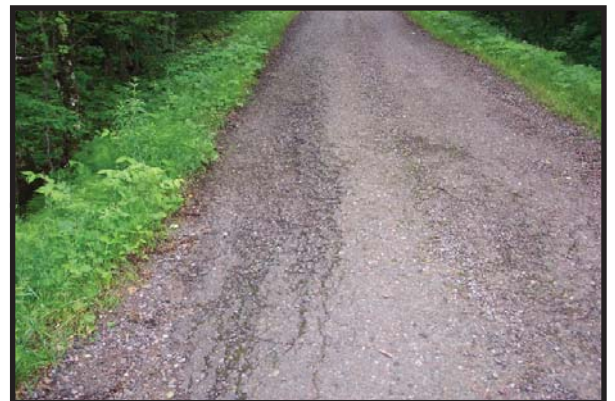
Route 0906A

Route	Public / NonPublic	Date Visited	Area (sq ft)	Lane Miles *	Surface Type	Condition / PCR
0906A	Public	6/26/2003	10122	0.17	OC	POOR / 45

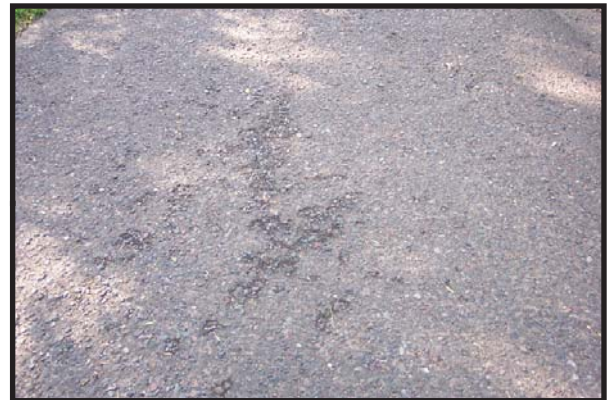
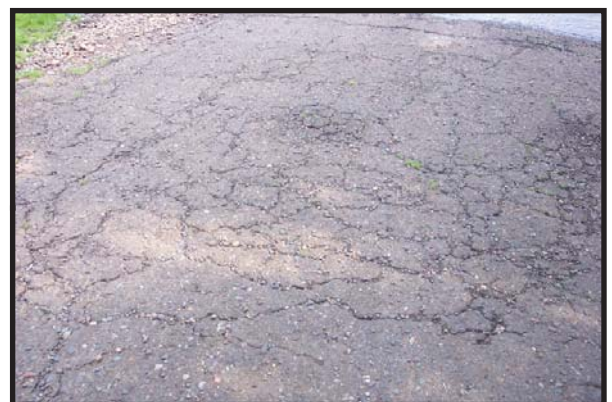
Route 0907

Route	Public / NonPublic	Date Visited	Area (sq ft)	Lane Miles *	Surface Type	Condition / PCR
0907	Public	6/26/2003	2513	0.04	OC	GOOD / 90

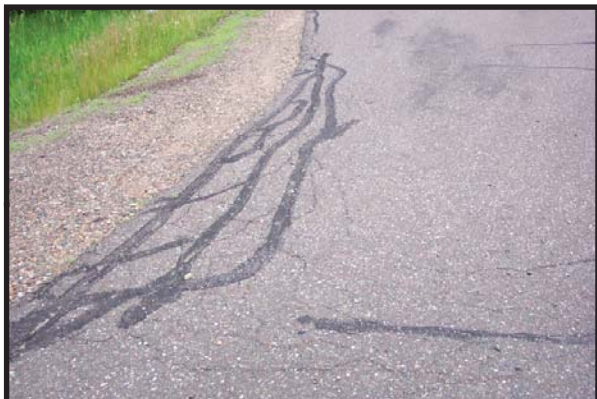
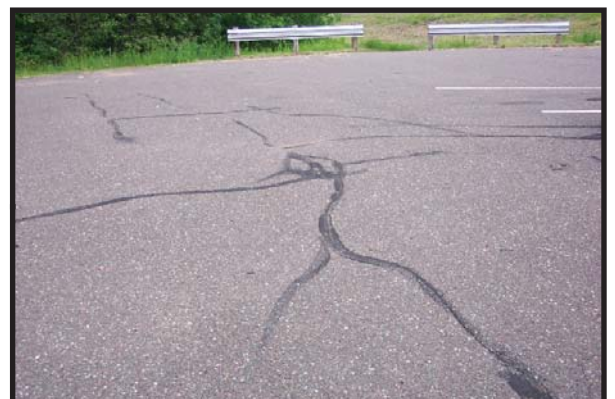
Route 0908

Route	Public / NonPublic	Date Visited	Area (sq ft)	Lane Miles *	Surface Type	Condition / PCR
0908	Public	6/26/2003	10888	0.19	AS	FAIR / 73

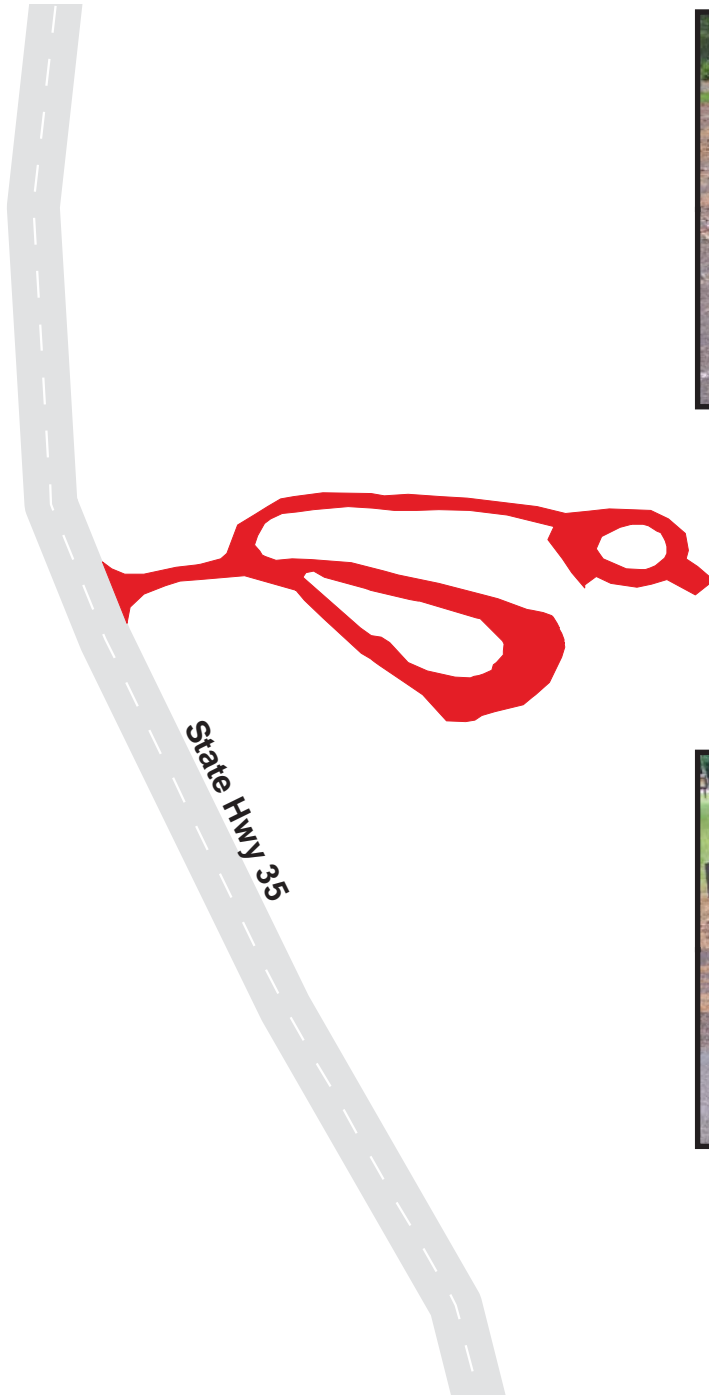
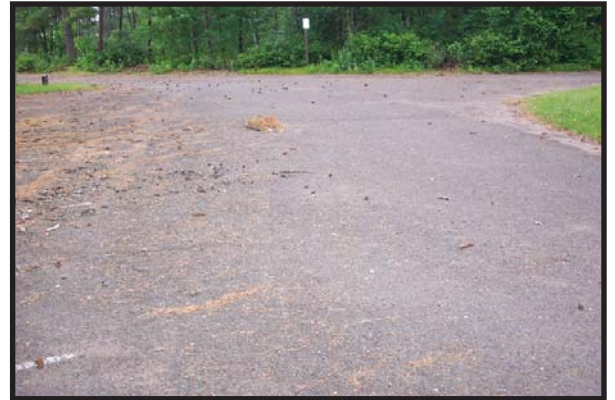
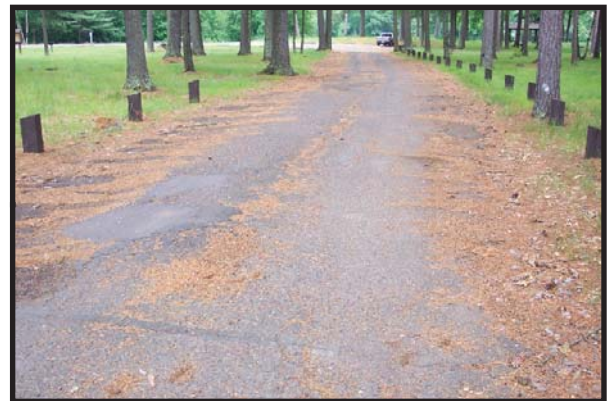
Route 0910

Route	Public / NonPublic	Date Visited	Area (sq ft)	Lane Miles *	Surface Type	Condition / PCR
0910	Public	6/26/2003	54238	0.93	OC	POOR / 45

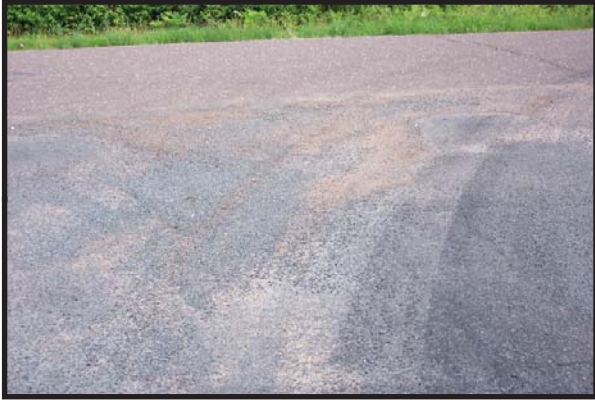
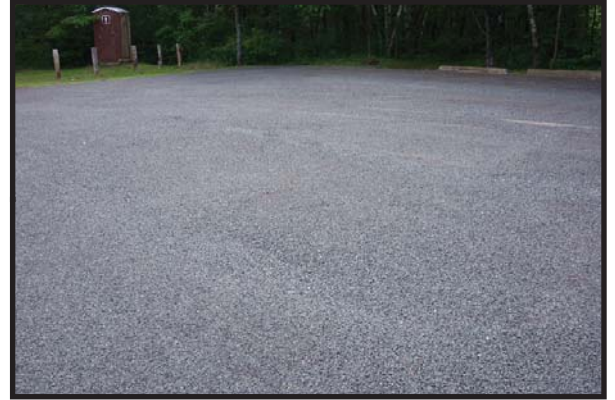
Route 0911

Route	Public / NonPublic	Date Visited	Area (sq ft)	Lane Miles *	Surface Type	Condition / PCR
0911	Public	6/27/2003	8880	0.15	OC	FAIR / 73

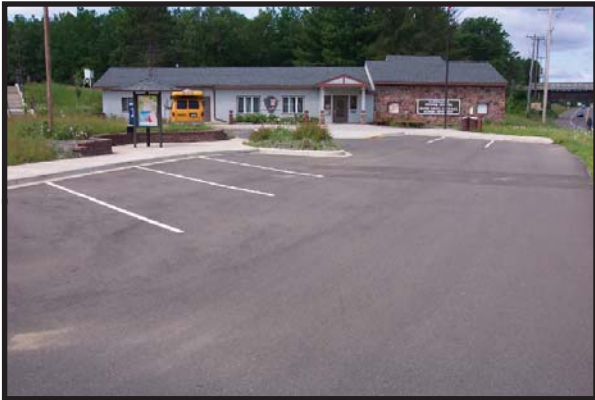
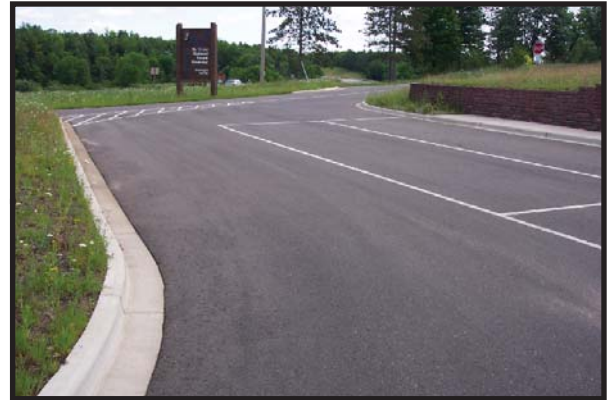
Route 0912

Route	Public / NonPublic	Date Visited	Area (sq ft)	Lane Miles *	Surface Type	Condition / PCR
0912	Public	6/27/2003	28594	0.49	AS	GOOD / 90

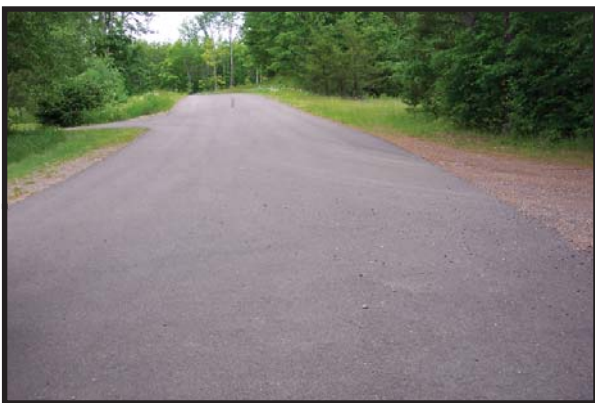
Route 0913

Route	Public / NonPublic	Date Visited	Area (sq ft)	Lane Miles *	Surface Type	Condition / PCR
0913	Public	6/27/2003	12165	0.21	AS	GOOD / 90

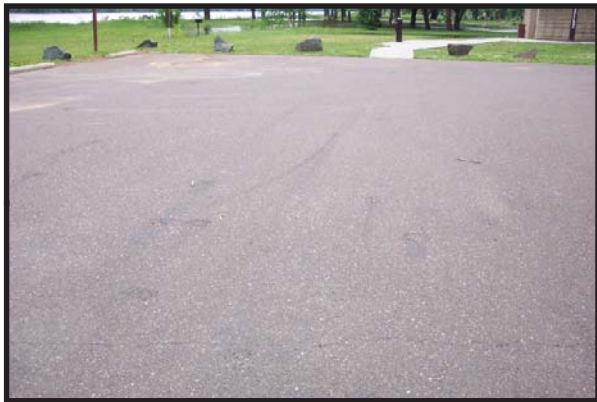
Route 0914

Route	Public / NonPublic	Date Visited	Area (sq ft)	Lane Miles *	Surface Type	Condition / PCR
0914	Public	6/26/2003	12410	0.21	AS	GOOD / 90

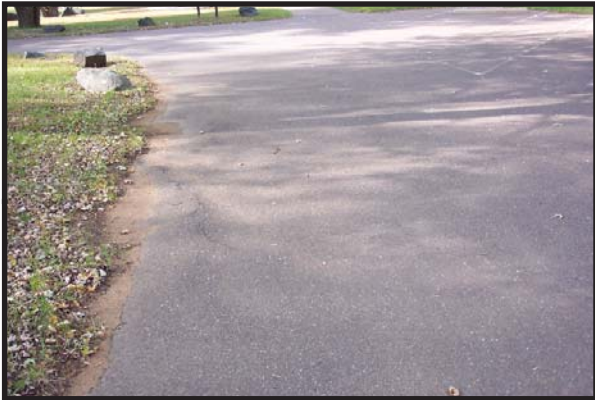
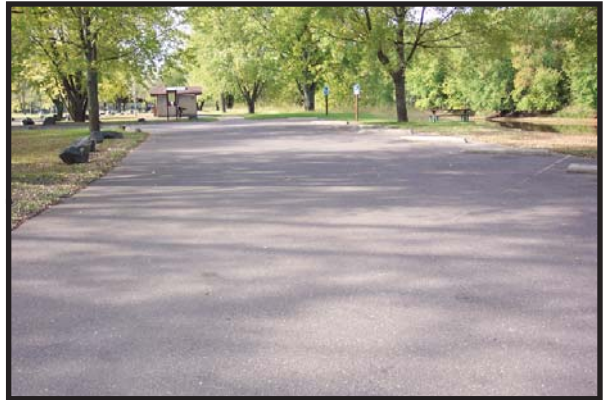
Route 0915

Route	Public / NonPublic	Date Visited	Area (sq ft)	Lane Miles *	Surface Type	Condition / PCR
0915	Public	10/4/2003	9019	0.16	AS	GOOD / 90

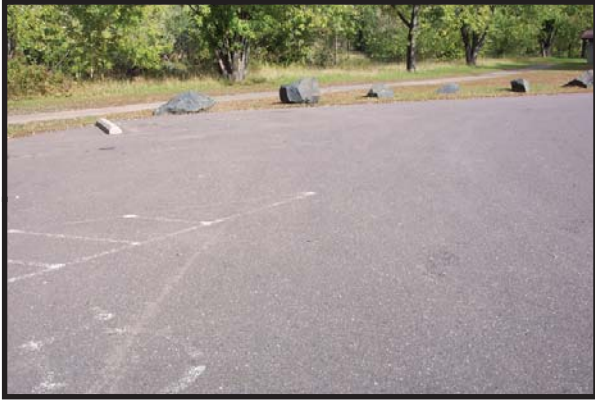
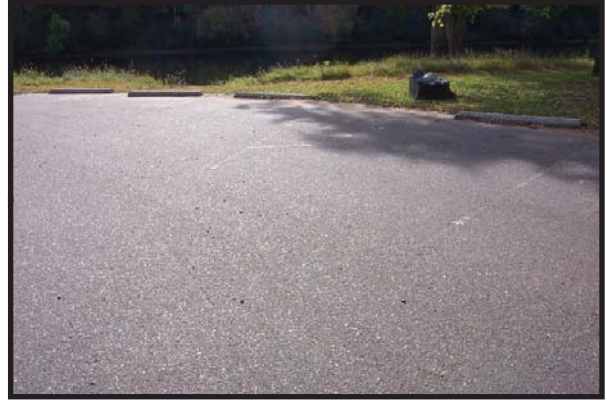
Route 0916

Route	Public / NonPublic	Date Visited	Area (sq ft)	Lane Miles *	Surface Type	Condition / PCR
0916	Public	10/4/2003	4673	0.08	AS	GOOD / 90
