**The Road Inventory  
of  
San Francisco Maritime National Historical Park  
SAFR - 8520**

**Road Inventory Program**

Prepared By:  
Federal Highway Administration  
Eastern Federal Lands Highway Division  
Cycle 3

# San Francisco Maritime National Historical Park in California

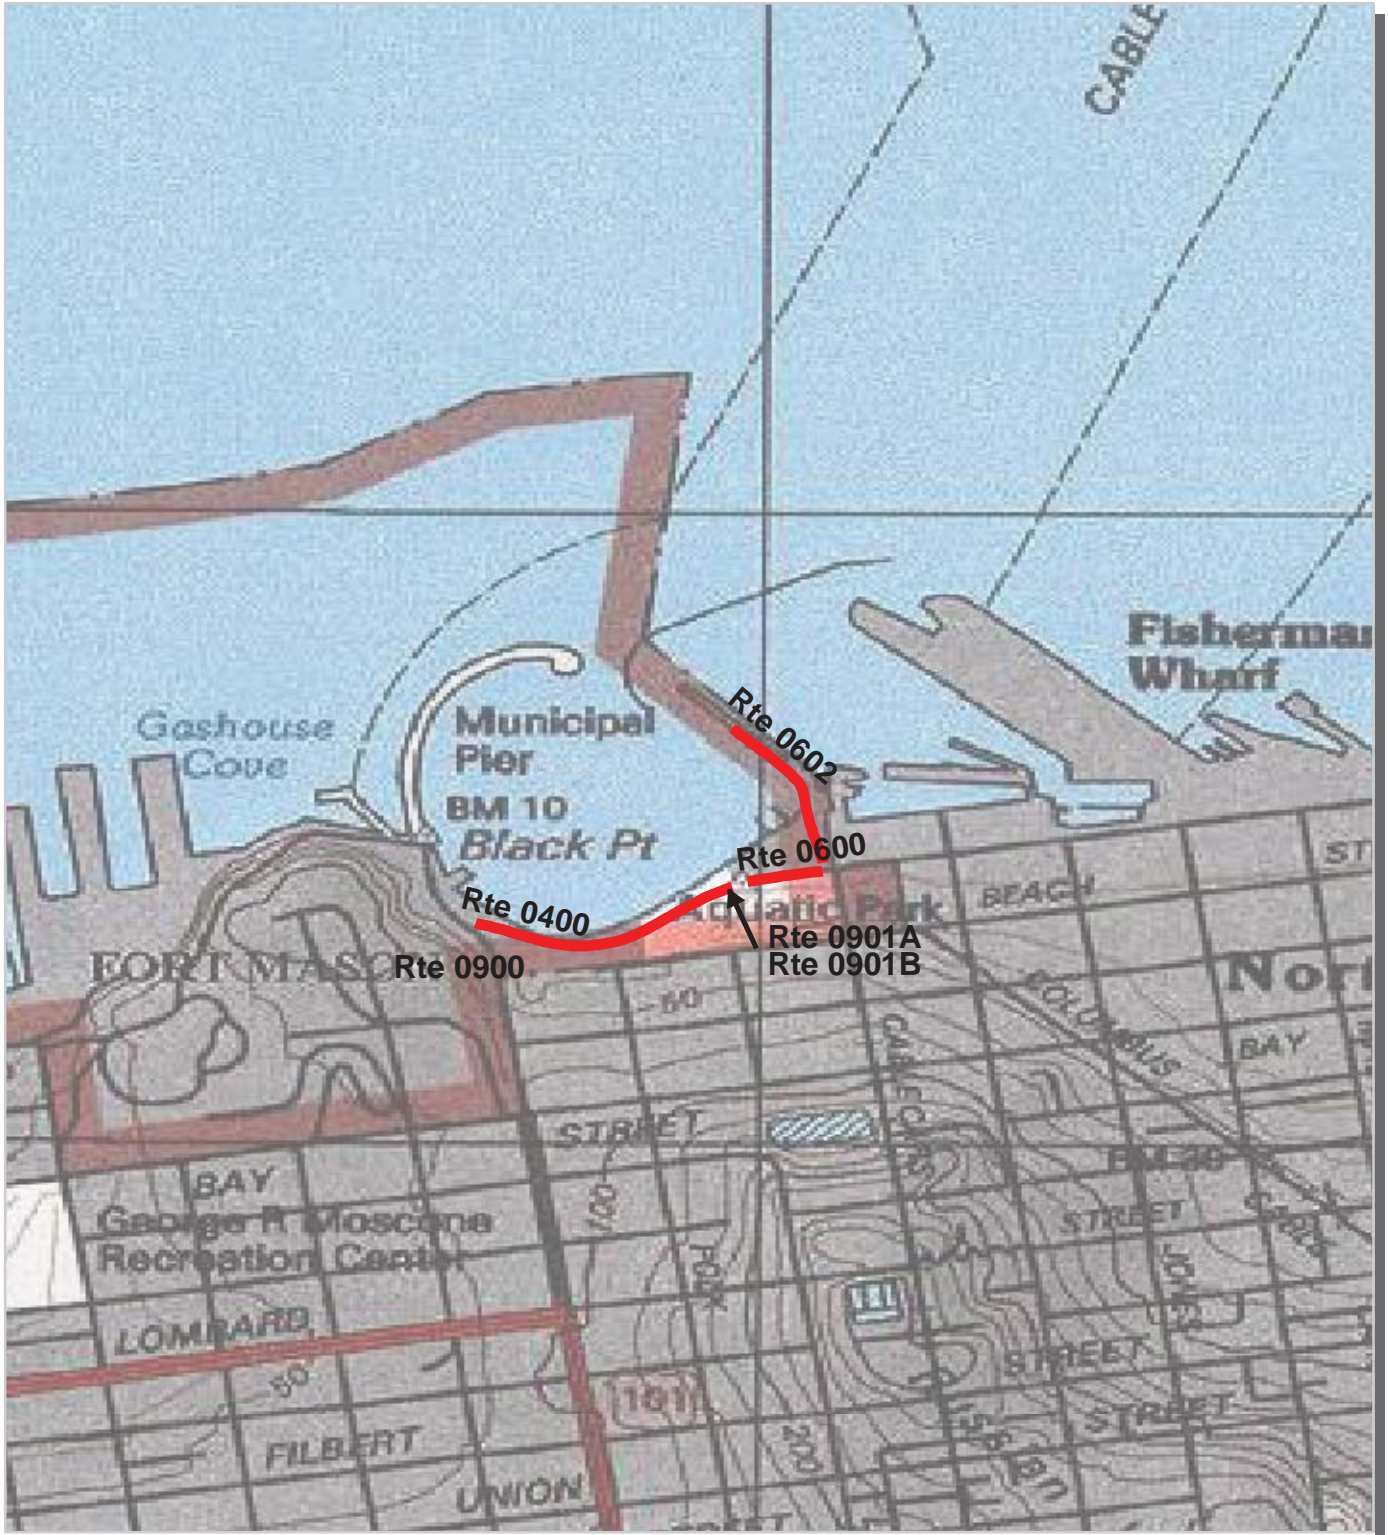
## Route Condition Key Map

PCR	Poor	<span style="display:inline-block; width:20px; height:10px; background-color:red;"></span>	Fair	<span style="display:inline-block; width:20px; height:10px; background-color:yellow;"></span>	Good	<span style="display:inline-block; width:20px; height:10px; background-color:lightgreen;"></span>	Excellent	<span style="display:inline-block; width:20px; height:10px; background-color:blue;"></span>
		(<=60)		(61 - 84)		(85 - 94)		(95 - 100)

\* If the PCR rating is not available for a section, the SCR rating will be displayed. See appendix for definitions and formulas.

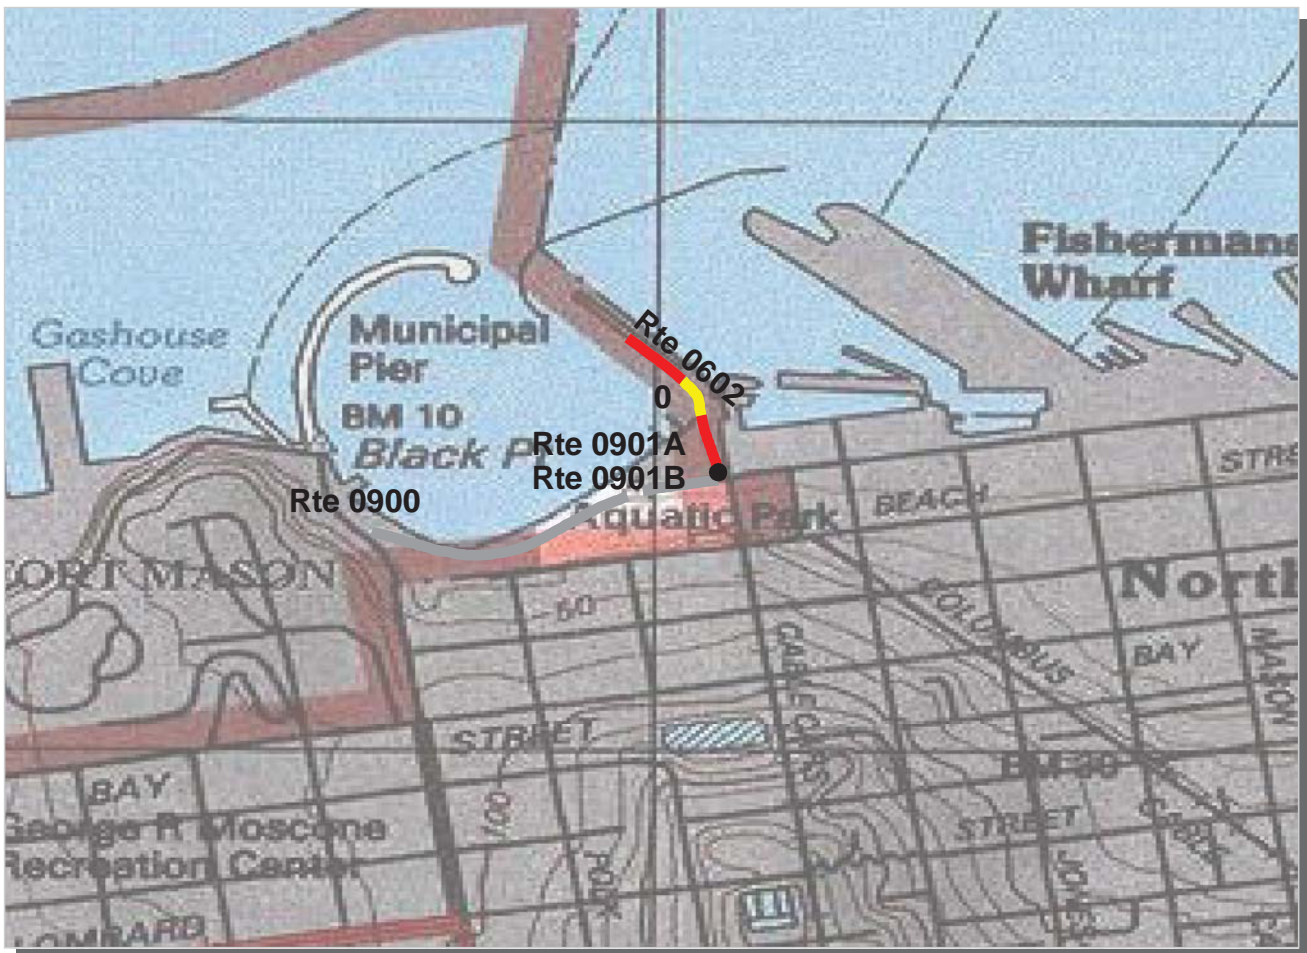
**ROUTE: 0602 Hyde Street Pier**

Section Number	0				
Section Length (mi)	0.18				
AADT	**				
SADT	**				
ADT Date	**				
<b>Cross Section Information</b>					
Number of Lanes	2				
Paved Width (ft)	25				
Lane Width (ft)	12				
Shoulder Width (ft)	0				
<b>Roadway Condition Information</b>					
PCR (Pavement Condition Rating)	53				
RCI (Roughness Condition Index)	NC				
SCR (Surface Condition Rating)	53				
Alligator Cracking Index	100				
Rutting Index	57				
Patching Index	97				
Transverse Cracking Index	99				
Longitudinal Cracking Index	99				
Shoulder Condition Rating	N/A				
Drainage Condition Rating	N/A

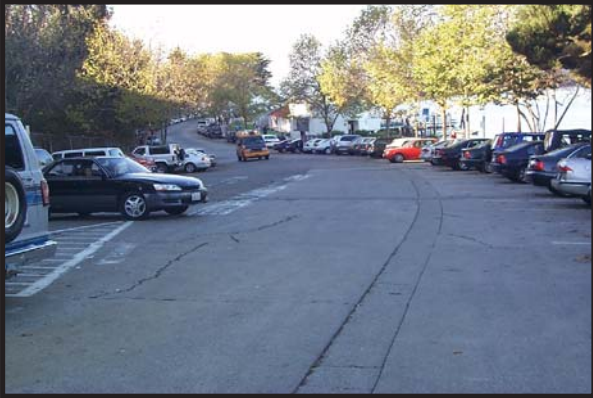
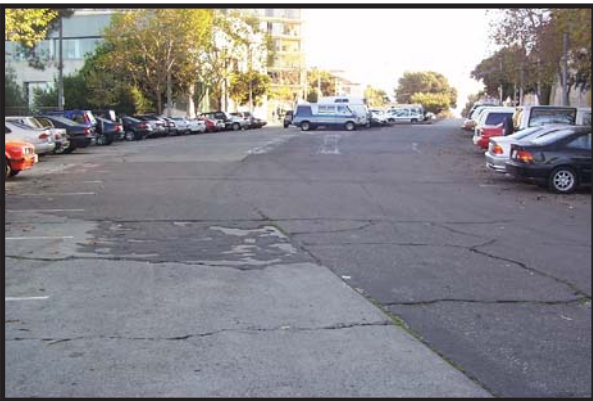
Route	Public / NonPublic	Date Visited	Area (sq ft)	Lane Miles *	Surface Type	Condition / PCR
0900	Public	10/31/2001	50297	0.87	CO	POOR / 45

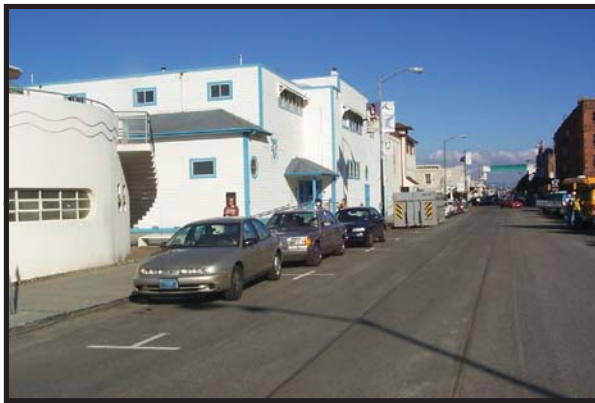
## Route 0901A

Route	Public / NonPublic	Date Visited	Area (sq ft)	Lane Miles *	Surface Type	Condition / PCR
0901A	Public	10/31/2001	1763	0.03	AS	EXCELLENT / 97

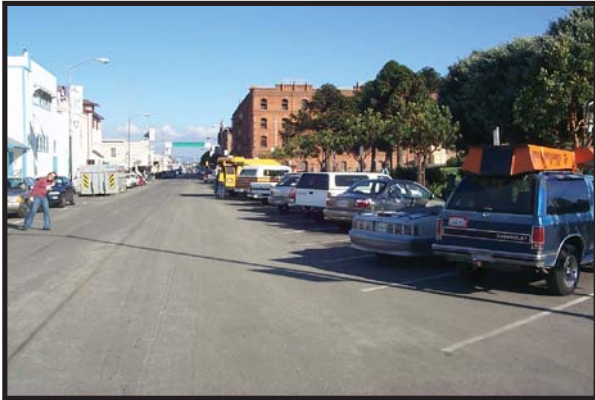
## Route 0901B

Route	Public / NonPublic	Date Visited	Area (sq ft)	Lane Miles *	Surface Type	Condition / PCR
0901B	Public	10/31/2001	4483	0.08	AS	EXCELLENT / 97
