# The Road Inventory of Saint-Gaudens National Historic Site SAGA – 1915

## Road Inventory Program

Prepared By:  
Federal Highway Administration  
Eastern Federal Lands Highway Division  
Cycle 3

# Saint-Gaudens National Historic Site in New Hampshire

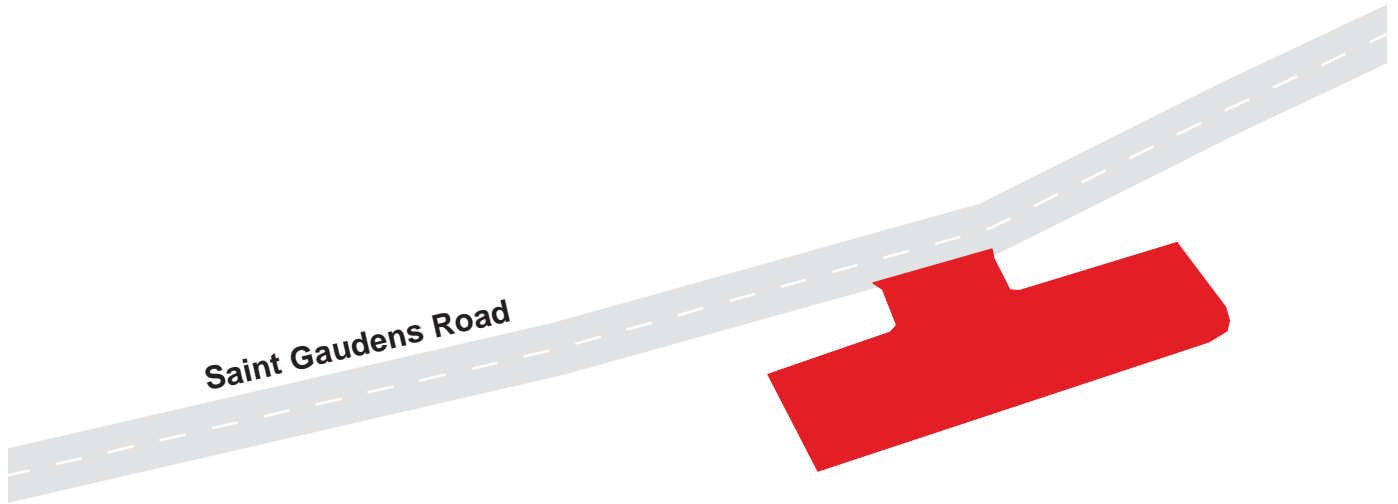
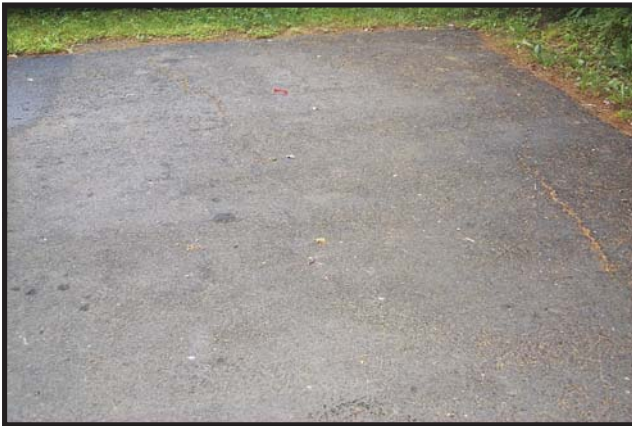
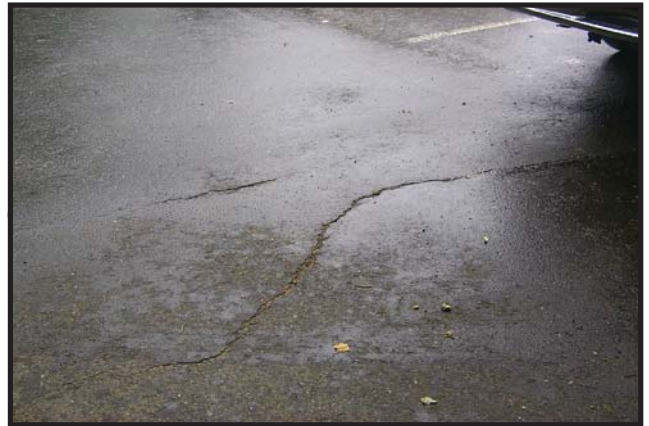
## Route 0900

### VISITOR PARKING

From Saint Gaudens Road

Route	Public / NonPublic	Date Visited	Area (sq ft)	Lane Miles *	Surface Type	Condition / PCR
0900	Public	8/24/2002	4090	0.07	AS	GOOD / 90

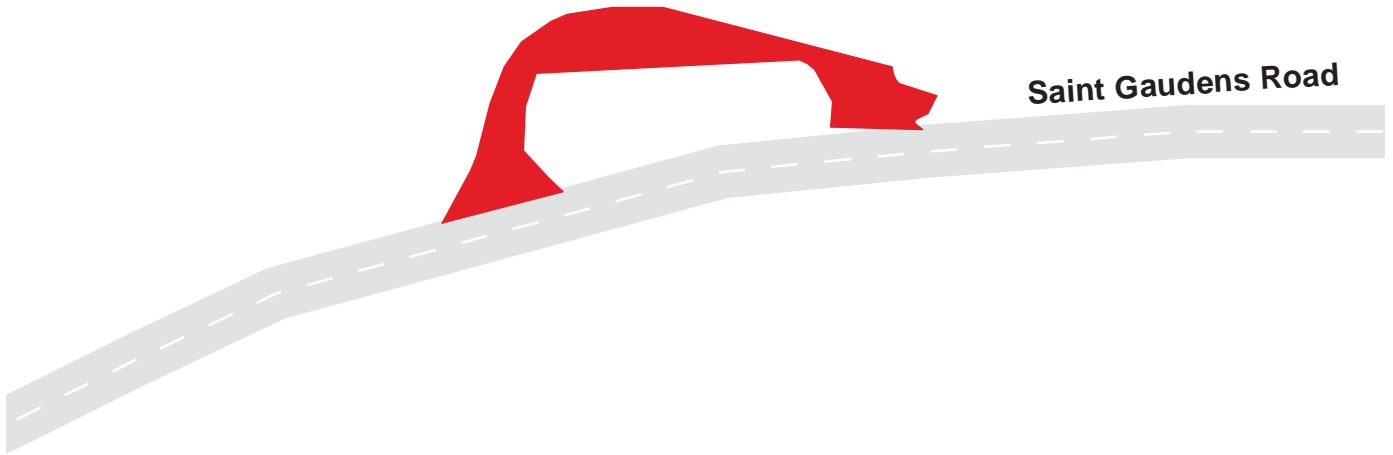
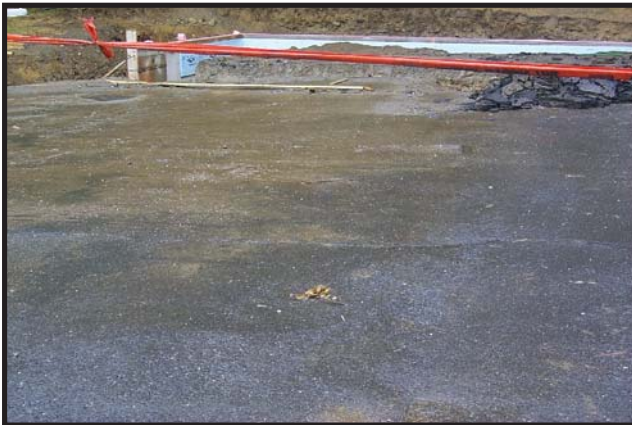
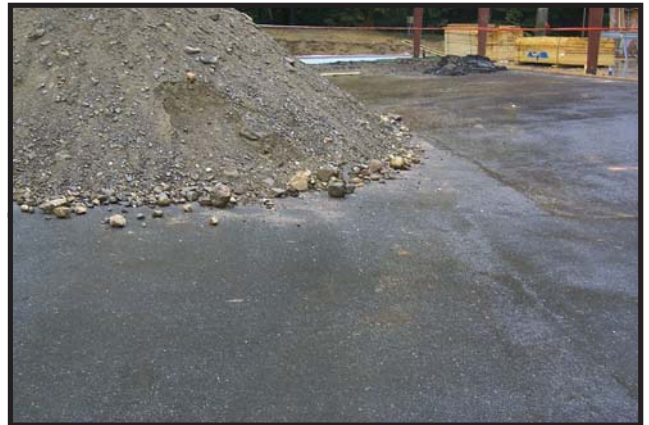
## Route 0901

CARETAKERS PARKING

From Saint Gaudens Road

Route	Public / NonPublic	Date Visited	Area (sq ft)	Lane Miles *	Surface Type	Condition / PCR
0901	Public	8/24/2002	6325	0.11	AS	GOOD / 90
