The Road Inventory of Saguaro National Park SAGU - 8670

Road Inventory Program

Prepared By:
Federal Highway Administration
Eastern Federal Lands Highway Division
Cycle 3

Saguaro National Park in Arizona

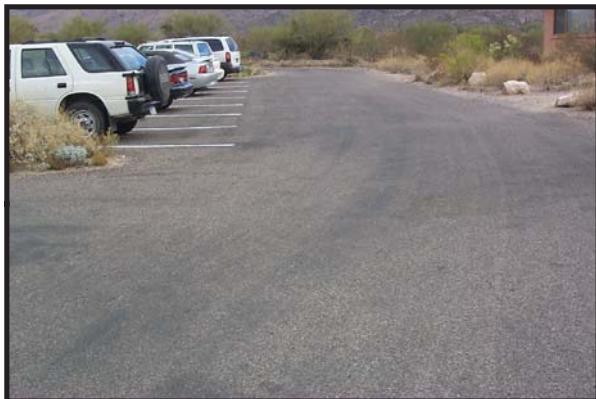
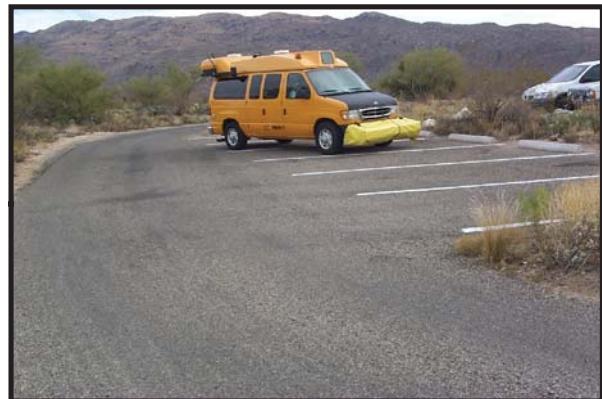
Saguaro National Park
Route 0901
Headquarters Maintenance Area Parking
From Route 0400

Route	Public / NonPublic	Date Visited	Area (sq ft)	Lane Miles *	Surface Type	Condition / PCR
0901	NonPublic	11/30/2001	10339	0.18	NC	GOOD / 90

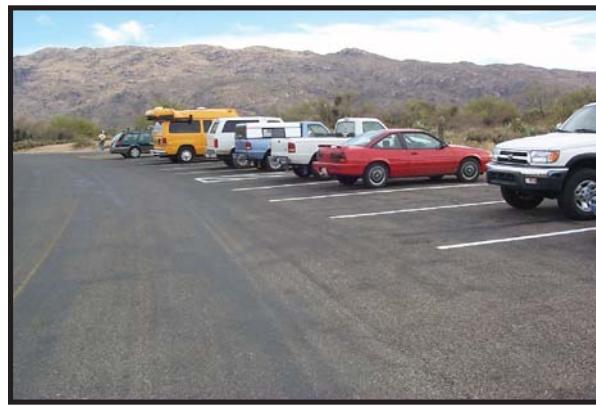
Route 0902B

Route	Public / NonPublic	Date Visited	Area (sq ft)	Lane Miles *	Surface Type	Condition / PCR
0902B	Public	11/30/2001	3505	0.06	NC	GOOD / 90

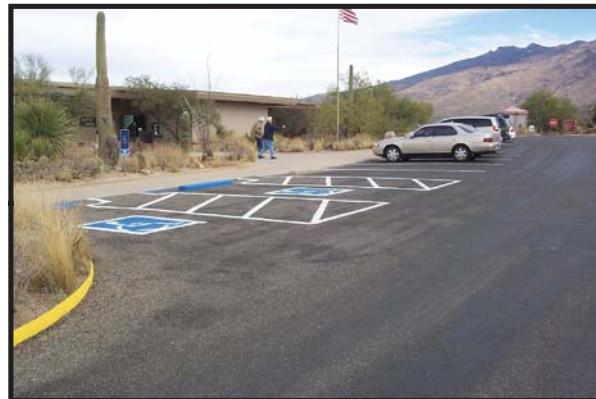
Saguaro National Park
Route 0903
Desert Ecology Trailhead Parking
From Route 0500

Route	Public / NonPublic	Date Visited	Area (sq ft)	Lane Miles *	Surface Type	Condition / PCR
0903	Public	11/27/2001	4230	0.07	NC	GOOD / 90

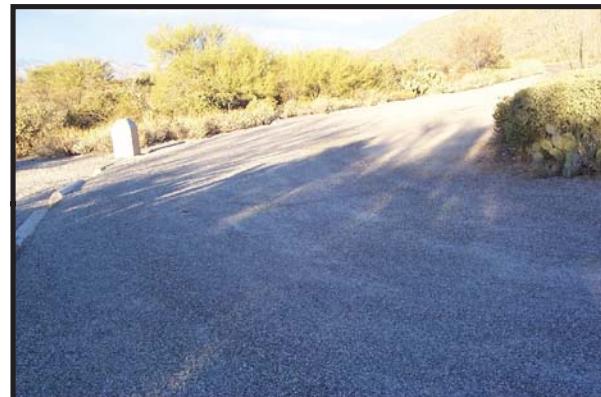
Saguaro National Park
Route 0905
Tanque Verde Trailhead Parking
From Route 0100

Route	Public / NonPublic	Date Visited	Area (sq ft)	Lane Miles *	Surface Type	Condition / PCR
0905	Public	11/27/2001	923	0.02	NC	FAIR / 73

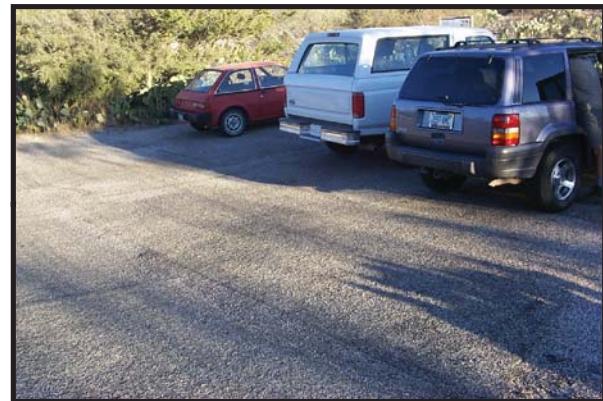
Route 0906

Route	Public / NonPublic	Date Visited	Area (sq ft)	Lane Miles *	Surface Type	Condition / PCR
0906	Public	11/27/2001	11613	0.20	NC	GOOD / 90

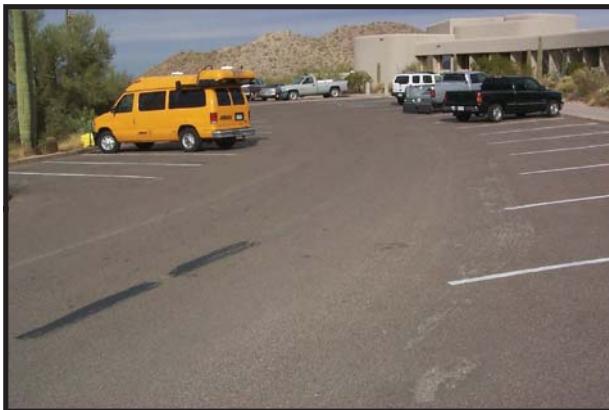
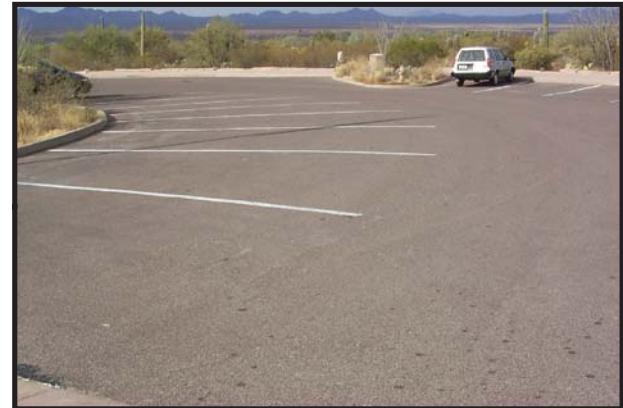
Saguaro National Park
Route 0912
Desert Discovery Nature Trail Parking
From Route 0012

Route	Public / NonPublic	Date Visited	Area (sq ft)	Lane Miles *	Surface Type	Condition / PCR
0912	Public	11/30/2001	2297	0.04	OC	FAIR / 73
