The Road Inventory of Sagamore Hill National Historic Site SAHI - 1880

Road Inventory Program

Prepared By:
Federal Highway Administration
Eastern Federal Lands Highway Division
Cycle 3

Sagamore Hill National Historic Site in New York

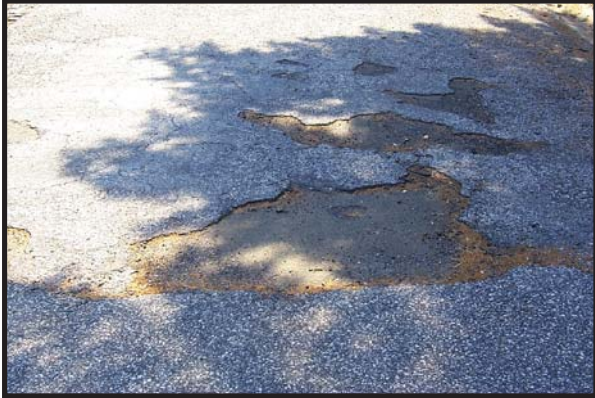
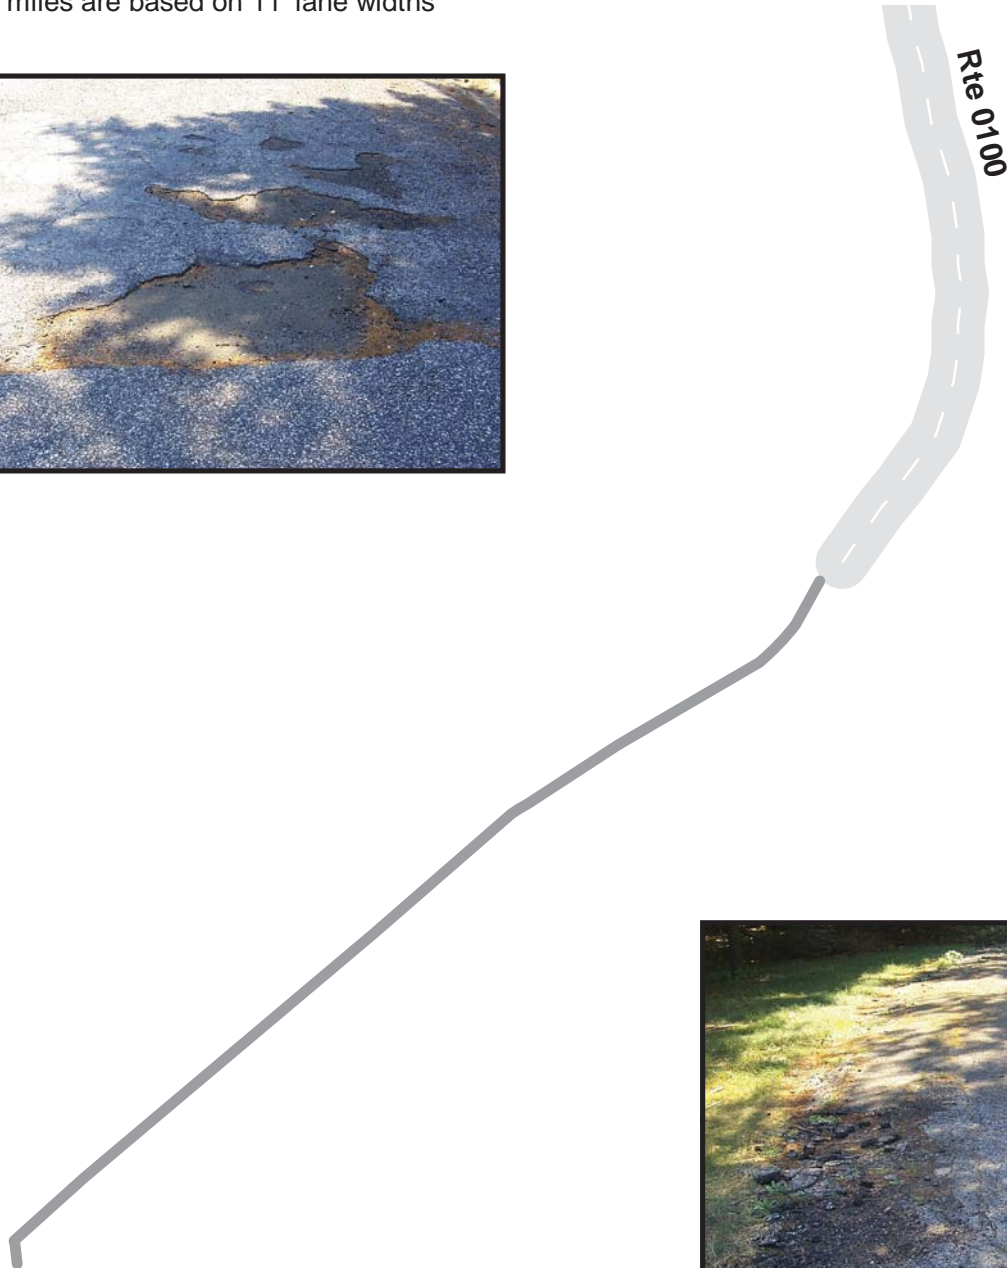
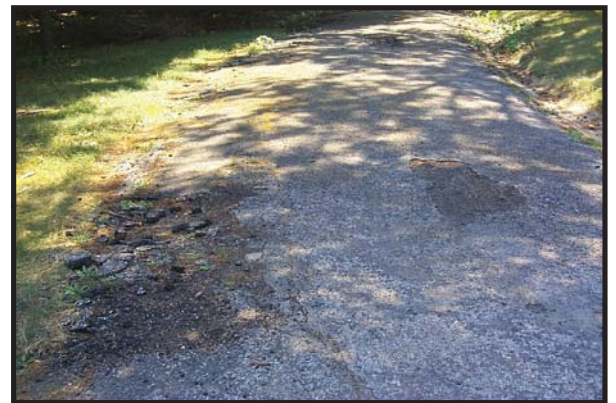
Route 0900

Route	Public / NonPublic	Date Visited	Area (sq ft)	Lane Miles *	Surface Type	Condition / PCR
0900	Public	8/11/2002	61931	1.07	AS	GOOD / 90

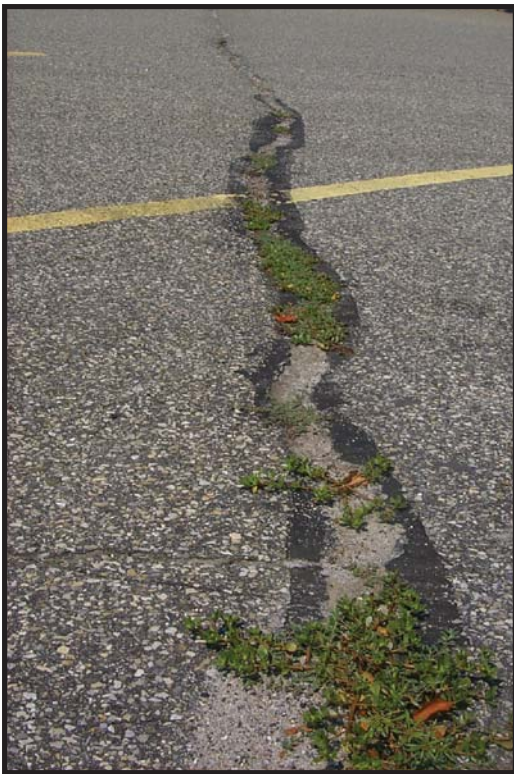
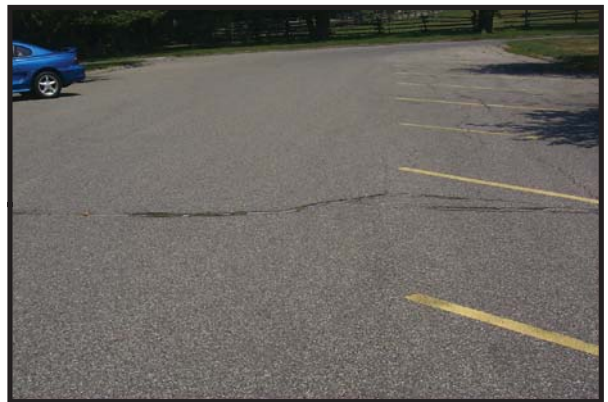
Route 0901

Route	Public / NonPublic	Date Visited	Area (sq ft)	Lane Miles *	Surface Type	Condition / PCR
0901	NonPublic	8/11/2002	4274	0.07	AS	FAIR / 73

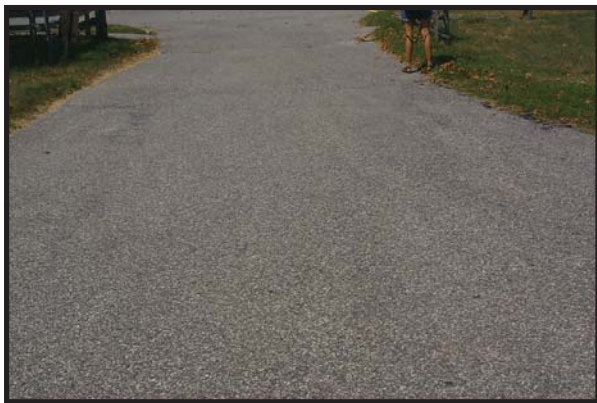
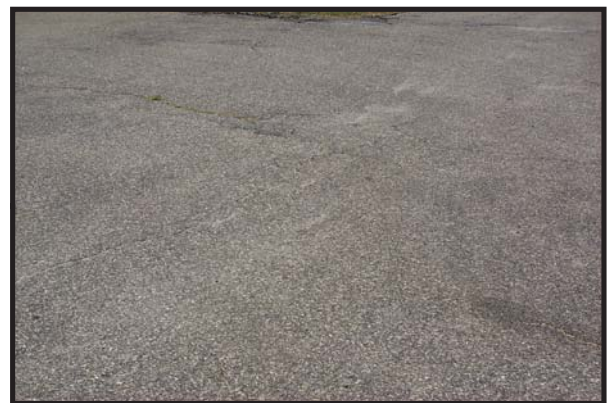
Route 0902

Route	Public / NonPublic	Date Visited	Area (sq ft)	Lane Miles *	Surface Type	Condition / PCR
0902	Public	8/11/2002	3715	0.06	AS	FAIR / 73

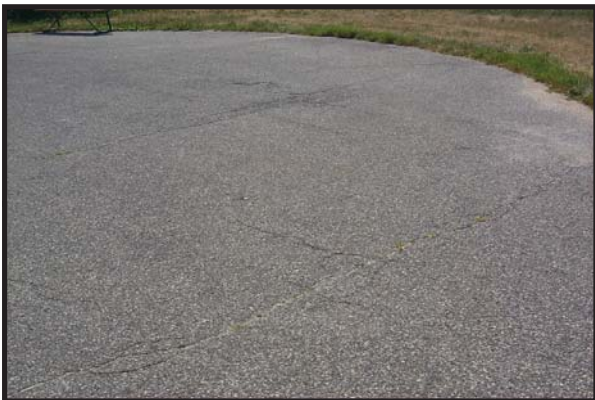
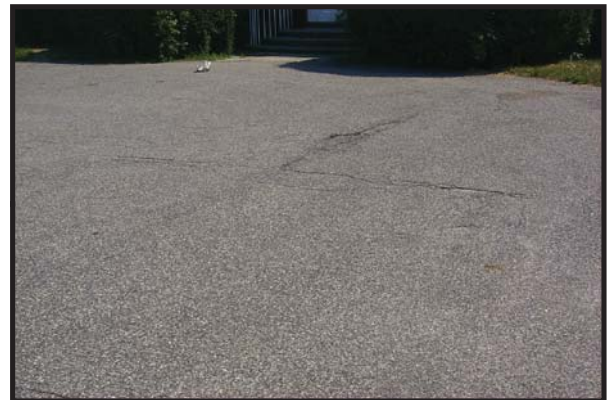
Sagamore Hill National Historic Site
Route 0903
 ADMINISTRATIVE AND HANDICAP PARKING
 From Route 0103

Route	Public / NonPublic	Date Visited	Area (sq ft)	Lane Miles *	Surface Type	Condition / PCR
0903	NonPublic	8/11/2002	3916	0.07	AS	FAIR / 73

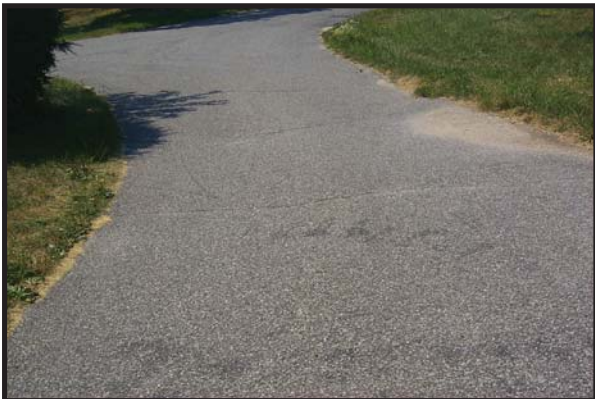
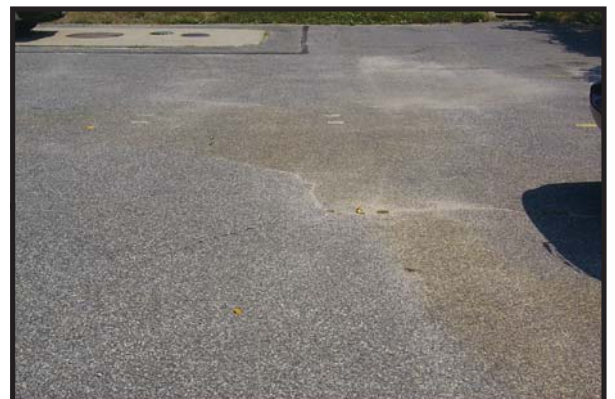
Route 0904

Route	Public / NonPublic	Date Visited	Area (sq ft)	Lane Miles *	Surface Type	Condition / PCR
0904	NonPublic	8/11/2002	4110	0.07	AS	GOOD / 90

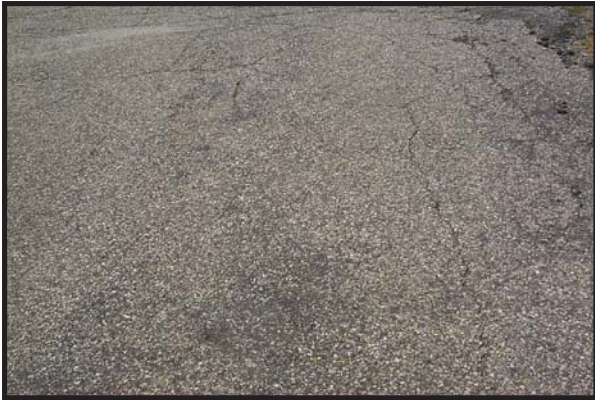
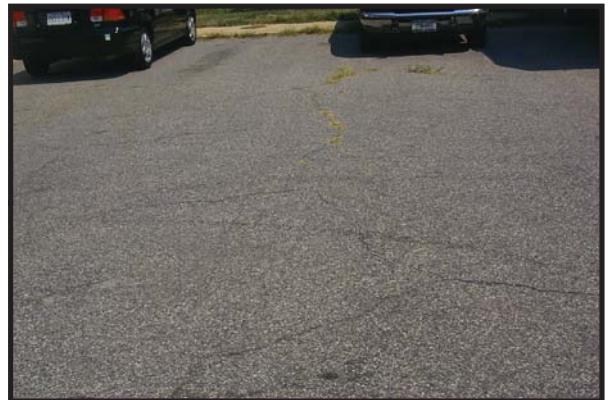
Route 0905

Route	Public / NonPublic	Date Visited	Area (sq ft)	Lane Miles *	Surface Type	Condition / PCR
0905	NonPublic	8/11/2002	3552	0.06	AS	POOR / 45

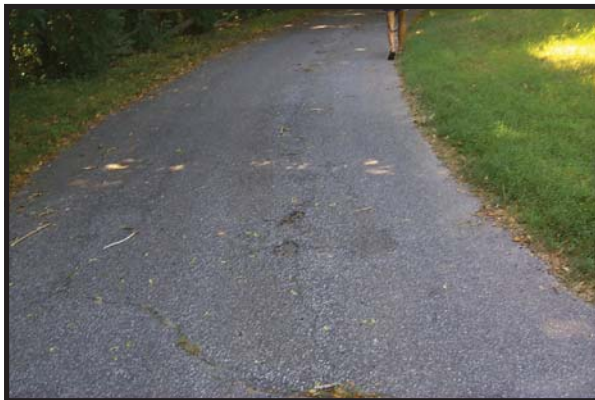
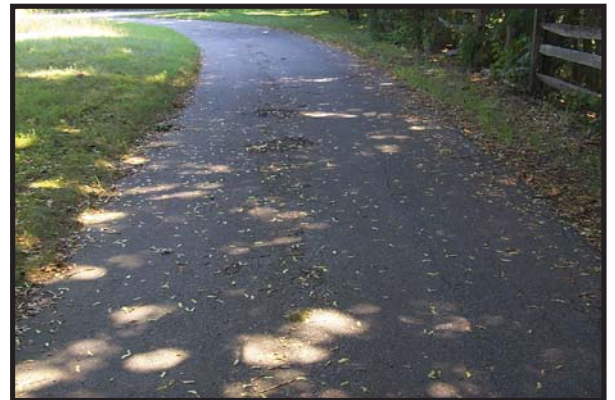
Route 0906

Route	Public / NonPublic	Date Visited	Area (sq ft)	Lane Miles *	Surface Type	Condition / PCR
0906	Public	8/11/2002	2348	0.04	AS	GOOD / 90

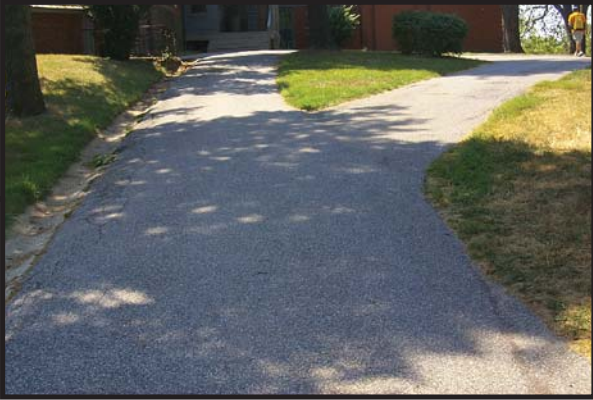
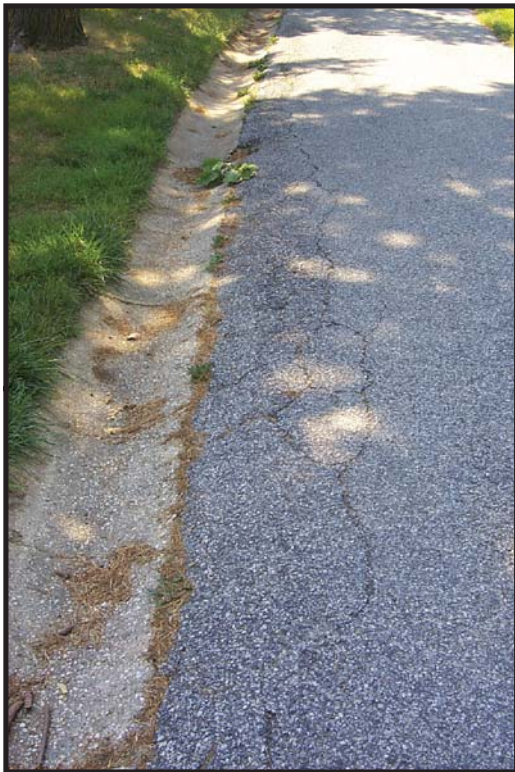
Sagamore Hill National Historic Site
Route 0907
 SPUR TO THEODORE ROOSEVELT HOUSE ROAD
 From Route 0900

Route	Public / NonPublic	Date Visited	Area (sq ft)	Lane Miles *	Surface Type	Condition / PCR
0907	Public	8/11/2002	4409	0.08	AS	FAIR / 73

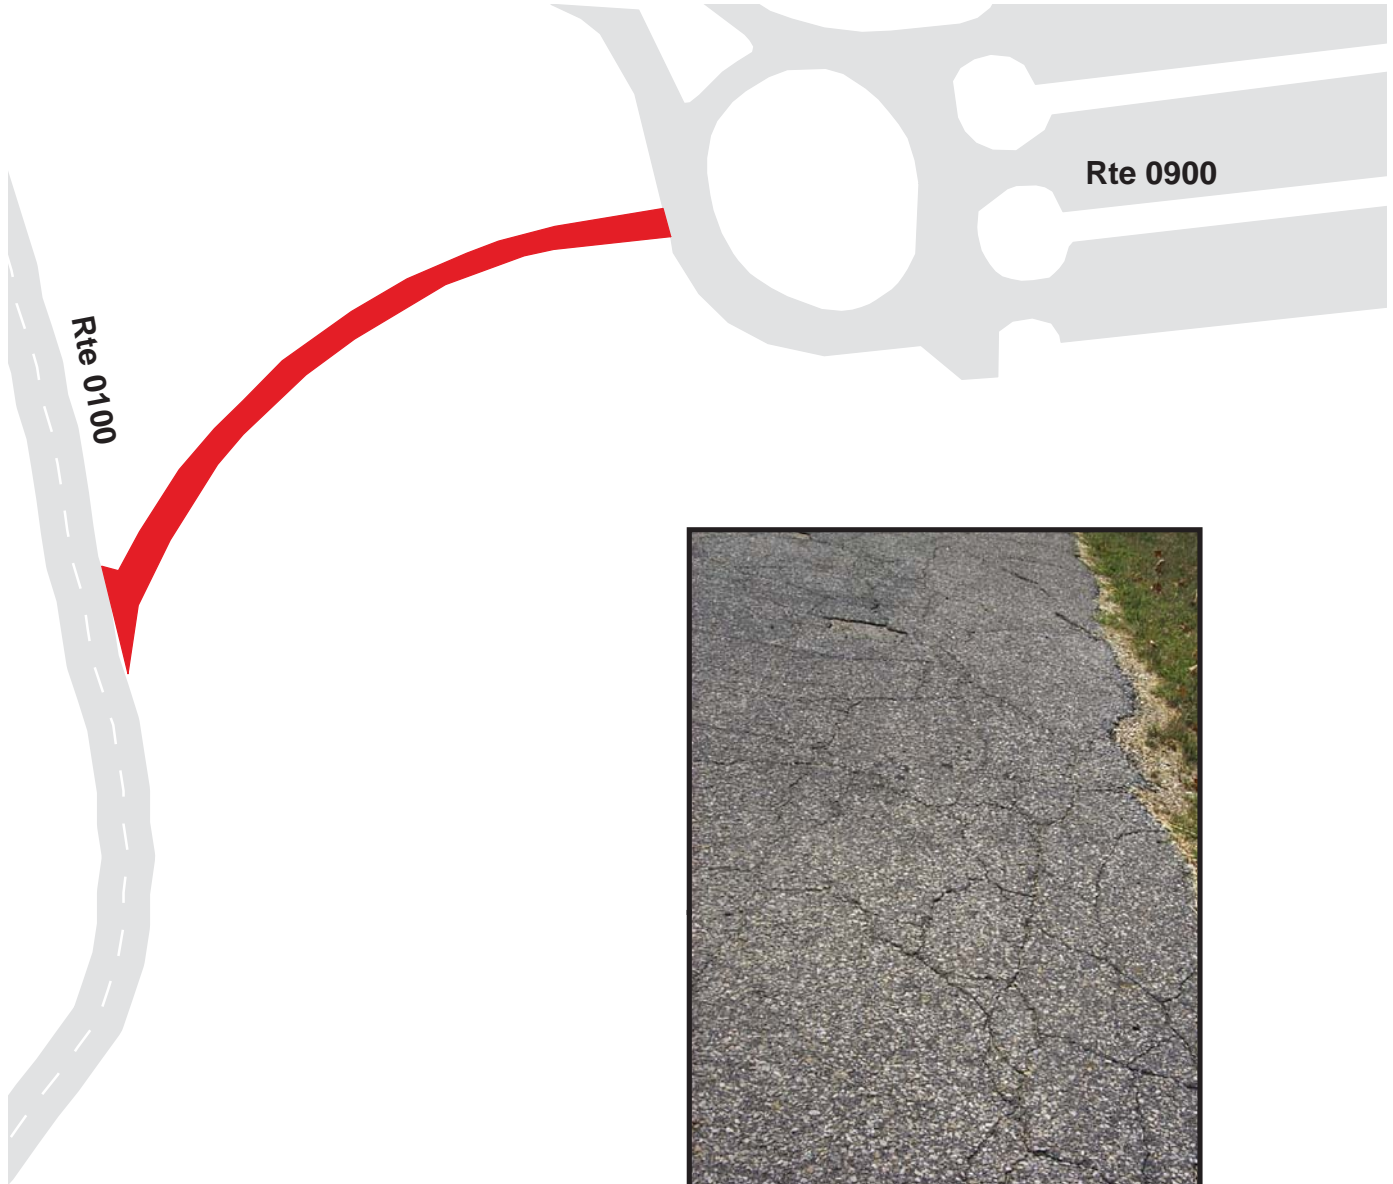
Route 0908

Route	Public / NonPublic	Date Visited	Area (sq ft)	Lane Miles *	Surface Type	Condition / PCR
0908	Public	8/11/2002	6204	0.11	AS	FAIR / 73

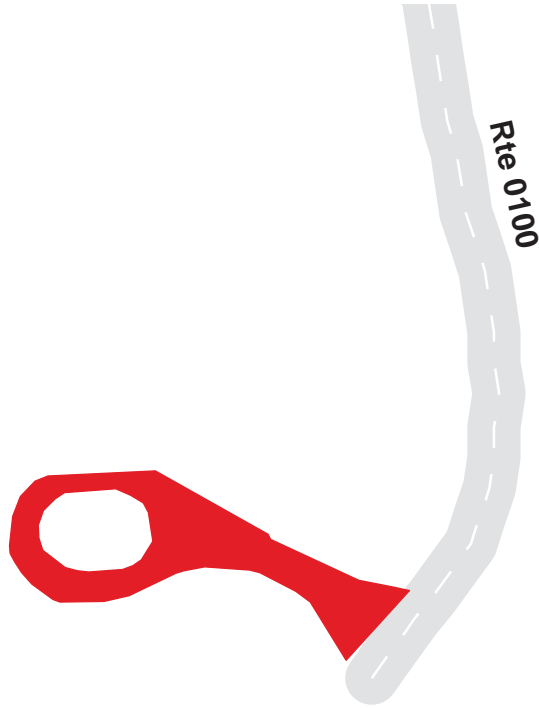
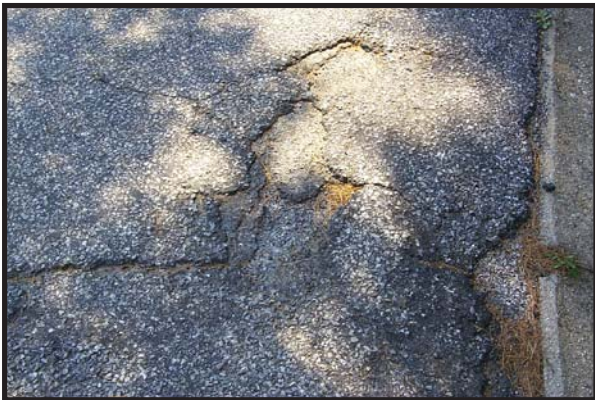
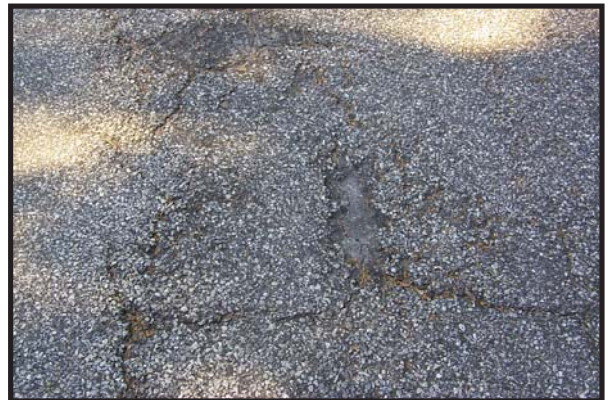
Route 0909

Route	Public / NonPublic	Date Visited	Area (sq ft)	Lane Miles *	Surface Type	Condition / PCR
0909	Public	8/11/2002	5249	0.09	AS	POOR / 45
