The Road Inventory of Saugus Iron Works National Historic Site SAIR - 1920

Road Inventory Program

Prepared By:
Federal Highway Administration
Eastern Federal Lands Highway Division
Cycle 3

Saugus Iron Works National Historic Site in Massachusetts

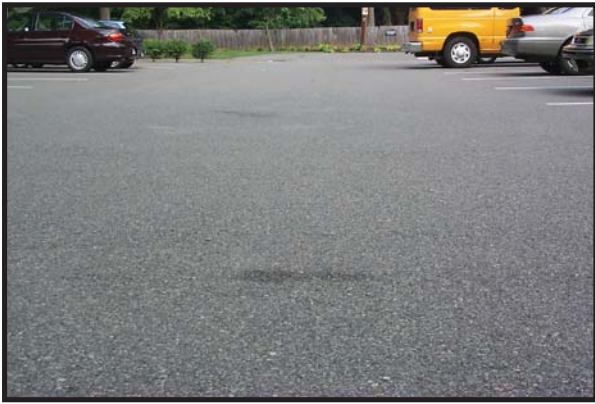
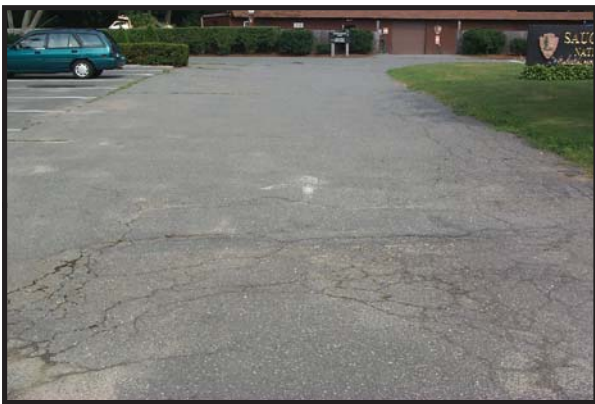
Route 0900

VISITOR CENTER PARKING

From Central Street

Route	Public / NonPublic	Date Visited	Area (sq ft)	Lane Miles *	Surface Type	Condition / PCR
0900	Public	8/13/2001	15872	0.27	OC	GOOD / 90

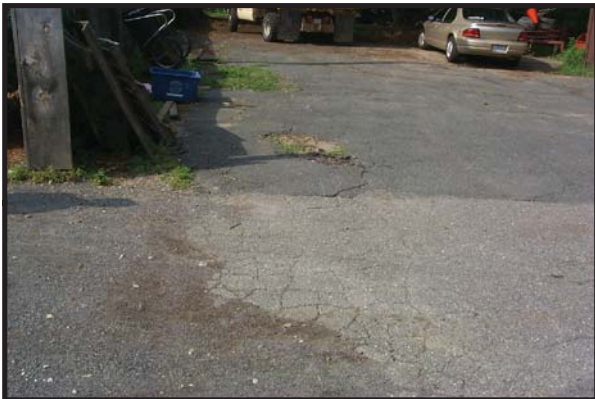
Route 0901

MAINTENANCE AREA

From Route 0900

Route	Public / NonPublic	Date Visited	Area (sq ft)	Lane Miles *	Surface Type	Condition / PCR
0901	NonPublic	8/13/2001	2298	0.04	OC	POOR / 45
