The Road Inventory of San Juan Island National Historical Park SAJH - 9530

Road Inventory Program

Prepared By:
Federal Highway Administration
Eastern Federal Lands Highway Division
Cycle 3

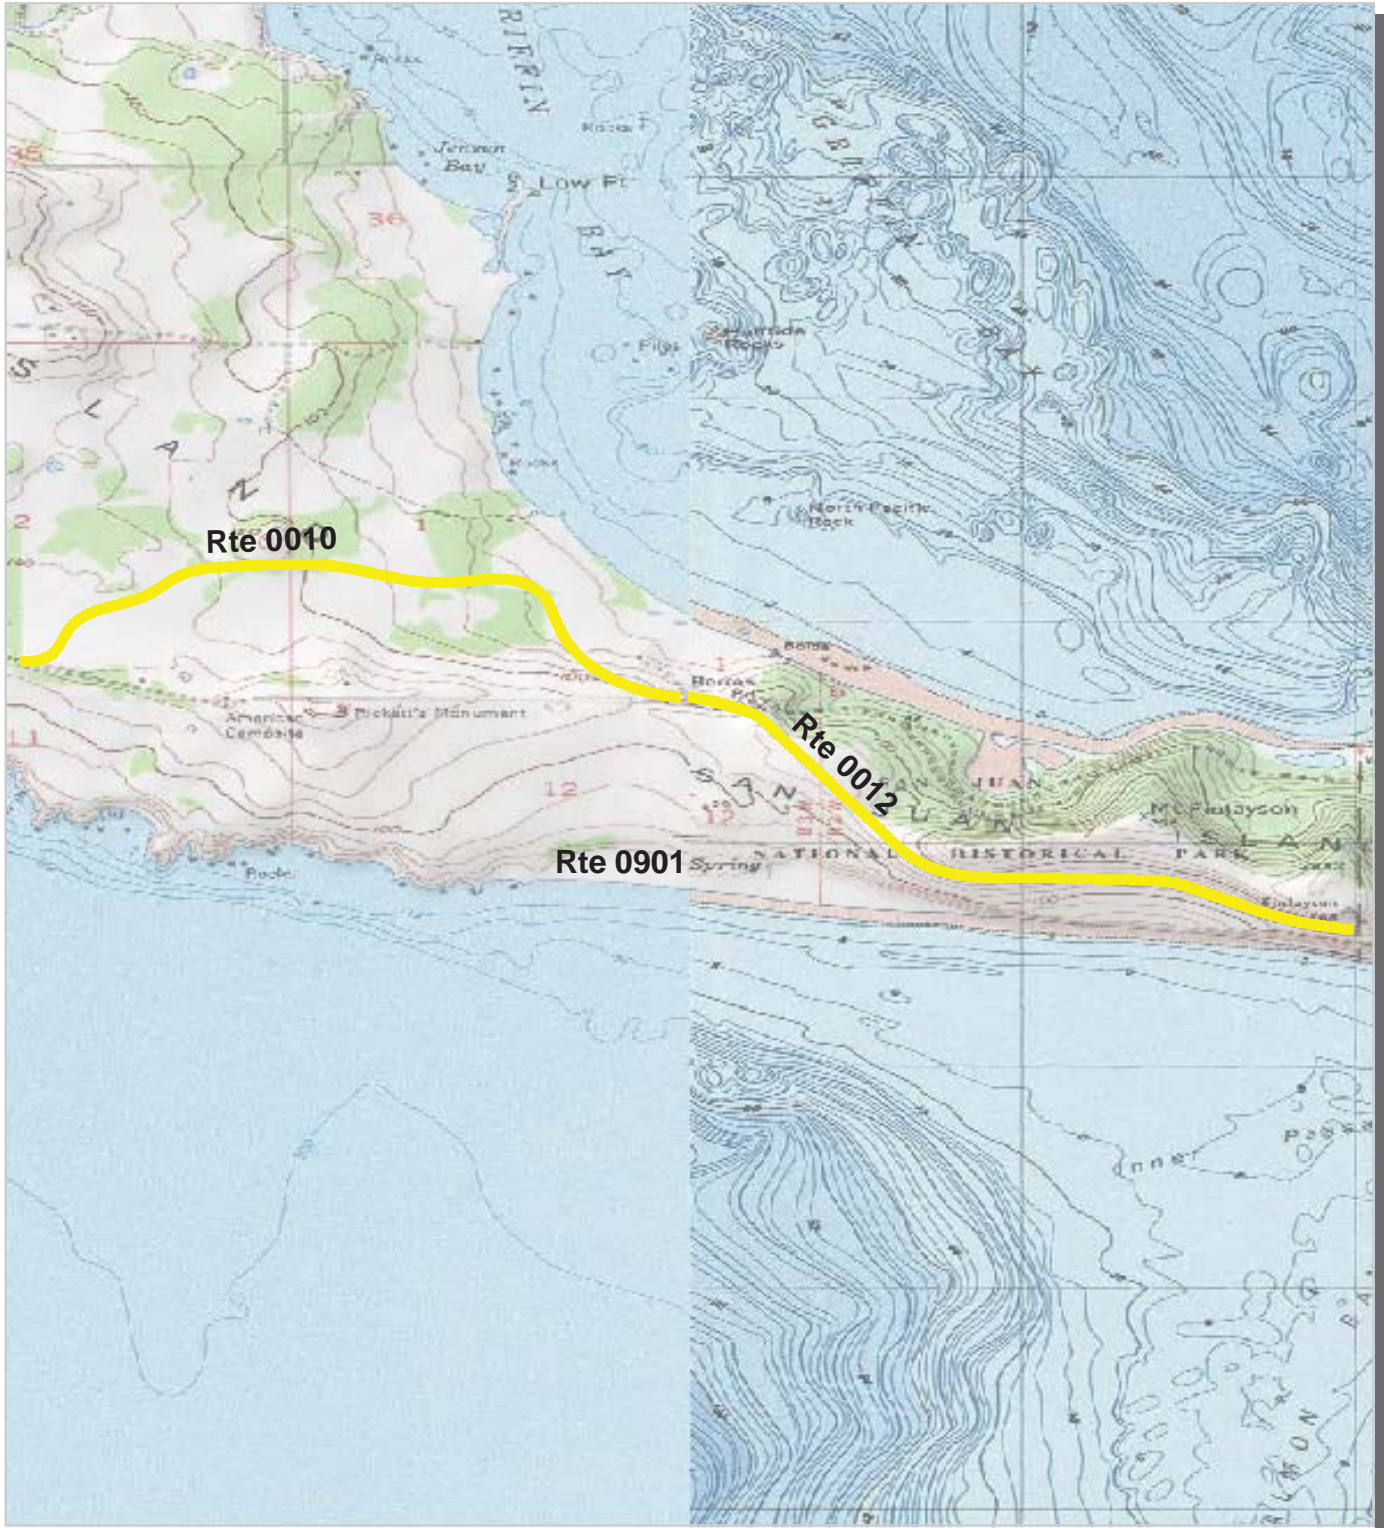
San Juan Island National Historical Park Route Condition Key Map PCR - Mile by Mile

PCR	Poor

Fair

Good

Excellent

(<=60)		(61 - 84)		(85 - 94)		(95 - 100)

* If the PCR rating is not available for a section, the SCR rating will be displayed. See appendix for definitions and formulas.

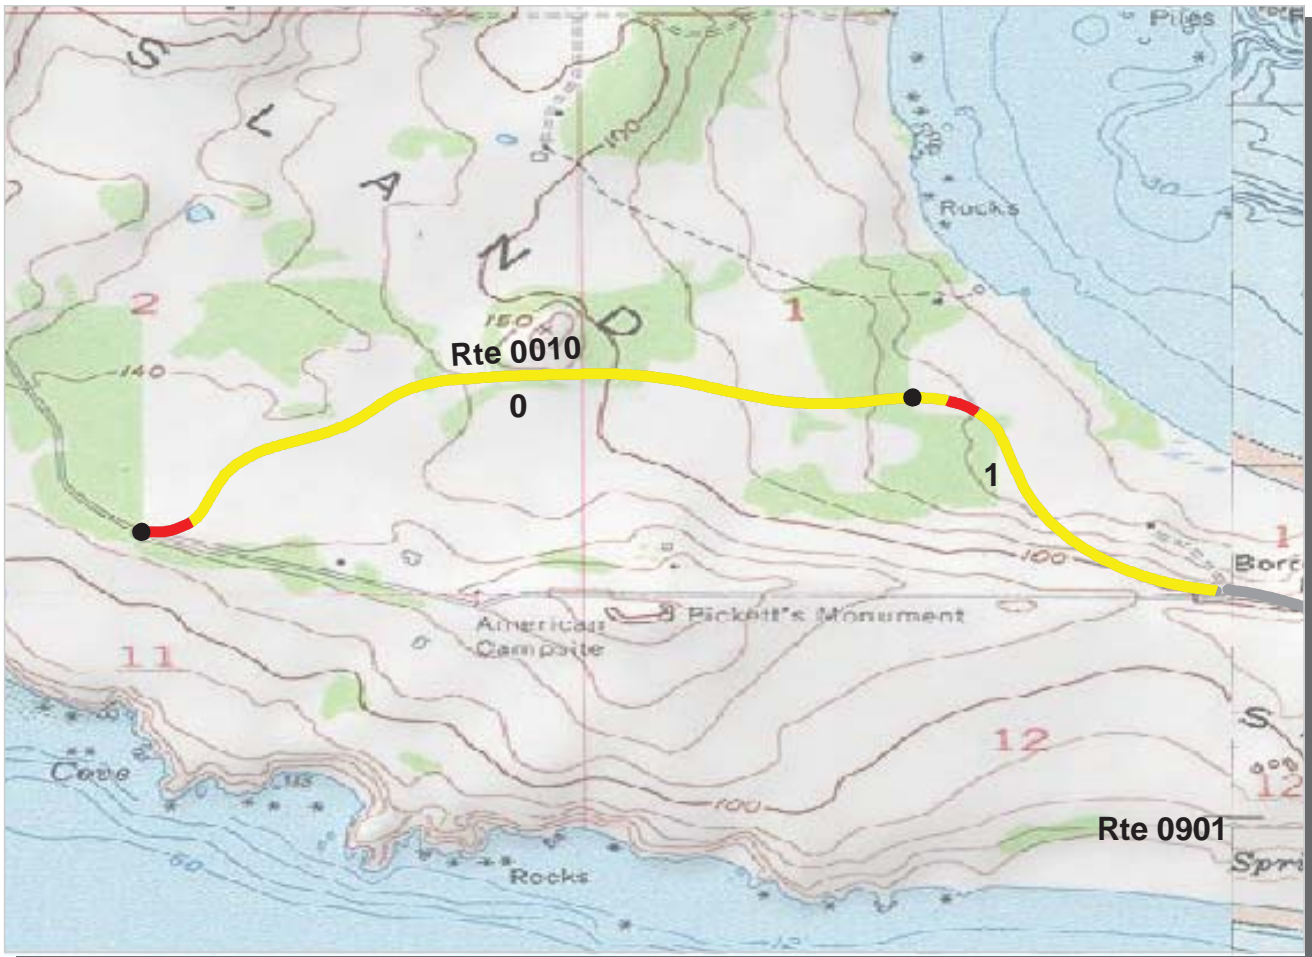
ROUTE: 0010 AMERICAN CAMP ROAD **TOTAL LENGTH: 1.53 Miles**

Section Number	0	1			
Section Length (mi)	1.00	0.53			
AADT	**				
SADT	**				
ADT Date	**				
Cross Section Information					
Number of Lanes	2	2			
Paved Width (ft)	23	23			
Lane Width (ft)	12	12			
Shoulder Width (ft)	6	6			
Roadway Condition Information					
PCR (Pavement Condition Rating)	66	67			
RCI (Roughness Condition Index)	82	91			
SCR (Surface Condition Rating)	55	51			
Alligator Cracking Index	100	100			
Rutting Index	55	51			
Patching Index	100	100			
Transverse Cracking Index	100	100			
Longitudinal Cracking Index	100	100			
Shoulder Condition Rating	GOOD	GOOD			
Drainage Condition Rating	GOOD	GOOD

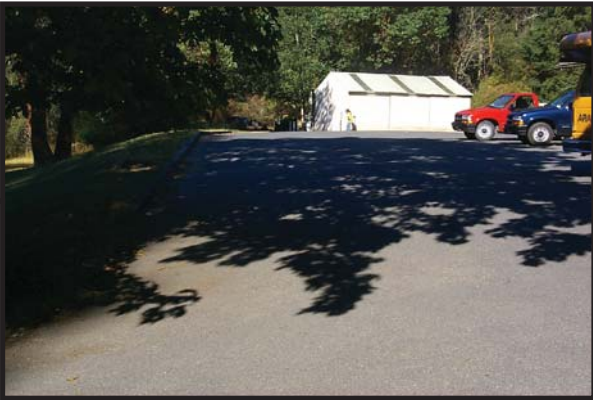
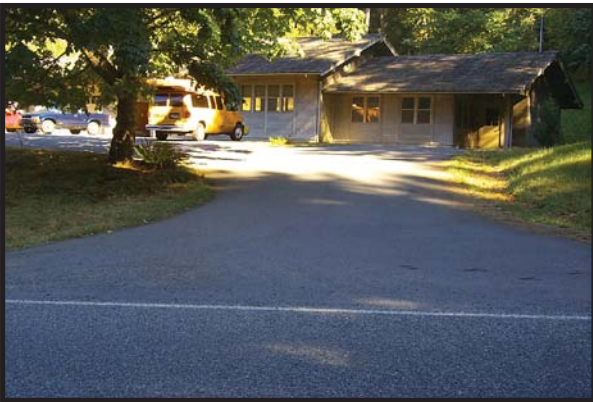
Route	Public / NonPublic	Date Visited	Area (sq ft)	Lane Miles *	Surface Type	Condition / PCR
0900	Public	9/21/2002	9068	0.16	AS	GOOD / 90

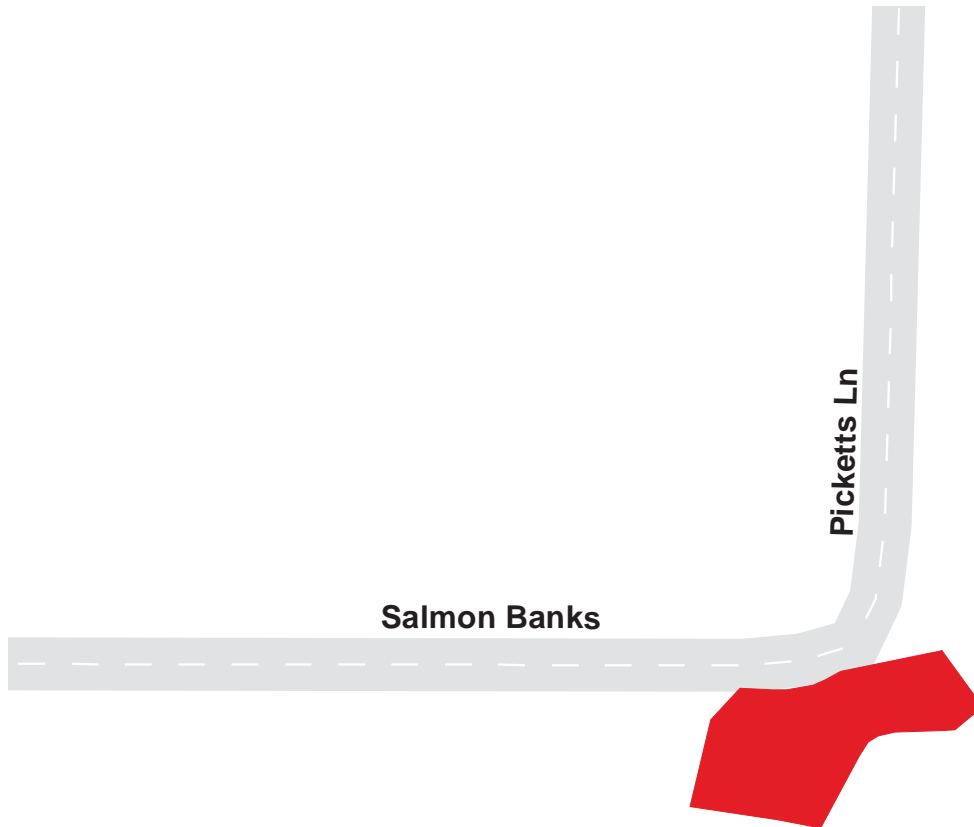
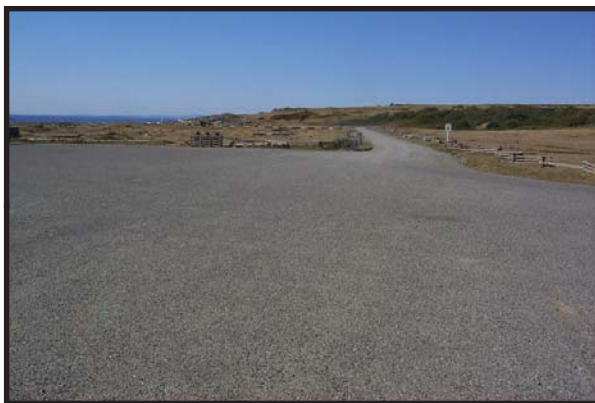
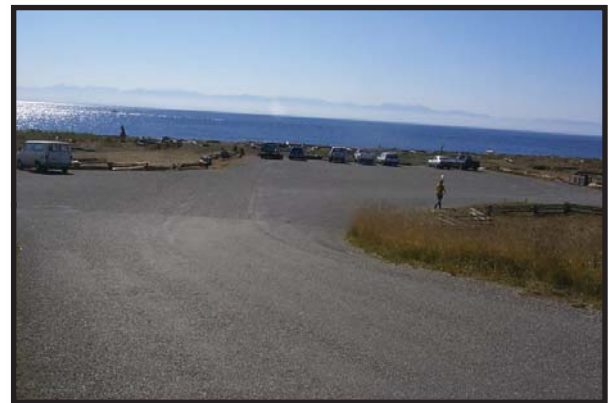
Route 0901

Route	Public / NonPublic	Date Visited	Area (sq ft)	Lane Miles *	Surface Type	Condition / PCR
0901	Public	9/21/2002	17908	0.31	AS	GOOD / 90
