The Road Inventory of San Juan National Historic Site SAJU - 5330

Road Inventory Program

Prepared By:
Federal Highway Administration
Eastern Federal Lands Highway Division
Cycle 3

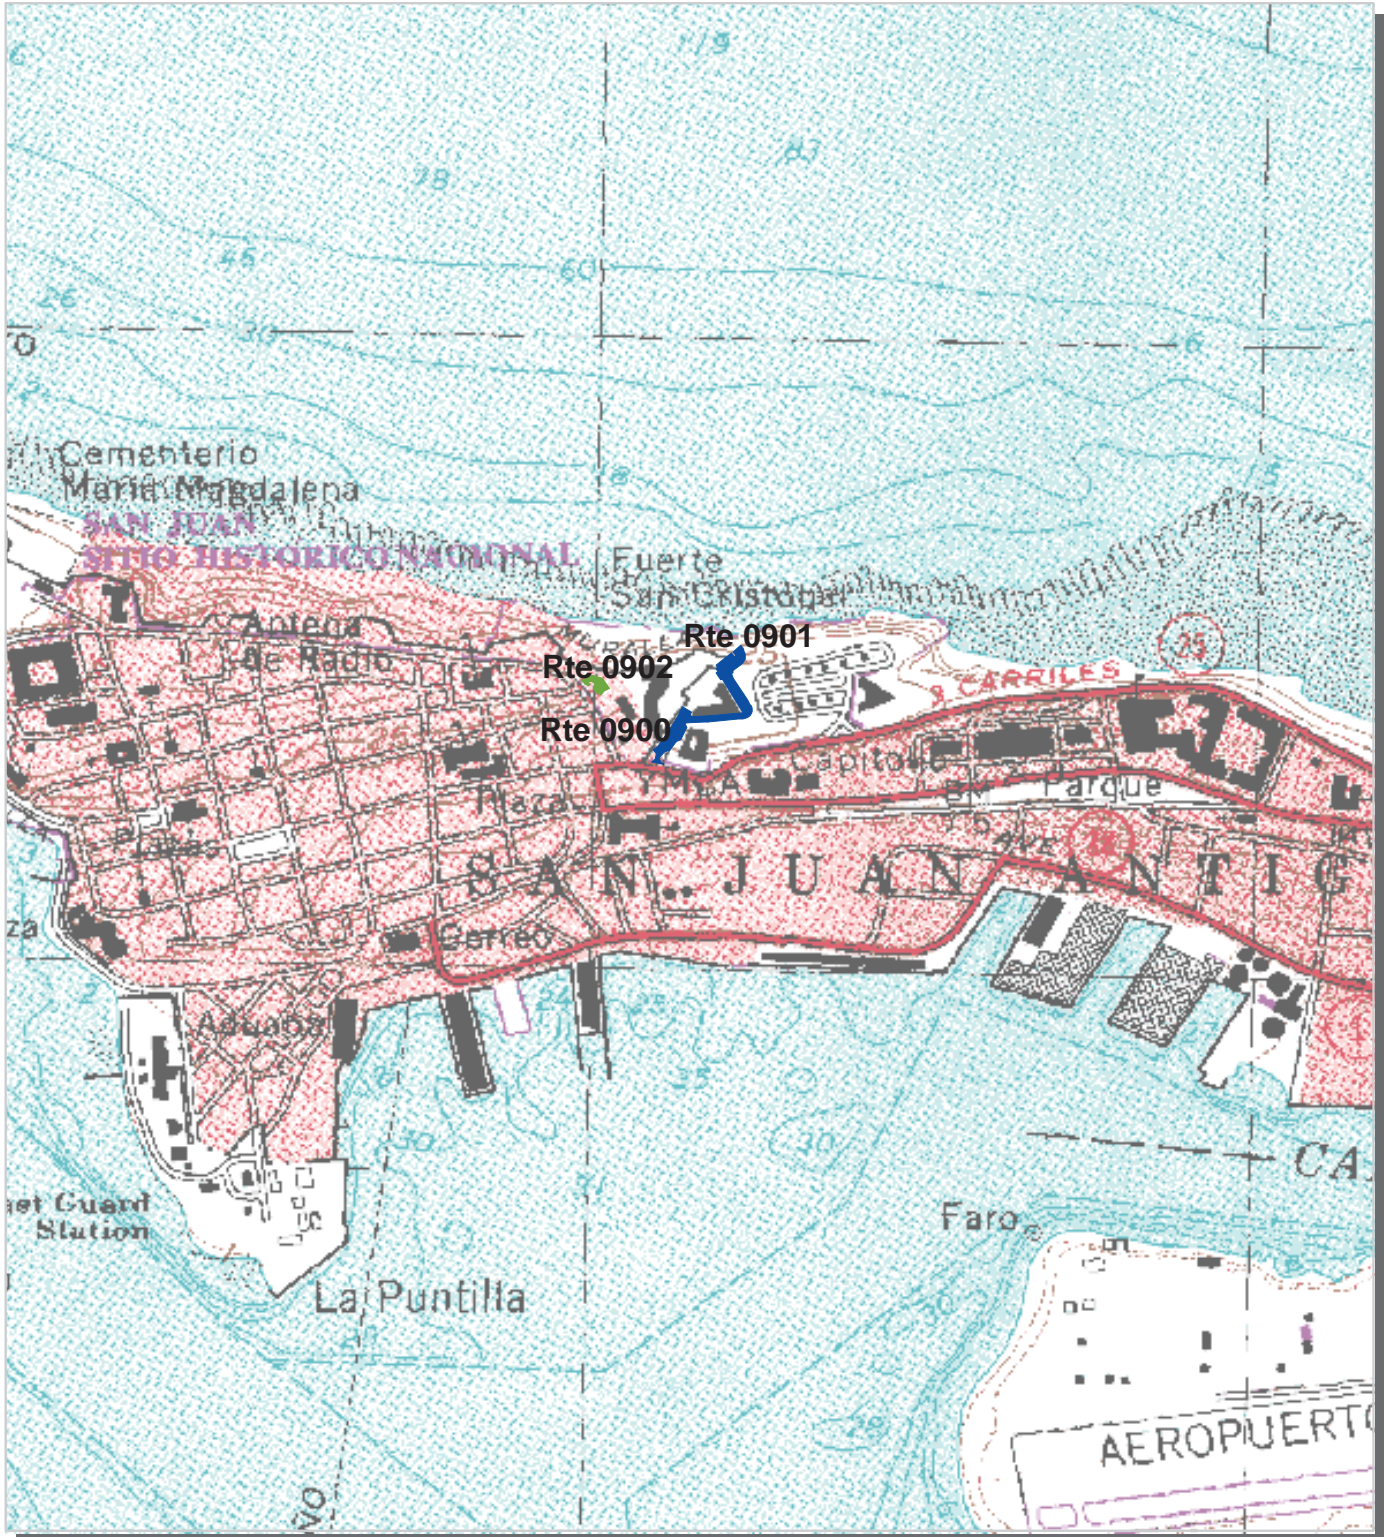
San Juan National Historic Site Route Condition Key Map PCR - Mile by Mile

PCR	Poor		Fair		Good		Excellent	
		(≤60)		(61 - 84)		(85 - 94)		(95 - 100)

* If the PCR rating is not available for a section, the SCR rating will be displayed. See appendix for definitions and formulas.

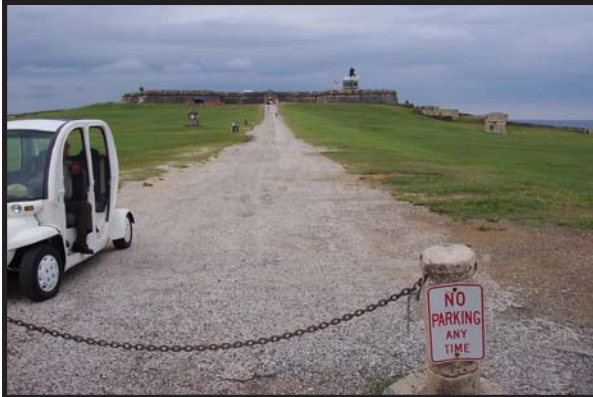
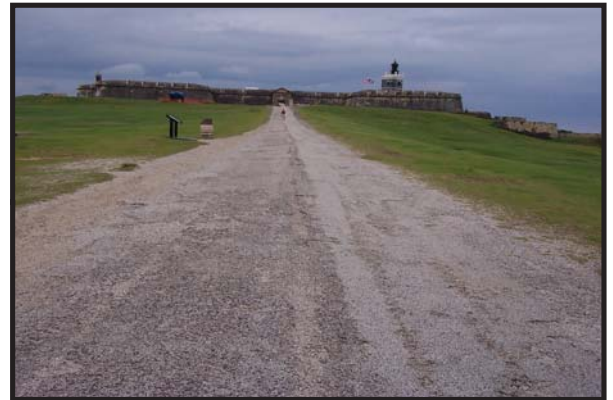
Route 0400

El Morro Administrative Road
From Route 0600

Route	Length (mi)	Width (ft)	Area (sq ft)	Lane Miles *	Condition / PCR	Surface Type
0400	0.22	0.00	24360	0.42	POOR / 45	OT

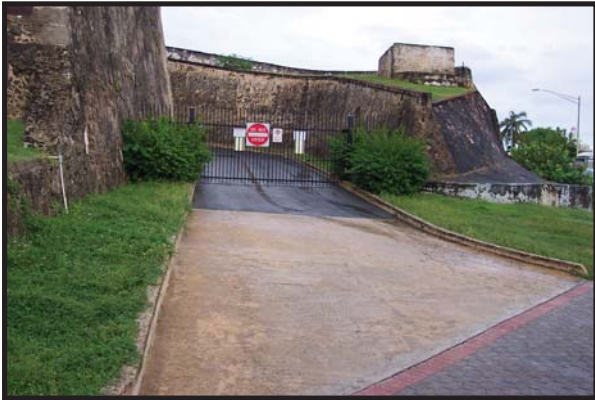
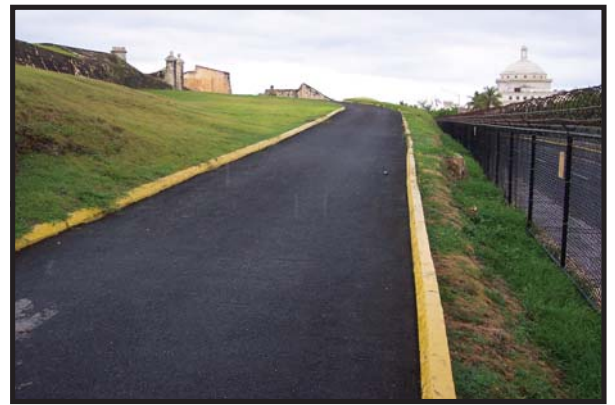
Route 0401

Administrative Access Road
From Munoz Rivera

Route	Length (mi)	Width (ft)	Area (sq ft)	Lane Miles *	Condition / PCR	Surface Type
0401	0.13	0.00	11439	0.20	GOOD / 90	AS

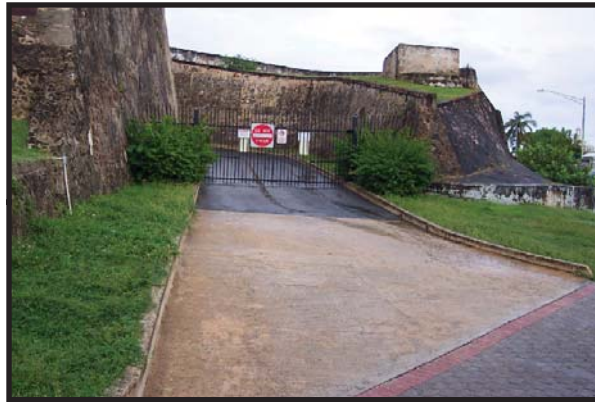
Route 0402

Visitor Center Administrative Road
From Norzagaray

Route	Length (mi)	Width (ft)	Area (sq ft)	Lane Miles *	Condition / PCR	Surface Type
0402	0.05	0.00	4743	0.08	GOOD / 90	AS

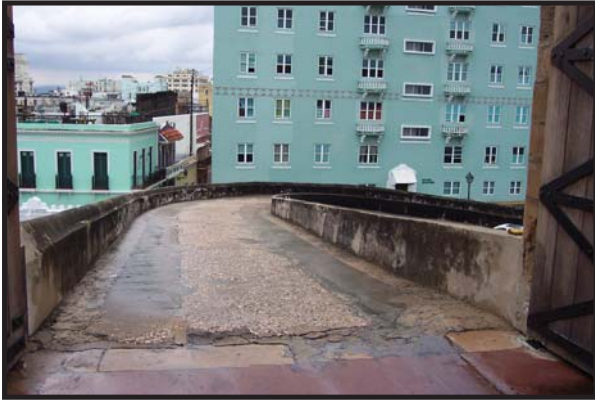
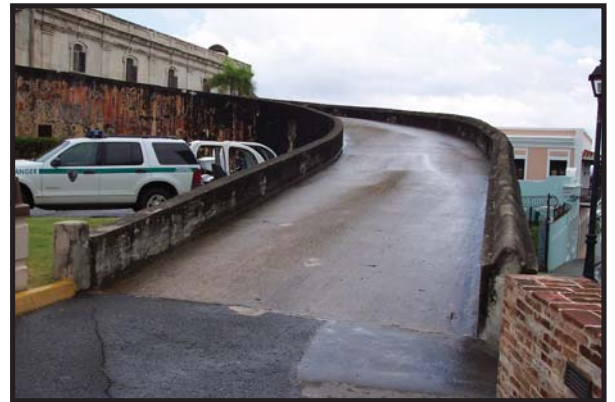
Route 0403

Headquarters Administrative Road
From Route 0902

Route	Length (mi)	Width (ft)	Area (sq ft)	Lane Miles *	Condition / PCR	Surface Type
0403	0.03	0.00	1356	0.02	FAIR / 73	CO

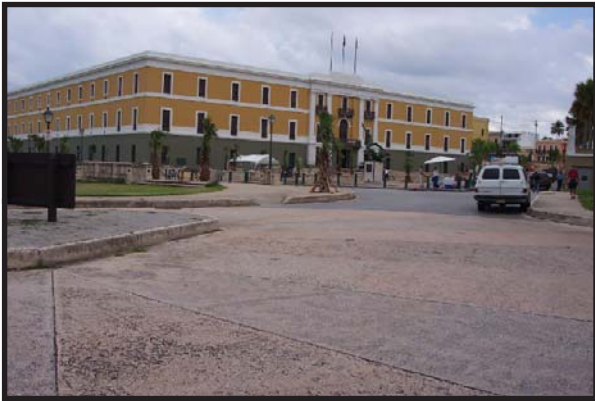
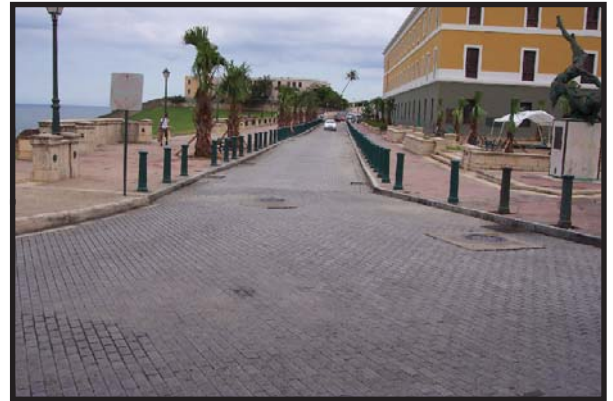
San Juan National Historic Site
Route 0600
 Norzagaray
 From Park Boundary

Route	Length (mi)	Width (ft)	Area (sq ft)	Lane Miles *	Condition / PCR	Surface Type
0600	0.16	0.00	19398	0.33	GOOD / 90	BR

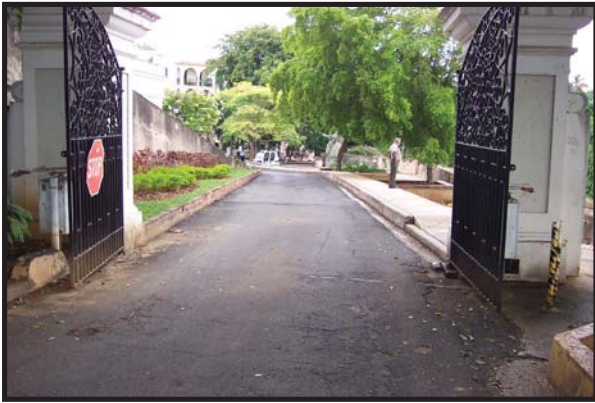
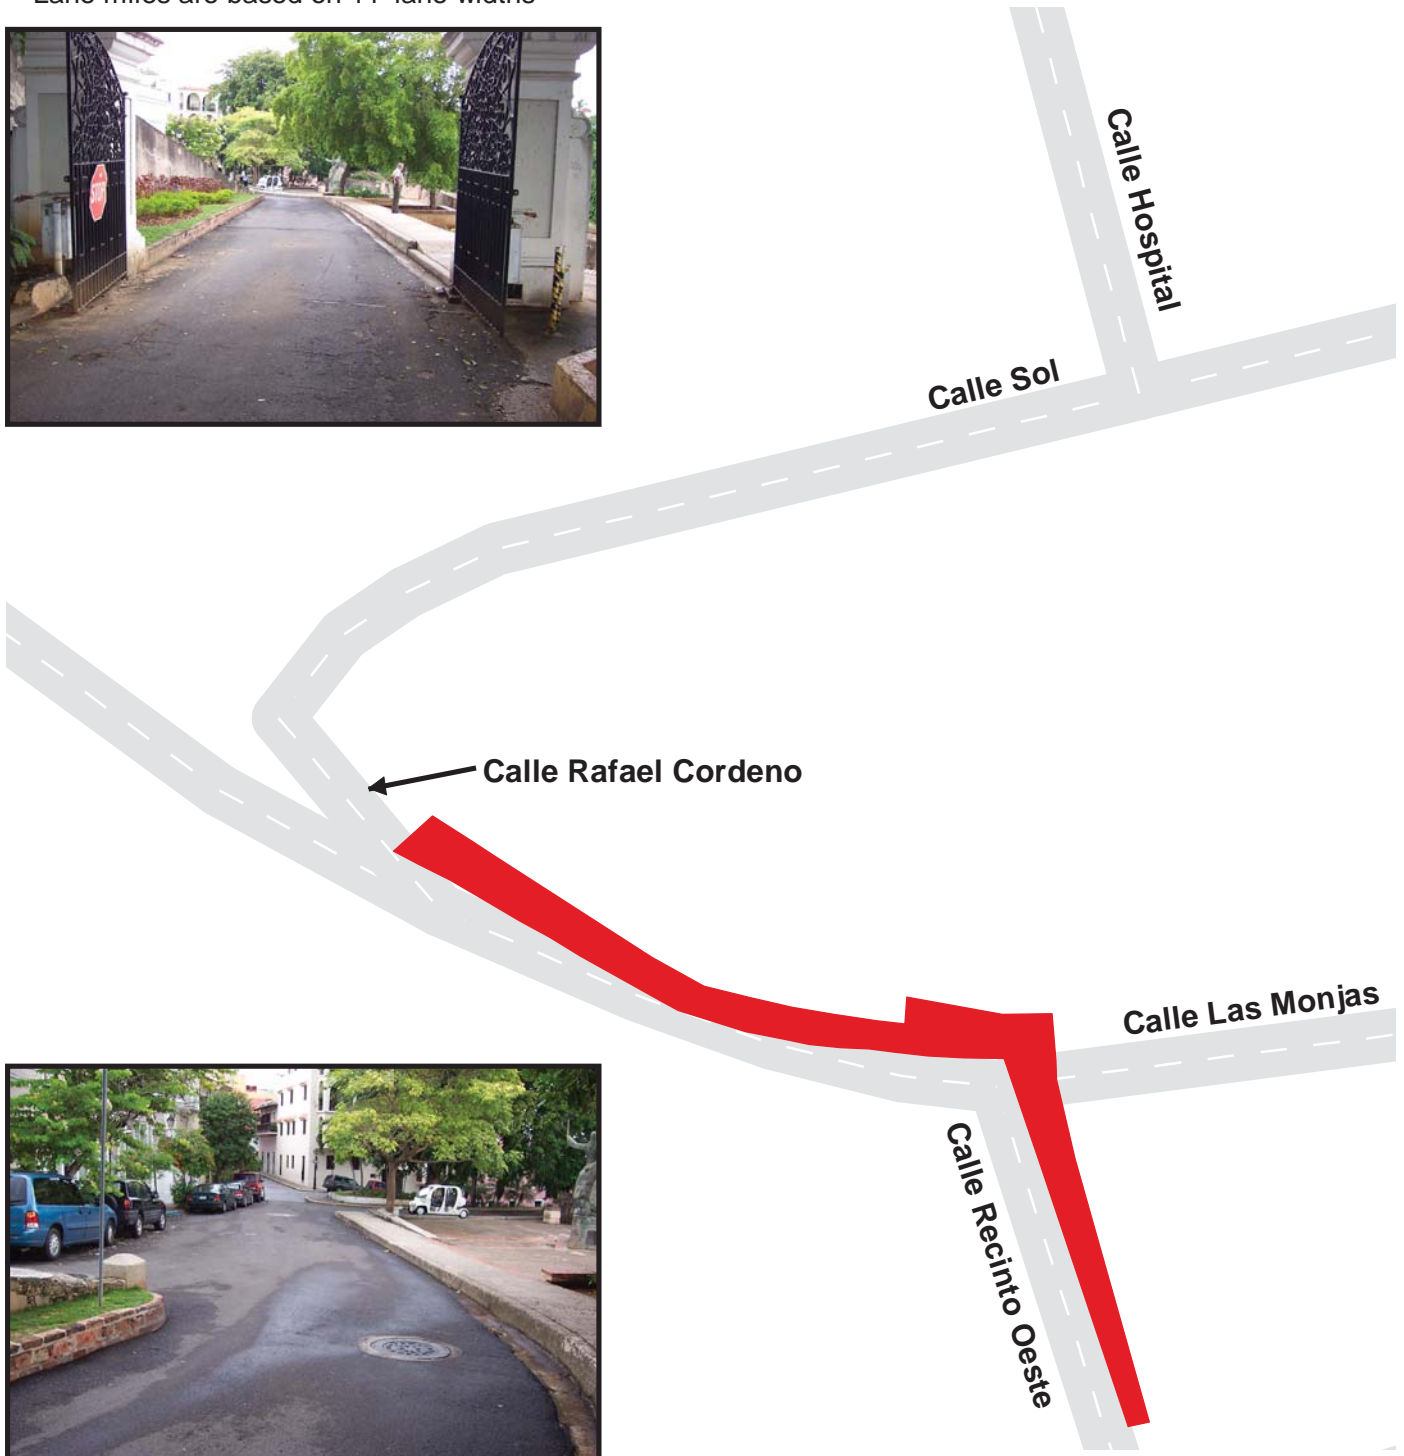
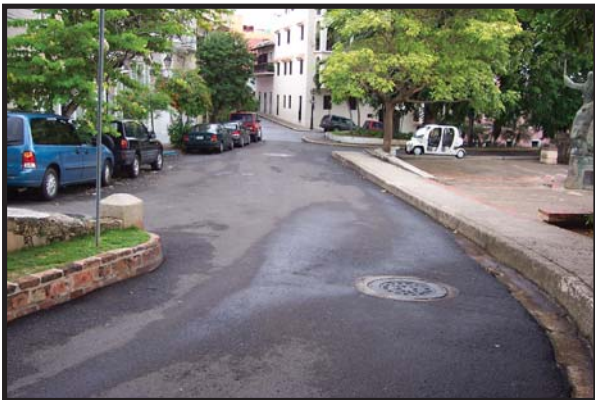
Route 0601

Recinto Oeste
From Sol

Route	Length (mi)	Width (ft)	Area (sq ft)	Lane Miles *	Condition / PCR	Surface Type
0601	0.06	0.00	3606	0.06	GOOD / 90	AS

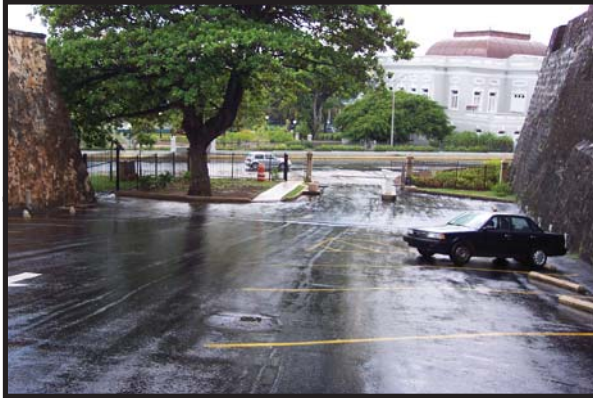
Route 0900

VISITOR CENTER PARKING

Route	Public / NonPublic	Date Visited	Area (sq ft)	Lane Miles *	Surface Type	Condition / PCR
0900	Public	4/13/2004	20316	0.35	AS	EXCELLENT / 97

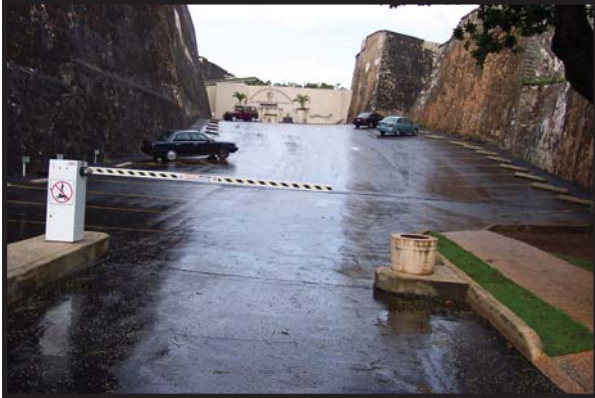
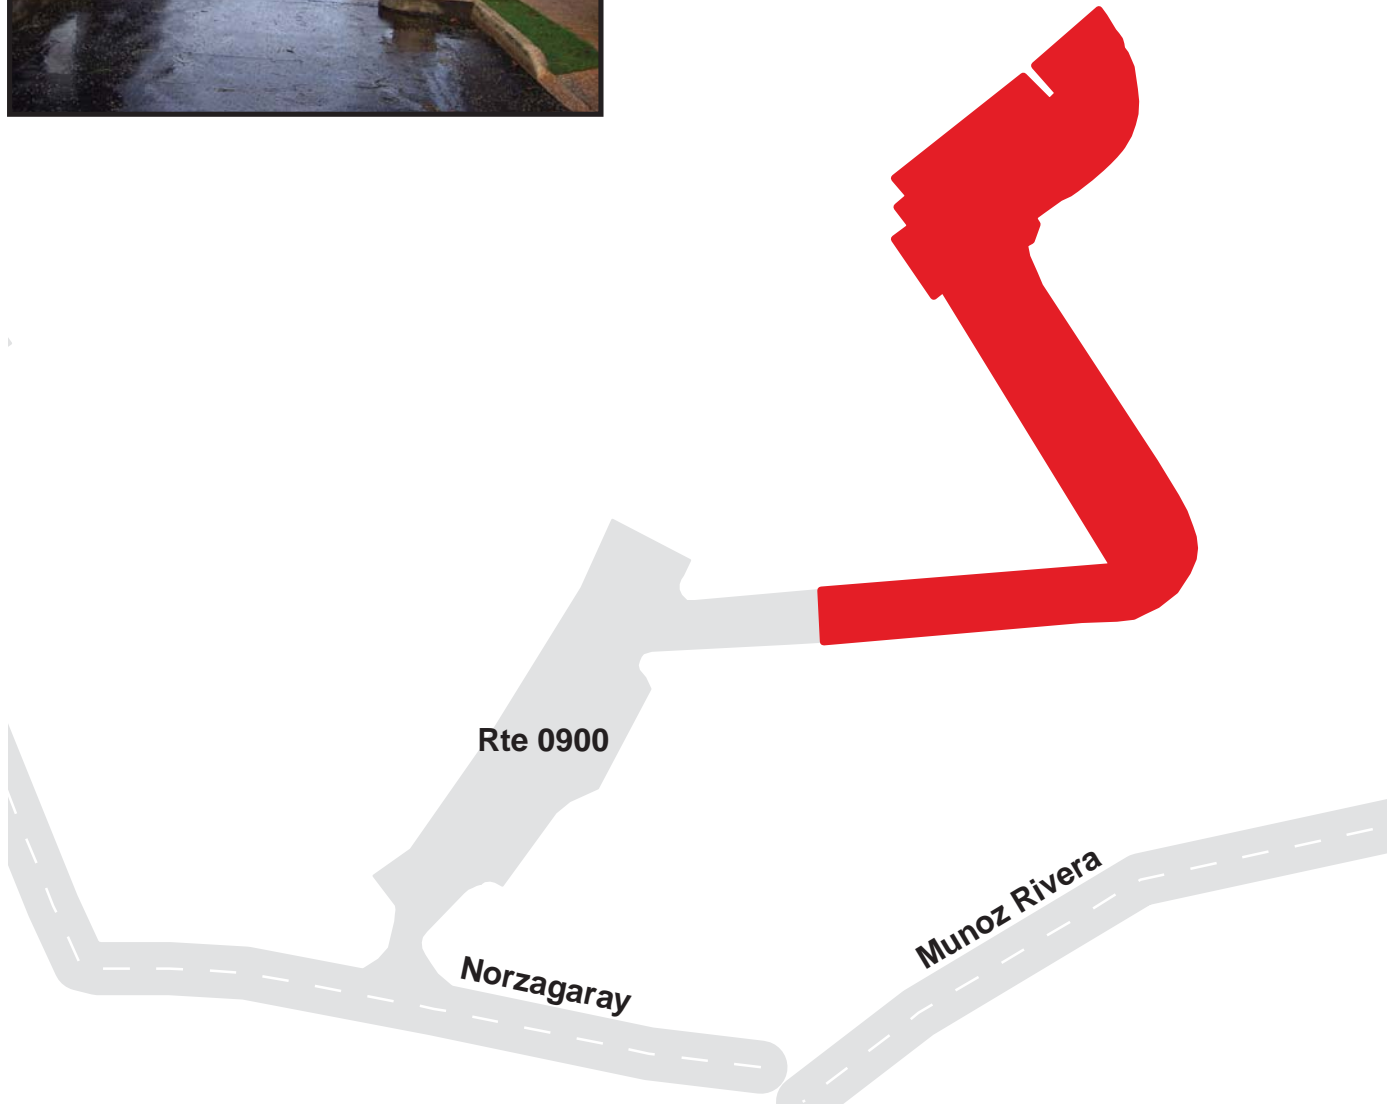
San Juan National Historic Site
Route 0901
 VISITOR CENTER ADMINISTRATIVE PARKING
 From Route 0900

Route	Public / NonPublic	Date Visited	Area (sq ft)	Lane Miles *	Surface Type	Condition / PCR
0901	NonPublic	4/13/2004	30360	0.52	AS	EXCELLENT / 97

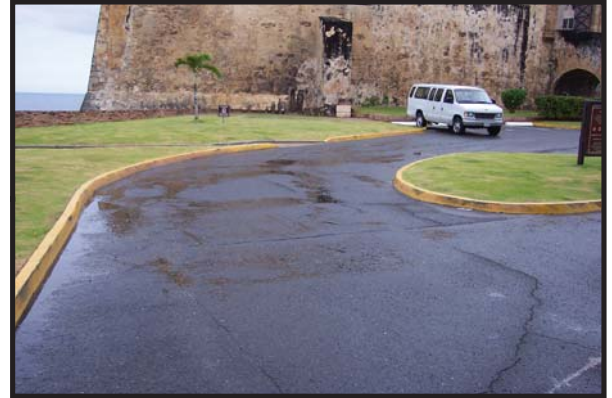
Route 0902

HEADQUARTERS PARKING

Route	Public / NonPublic	Date Visited	Area (sq ft)	Lane Miles *	Surface Type	Condition / PCR
0902	NonPublic	4/13/2004	6368	0.11	AS	GOOD / 90
