**The Road Inventory
of
Saint Paul's Church National Historic Site
SAPA - 1811**

Prepared By:
Federal Highway Administration
Eastern Federal Lands Highway Division
Cycle 3

Saint Paul's Church National Historic Site in New York

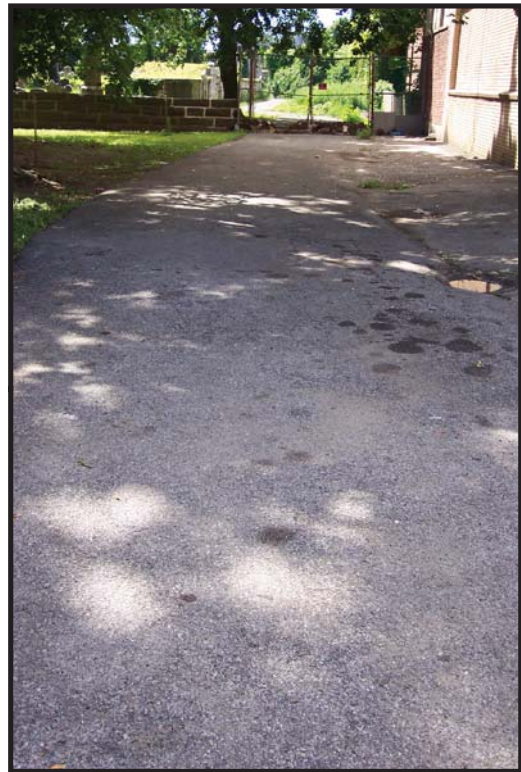
Saint Paul's Church National Historic Site
Route 0400
 Hearse Road
 From South Columbus Avenue

Route	Length (mi)	Width (ft)	Area (sq ft)	Lane Miles *	Condition / PCR	Surface Type
0400	0.09	11.00	5111	0.09	POOR / 45	AS

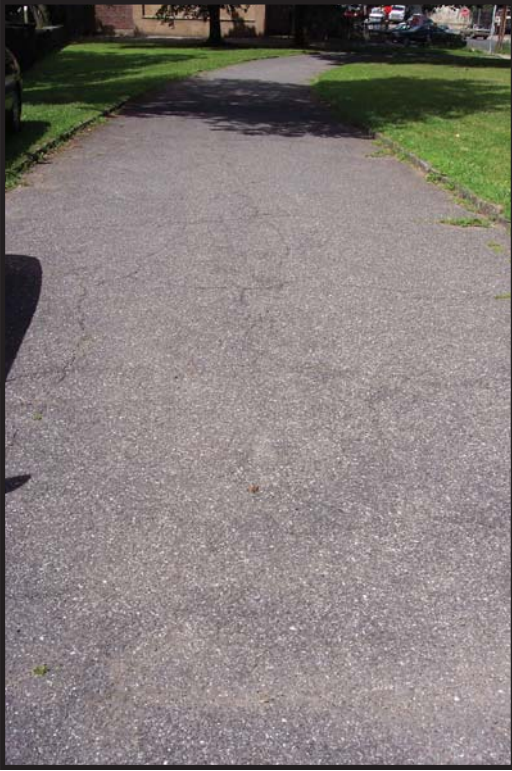
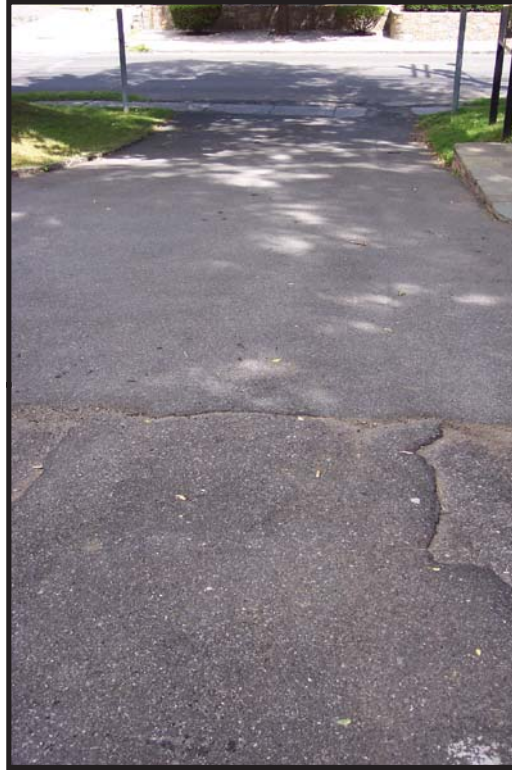
Route 0900

DRIVEWAY PARKING LOT
From South Columbus Avenue

Route	Public / NonPublic	Date Visited	Area (sq ft)	Lane Miles *	Surface Type	Condition / PCR
0900	Public	7/17/2004	6914	0.12	AS	POOR / 45
