The Road Inventory of Saratoga National Historical Park SARA - 1910

Road Inventory Program

Prepared By:
Federal Highway Administration
Eastern Federal Lands Highway Division
Cycle 3

Saratoga National Historical Park in New York

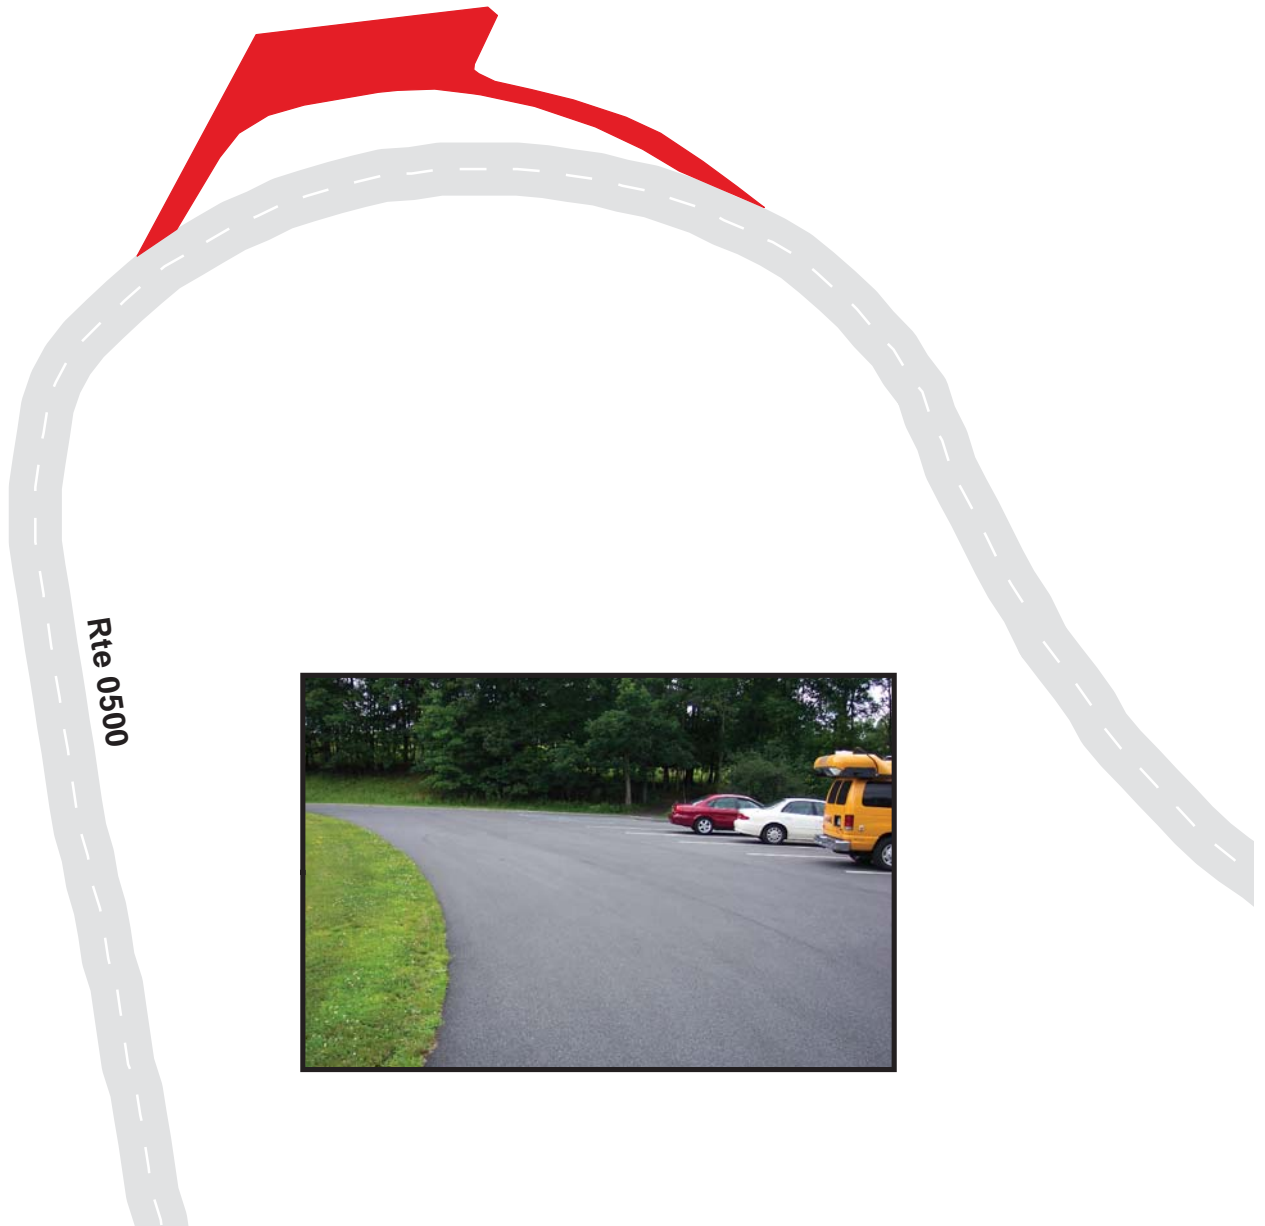
Saratoga National Historical Park
Route 0912
 BURGOYNES HEADQUARTERS PARKING
 FROM ROUTE 0500

Route	Public / NonPublic	Date Visited	Area (sq ft)	Lane Miles *	Surface Type	Condition / PCR
0912	Public	7/12/2003	8432	0.15	AS	GOOD / 90
