**The Road Inventory
of
Scotts Bluff National Monument
SCBL - 6700**

Road Inventory Program

Prepared By:
Federal Highway Administration
Eastern Federal Lands Highway Division
Cycle 3

Scotts Bluff National Monument in Nebraska

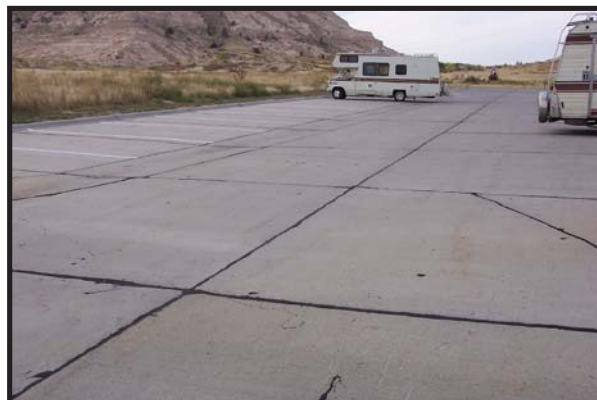
Route	Public / NonPublic	Date Visited	Area (sq ft)	Lane Miles *	Surface Type	Condition / PCR
0900	Public	10/2/2003	11644	0.20	CO	FAIR / 73

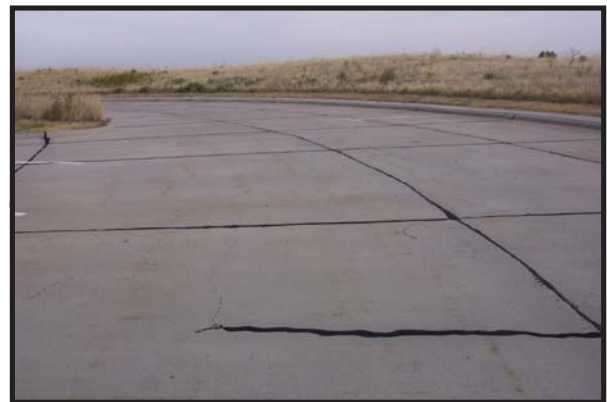
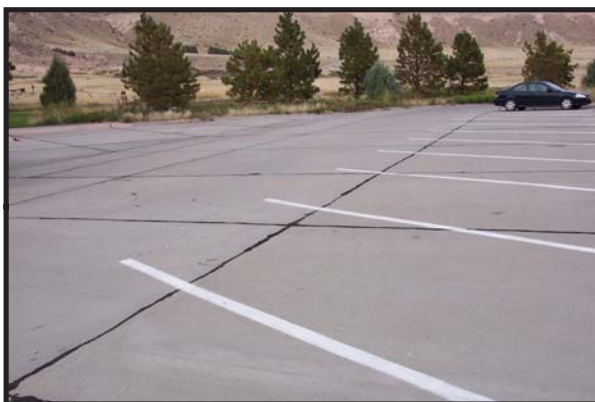
Route 0901

Route	Public / NonPublic	Date Visited	Area (sq ft)	Lane Miles *	Surface Type	Condition / PCR
0901	Public	10/2/2003	26478	0.46	CO	FAIR / 73

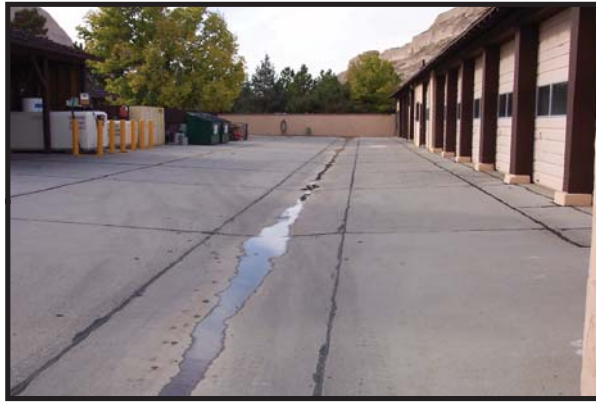
Route 0902

Route	Public / NonPublic	Date Visited	Area (sq ft)	Lane Miles *	Surface Type	Condition / PCR
0902	NonPublic	10/2/2003	7416	0.13	CO	POOR / 45

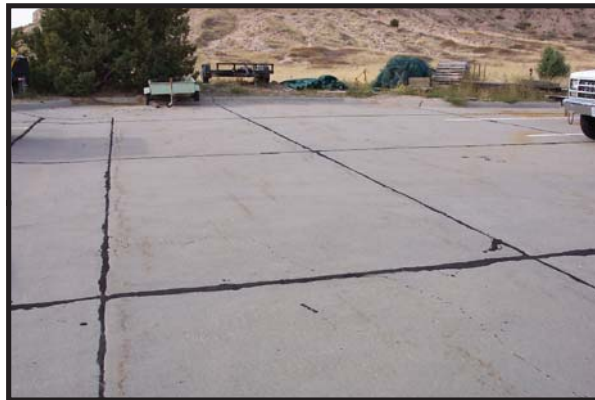
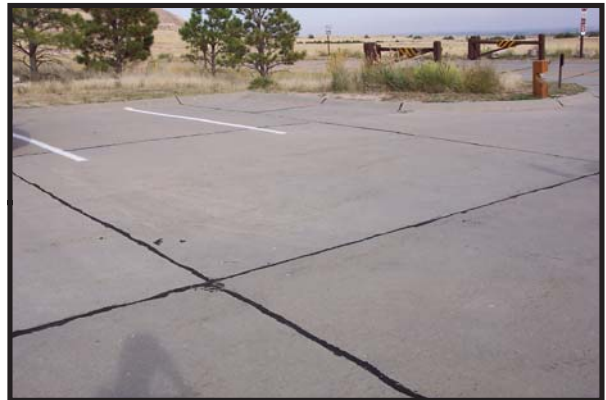
Route 0903

Route	Public / NonPublic	Date Visited	Area (sq ft)	Lane Miles *	Surface Type	Condition / PCR
0903	NonPublic	10/2/2003	6654	0.11	CO	FAIR / 73

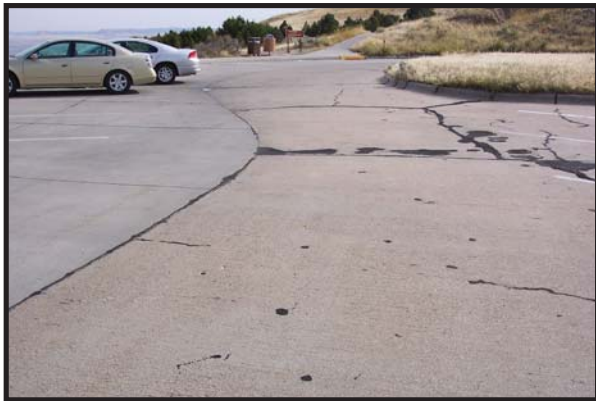
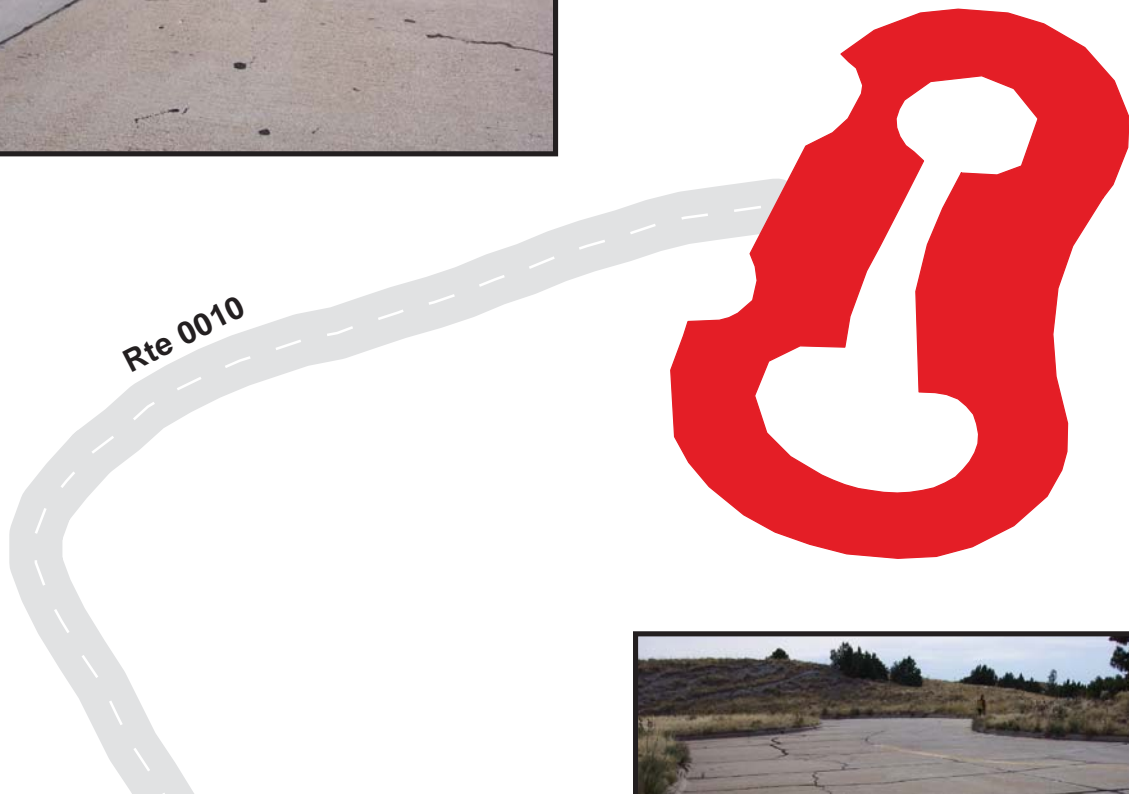
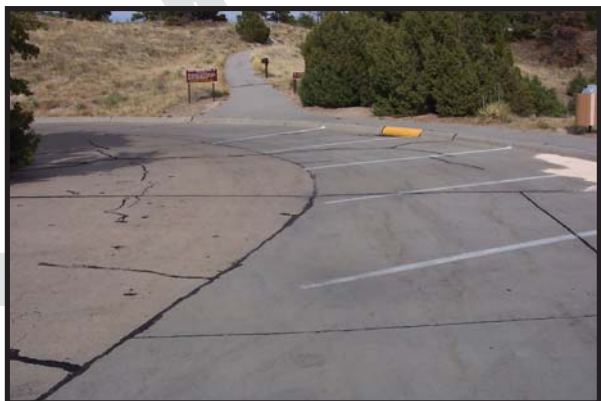
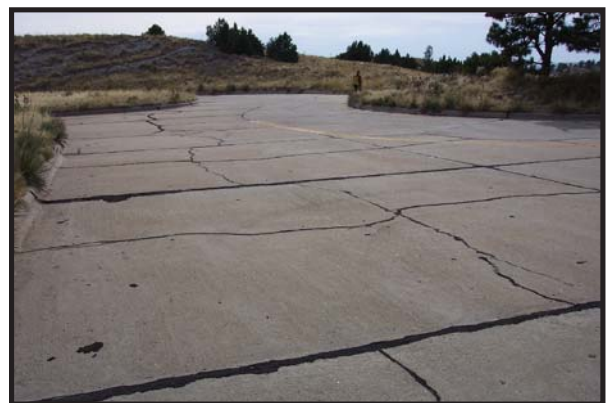
Route 0904

Route	Public / NonPublic	Date Visited	Area (sq ft)	Lane Miles *	Surface Type	Condition / PCR
0904	Public	10/2/2003	27384	0.47	CO	FAIR / 73
