The Road Inventory of Sequoia National Park SEQU – 8550

Road Inventory Program

Prepared By:
Federal Highway Administration
Eastern Federal Lands Highway Division
Cycle 3

Sequoia National Park in California

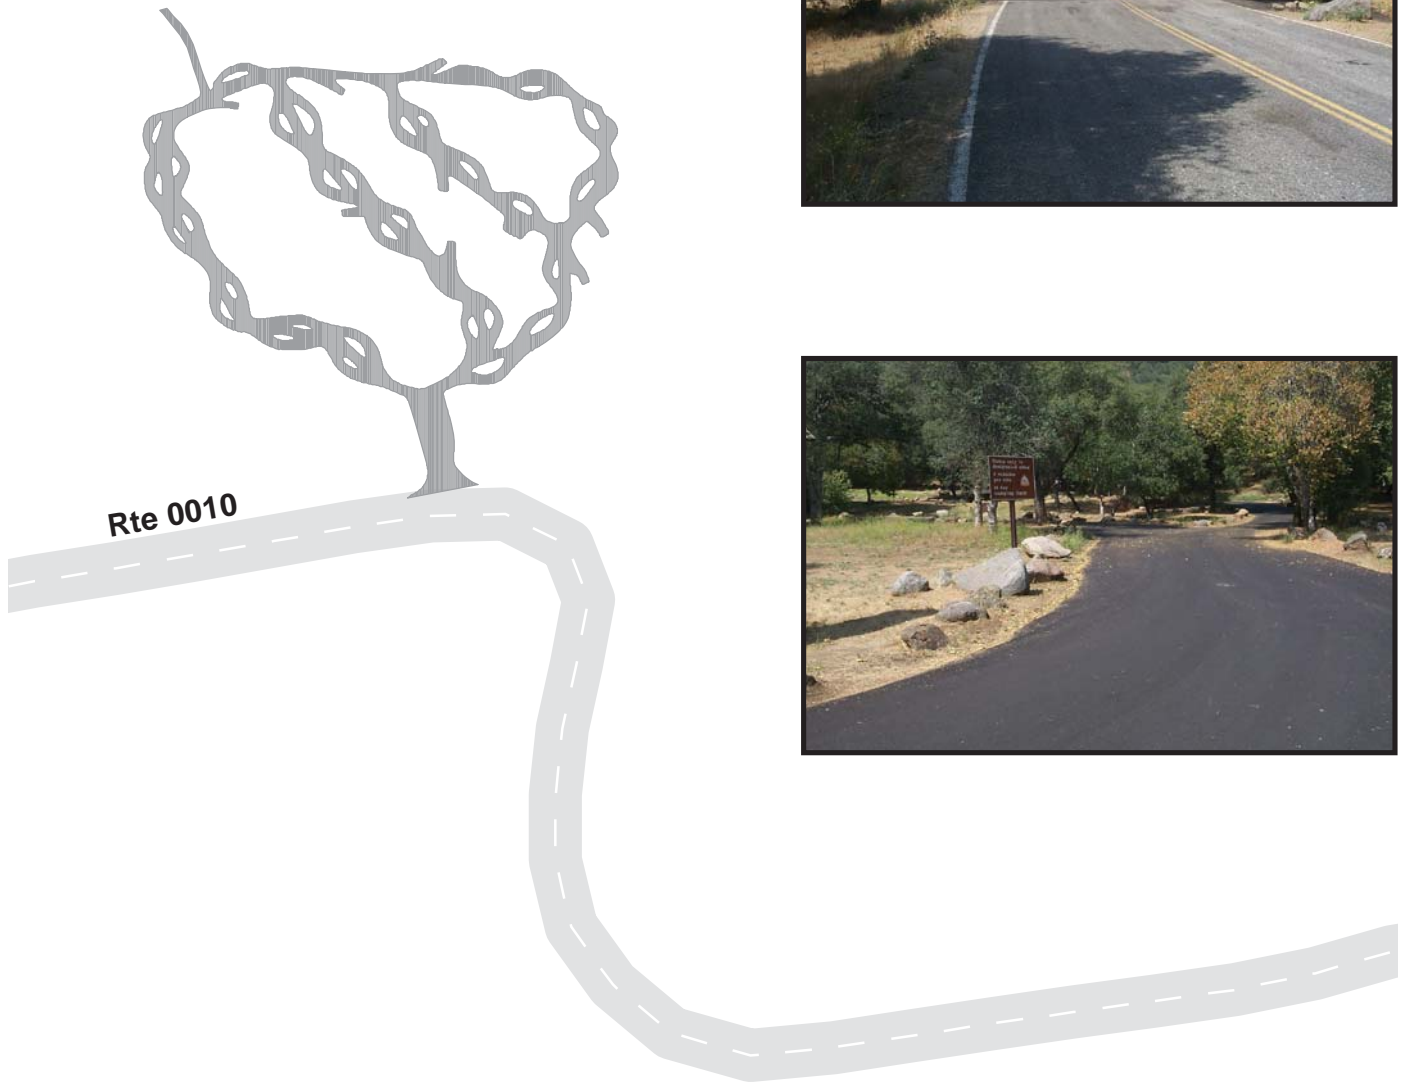
Sequoia National Park
Route 0203
 Buckeye Flat Road
 From Route 0010 at MP 6.363

| Route | Length (mi) | Width (ft) | Area (sq ft) | Lane Miles * | Condition / PCR | Surface Type |
|---|---|---|---|---|---|---|
| 0203 | 0.79 | 0.00 | 91421 | 1.57 | FAIR / 73 | AS |

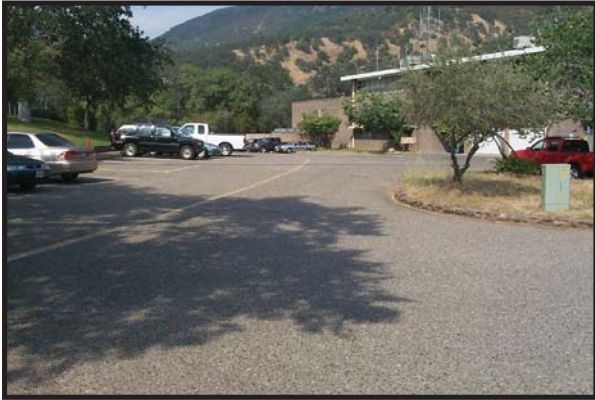
Sequoia National Park
Route 0425
 Headquarters Street
 From Route 0010 at MP 1.20

| Route | Length (mi) | Width (ft) | Area (sq ft) | Lane Miles * | Condition / PCR | Surface Type |
|---|---|---|---|---|---|---|
| 0425 | 0.16 | 0.00 | 18229 | 0.31 | FAIR / 73 | AS |

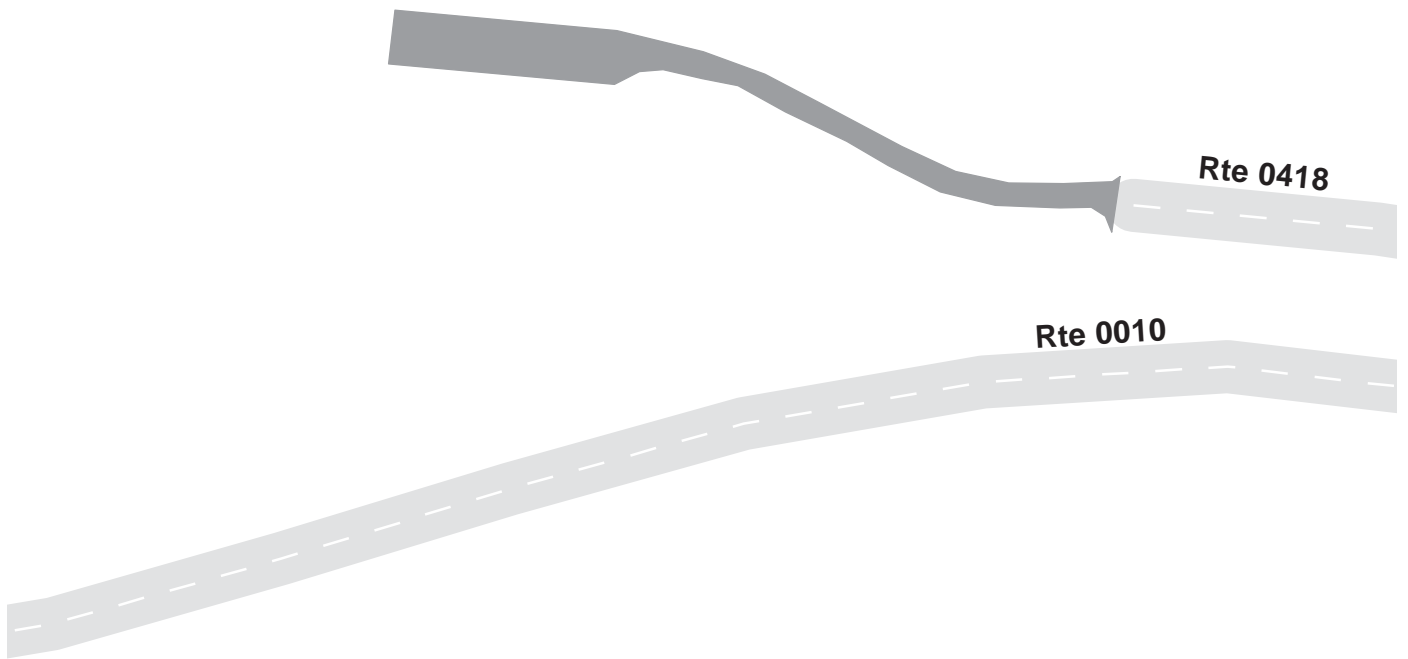
Sequoia National Park
Route 0427B
 Lodgepole North Residence Road B
 From Route 0418 at MP 0.2, Left

| Route | Length (mi) | Width (ft) | Area (sq ft) | Lane Miles * | Condition / PCR | Surface Type |
|---|---|---|---|---|---|---|
| 0427B | 0.53 | 0.00 | 30997 | 0.53 | POOR / 45 | AS |

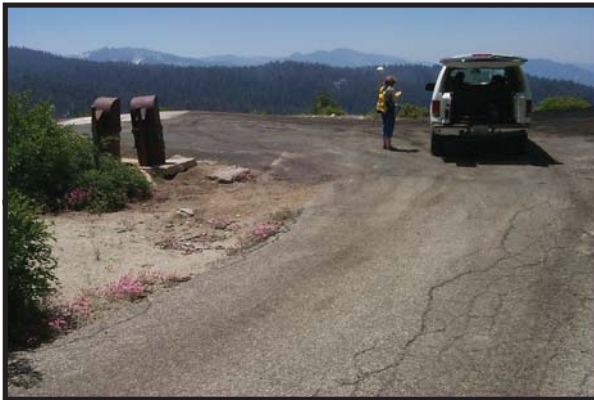
Sequoia National Park

| Route | Length (mi) | Width (ft) | Area (sq ft) | Lane Miles * | Condition / PCR | Surface Type |
|---|---|---|---|---|---|---|
| 0430 | 0.56 | 0.00 | 31633 | 0.54 | FAIR / 73 | AS |

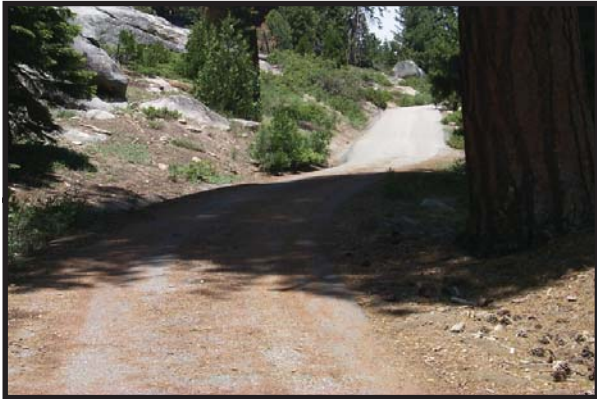
Sequoia National Park
Route 0433
 Southern Sierra Research Center
 From Route 0010 at MP 1.07

| Route | Length (mi) | Width (ft) | Area (sq ft) | Lane Miles * | Condition / PCR | Surface Type |
|---|---|---|---|---|---|---|
| 0433 | 0.18 | 0.00 | 10834 | 0.19 | FAIR / 73 | AS |

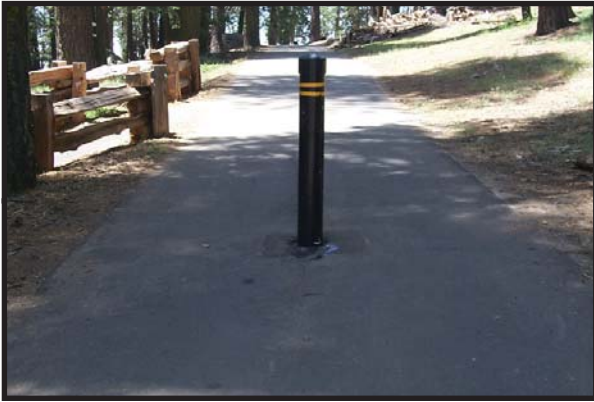
Sequoia National Park
Route 0441
 Buckeye Water Treatment Service Road
 From Route 0435

| Route | Length (mi) | Width (ft) | Area (sq ft) | Lane Miles * | Condition / PCR | Surface Type |
|---|---|---|---|---|---|---|
| 0441 | 0.06 | 0.00 | 4067 | 0.07 | POOR / 45 | AS |

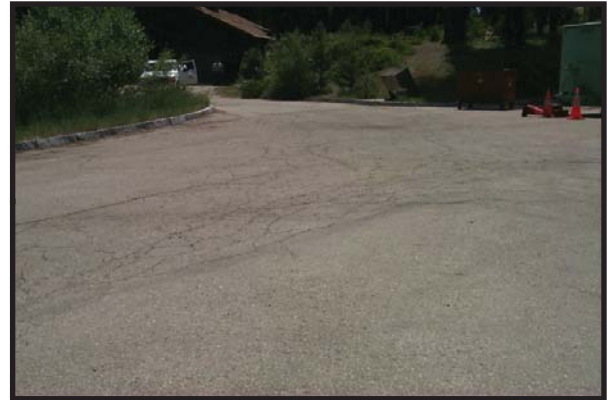
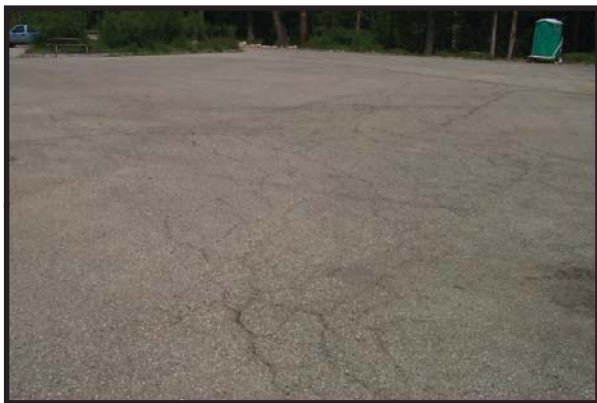
| Route | Public / NonPublic | Date Visited | Area (sq ft) | Lane Miles * | Surface Type | Condition / PCR |
|---|---|---|---|---|---|---|
| 0927 | NonPublic | 6/28/2002 | 30538 | 0.53 | AS | FAIR / 73 |

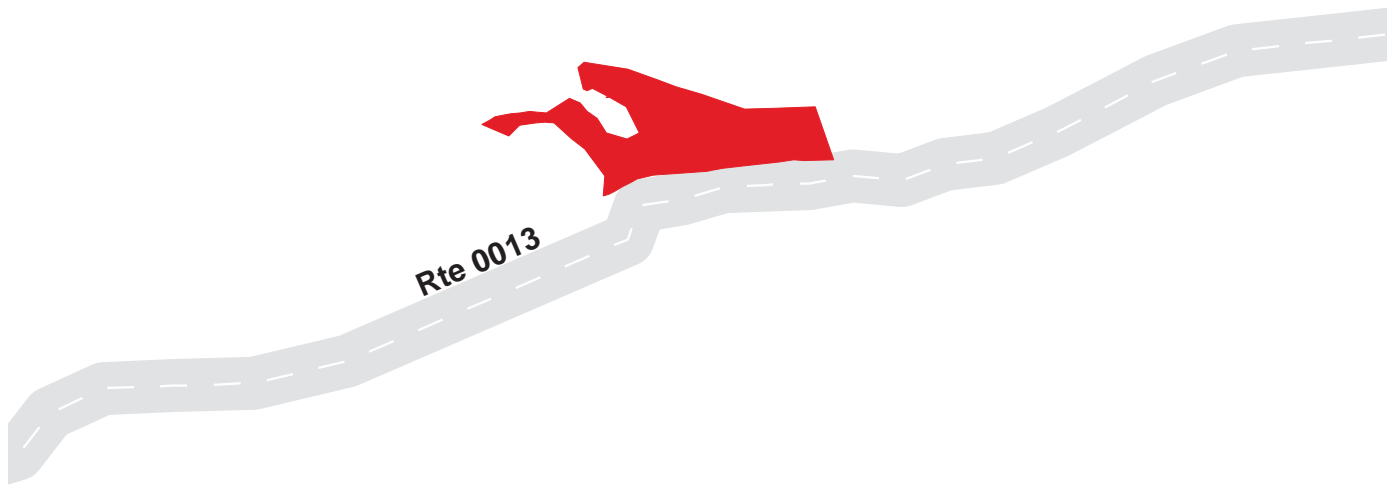
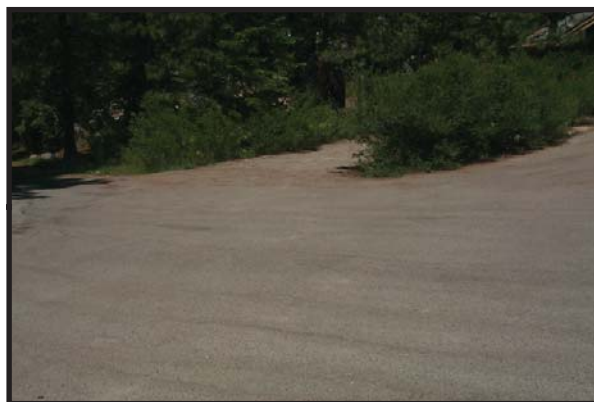
| Route | Public / NonPublic | Date Visited | Area (sq ft) | Lane Miles * | Surface Type | Condition / PCR |
|---|---|---|---|---|---|---|
| 0930 | Public | 6/28/2002 | 4986 | 0.09 | AS | FAIR / 73 |

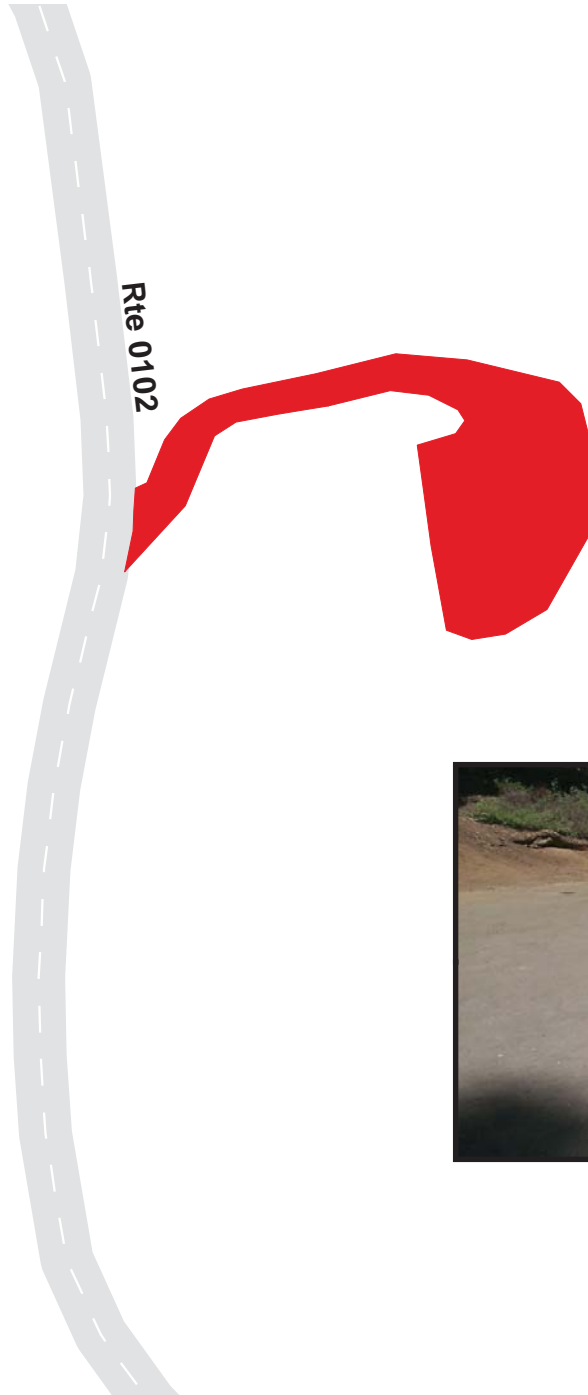
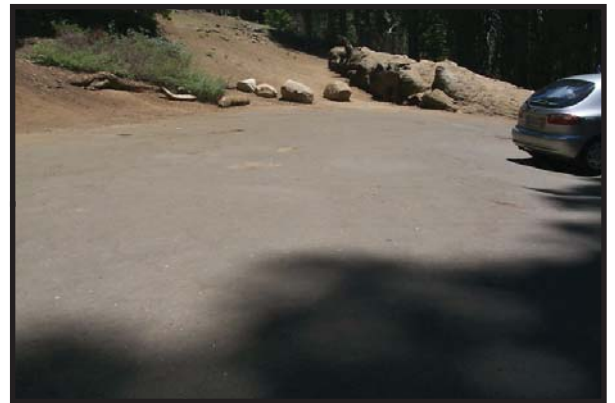
| Route | Public / NonPublic | Date Visited | Area (sq ft) | Lane Miles * | Surface Type | Condition / PCR |
|---|---|---|---|---|---|---|
| 0931 | Public | 6/28/2002 | 7951 | 0.14 | AS | POOR / 45 |

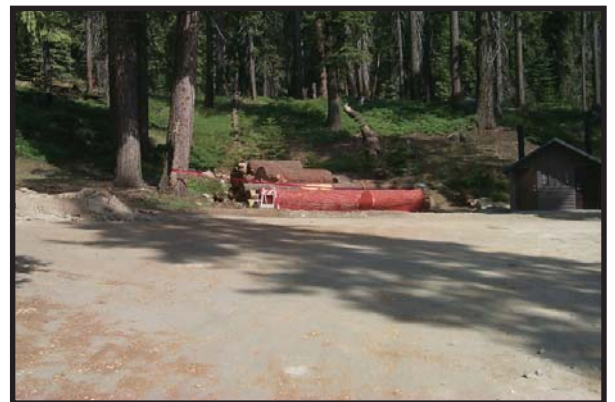
| Route | Public / NonPublic | Date Visited | Area (sq ft) | Lane Miles * | Surface Type | Condition / PCR |
|---|---|---|---|---|---|---|
| 0932 | NonPublic | 6/28/2002 | 29167 | 0.50 | AS | POOR / 45 |

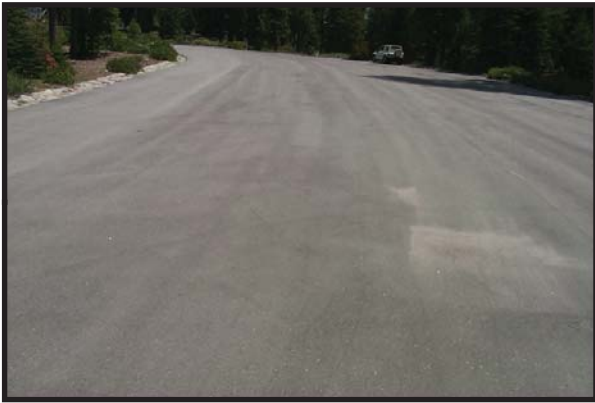
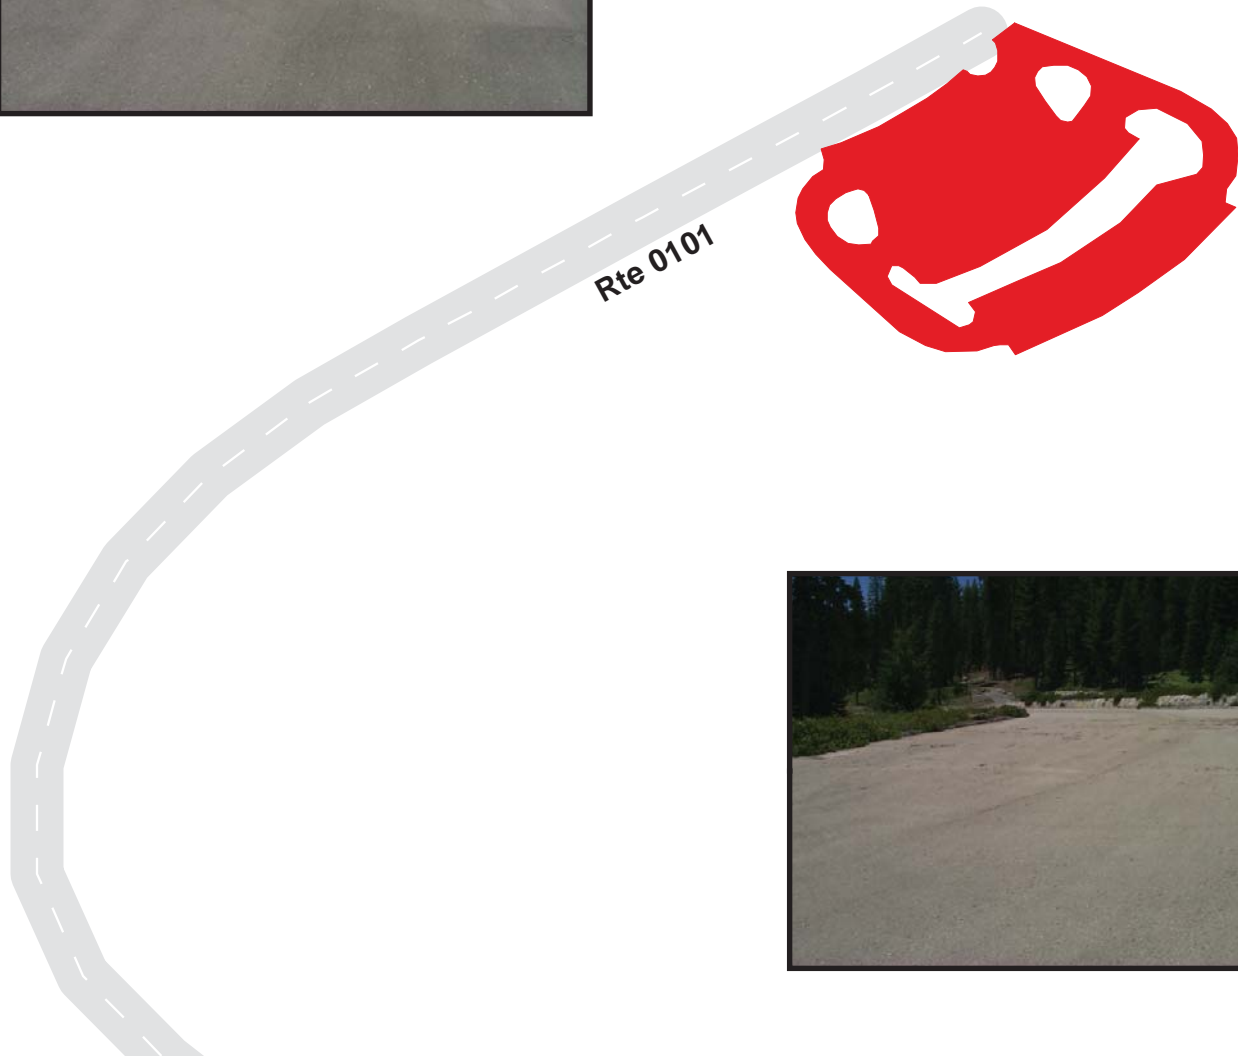
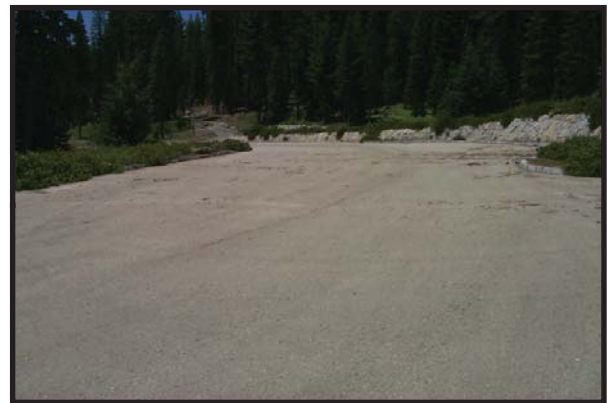
| Route | Public / NonPublic | Date Visited | Area (sq ft) | Lane Miles * | Surface Type | Condition / PCR |
|---|---|---|---|---|---|---|
| 0934 | Public | 6/26/2002 | 56876 | 0.98 | AS | GOOD / 90 |

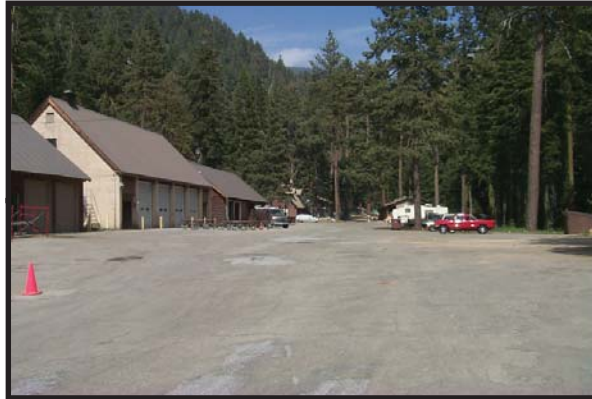
| Route | Public / NonPublic | Date Visited | Area (sq ft) | Lane Miles * | Surface Type | Condition / PCR |
|---|---|---|---|---|---|---|
| 0935 | NonPublic | 6/26/2002 | 42257 | 0.73 | AS | POOR / 45 |

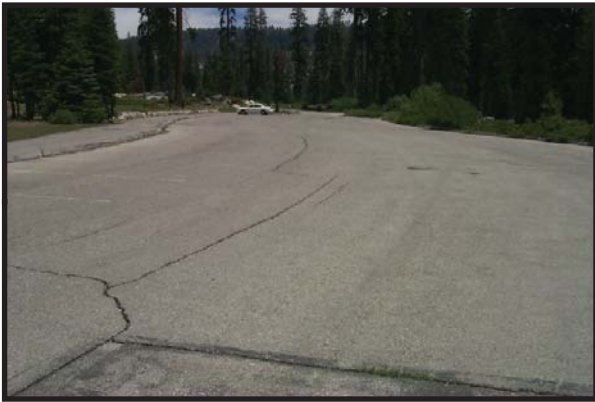
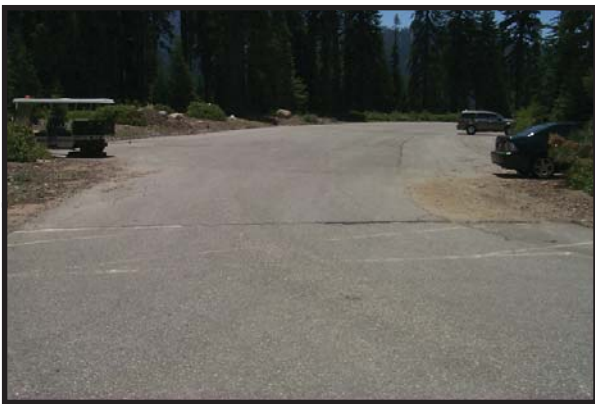
| Route | Public / NonPublic | Date Visited | Area (sq ft) | Lane Miles * | Surface Type | Condition / PCR |
|---|---|---|---|---|---|---|
| 0937 | Public | 6/26/2002 | 109878 | 1.89 | AS | FAIR / 73 |

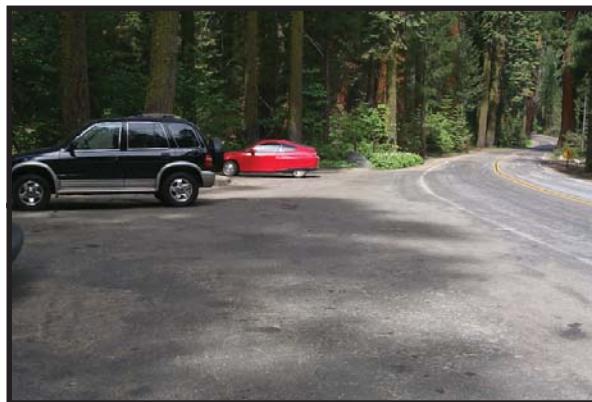
| Route | Public / NonPublic | Date Visited | Area (sq ft) | Lane Miles * | Surface Type | Condition / PCR |
|---|---|---|---|---|---|---|
| 0938 | Public | 6/26/2002 | 1764 | 0.03 | AS | GOOD / 90 |

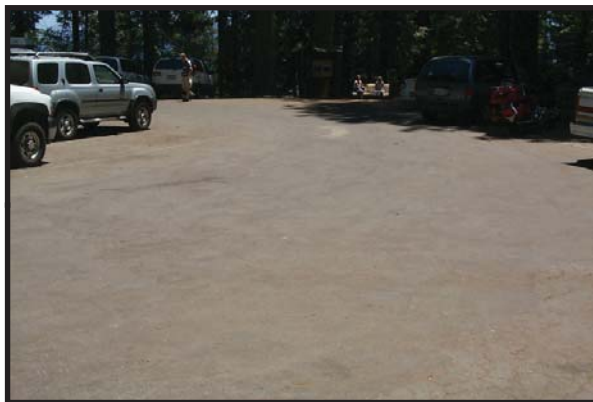
| Route | Public / NonPublic | Date Visited | Area (sq ft) | Lane Miles * | Surface Type | Condition / PCR |
|---|---|---|---|---|---|---|
| 0939 | Public | 6/26/2002 | 2171 | 0.04 | AS | FAIR / 73 |

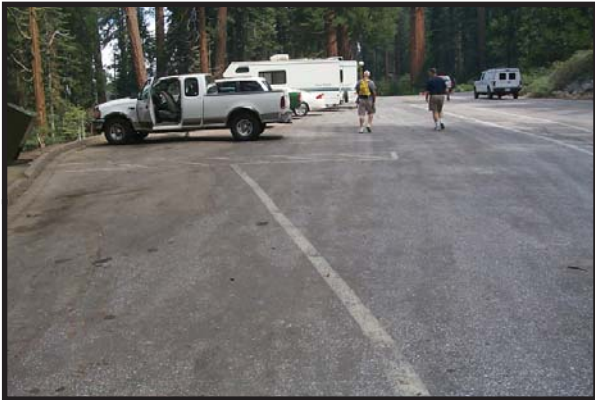
| Route | Public / NonPublic | Date Visited | Area (sq ft) | Lane Miles * | Surface Type | Condition / PCR |
|---|---|---|---|---|---|---|
| 0941 | Public | 6/26/2002 | 8952 | 0.15 | AS | FAIR / 73 |

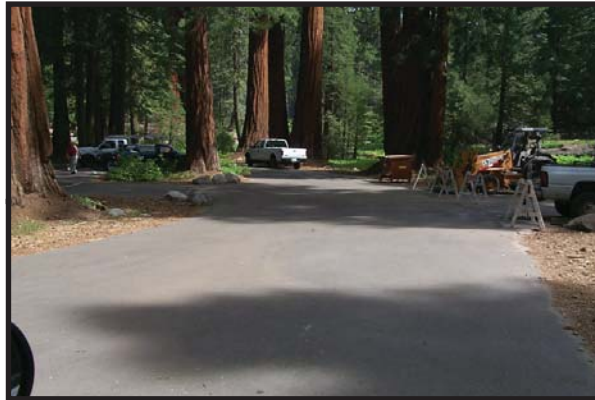
| Route | Public / NonPublic | Date Visited | Area (sq ft) | Lane Miles * | Surface Type | Condition / PCR |
|---|---|---|---|---|---|---|
| 0942 | Public | 6/26/2002 | 9096 | 0.16 | AS | GOOD / 90 |

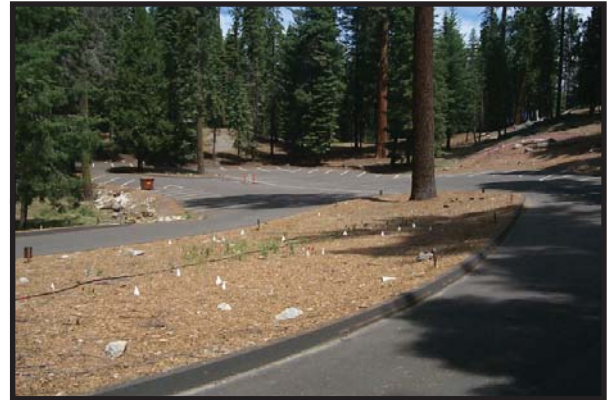
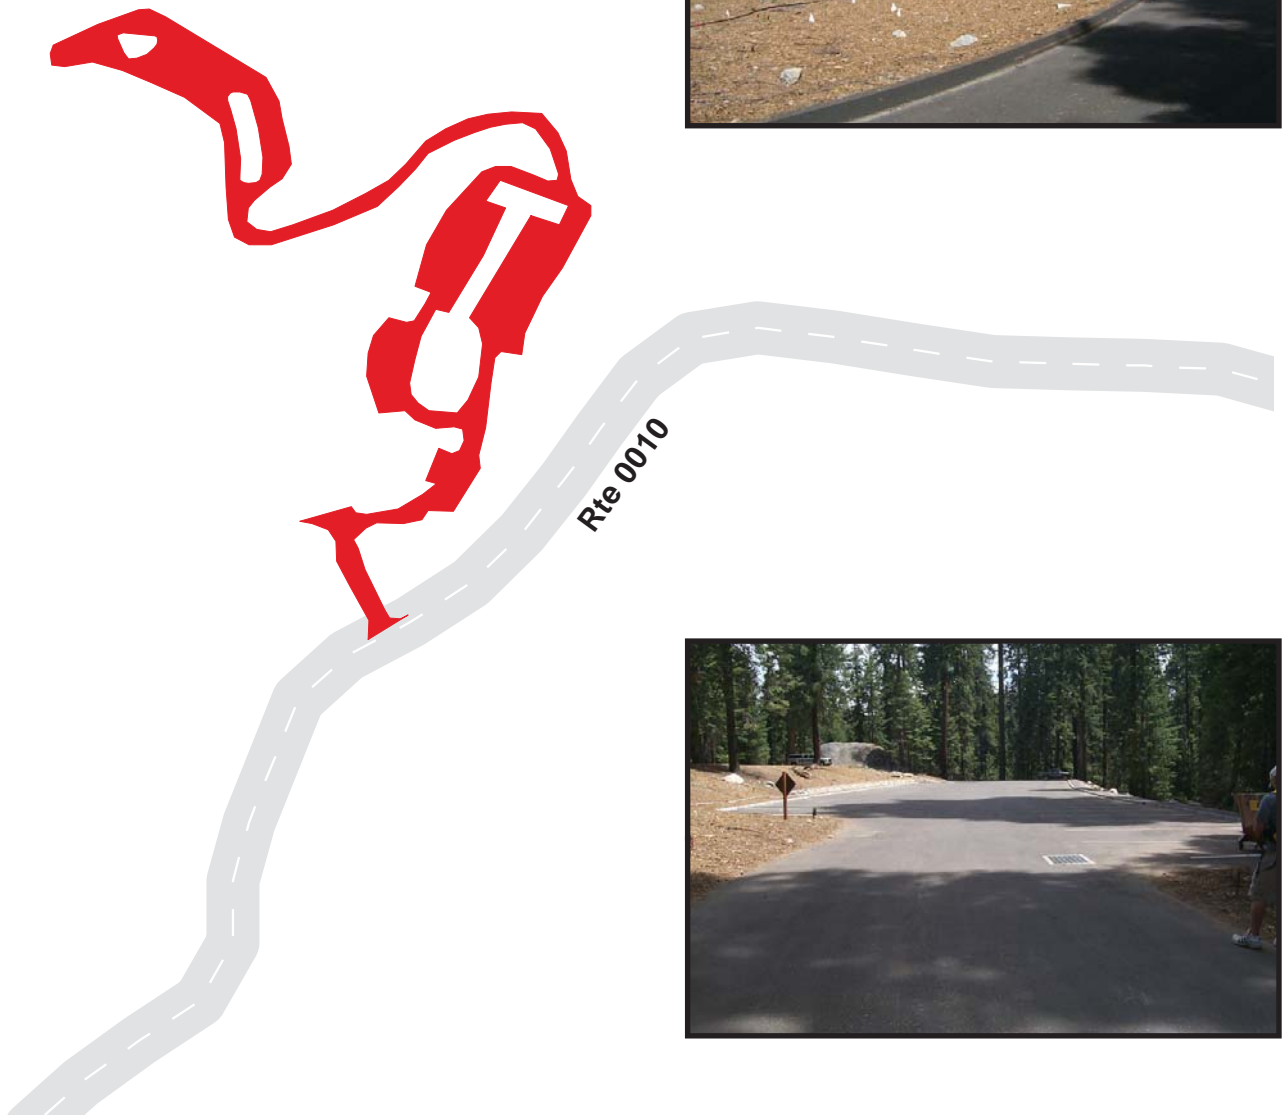
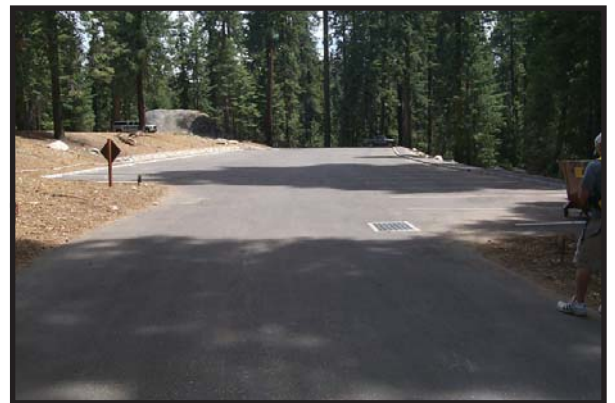
| Route | Public / NonPublic | Date Visited | Area (sq ft) | Lane Miles * | Surface Type | Condition / PCR |
|---|---|---|---|---|---|---|
| 0944 | Public | 6/26/2002 | 116096 | 2.00 | AS | EXCELLENT / 97 |

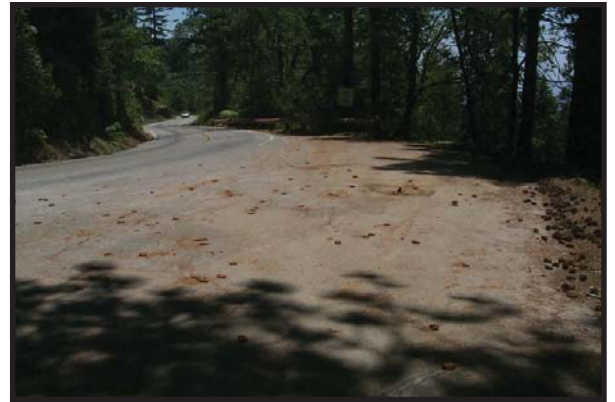
| Route | Public / NonPublic | Date Visited | Area (sq ft) | Lane Miles * | Surface Type | Condition / PCR |
|---|---|---|---|---|---|---|
| 0945 | Public | 6/28/2002 | 662 | 0.01 | AS | FAIR / 73 |

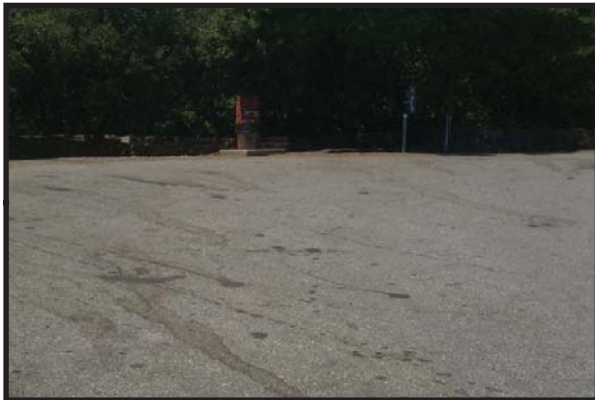
| Route | Public / NonPublic | Date Visited | Area (sq ft) | Lane Miles * | Surface Type | Condition / PCR |
|---|---|---|---|---|---|---|
| 0946 | Public | 6/26/2002 | 3344 | 0.06 | AS | GOOD / 90 |

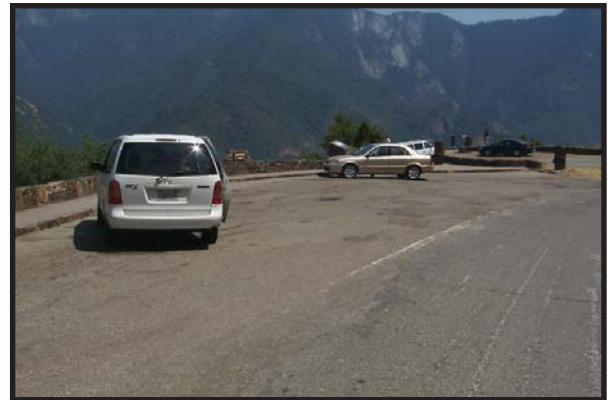
| Route | Public / NonPublic | Date Visited | Area (sq ft) | Lane Miles * | Surface Type | Condition / PCR |
|---|---|---|---|---|---|---|
| 0947 | Public | 6/26/2002 | 4942 | 0.09 | AS | POOR / 45 |

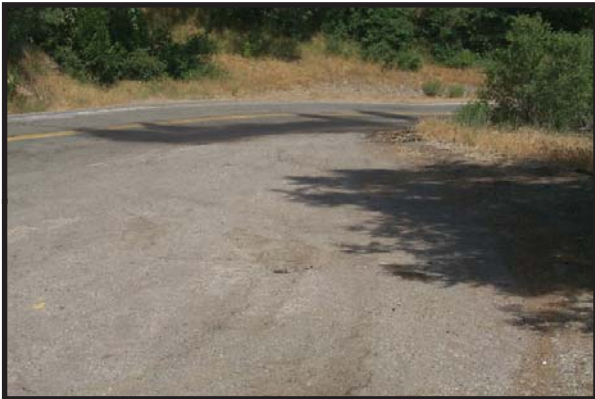
| Route | Public / NonPublic | Date Visited | Area (sq ft) | Lane Miles * | Surface Type | Condition / PCR |
|---|---|---|---|---|---|---|
| 0948A | Public | 6/26/2002 | 2829 | 0.05 | AS | FAIR / 73 |

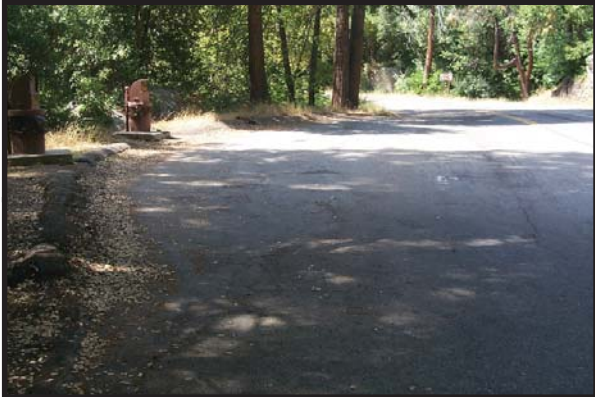
| Route | Public / NonPublic | Date Visited | Area (sq ft) | Lane Miles * | Surface Type | Condition / PCR |
|---|---|---|---|---|---|---|
| 0948B | Public | 6/26/2002 | 562 | 0.01 | AS | FAIR / 73 |

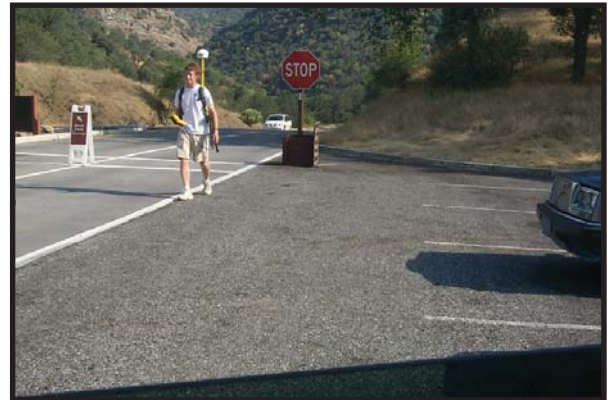
| Route | Public / NonPublic | Date Visited | Area (sq ft) | Lane Miles * | Surface Type | Condition / PCR |
|---|---|---|---|---|---|---|
| 0950 | Public | 6/26/2002 | 1824 | 0.03 | AS | GOOD / 90 |
