The Road Inventory of Sitka National Historical Park SITK – 9835

Prepared By:
Federal Highway Administration
Eastern Federal Lands Highway Division
Cycle 3

Sitka National Historical Park in Alaska

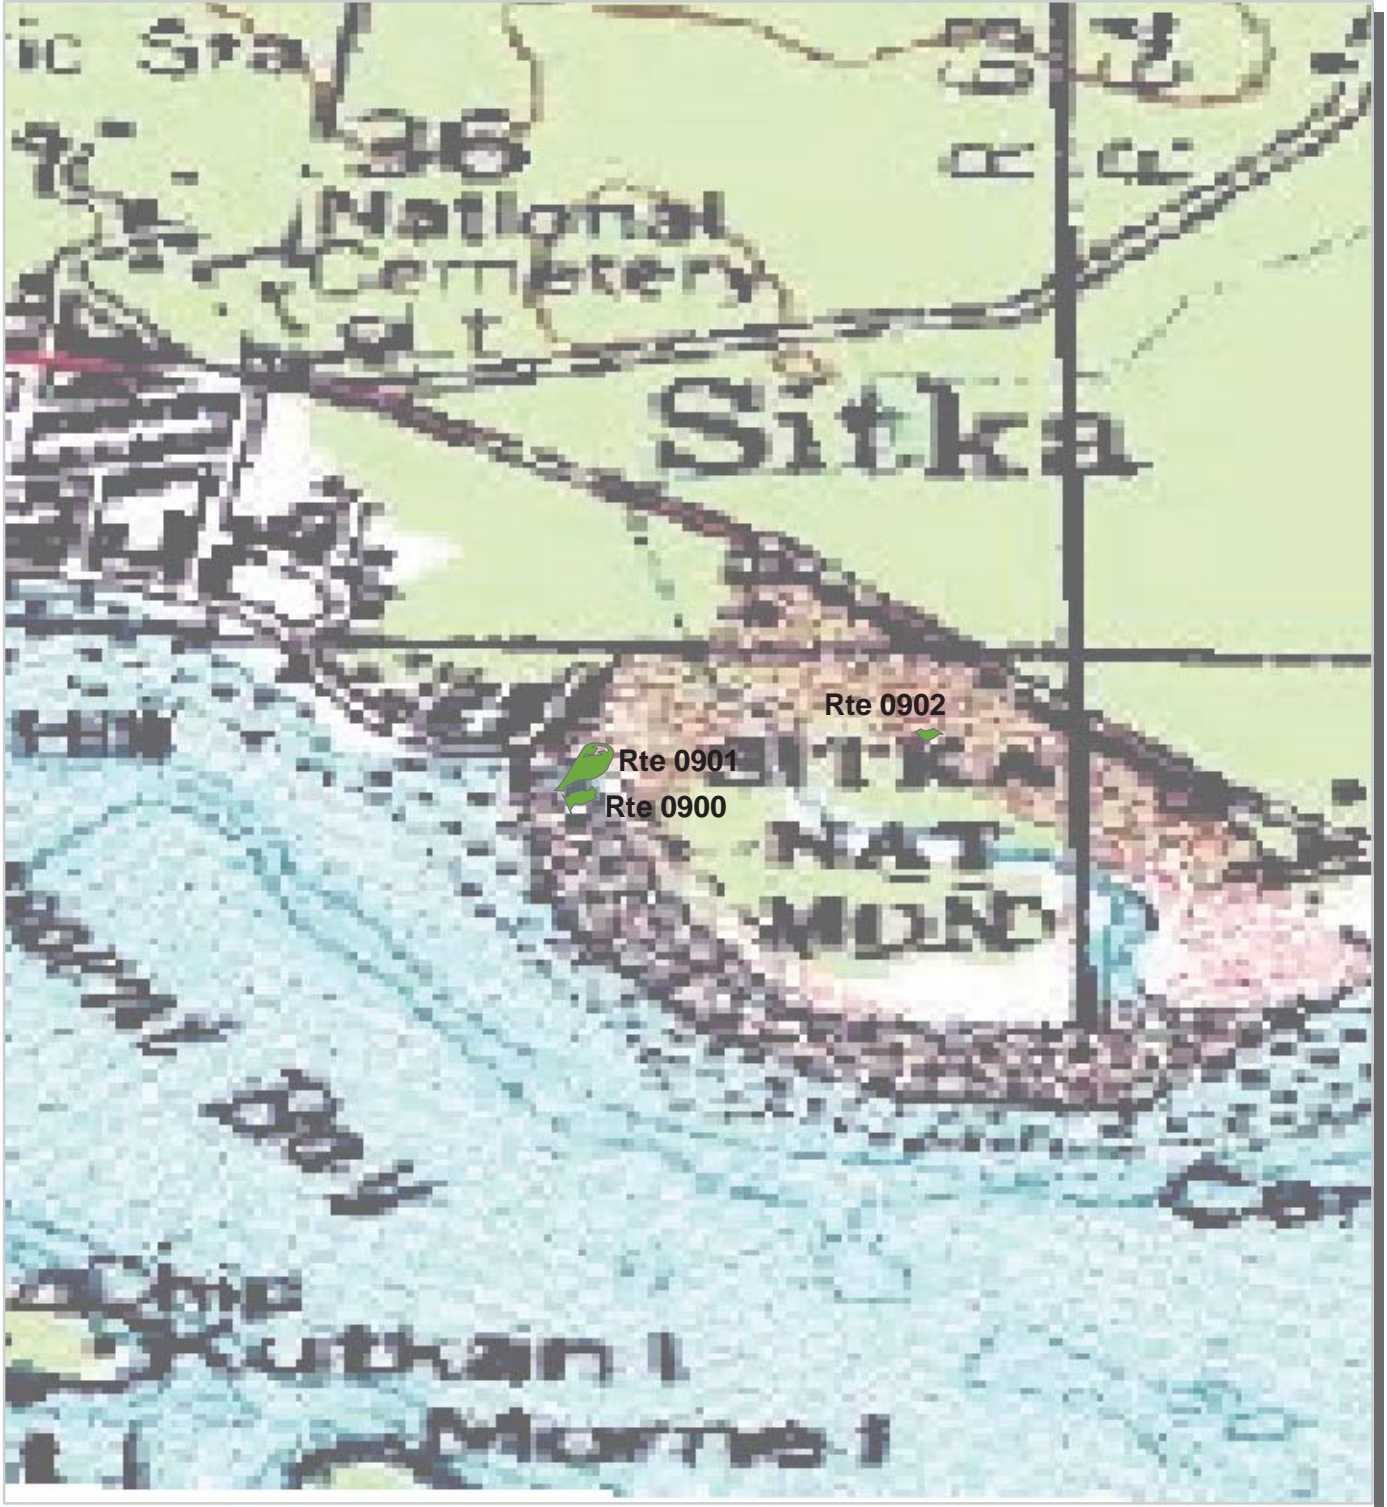
Sitka National Historical Park Route Condition Key Map PCR - Mile by Mile

PCR	Poor	Fair	Good	Excellent
	(≤ 60)	(61 - 84)	(85 - 94)	(95 - 100)

* If the PCR rating is not available for a section, the SCR rating will be displayed. See appendix for definitions and formulas.

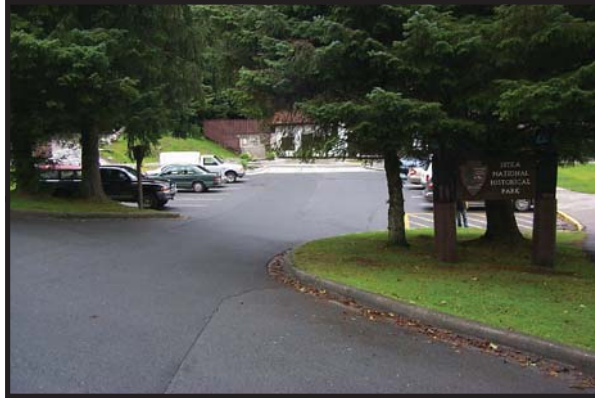
Route 0900

LOWER PARKING
FROM METLAKATLA STREET

Route	Public / NonPublic	Date Visited	Area (sq ft)	Lane Miles *	Surface Type	Condition / PCR
0900	Public	8/26/2002	6549	0.11	AS	GOOD / 90

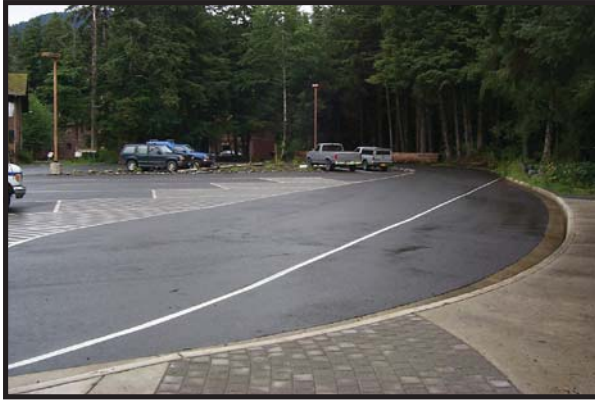
Route 0901

UPPER PARKING
FROM METLAKATLA STREET

Route	Public / NonPublic	Date Visited	Area (sq ft)	Lane Miles *	Surface Type	Condition / PCR
0901	Public	8/26/2002	20617	0.35	AS	GOOD / 90

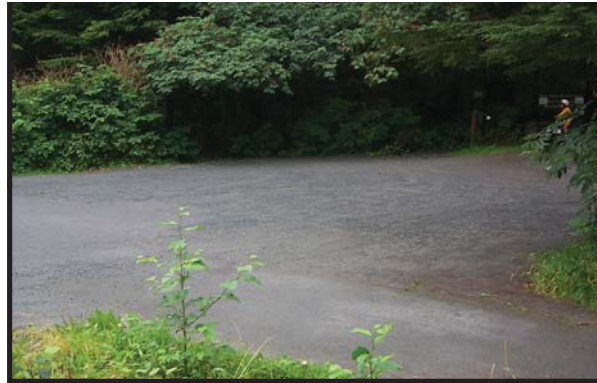
Route 0902

EAST ENTRANCE PARKING
FROM SAWMILL CREEK ROAD

Route	Public / NonPublic	Date Visited	Area (sq ft)	Lane Miles *	Surface Type	Condition / PCR
0902	Public	8/26/2002	3156	0.05	GR	N/A
