# The Road Inventory of Sleeping Bear Dunes National Lakeshore SLBE - 6620

## Road Inventory Program

Prepared By:  
Federal Highway Administration  
Eastern Federal Lands Highway Division  
Cycle 3

# Sleeping Bear Dunes National Lakeshore in Michigan

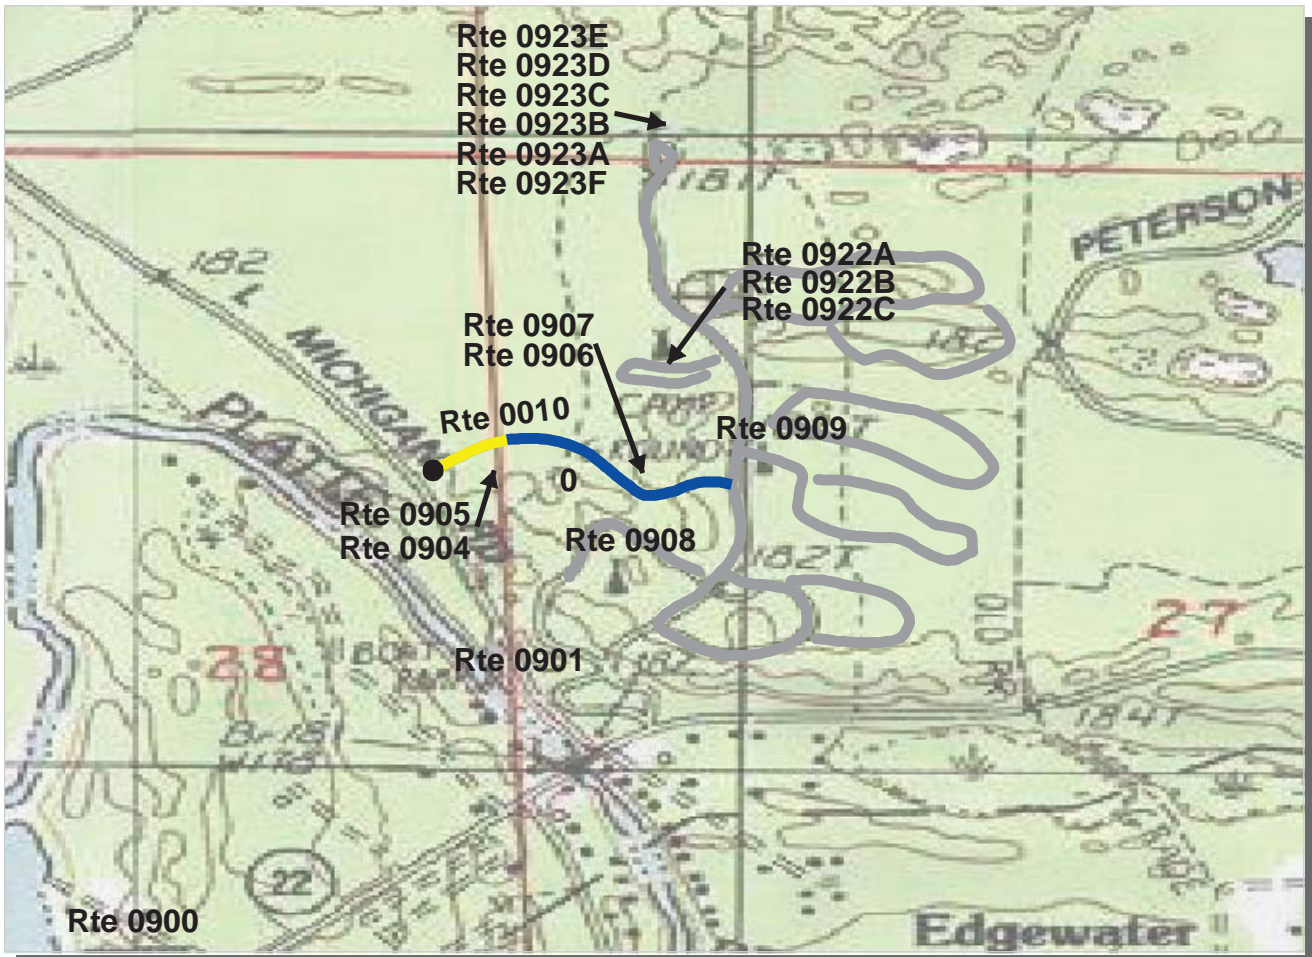
**ROUTE: 0012 Stocking Scenic Drive**

Section Number	0	1	2	3	4
Section Length (mi)	1.00	1.00	1.00	1.00	1.00
AADT	**				
SADT	**				
ADT Date	**				
<b>Cross Section Information</b>					
Number of Lanes	2	1	1	1	1
Paved Width (ft)	24	13	11	12	12
Lane Width (ft)	12	13	11	12	12
Shoulder Width (ft)	7	0	7	9	4
<b>Roadway Condition Information</b>					
PCR (Pavement Condition Rating)	86	81	77	82	79
RCI (Roughness Condition Index)	86	82	82	93	85
SCR (Surface Condition Rating)	86	80	74	74	74
Alligator Cracking Index	100	100	100	100	100
Rutting Index	86	80	74	74	74
Patching Index	100	100	100	100	100
Transverse Cracking Index	99	100	100	100	100
Longitudinal Cracking Index	100	100	99	100	100
Shoulder Condition Rating	GOOD	N/A	GOOD	GOOD	GOOD
Drainage Condition Rating	GOOD	GOOD	GOOD	GOOD	GOOD

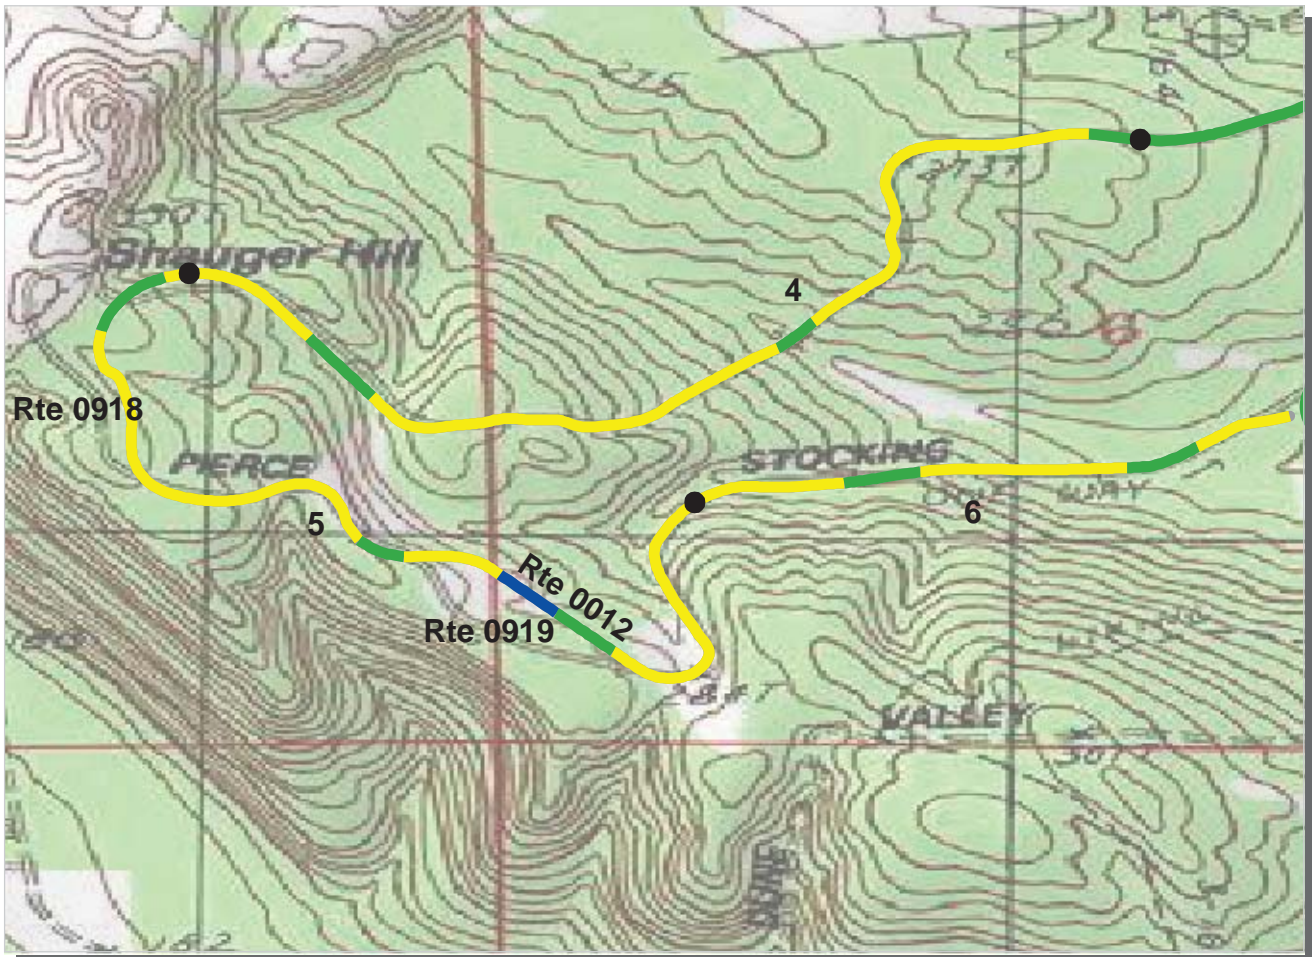
**ROUTE: 0012 Stocking Scenic Drive**

Section Number	5	6			
Section Length (mi)	1.00	0.50			
AADT	**				
SADT	**				
ADT Date	**				
<b>Cross Section Information</b>					
Number of Lanes	1	1			
Paved Width (ft)	11	11			
Lane Width (ft)	11	11			
Shoulder Width (ft)	9	6			
<b>Roadway Condition Information</b>					
PCR (Pavement Condition Rating)	79	78			
RCI (Roughness Condition Index)	88	92			
SCR (Surface Condition Rating)	73	71			
Alligator Cracking Index	100	100			
Rutting Index	73	71			
Patching Index	100	100			
Transverse Cracking Index	99	100			
Longitudinal Cracking Index	100	100			
Shoulder Condition Rating	GOOD	GOOD			
Drainage Condition Rating	GOOD	GOOD

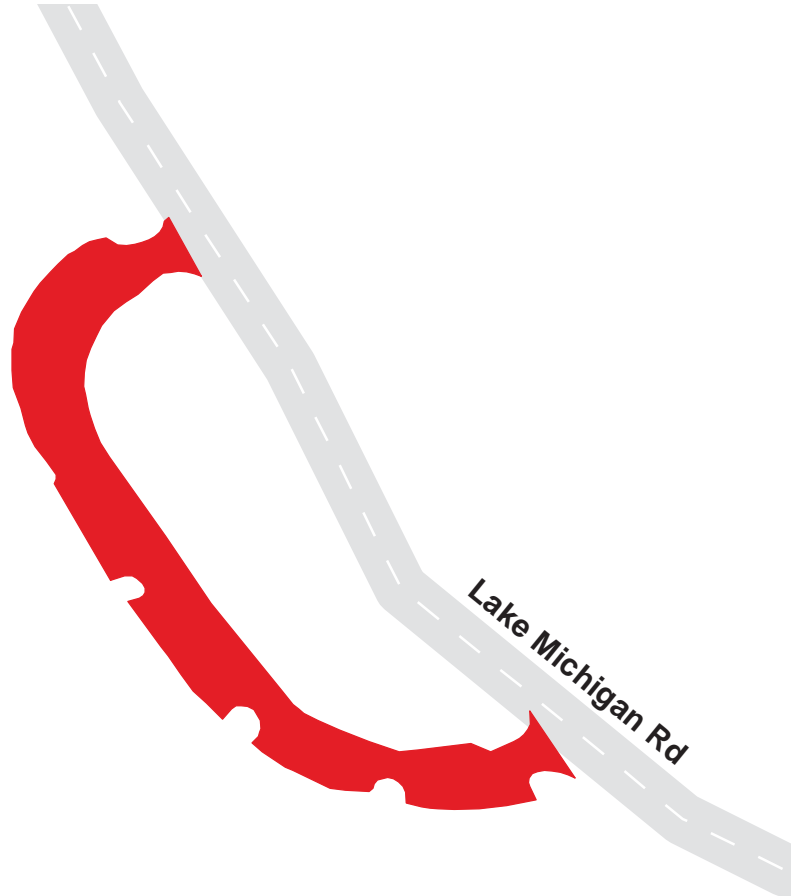
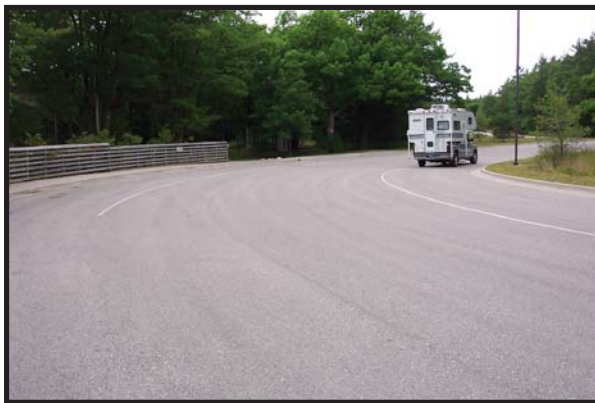
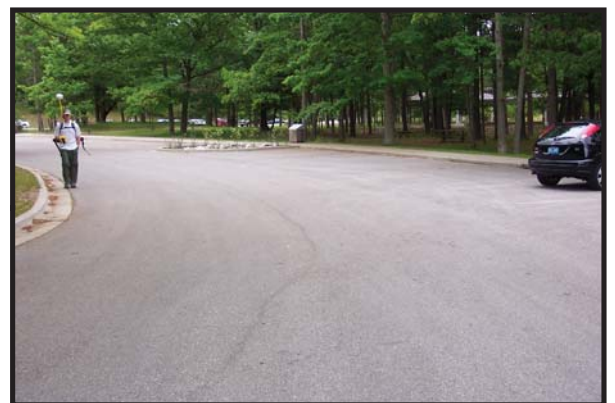
## Route 0901

Route	Public / NonPublic	Date Visited	Area (sq ft)	Lane Miles *	Surface Type	Condition / PCR
0901	Public	6/29/2003	27328	0.47	AS	GOOD / 90

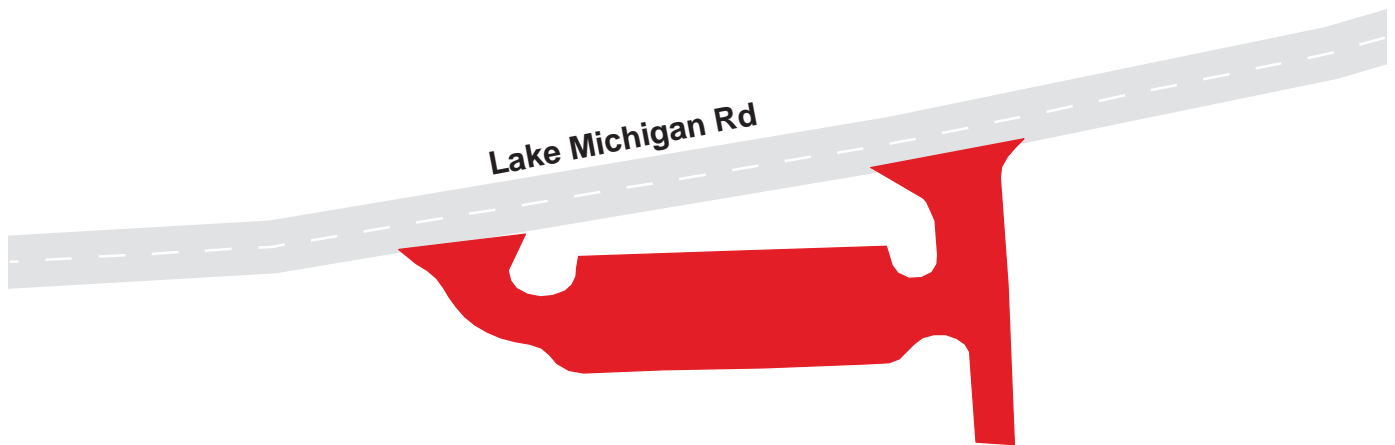
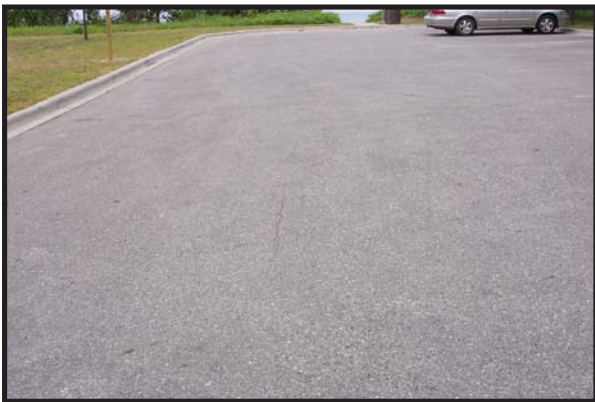
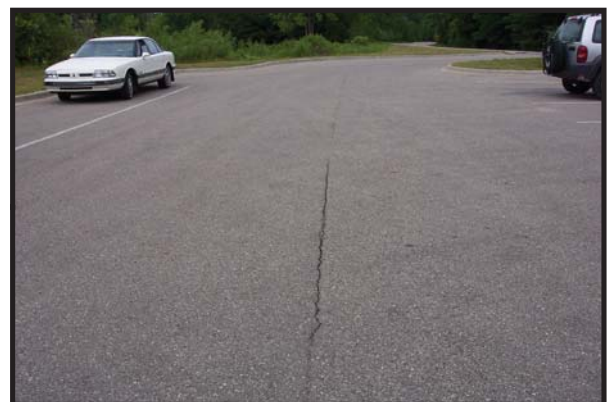
## Route 0902

Route	Public / NonPublic	Date Visited	Area (sq ft)	Lane Miles *	Surface Type	Condition / PCR
0902	Public	6/29/2003	10774	0.19	AS	FAIR / 73

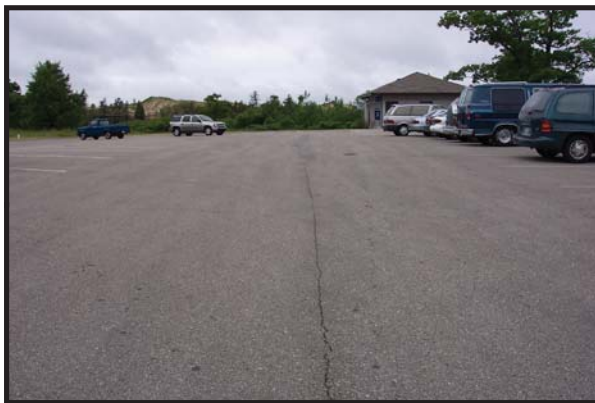
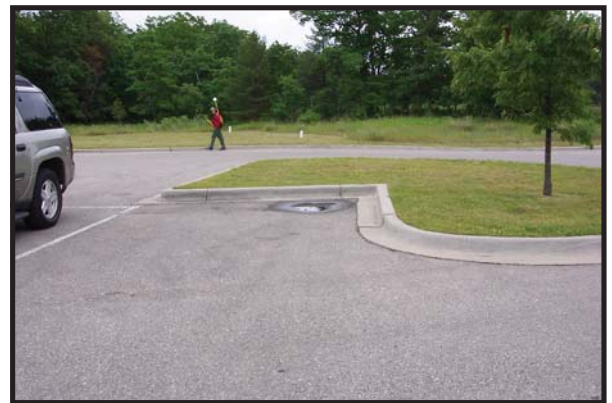
## Route 0903A

Route	Public / NonPublic	Date Visited	Area (sq ft)	Lane Miles *	Surface Type	Condition / PCR
0903A	Public	6/29/2003	32615	0.56	AS	GOOD / 90

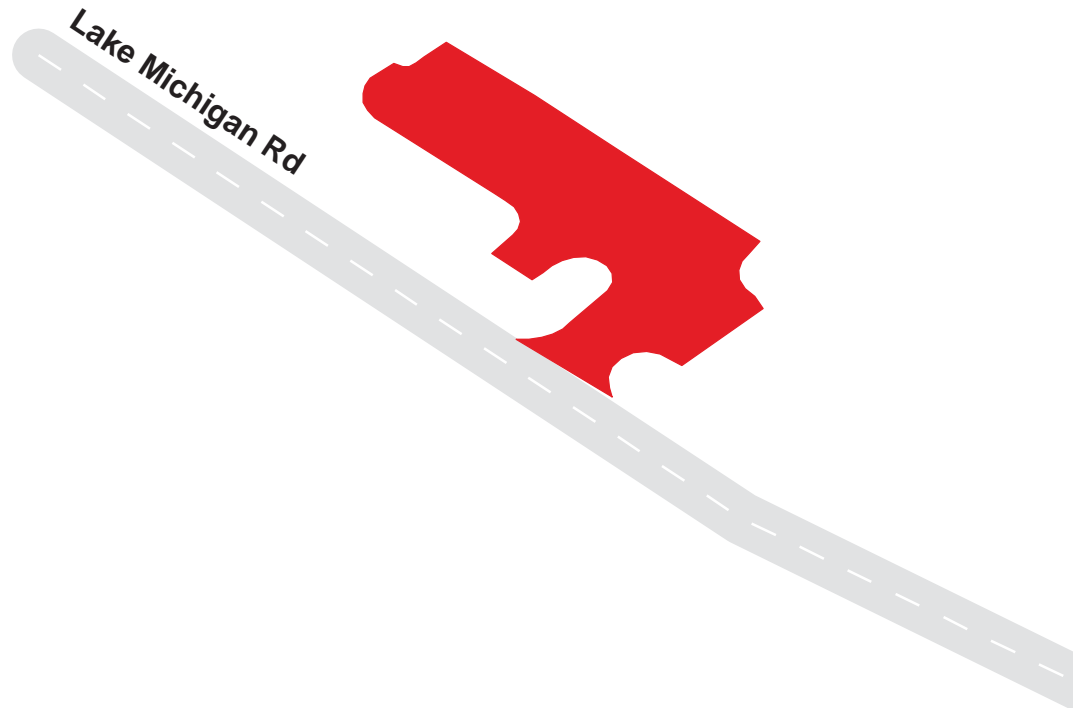
## Route 0903B

Route	Public / NonPublic	Date Visited	Area (sq ft)	Lane Miles *	Surface Type	Condition / PCR
0903B	Public	6/29/2003	8297	0.14	AS	GOOD / 90

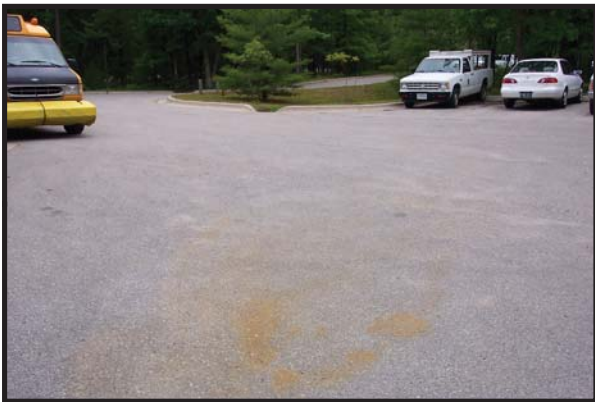
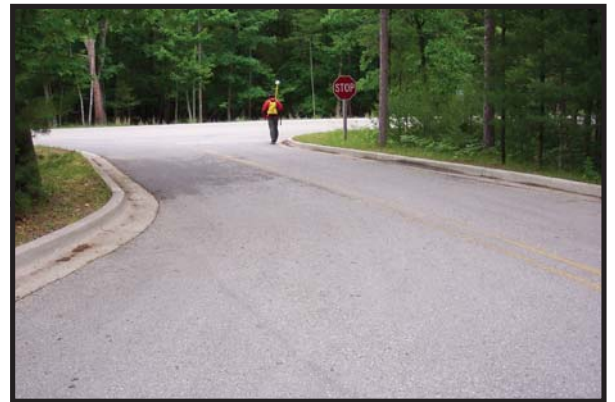
## Route 0904

Route	Public / NonPublic	Date Visited	Area (sq ft)	Lane Miles *	Surface Type	Condition / PCR
0904	NonPublic	6/29/2003	8733	0.15	AS	GOOD / 90

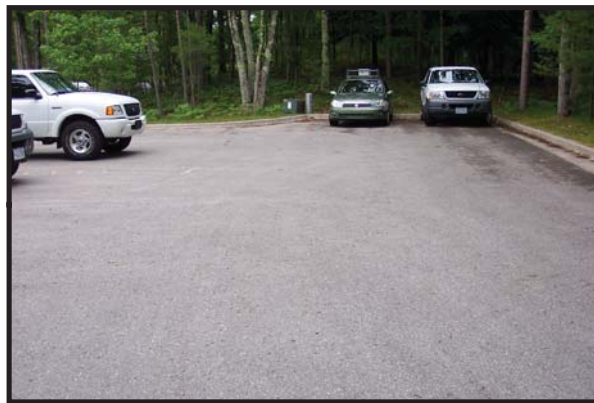
## Route 0906

Route	Public / NonPublic	Date Visited	Area (sq ft)	Lane Miles *	Surface Type	Condition / PCR
0906	Public	6/29/2003	11165	0.19	AS	FAIR / 73

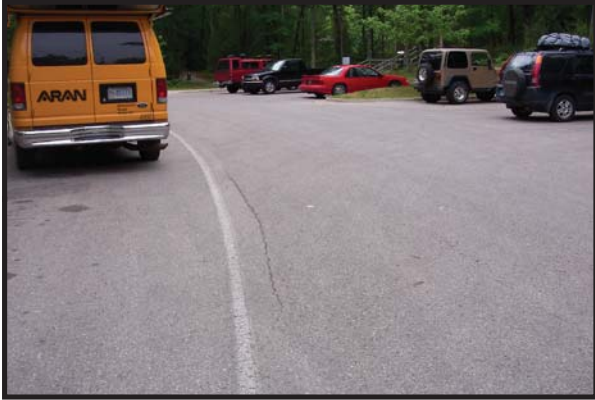
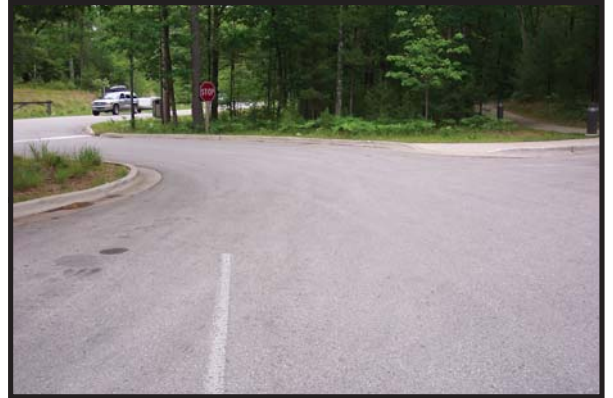
## Route 0907

Route	Public / NonPublic	Date Visited	Area (sq ft)	Lane Miles *	Surface Type	Condition / PCR
0907	Public	6/29/2003	8740	0.15	AS	GOOD / 90

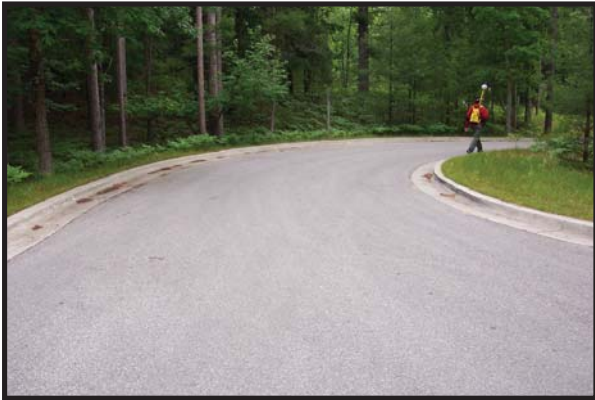
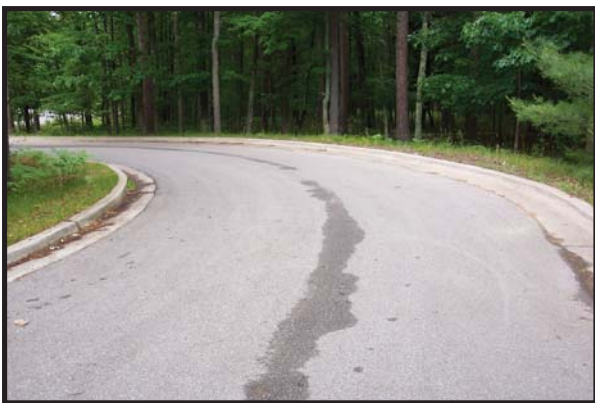
## Route 0908

Route	Public / NonPublic	Date Visited	Area (sq ft)	Lane Miles *	Surface Type	Condition / PCR
0908	Public	6/29/2003	2285	0.04	AS	GOOD / 90

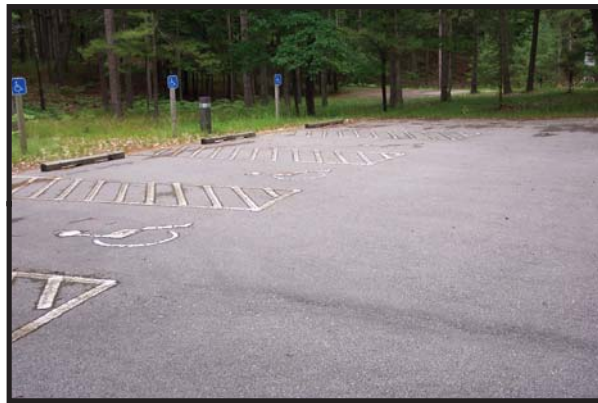
## Route 0909

Route	Public / NonPublic	Date Visited	Area (sq ft)	Lane Miles *	Surface Type	Condition / PCR
0909	Public	6/29/2003	904	0.02	AS	GOOD / 90

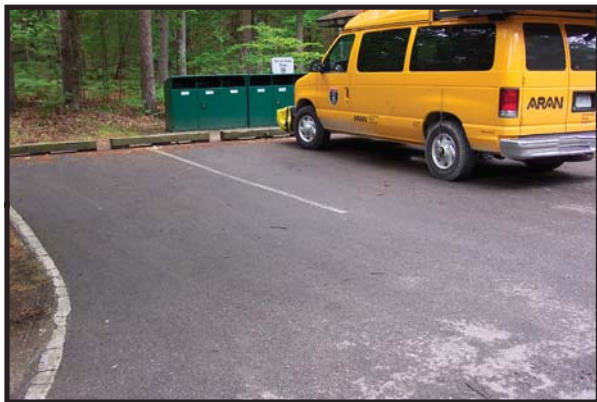
## Route 0910A

Route	Public / NonPublic	Date Visited	Area (sq ft)	Lane Miles *	Surface Type	Condition / PCR
0910A	NonPublic	6/30/2003	74696	1.29	AS	POOR / 45

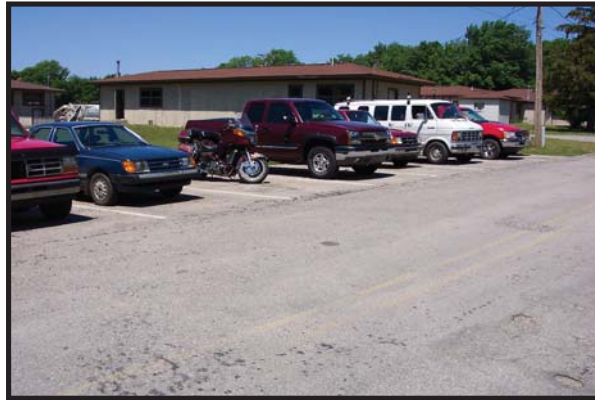
## Route 0910C

Route	Public / NonPublic	Date Visited	Area (sq ft)	Lane Miles *	Surface Type	Condition / PCR
0910C	NonPublic	6/30/2003	1471	0.03	AS	FAIR / 73

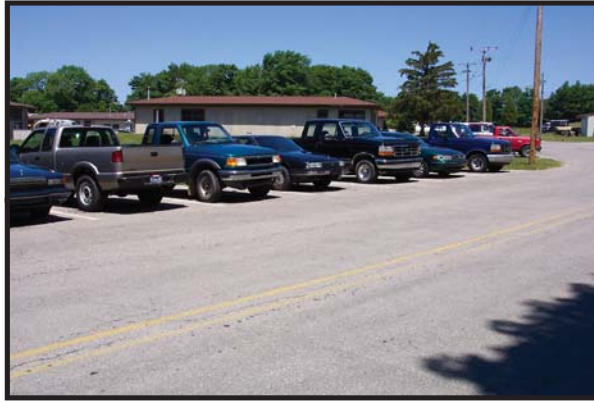
## Route 0910D

Route	Public / NonPublic	Date Visited	Area (sq ft)	Lane Miles *	Surface Type	Condition / PCR
0910D	NonPublic	6/30/2003	1069	0.02	AS	FAIR / 73

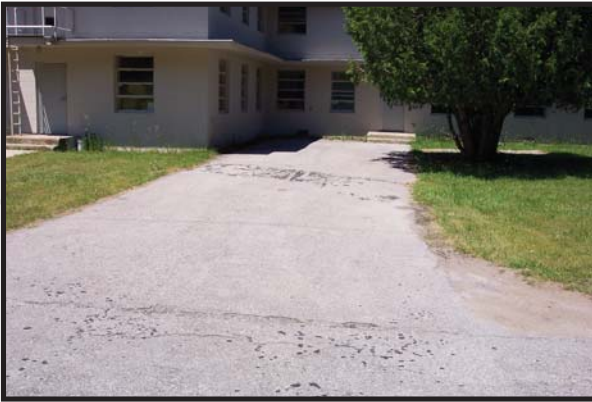
## Route 0910E

Route	Public / NonPublic	Date Visited	Area (sq ft)	Lane Miles *	Surface Type	Condition / PCR
0910E	NonPublic	6/30/2003	1235	0.02	AS	FAIR / 73

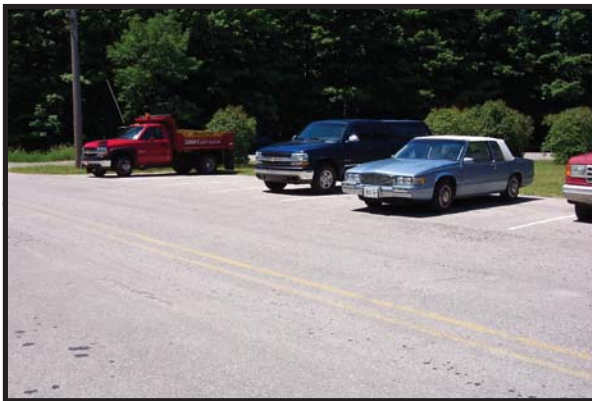
## Route 0911

Route	Public / NonPublic	Date Visited	Area (sq ft)	Lane Miles *	Surface Type	Condition / PCR
0911	Public	6/29/2003	44944	0.77	OC	GOOD / 90

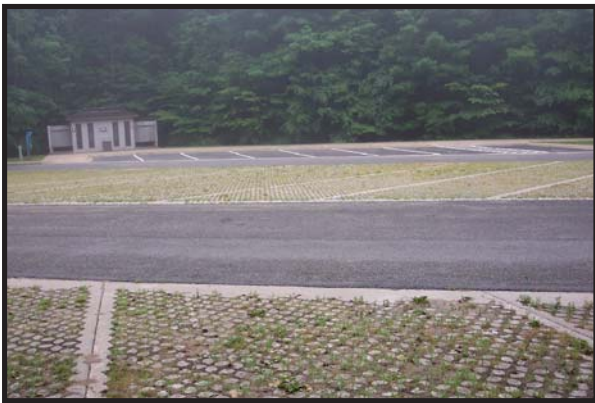
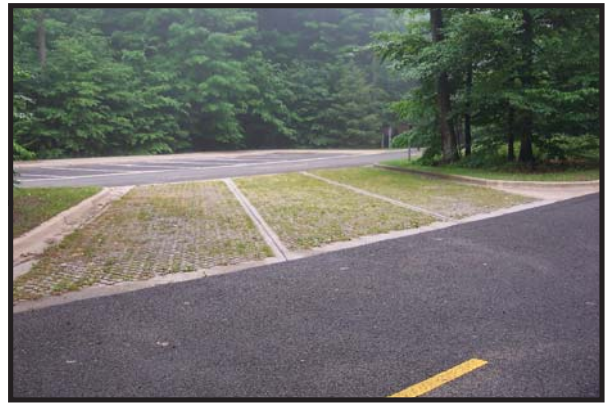
## Route 0913

Route	Public / NonPublic	Date Visited	Area (sq ft)	Lane Miles *	Surface Type	Condition / PCR
0913	Public	6/29/2003	5296	0.09	OC	GOOD / 90

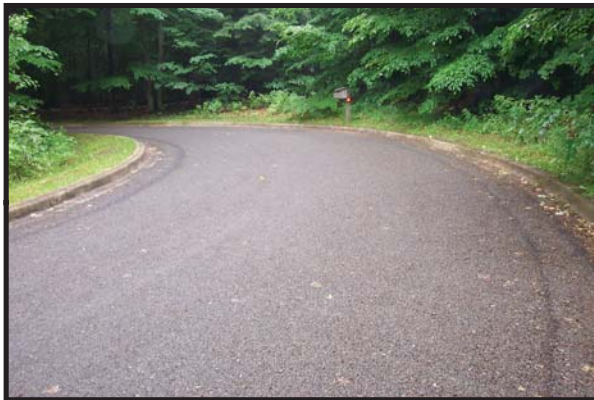
## Route 0914

Route	Public / NonPublic	Date Visited	Area (sq ft)	Lane Miles *	Surface Type	Condition / PCR
0914	Public	6/29/2003	17383	0.30	OC	GOOD / 90

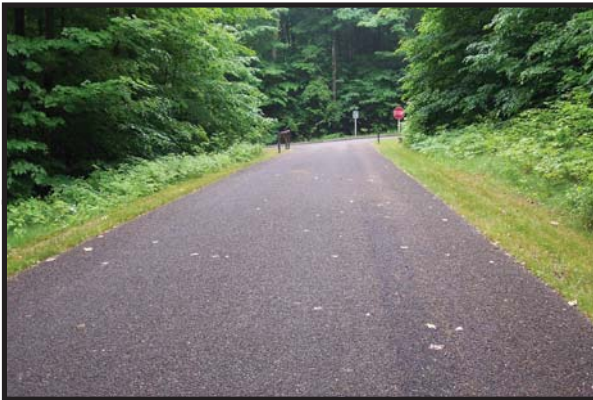
## Route 0918

Route	Public / NonPublic	Date Visited	Area (sq ft)	Lane Miles *	Surface Type	Condition / PCR
0918	Public	6/29/2003	29384	0.51	OC	GOOD / 90

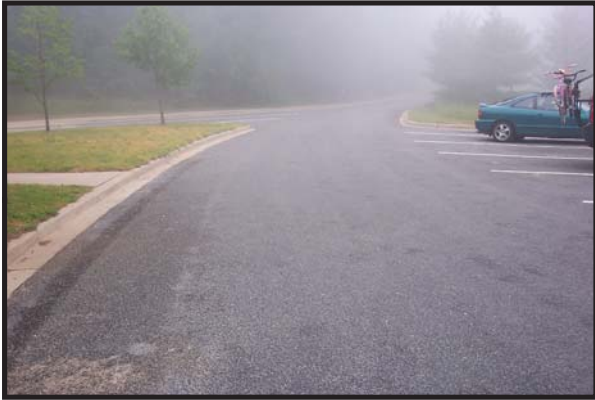
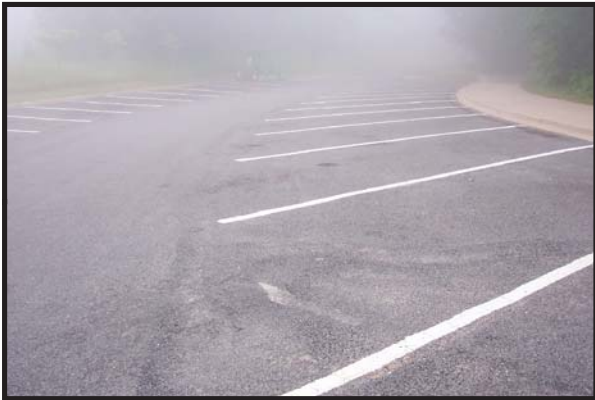
## Route 0919

Route	Public / NonPublic	Date Visited	Area (sq ft)	Lane Miles *	Surface Type	Condition / PCR
0919	Public	6/29/2003	28433	0.49	OC	GOOD / 90

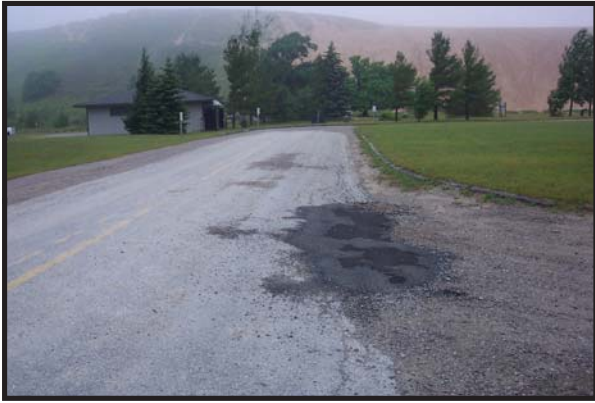
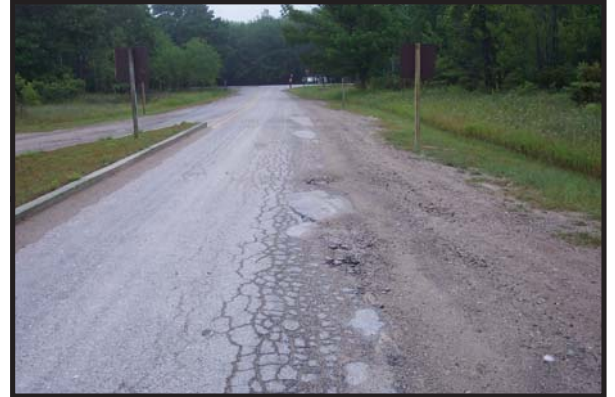
## Route 0920A

Route	Public / NonPublic	Date Visited	Area (sq ft)	Lane Miles *	Surface Type	Condition / PCR
0920A	Public	6/29/2003	13972	0.24	AS	POOR / 45

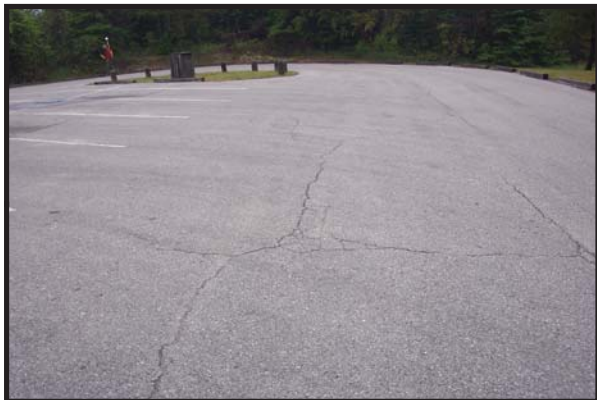
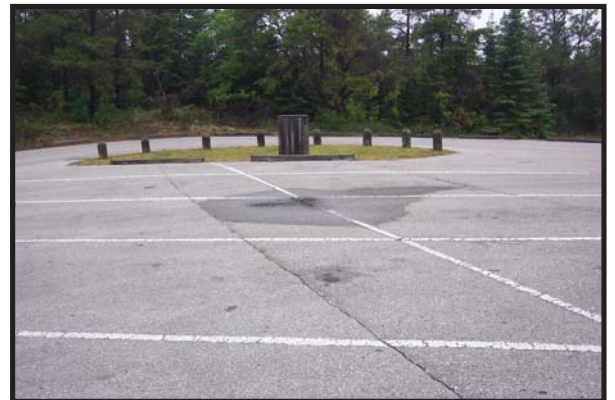
## Route 0922A

Route	Public / NonPublic	Date Visited	Area (sq ft)	Lane Miles *	Surface Type	Condition / PCR
0922A	Public	6/29/2003	2102	0.04	AS	GOOD / 90

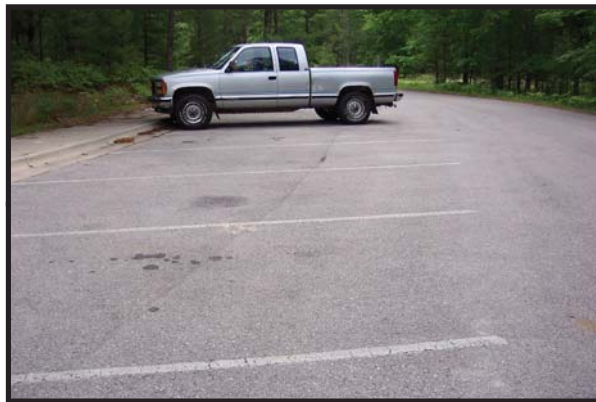
## Route 0922B

Route	Public / NonPublic	Date Visited	Area (sq ft)	Lane Miles *	Surface Type	Condition / PCR
0922B	Public	6/29/2003	2261	0.04	AS	GOOD / 90

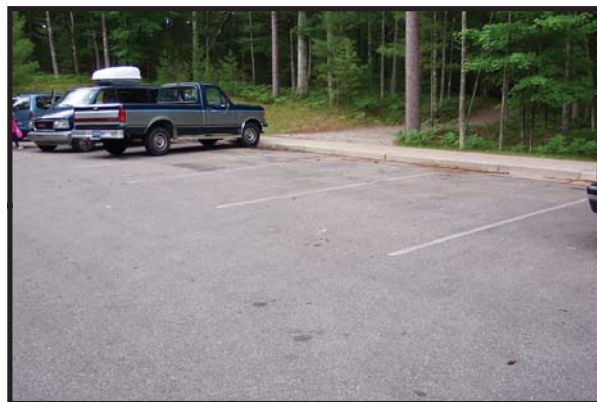
## Route 0922C

Route	Public / NonPublic	Date Visited	Area (sq ft)	Lane Miles *	Surface Type	Condition / PCR
0922C	Public	6/29/2003	2427	0.04	AS	GOOD / 90

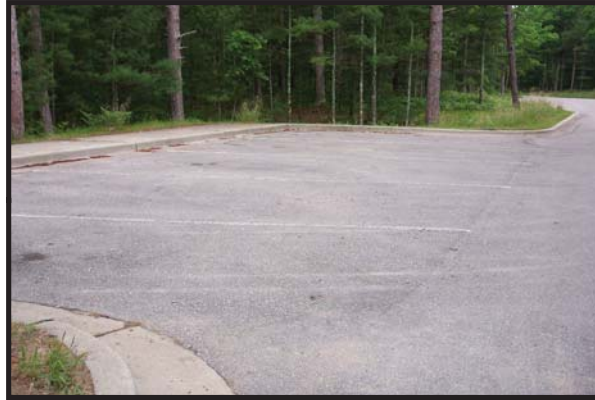
Route	Public / NonPublic	Date Visited	Area (sq ft)	Lane Miles *	Surface Type	Condition / PCR
0923A	Public	6/29/2003	742	0.01	AS	GOOD / 90

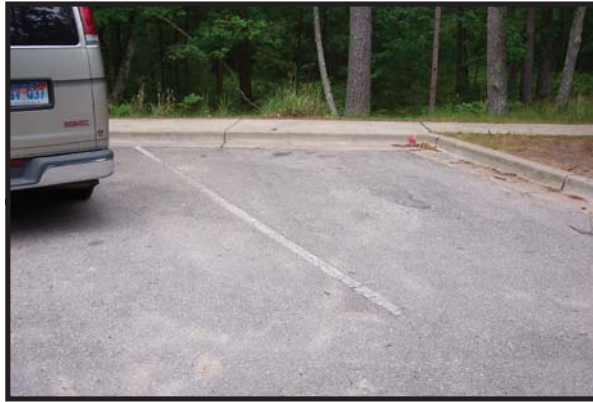
Route	Public / NonPublic	Date Visited	Area (sq ft)	Lane Miles *	Surface Type	Condition / PCR
0923B	Public	6/29/2003	1033	0.02	AS	GOOD / 90

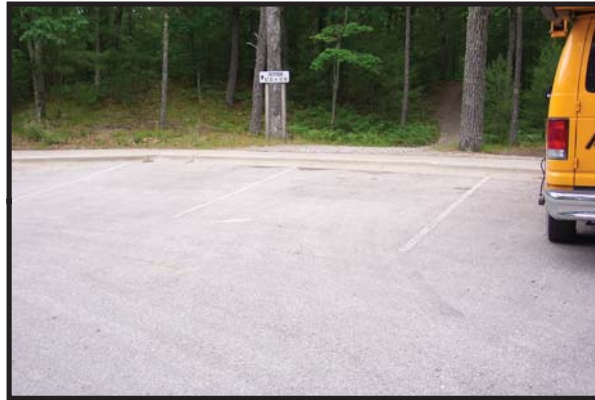
## Route 0923C

Route	Public / NonPublic	Date Visited	Area (sq ft)	Lane Miles *	Surface Type	Condition / PCR
0923C	Public	6/29/2003	1025	0.02	AS	GOOD / 90

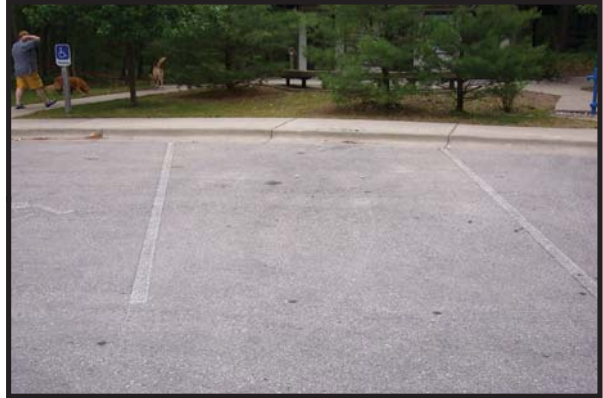
## Route 0923D

Route	Public / NonPublic	Date Visited	Area (sq ft)	Lane Miles *	Surface Type	Condition / PCR
0923D	Public	6/29/2003	1077	0.02	AS	GOOD / 90

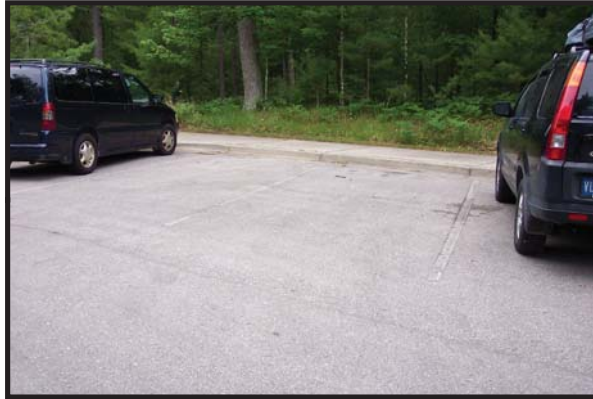
## Route 0923E

Route	Public / NonPublic	Date Visited	Area (sq ft)	Lane Miles *	Surface Type	Condition / PCR
0923E	Public	6/29/2003	790	0.01	AS	GOOD / 90
