The Road Inventory
of
Springfield Armory National Historic Site
SPAR - 1930

Road Inventory Program

Prepared By:
Federal Highway Administration
Eastern Federal Lands Highway Division
Cycle 3

Springfield Armory National Historic Site in Massachusetts

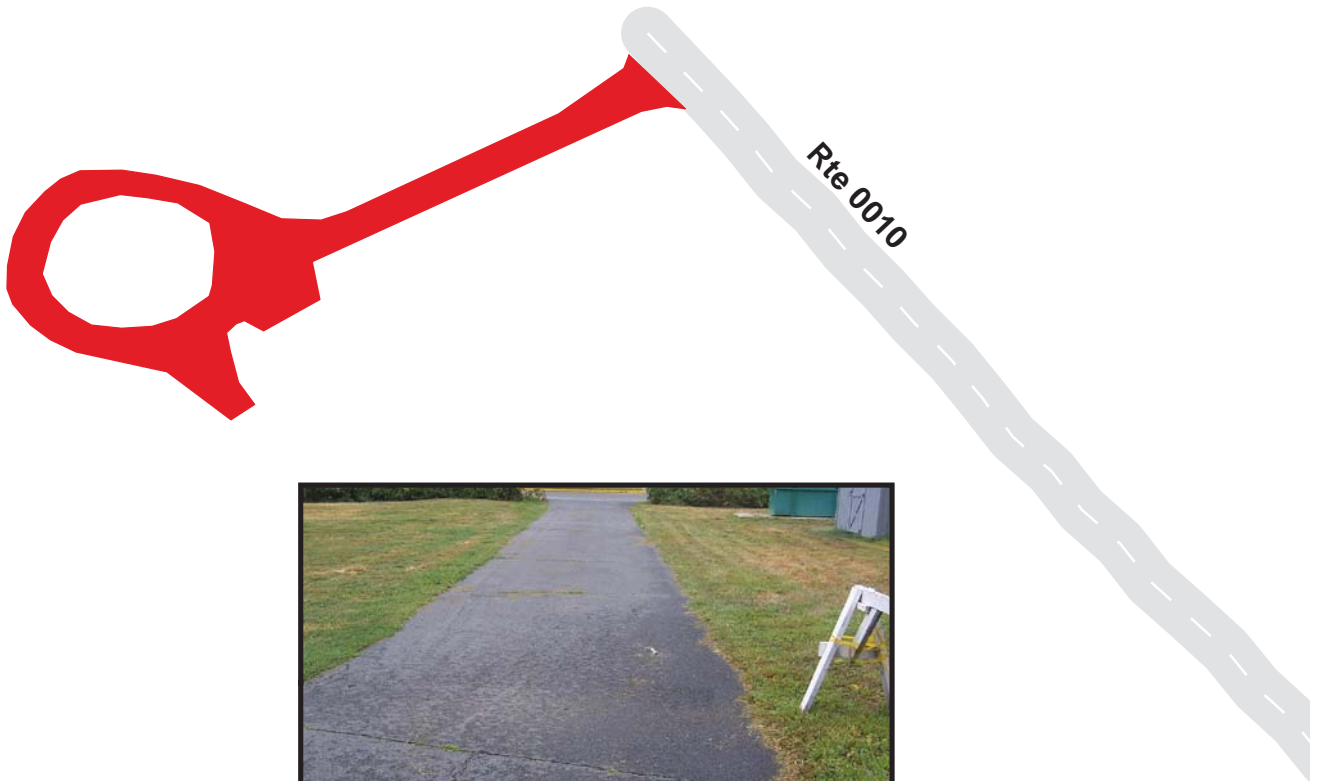
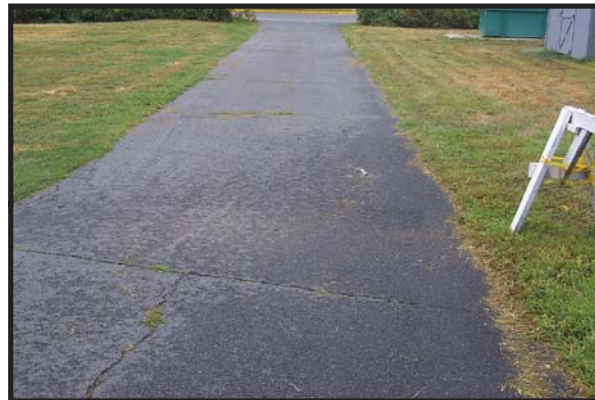
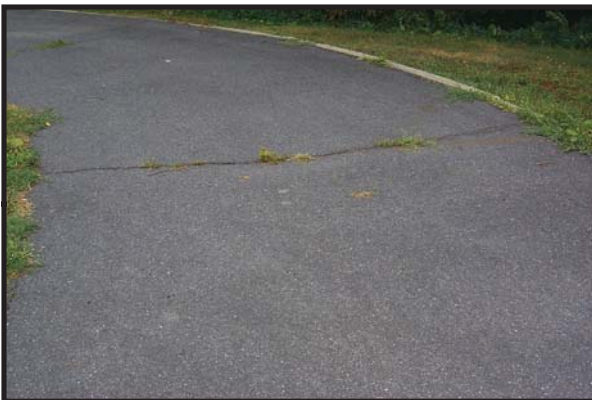
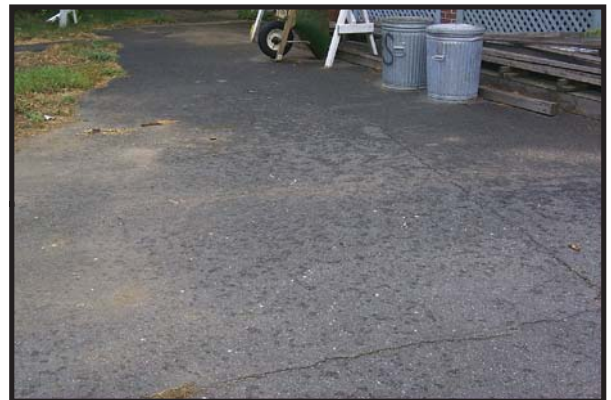
Route 0901

Route	Public / NonPublic	Date Visited	Area (sq ft)	Lane Miles *	Surface Type	Condition / PCR
0901	NonPublic	8/23/2002	4401	0.08	AS	FAIR / 73
