The Road Inventory of Steamtown National Historic Site STEAM – 4810

Road Inventory Program

Prepared By:
Federal Highway Administration
Eastern Federal Lands Highway Division
Cycle 3

Steamtown National Historic Site in Pennsylvania

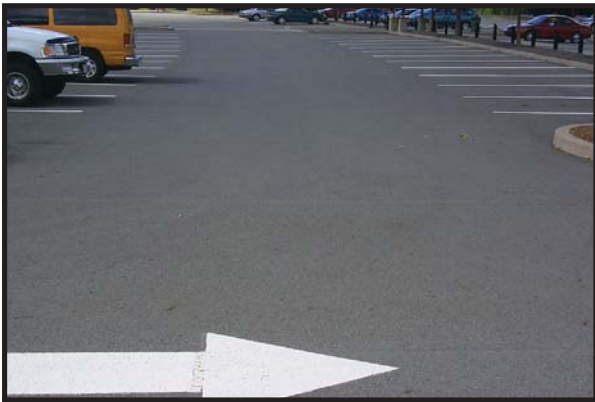
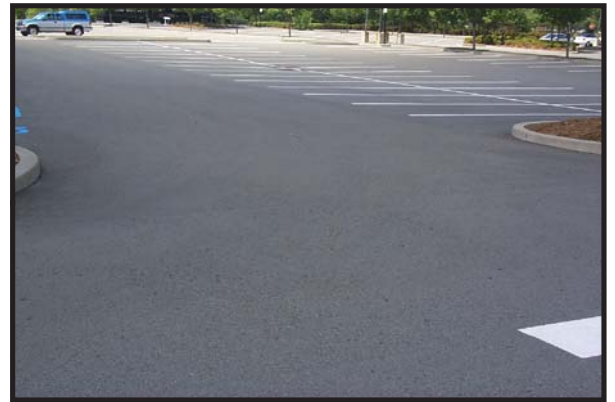
Route 0900

VISITOR CENTER PARKING
From Lackawanna Avenue

Route	Public / NonPublic	Date Visited	Area (sq ft)	Lane Miles *	Surface Type	Condition / PCR
0900	Public	8/7/2002	218497	3.76	AS	GOOD / 90

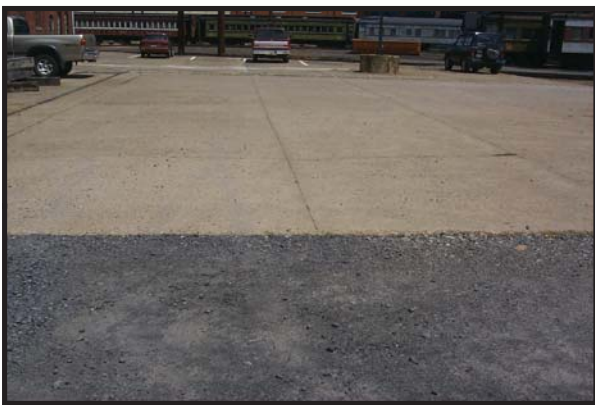
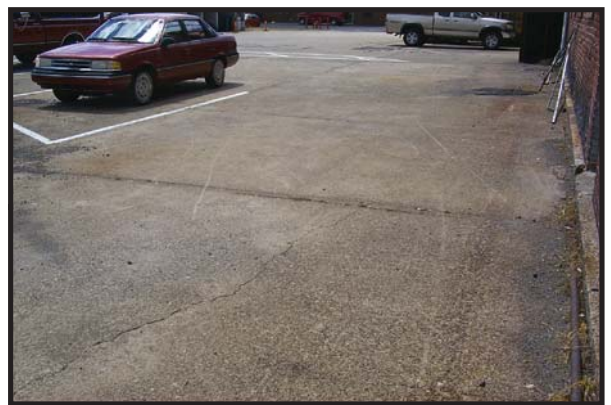
Steamtown National Historic Site
Route 0902A
 LOCOMOTIVE SHOP EMPLOYEE PARKING
 From Route 0903

Route	Public / NonPublic	Date Visited	Area (sq ft)	Lane Miles *	Surface Type	Condition / PCR
0902A	NonPublic	8/7/2002	7782	0.13	CO	FAIR / 73

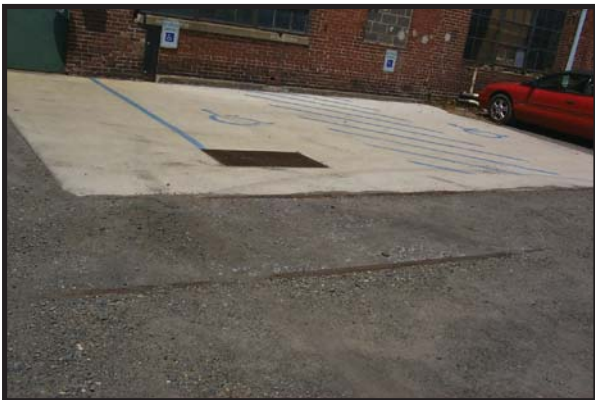
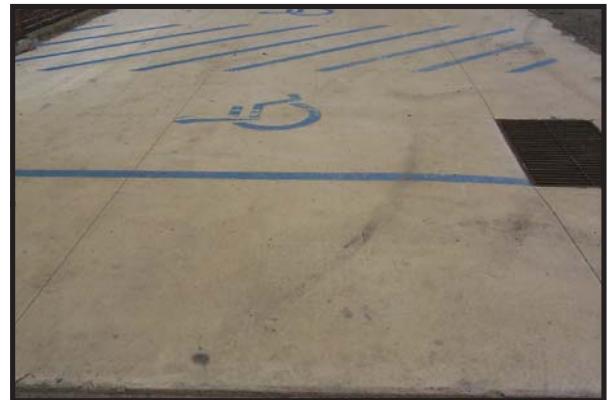
Steamtown National Historic Site
Route 0902B
 LOCOMOTIVE SHOP EMPLOYEE PARKING
 From Route 0903

Route	Public / NonPublic	Date Visited	Area (sq ft)	Lane Miles *	Surface Type	Condition / PCR
0902B	NonPublic	8/7/2002	434	0.01	CO	GOOD / 90

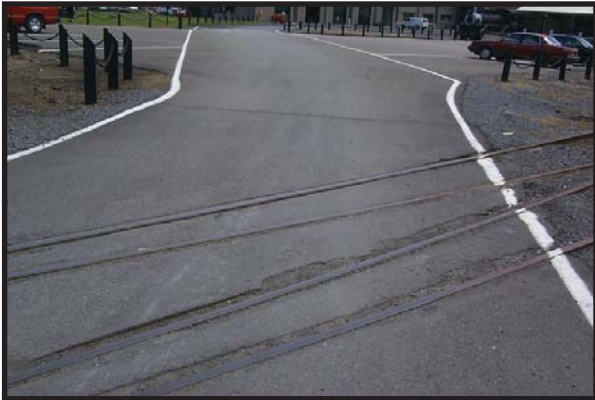
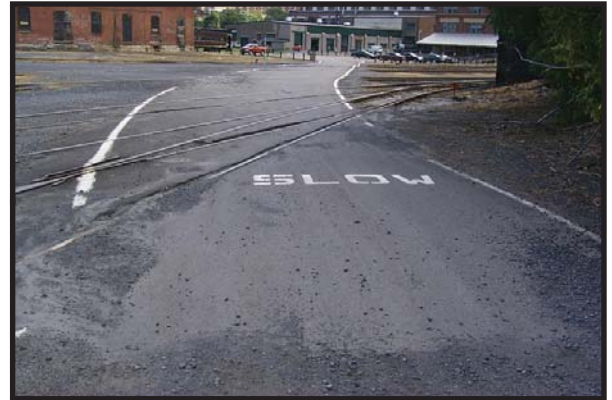
Steamtown National Historic Site
Route 0906
 OFFICE AND STORAGE BUILDING PARKING
 From Route 0400

Route	Public / NonPublic	Date Visited	Area (sq ft)	Lane Miles *	Surface Type	Condition / PCR
0906	NonPublic	8/7/2002	18693	0.32	AS	GOOD / 90

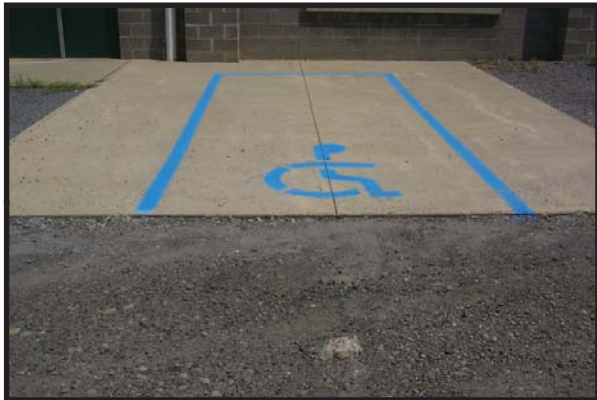
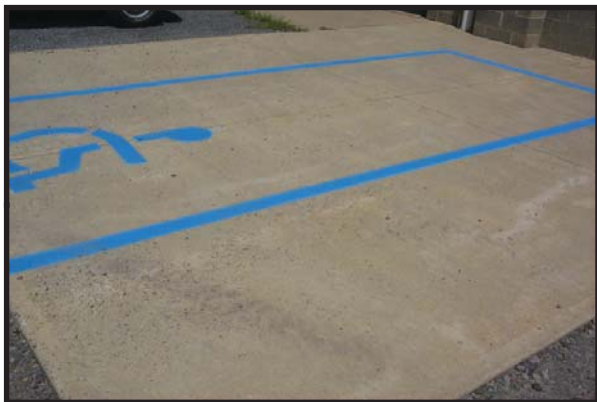
Route 0908

MAINTENANCE AREA HANDICAPPED PARKING
From Route 0907

Route	Public / NonPublic	Date Visited	Area (sq ft)	Lane Miles *	Surface Type	Condition / PCR
0908	Public	8/7/2002	369	0.01	CO	GOOD / 90
