The Road Inventory of Stones River National Battlefield STRI - 5590

Road Inventory Program

Prepared By:
Federal Highway Administration
Eastern Federal Lands Highway Division
Cycle 3

Stones River National Battlefield in Tennessee

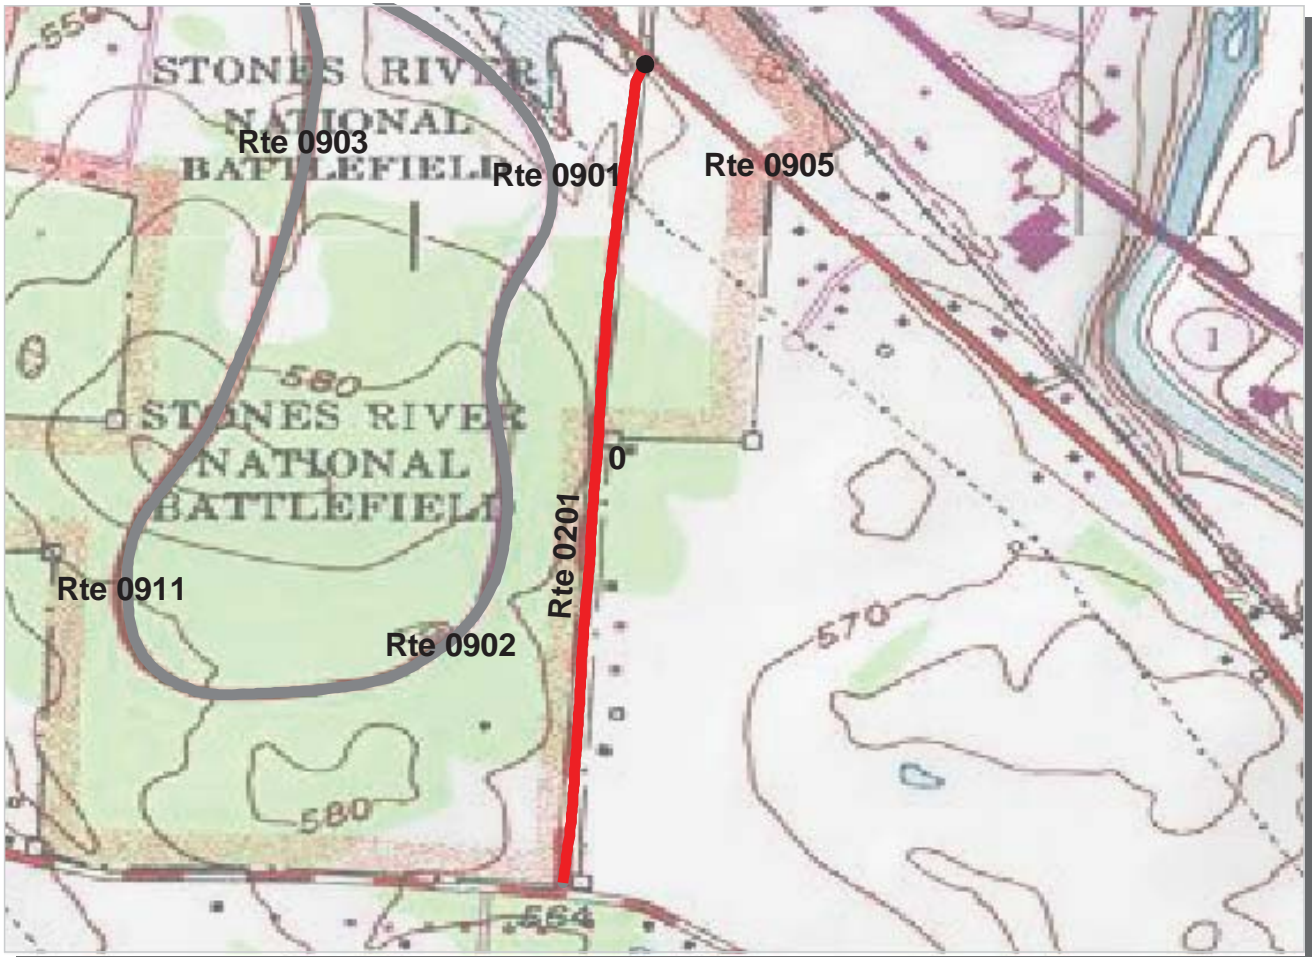
Section Number	0				
Section Length (mi)	0.84				
AADT	**				
SADT	**				
ADT Date	**				
Cross Section Information					
Number of Lanes	2				
Paved Width (ft)	17				
Lane Width (ft)	9				
Shoulder Width (ft)	4				
Roadway Condition Information					
PCR (Pavement Condition Rating)	36				
RCI (Roughness Condition Index)	62				
SCR (Surface Condition Rating)	26				
Alligator Cracking Index	86				
Rutting Index	40				
Patching Index	98				
Transverse Cracking Index	98				
Longitudinal Cracking Index	97				
Shoulder Condition Rating	N/C				
Drainage Condition Rating	N/C

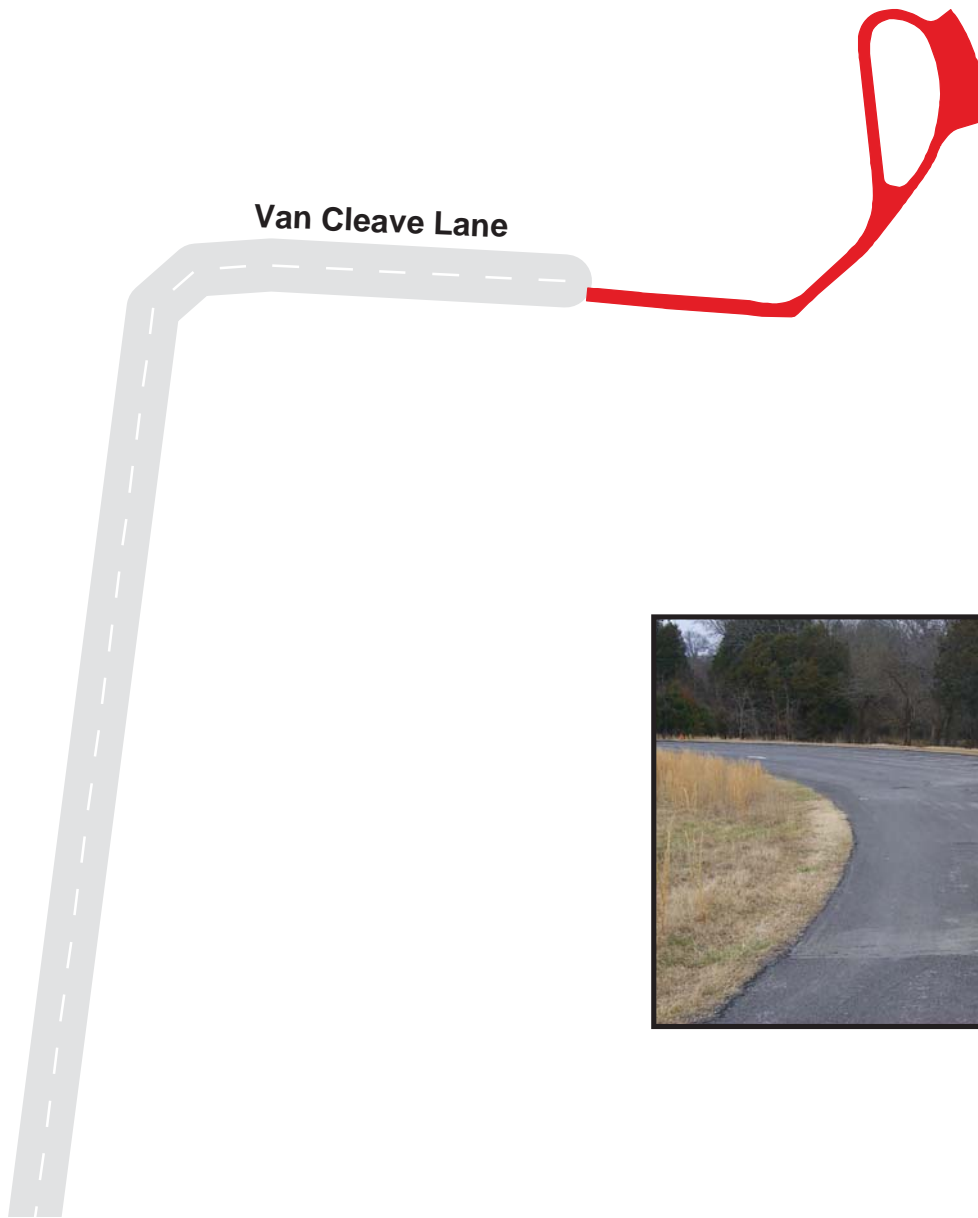
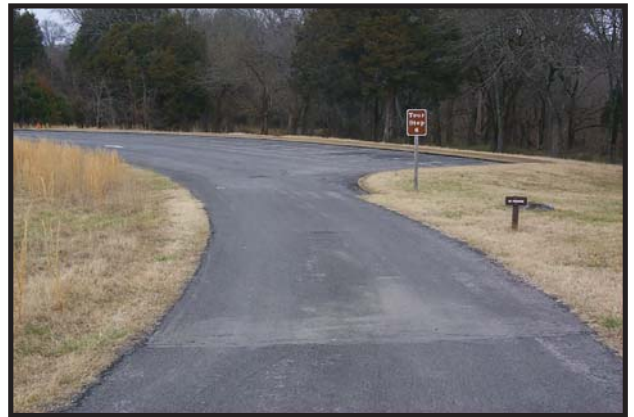
Stones River National Battlefield
Route 0906
 TOUR STOP 6 "ARTILLERY MONUMENT"
 From Van Cleave Lane at Park Boundary

Route	Public / NonPublic	Date Visited	Area (sq ft)	Lane Miles *	Surface Type	Condition / PCR
0906	Public	1/29/2002	19980	0.34	AS	GOOD / 90
