# The Road Inventory of Sunset Crater Volcano National Monument SUCR – 7460

## Road Inventory Program

Prepared By:  
Federal Highway Administration  
Eastern Federal Lands Highway Division  
Cycle 3

# Sunset Crater Volcano National Monument in Arizona

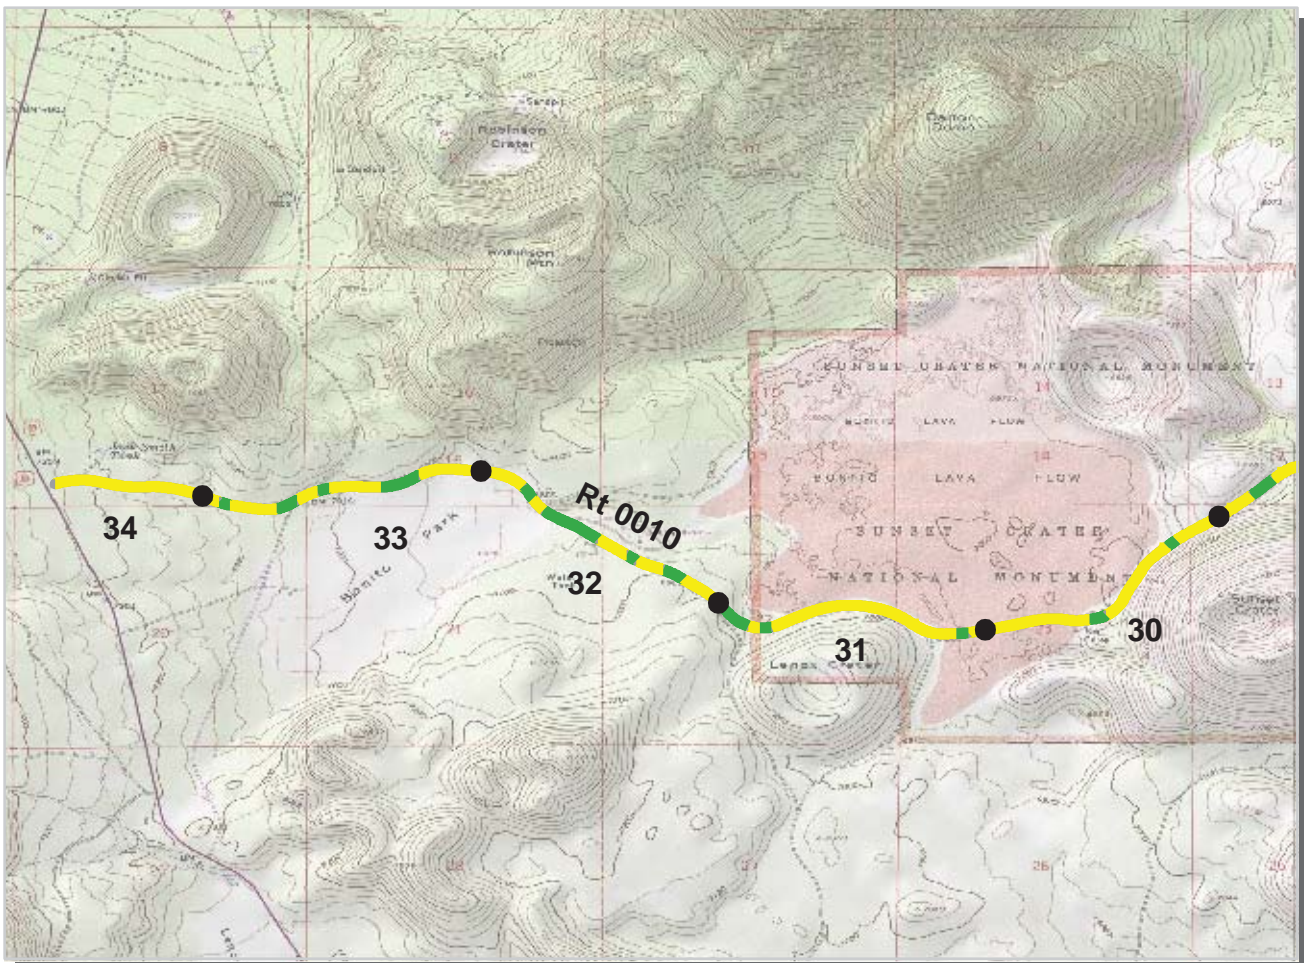
Section Number	30	31	32	33	34
Section Length (mi)	1.00	1.00	1.00	1.00	0.53
AADT	**				
SADT	**				
ADT Date	**				
<b>Cross Section Information</b>					
Number of Lanes	2	2	2	2	2
Paved Width (ft)	22	22	22	21	22
Lane Width (ft)	11	11	11	10	11
Shoulder Width (ft)	8	8	4	5	8
<b>Roadway Condition Information</b>					
PCR (Pavement Condition Rating)	81	80	82	82	79
RCI (Roughness Condition Index)	100	98	99	100	100
SCR (Surface Condition Rating)	69	67	71	71	68
Alligator Cracking Index	100	100	100	100	100
Rutting Index	69	67	71	71	68
Patching Index	100	99	100	100	100
Transverse Cracking Index	100	100	100	100	100
Longitudinal Cracking Index	100	100	100	100	100
Shoulder Condition Rating	GOOD	GOOD	GOOD	GOOD	GOOD
Drainage Condition Rating	GOOD	GOOD	GOOD	GOOD	GOOD

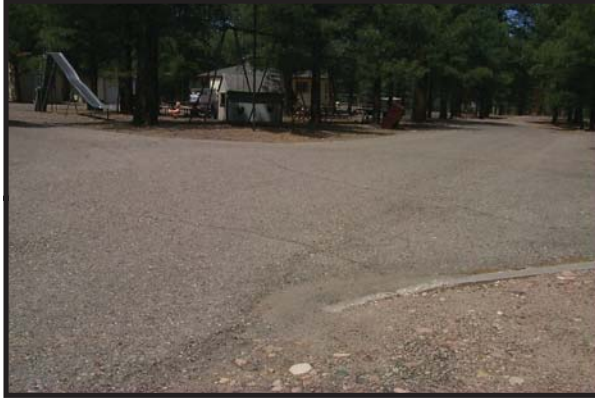
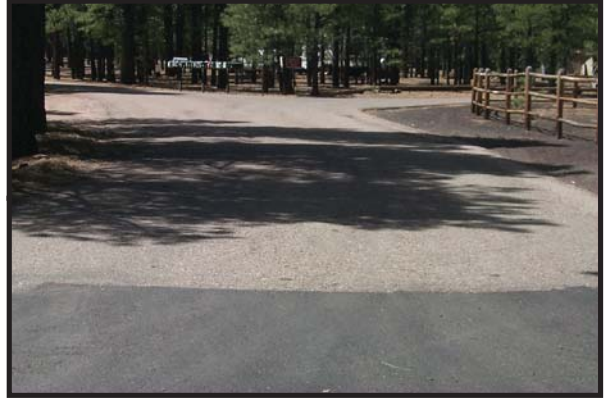
## Route 0909

Route	Public / NonPublic	Date Visited	Area (sq ft)	Lane Miles *	Surface Type	Condition / PCR
0909	Public	3/10/2004	28105	0.48	AS	EXCELLENT / 97

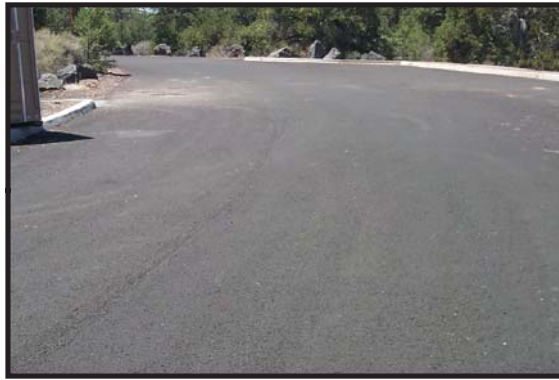
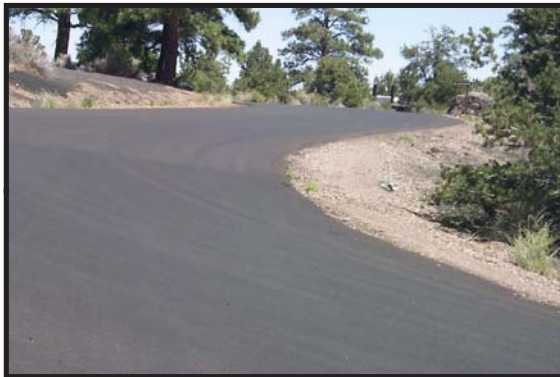
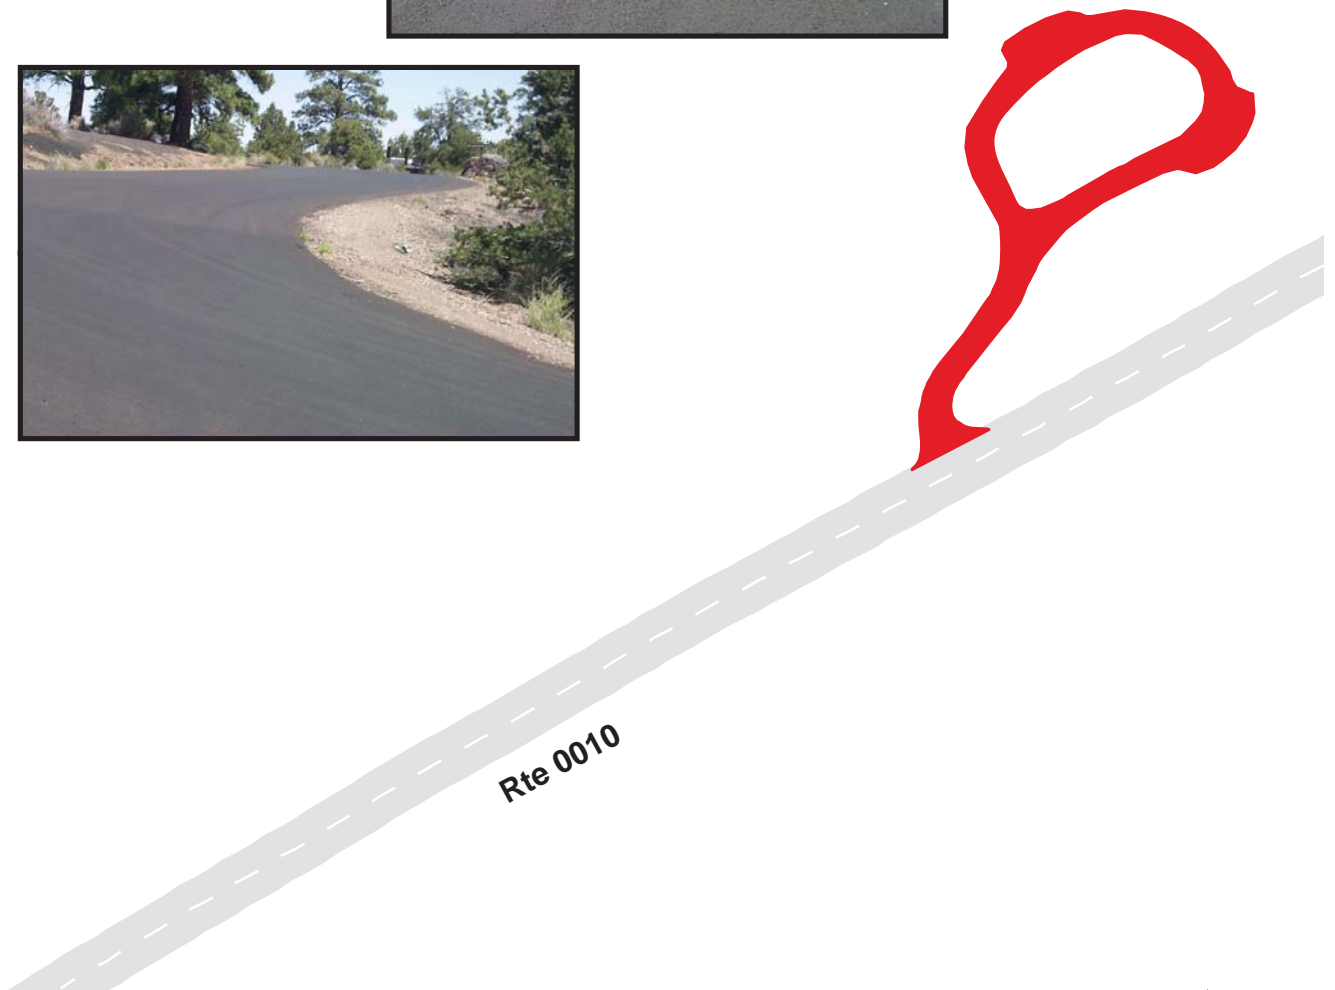
## Route 0910

Route	Public / NonPublic	Date Visited	Area (sq ft)	Lane Miles *	Surface Type	Condition / PCR
0910	Public	5/9/2002	22870	0.39	AS	FAIR / 73

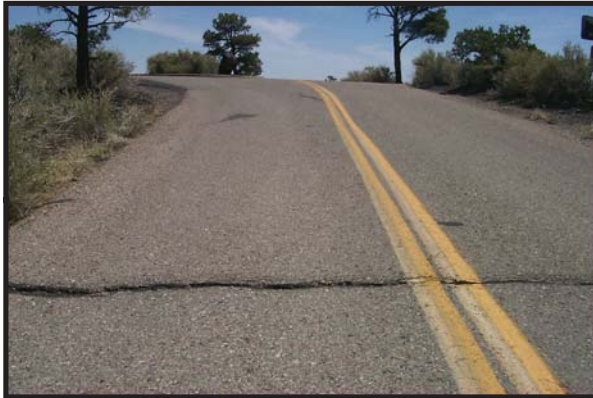
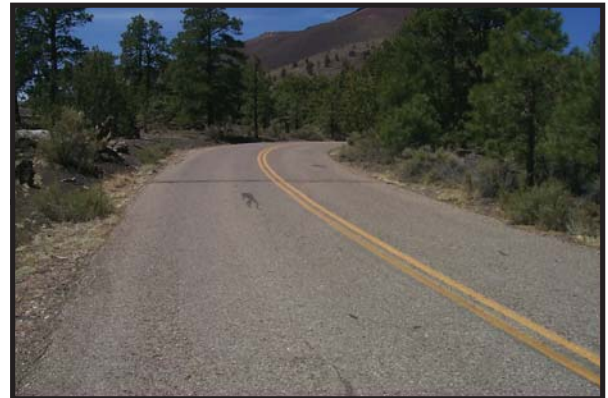
## Route 0911

Route	Public / NonPublic	Date Visited	Area (sq ft)	Lane Miles *	Surface Type	Condition / PCR
0911	Public	5/9/2002	41458	0.71	AS	GOOD / 90

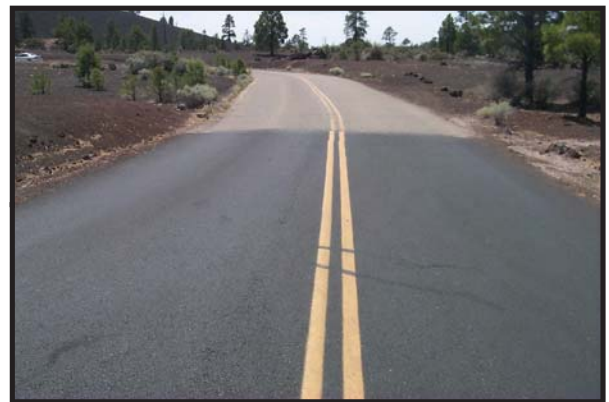
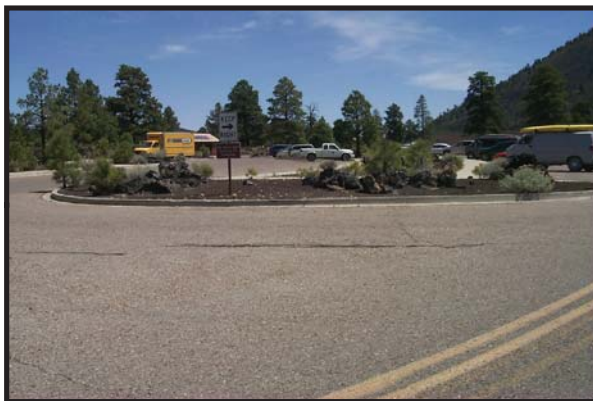
## Route 0912

Route	Public / NonPublic	Date Visited	Area (sq ft)	Lane Miles *	Surface Type	Condition / PCR
0912	Public	5/9/2002	5116	0.09	AS	EXCELLENT / 97

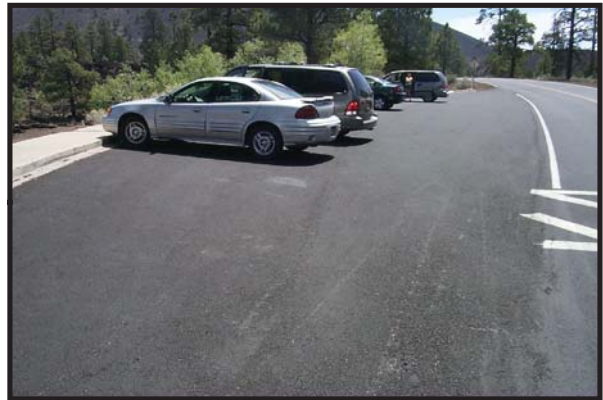
## Route 0914

Route	Public / NonPublic	Date Visited	Area (sq ft)	Lane Miles *	Surface Type	Condition / PCR
0914	Public	5/9/2002	13437	0.23	AS	EXCELLENT / 97

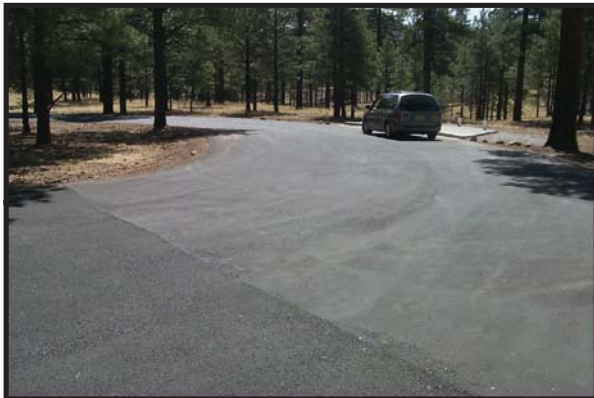
## Route 0919

Route	Public / NonPublic	Date Visited	Area (sq ft)	Lane Miles *	Surface Type	Condition / PCR
0919	NonPublic	5/9/2002	10315	0.18	AS	FAIR / 73
