The Road Inventory of Theodore Roosevelt National Park THRO - 1540

Road Inventory Program

Prepared By:
Federal Highway Administration
Eastern Federal Lands Highway Division
Cycle 3

Theodore Roosevelt National Park in North Dakota

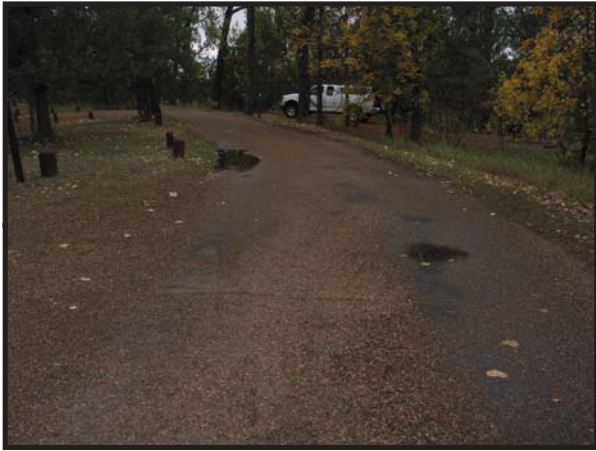
Route 0201C

Route	Length (mi)	Width (ft)	Area (sq ft)	Lane Miles *	Condition / PCR	Surface Type
0201C	0.33	17.00	29531	0.51	GOOD / 90	AS

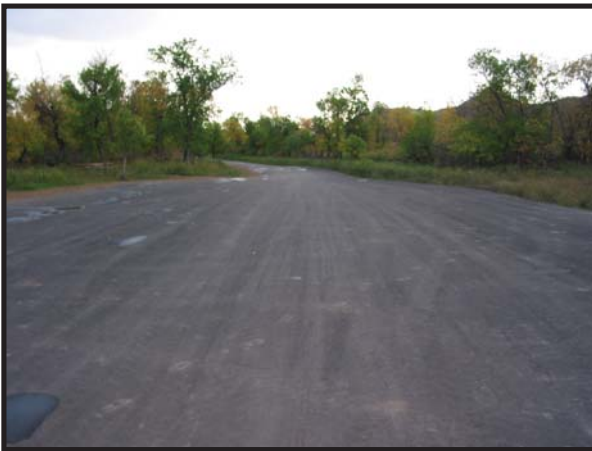
Route 0400

Route	Length (mi)	Width (ft)	Area (sq ft)	Lane Miles *	Condition / PCR	Surface Type
0400	0.04	0.00	4669	0.08	GOOD / 90	AS

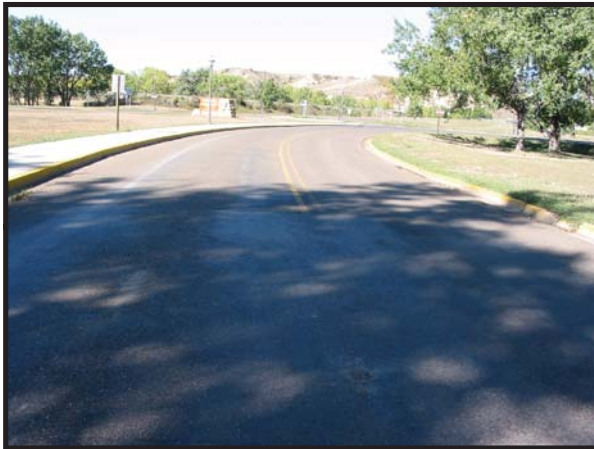
Route 0405

Route	Length (mi)	Width (ft)	Area (sq ft)	Lane Miles *	Condition / PCR	Surface Type
0405	0.38	0.00	44325	0.76	GOOD / 90	AS

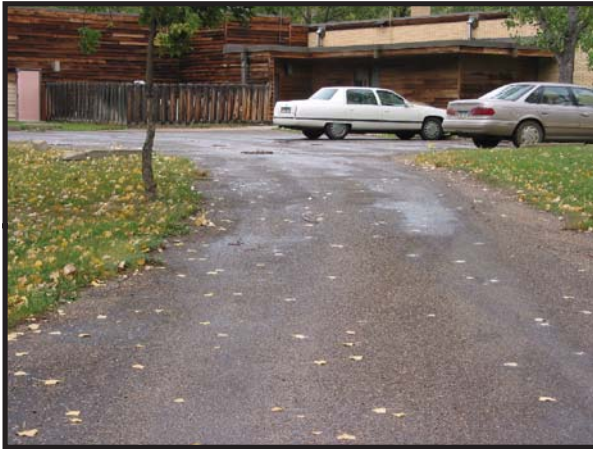
Route 0902

Route	Public / NonPublic	Date Visited	Area (sq ft)	Lane Miles *	Surface Type	Condition / PCR
0902	NonPublic	9/19/2002	34179	0.59	OC	GOOD / 90

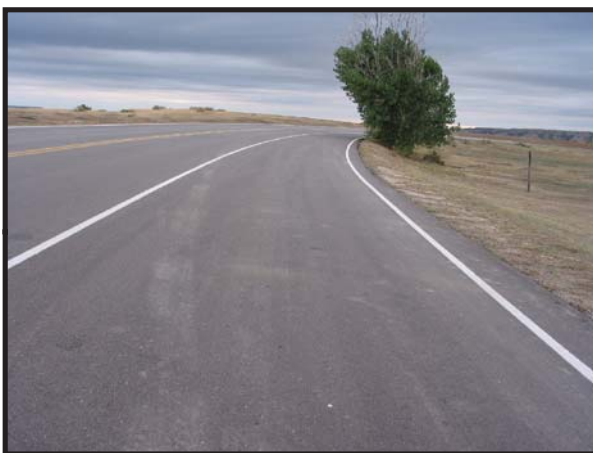
Route 0905

Route	Public / NonPublic	Date Visited	Area (sq ft)	Lane Miles *	Surface Type	Condition / PCR
0905	Public	9/19/2002	30564	0.53	AS	FAIR / 73

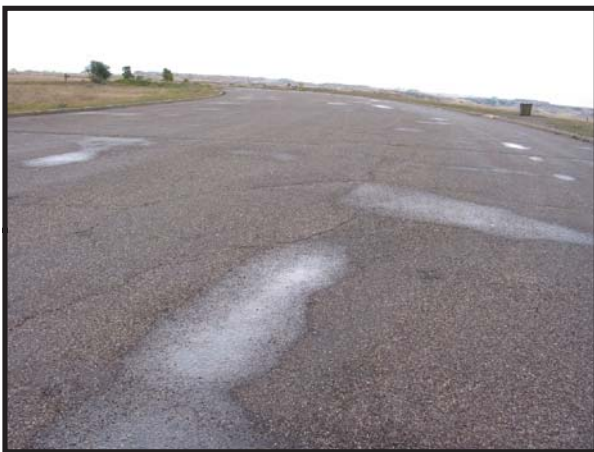
Route 0906

Route	Public / NonPublic	Date Visited	Area (sq ft)	Lane Miles *	Surface Type	Condition / PCR
0906	Public	9/19/2002	8390	0.14	AS	FAIR / 73

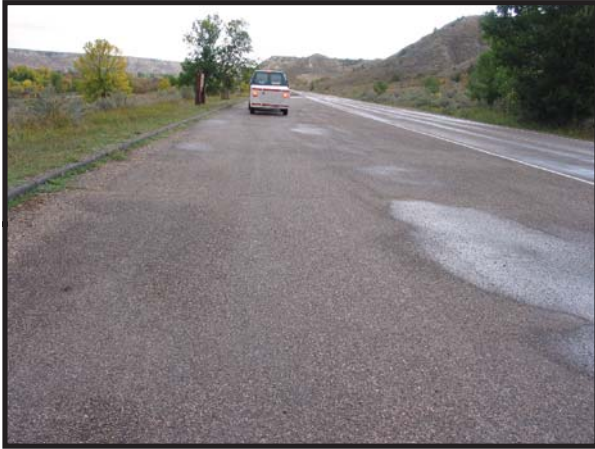
Route 0907

Route	Public / NonPublic	Date Visited	Area (sq ft)	Lane Miles *	Surface Type	Condition / PCR
0907	Public	9/19/2002	3682	0.06	AS	EXCELLENT / 97

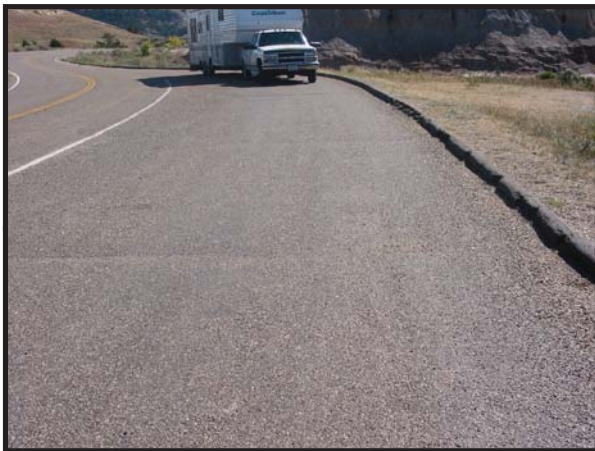
Route 0916B

Route	Public / NonPublic	Date Visited	Area (sq ft)	Lane Miles *	Surface Type	Condition / PCR
0916B	Public	9/19/2002	4309	0.07	AS	FAIR / 73

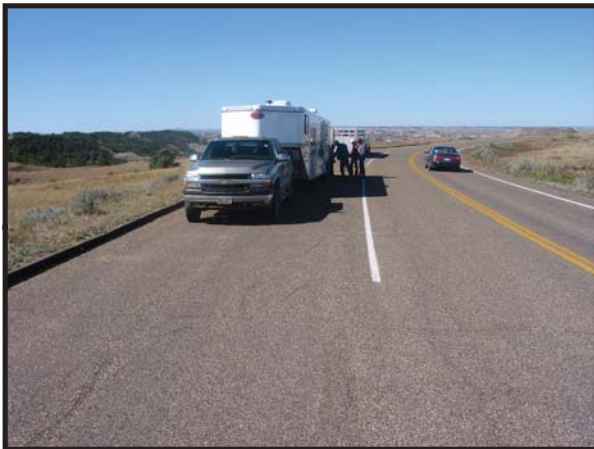
Route 0916C

Route	Public / NonPublic	Date Visited	Area (sq ft)	Lane Miles *	Surface Type	Condition / PCR
0916C	Public	9/19/2002	6988	0.12	AS	FAIR / 73

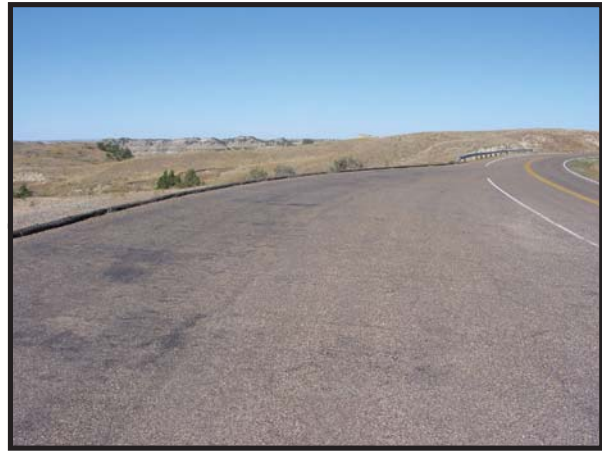
Route 0918

Route	Public / NonPublic	Date Visited	Area (sq ft)	Lane Miles *	Surface Type	Condition / PCR
0918	Public	9/18/2002	24002	0.41	AS	FAIR / 73

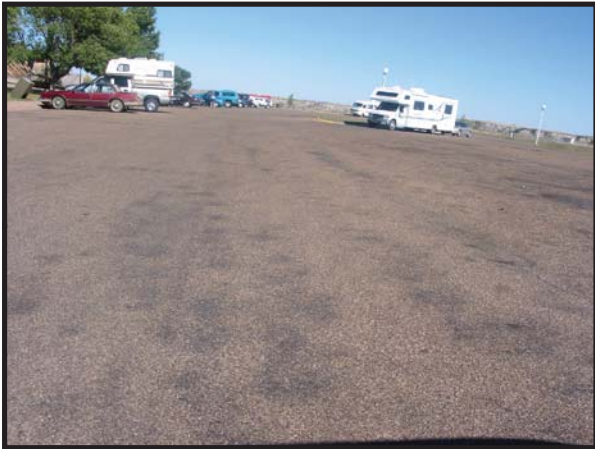
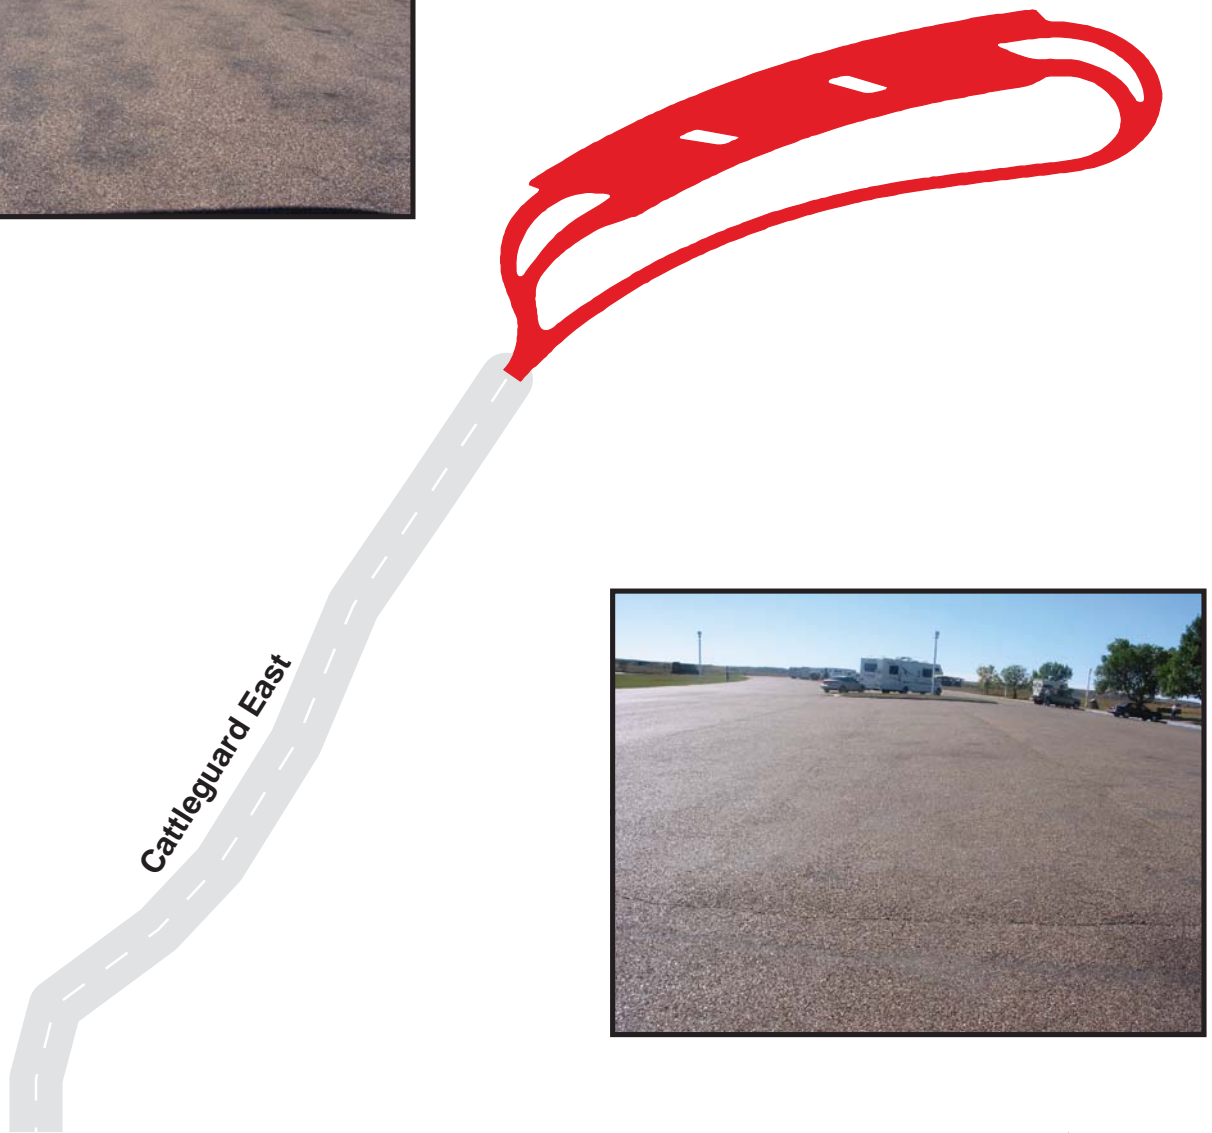
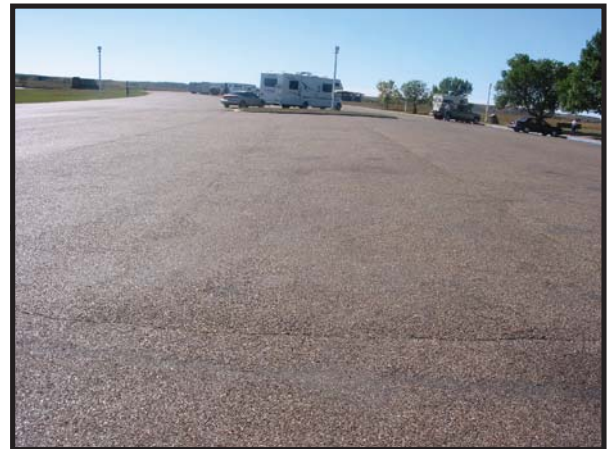
Route	Public / NonPublic	Date Visited	Area (sq ft)	Lane Miles *	Surface Type	Condition / PCR
0922	Public	9/18/2002	119249	2.05	AS	FAIR / 73

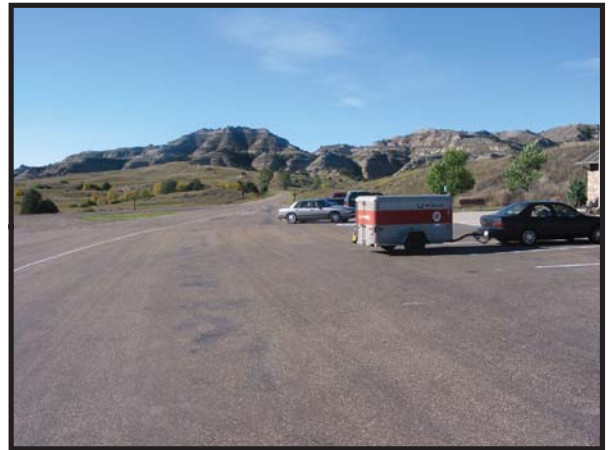
Route 0924

Route	Public / NonPublic	Date Visited	Area (sq ft)	Lane Miles *	Surface Type	Condition / PCR
0924	Public	9/19/2002	14127	0.24	AS	GOOD / 90

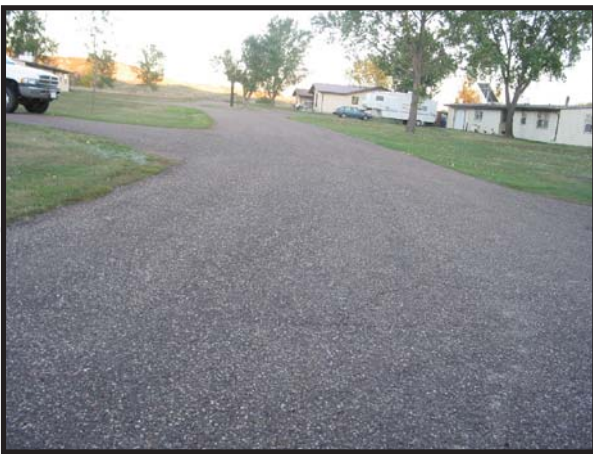
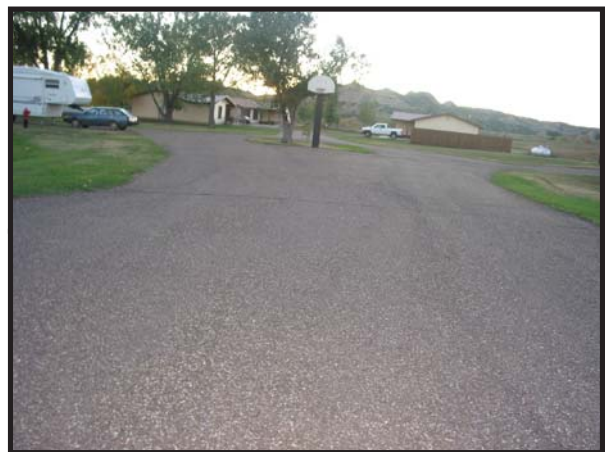
Route 0925

Route	Public / NonPublic	Date Visited	Area (sq ft)	Lane Miles *	Surface Type	Condition / PCR
0925	NonPublic	9/19/2002	15162	0.26	AS	GOOD / 90

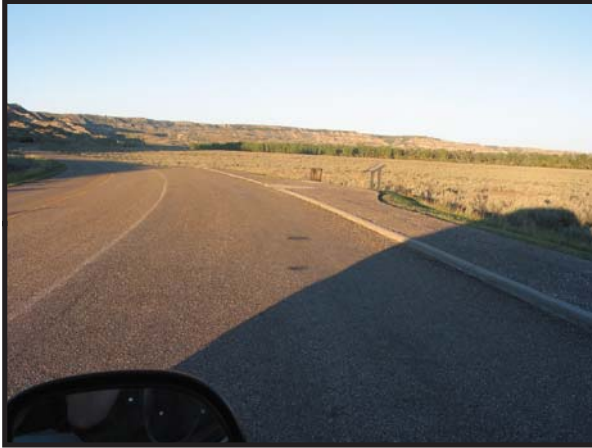
Route 0926

Route	Public / NonPublic	Date Visited	Area (sq ft)	Lane Miles *	Surface Type	Condition / PCR
0926	Public	9/19/2002	4245	0.07	AS	GOOD / 90

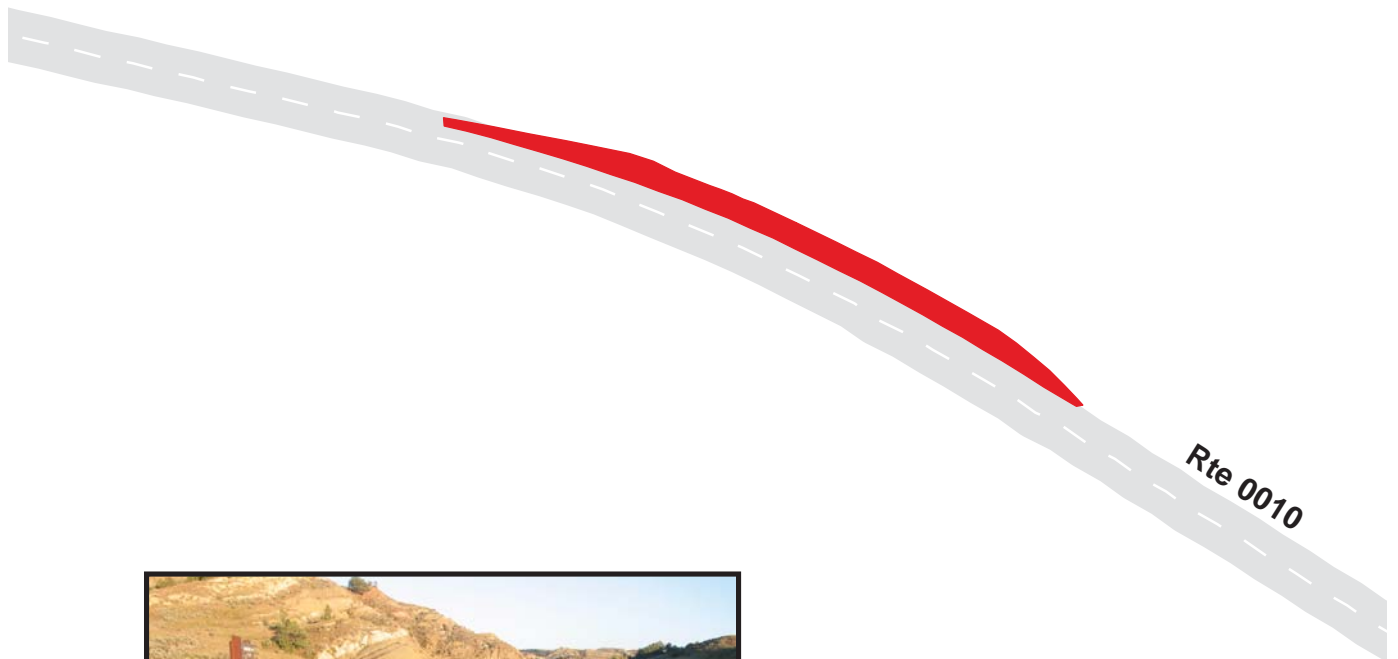
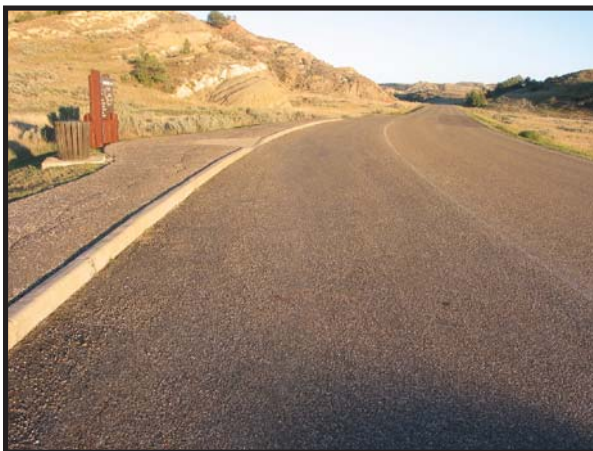
Route 0927

Route	Public / NonPublic	Date Visited	Area (sq ft)	Lane Miles *	Surface Type	Condition / PCR
0927	Public	9/19/2002	3552	0.06	OC	GOOD / 90

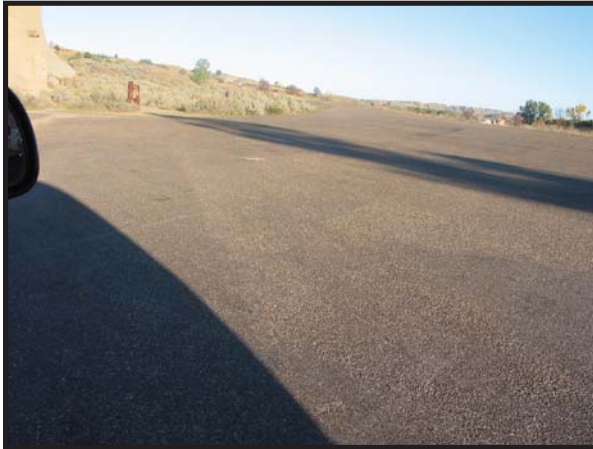
Route 0928

Route	Public / NonPublic	Date Visited	Area (sq ft)	Lane Miles *	Surface Type	Condition / PCR
0928	Public	9/19/2002	13645	0.23	AS	GOOD / 90

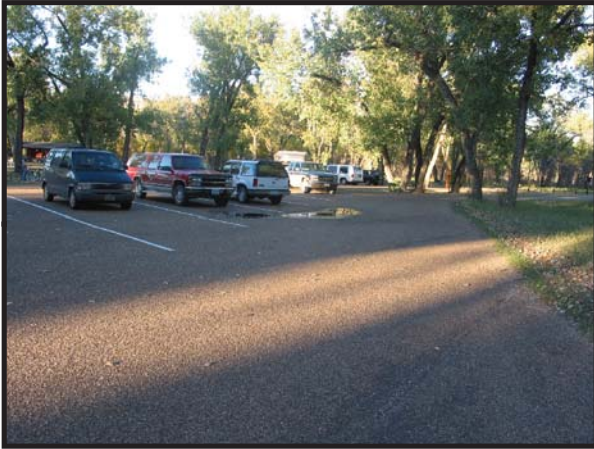
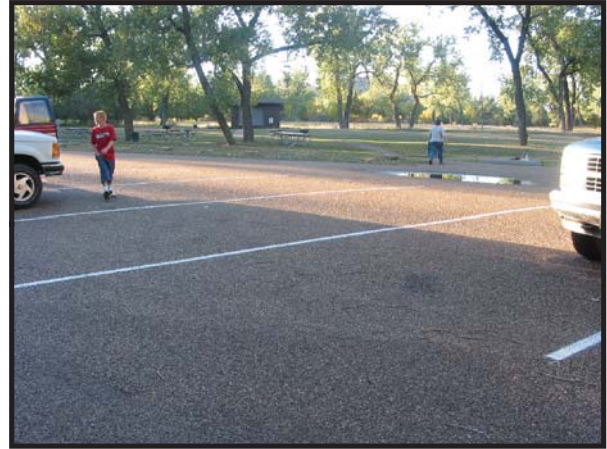
Route 0930

Route	Public / NonPublic	Date Visited	Area (sq ft)	Lane Miles *	Surface Type	Condition / PCR
0930	Public	9/19/2002	26368	0.45	OC	GOOD / 90

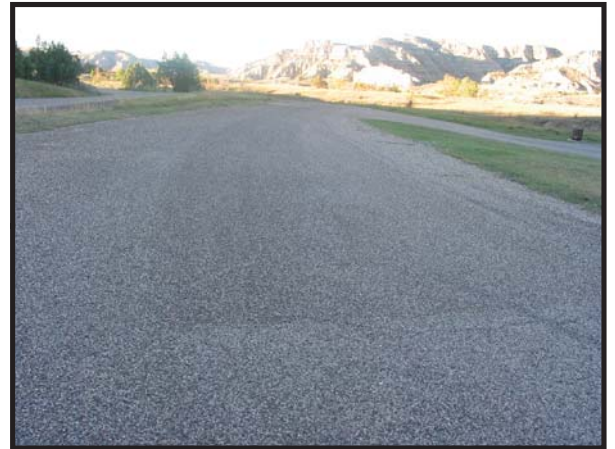
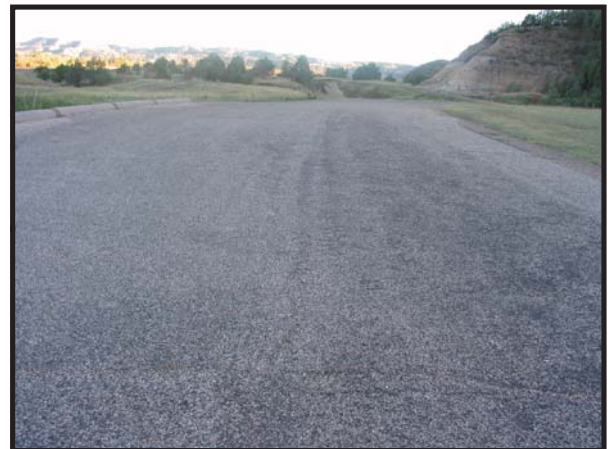
Route 0932

Route	Public / NonPublic	Date Visited	Area (sq ft)	Lane Miles *	Surface Type	Condition / PCR
0932	Public	9/19/2002	12886	0.22	OC	FAIR / 73

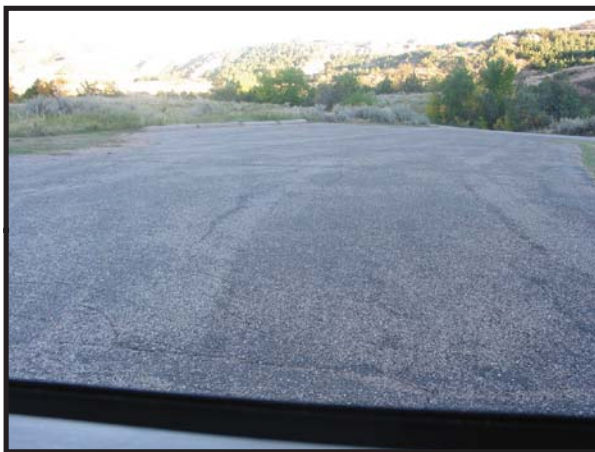
Route 0934

Route	Public / NonPublic	Date Visited	Area (sq ft)	Lane Miles *	Surface Type	Condition / PCR
0934	Public	9/19/2002	13661	0.24	AS	FAIR / 73

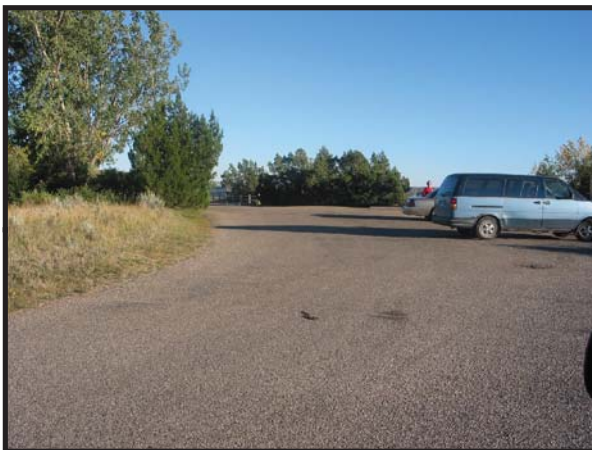
Route 0935

Route	Public / NonPublic	Date Visited	Area (sq ft)	Lane Miles *	Surface Type	Condition / PCR
0935	Public	9/18/2002	7756	0.13	AS	FAIR / 73

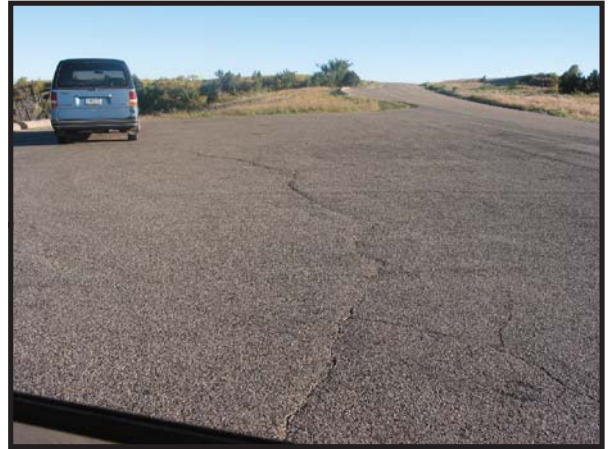
Route 0936

Route	Public / NonPublic	Date Visited	Area (sq ft)	Lane Miles *	Surface Type	Condition / PCR
0936	Public	9/18/2002	8383	0.14	OC	FAIR / 73

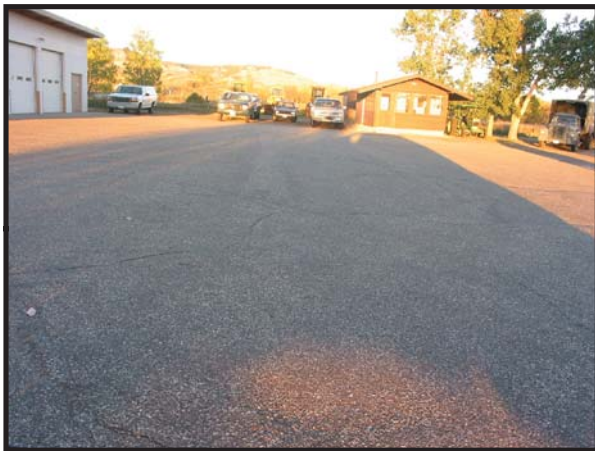
Route 0941

Route	Public / NonPublic	Date Visited	Area (sq ft)	Lane Miles *	Surface Type	Condition / PCR
0941	Public	9/18/2002	8020	0.14	AS	EXCELLENT / 97

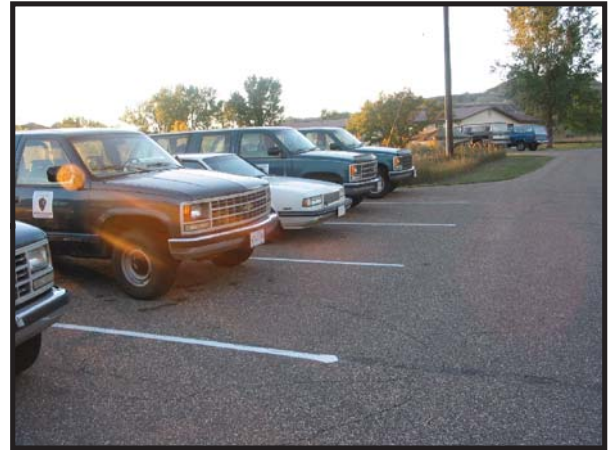
Route 0943

Route	Public / NonPublic	Date Visited	Area (sq ft)	Lane Miles *	Surface Type	Condition / PCR
0943	Public	9/19/2002	5150	0.09	AS	GOOD / 90
