# The Road Inventory of Timpanogos National Monument TICA - 1550

## Road Inventory Program

Prepared By:  
Federal Highway Administration  
Eastern Federal Lands Highway Division  
Cycle 3

# Timpanogos National Monument in Utah

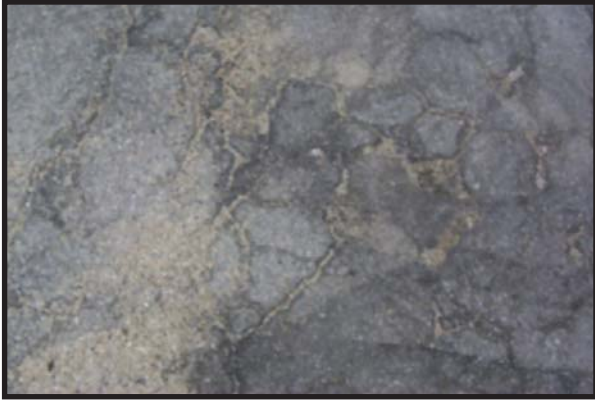
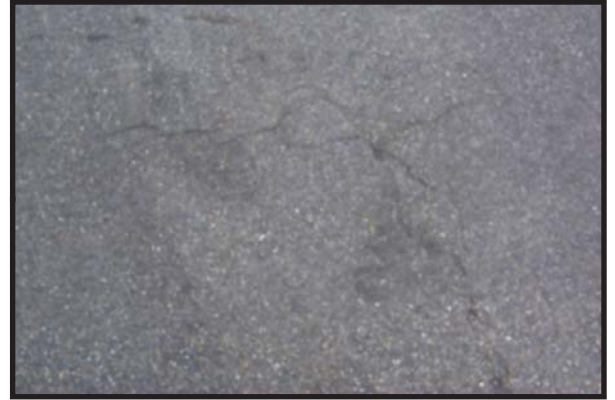
## Route 0900

### VISITOR CENTER PARKING

Route	Public / NonPublic	Date Visited	Area (sq ft)	Lane Miles *	Surface Type	Condition / PCR
0900	Public	5/2/2003	17941	0.31	AS	FAIR / 73

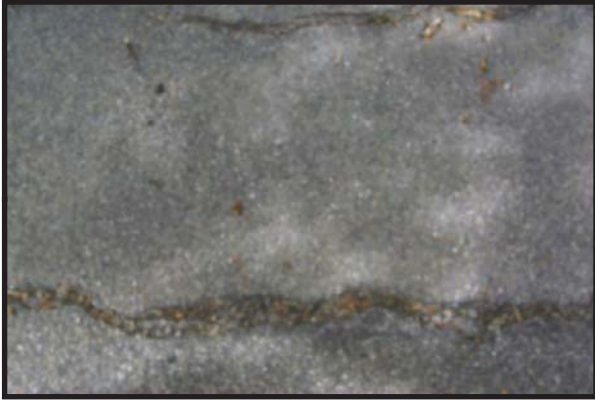
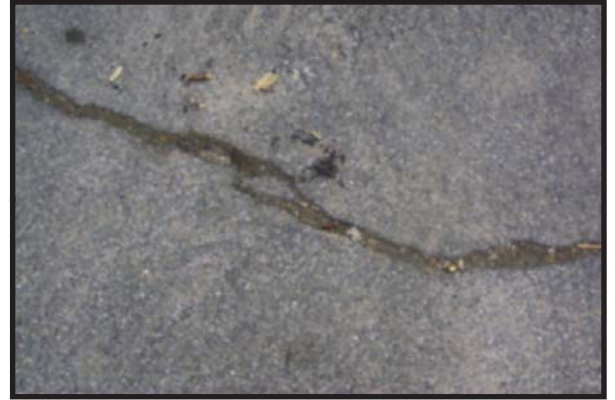
## Route 0901

### RESIDENCE AREA PARKING

Route	Public / NonPublic	Date Visited	Area (sq ft)	Lane Miles *	Surface Type	Condition / PCR
0901	NonPublic	5/2/2003	2738	0.05	AS	POOR / 45

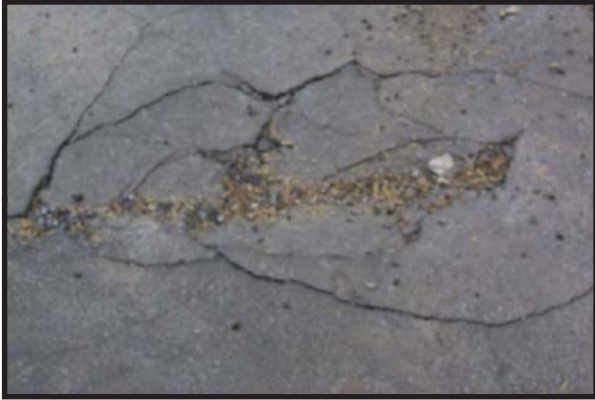
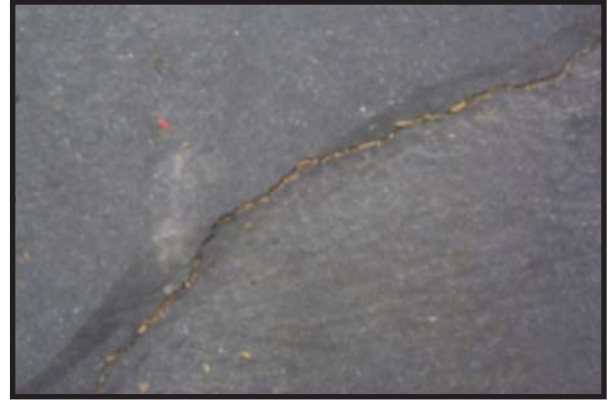
## Route 0902

SWINGING BRIDGE PICNIC AREA

Route	Public / NonPublic	Date Visited	Area (sq ft)	Lane Miles *	Surface Type	Condition / PCR
0902	Public	5/2/2003	7380	0.13	AS	POOR / 45

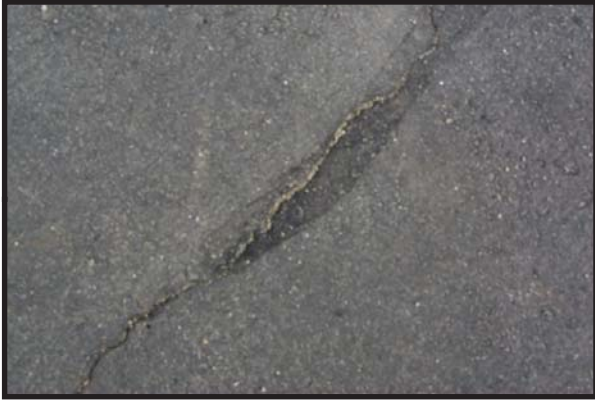
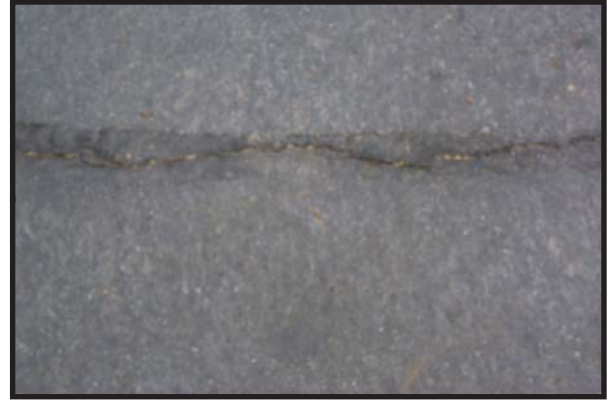
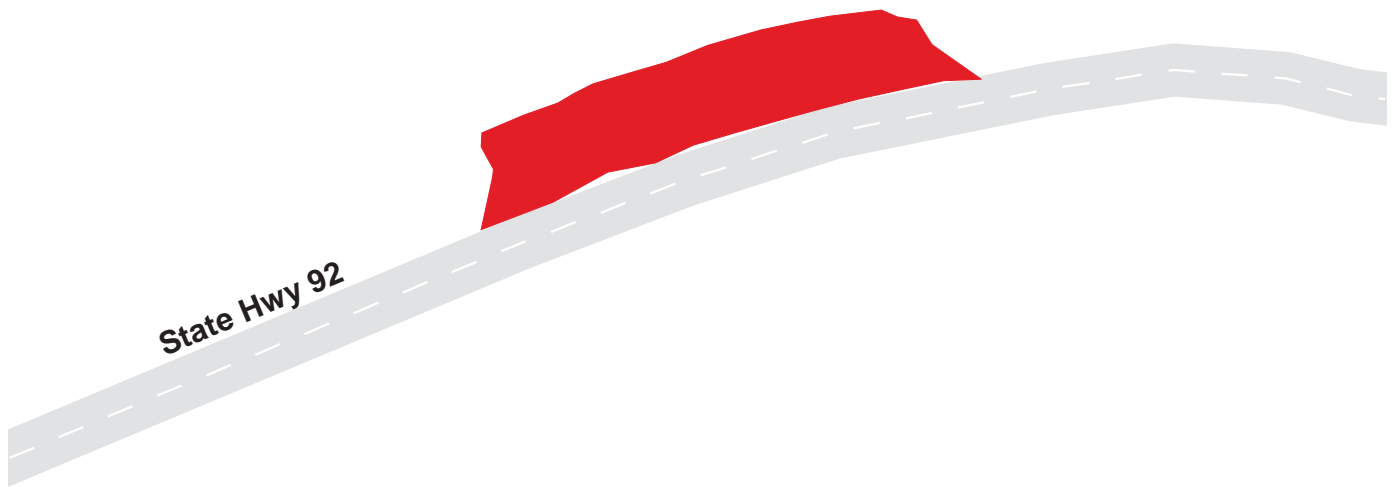
## Route 0903

### CANYON NATURE TRAIL PARKING

Route	Public / NonPublic	Date Visited	Area (sq ft)	Lane Miles *	Surface Type	Condition / PCR
0903	Public	5/2/2003	2868	0.05	AS	FAIR / 73

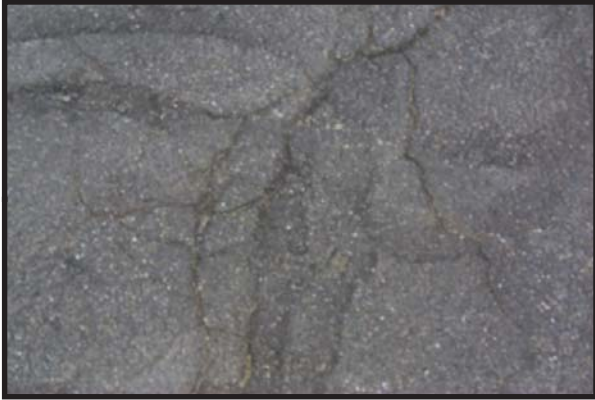
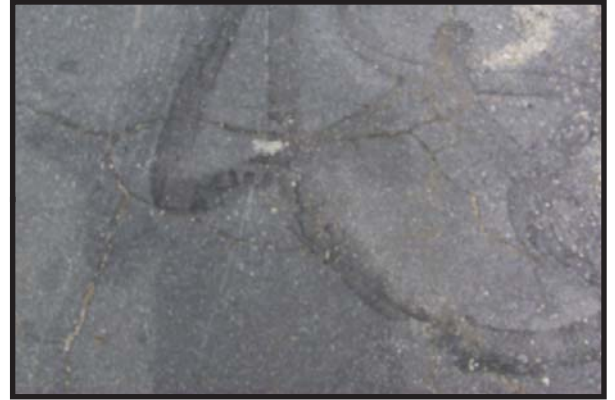
## Route 0904

CANYON VIEW PARKING

Route	Public / NonPublic	Date Visited	Area (sq ft)	Lane Miles *	Surface Type	Condition / PCR
0904	Public	5/2/2003	8415	0.14	AS	POOR / 45

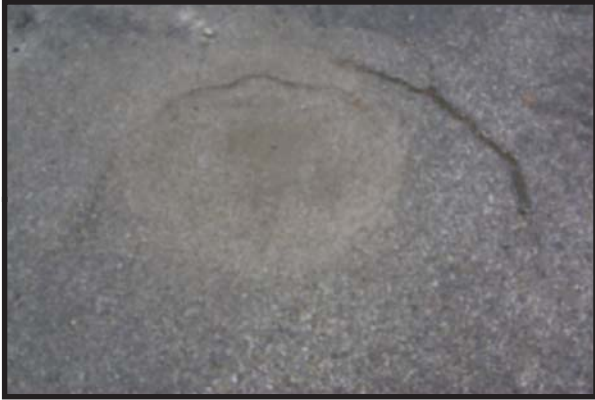
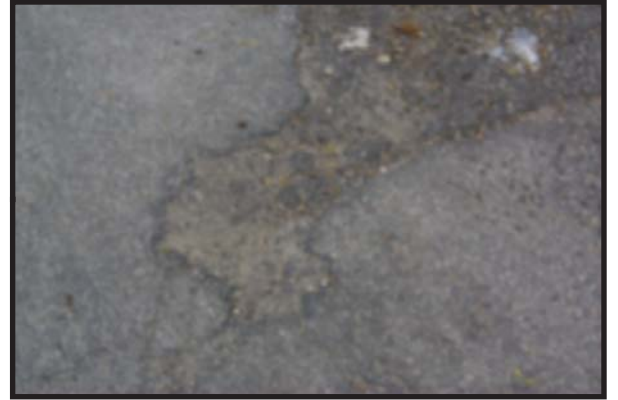
## Route 0906

### MAINTENANCE FACILITY

Route	Public / NonPublic	Date Visited	Area (sq ft)	Lane Miles *	Surface Type	Condition / PCR
0906	NonPublic	5/2/2003	12114	0.21	AS	POOR / 45
