The Road Inventory of Tonto National Monument TONT - 8680

Road Inventory Program

Prepared By:
Federal Highway Administration
Eastern Federal Lands Highway Division
Cycle 3

Tonto National Monument in Arizona

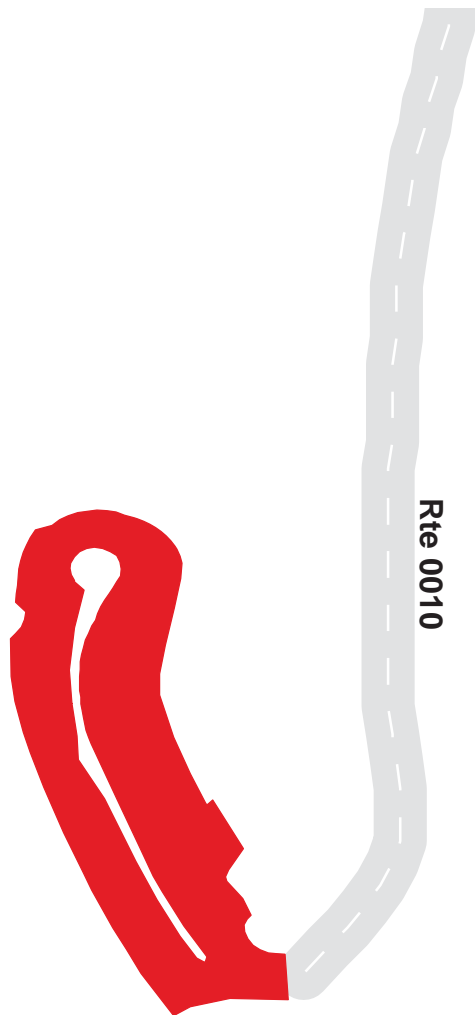
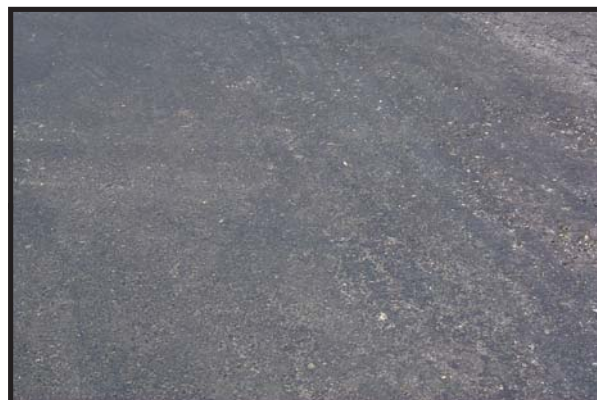
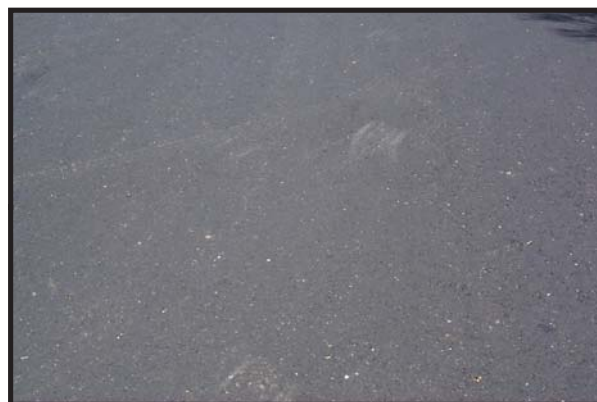
Route	Public / NonPublic	Date Visited	Area (sq ft)	Lane Miles *	Surface Type	Condition / PCR
0900	Public	4/7/2003	26306	0.45	AS	GOOD / 90

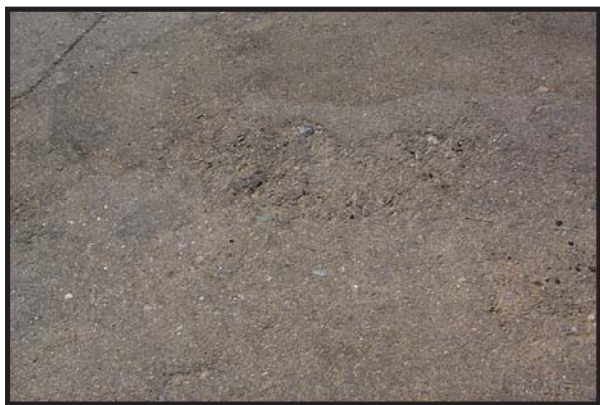
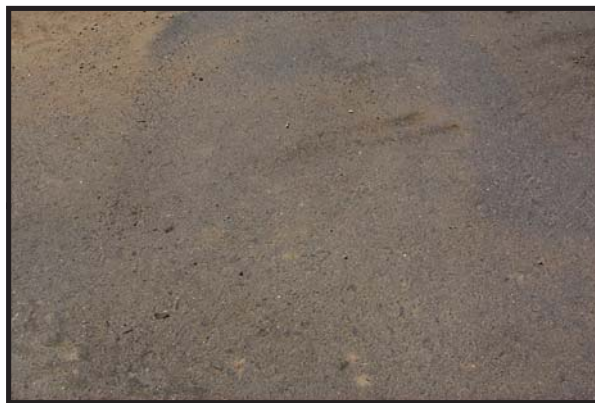
Route 0902

Route	Public / NonPublic	Date Visited	Area (sq ft)	Lane Miles *	Surface Type	Condition / PCR
0902	NonPublic	4/7/2003	6845	0.12	AS	FAIR / 73

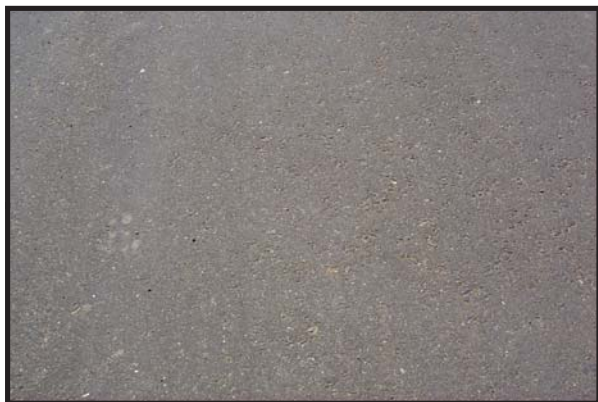
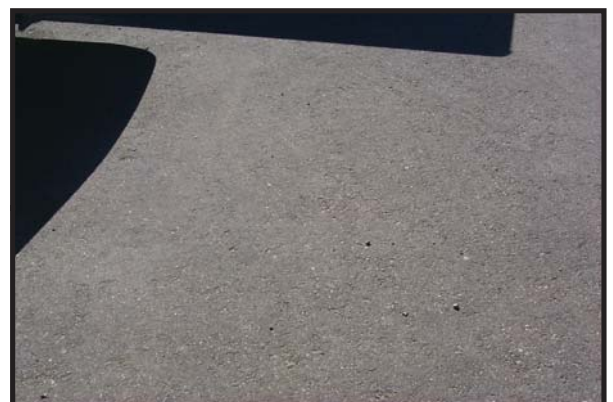
Route 0903

Route	Public / NonPublic	Date Visited	Area (sq ft)	Lane Miles *	Surface Type	Condition / PCR
0903	NonPublic	4/7/2003	4108	0.07	AS	GOOD / 90
