The Road Inventory of Tuskegee Airmen National Historic Site TUIAI – 5682

Road Inventory Program

Prepared By:
Federal Highway Administration
Eastern Federal Lands Highway Division
Cycle 3

Tuskegee Airmen National Historic Site in Alabama

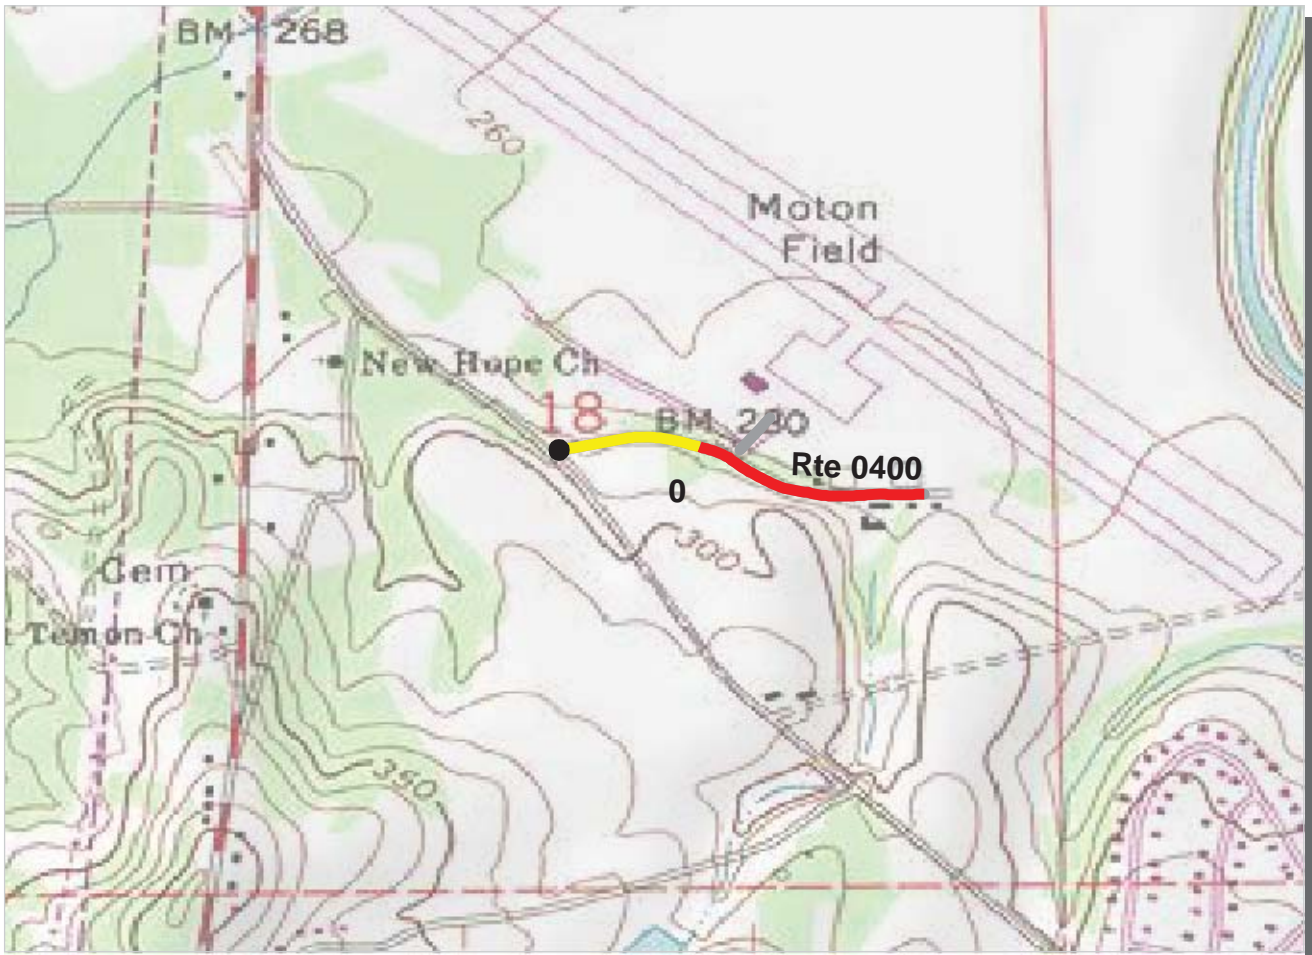
ROUTE: 0400 Chief Anderson Drive **TOTAL LENGTH: 0.34 Miles**

Section Number	0				
Section Length (mi)	0.34				
AADT	**				
SADT	**				
ADT Date	**				
Cross Section Information					
Number of Lanes	2				
Paved Width (ft)	21				
Lane Width (ft)	12				
Shoulder Width (ft)	3				
Roadway Condition Information					
PCR (Pavement Condition Rating)	30				
RCI (Roughness Condition Index)	45				
SCR (Surface Condition Rating)	25				
Alligator Cracking Index	66				
Rutting Index	50				
Patching Index	95				
Transverse Cracking Index	93				
Longitudinal Cracking Index	92				
Shoulder Condition Rating	GOOD				
Drainage Condition Rating	GOOD
