# The Road Inventory of Tuskegee Institute National Historic Site TUIN - 5680

## Road Inventory Program

Prepared By:  
Federal Highway Administration  
Eastern Federal Lands Highway Division  
Cycle 3

# Tuskegee Institute National Historic Site in Alabama

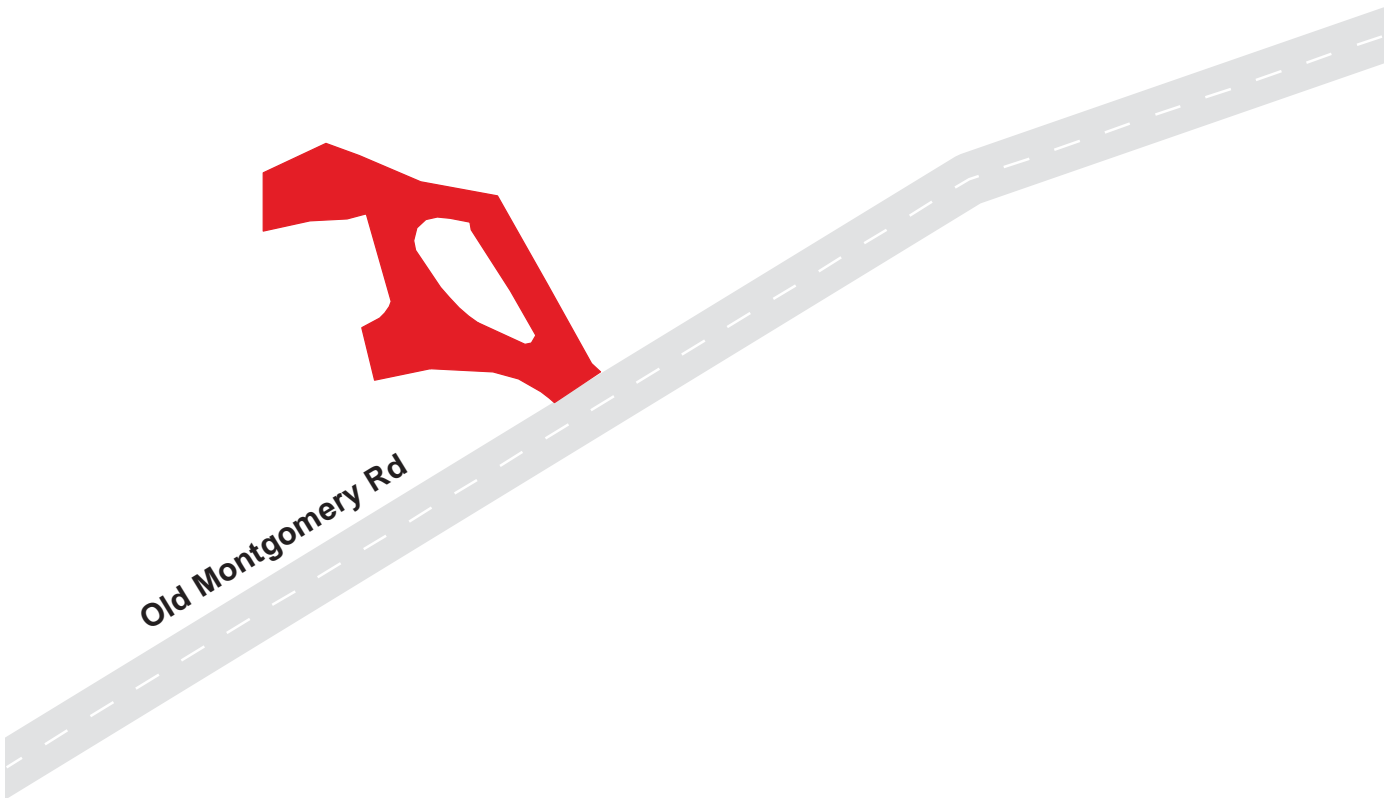
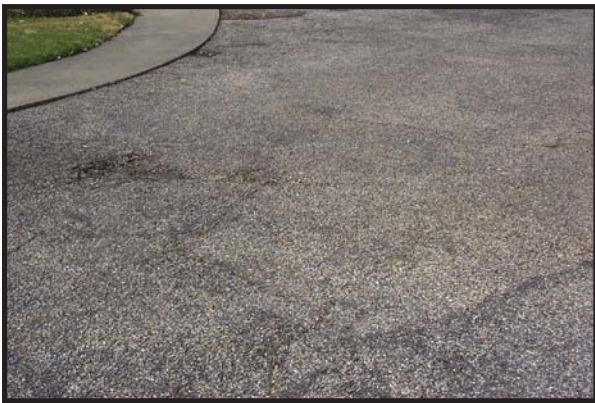
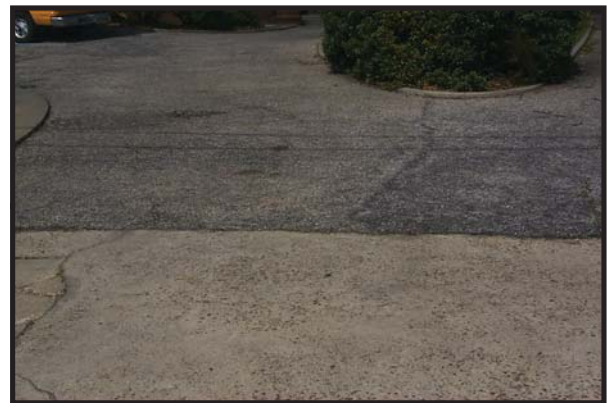
## Route 0900

TUSKEGEE INSTITUTE HEADQUARTERS PARKING  
From Old Montgomery Road

Route	Public / NonPublic	Date Visited	Area (sq ft)	Lane Miles *	Surface Type	Condition / PCR
0900	Public	3/7/2002	4375	0.08	AS	POOR / 45

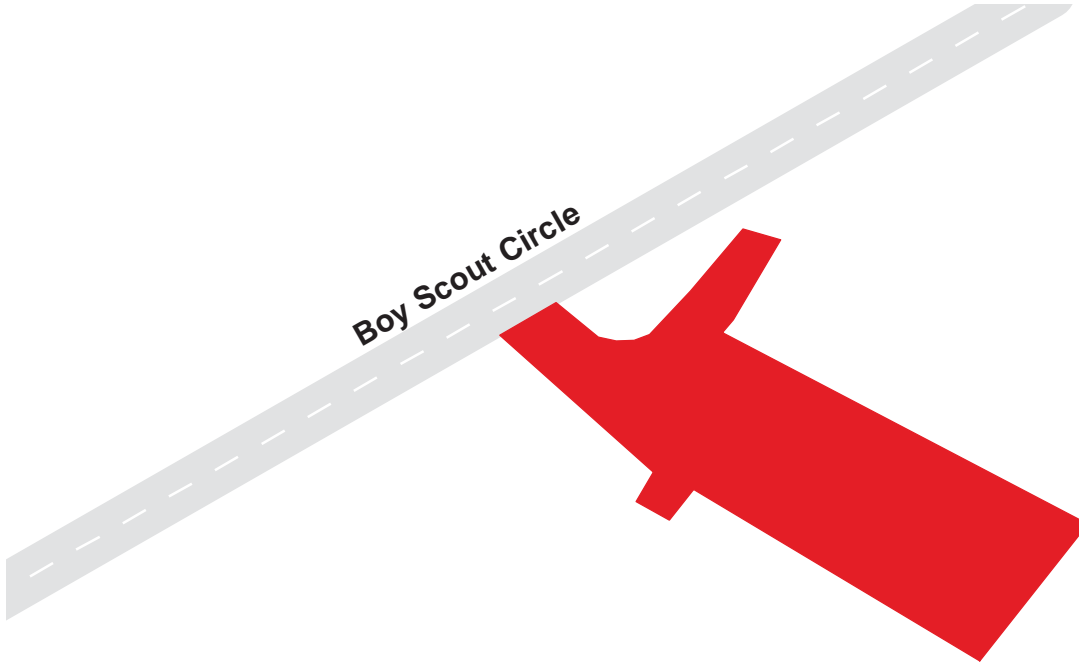
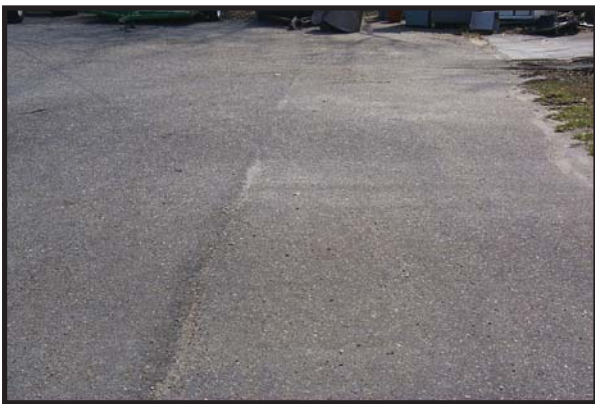
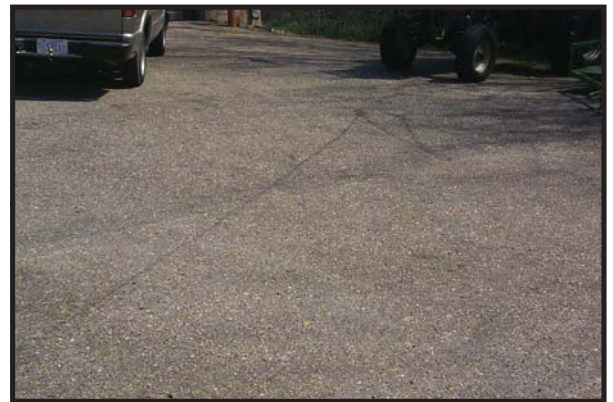
## Route 0901

TUSKEGEE INSTITUTE MAINTENANCE YARD  
From Boy Scout Circle

Route	Public / NonPublic	Date Visited	Area (sq ft)	Lane Miles *	Surface Type	Condition / PCR
0901	NonPublic	3/7/2002	7866	0.14	AS	GOOD / 90

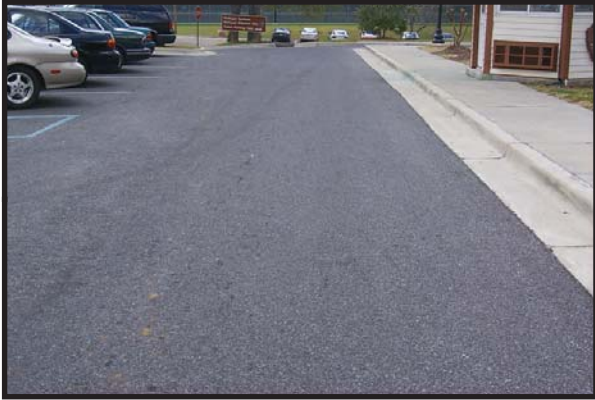
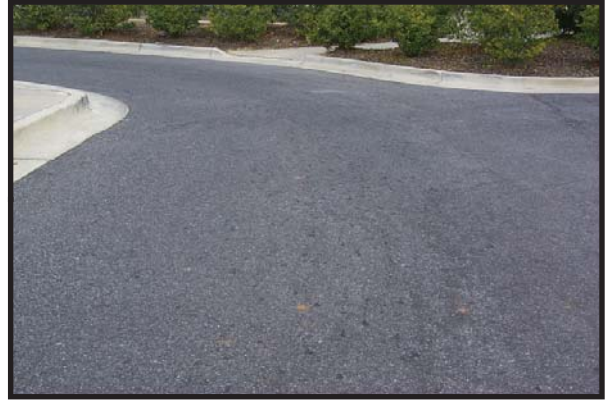
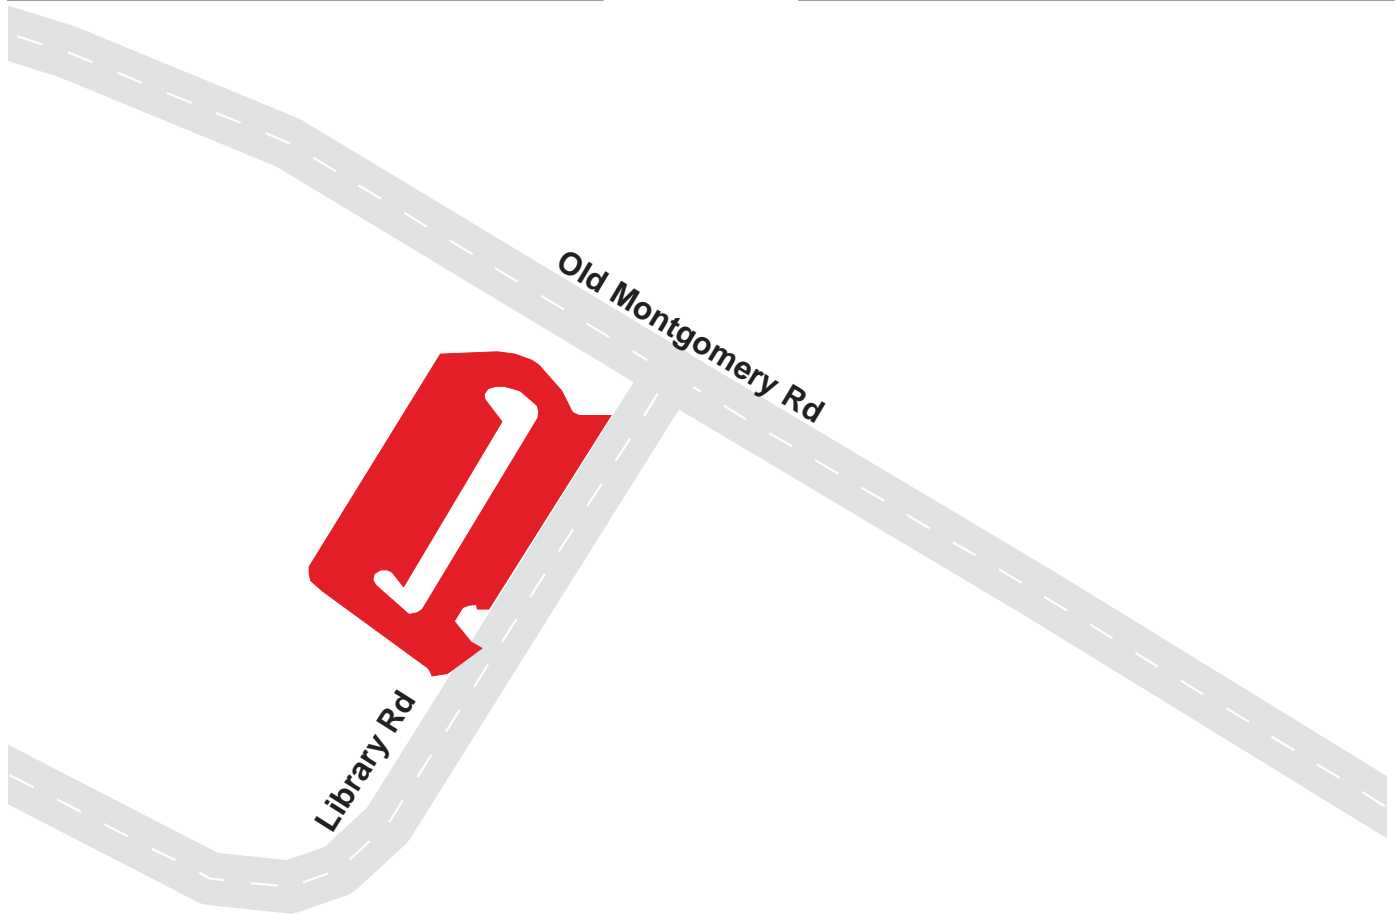
## Route 0902

### OAKS INFORMATION KIOSK PARKING

From Library Road

Route	Public / NonPublic	Date Visited	Area (sq ft)	Lane Miles *	Surface Type	Condition / PCR
0902	Public	3/7/2002	14808	0.25	AS	GOOD / 90

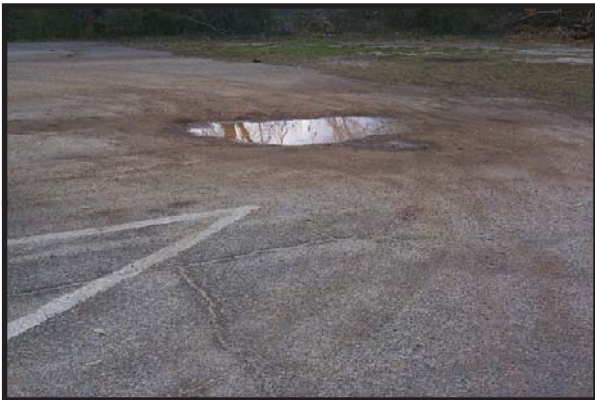
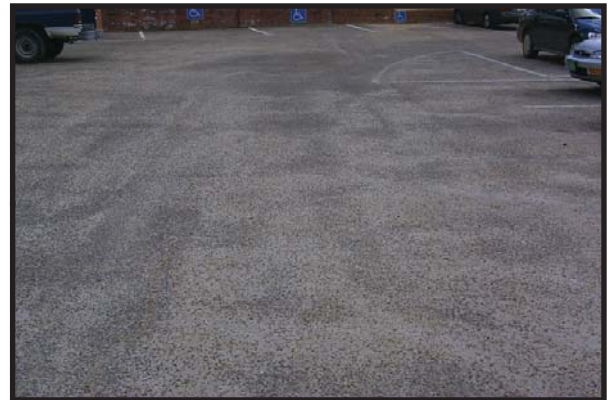
## Route 0903

### OAKS BUS PARKING

From Library Road

Route	Public / NonPublic	Date Visited	Area (sq ft)	Lane Miles *	Surface Type	Condition / PCR
0903	Public	3/7/2002	27229	0.47	AS	POOR / 45

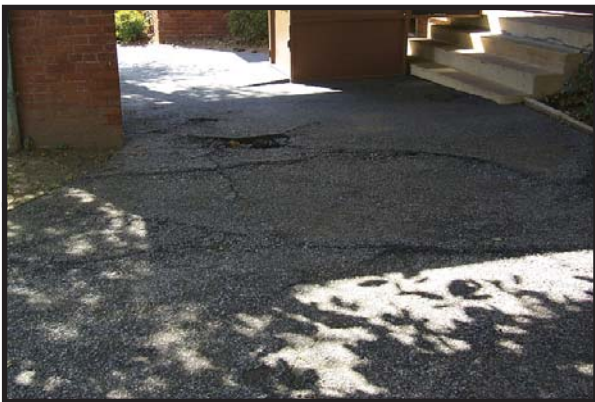
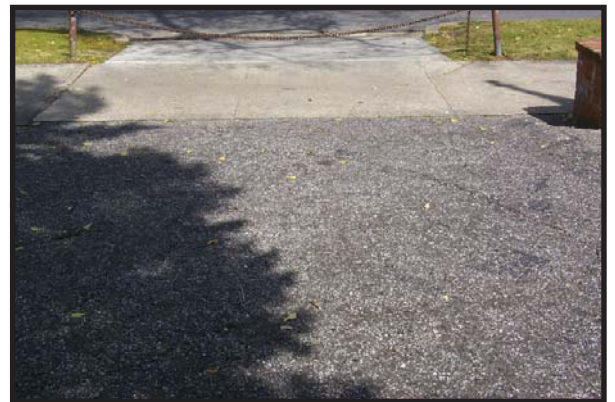
## Route 0904

OAKS HOUSE PARKING  
From Old Montgomery Road

Route	Public / NonPublic	Date Visited	Area (sq ft)	Lane Miles *	Surface Type	Condition / PCR
0904	NonPublic	3/7/2002	2716	0.05	AS	FAIR / 73

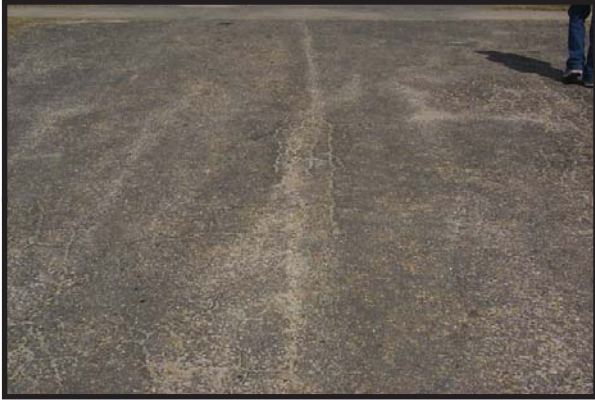
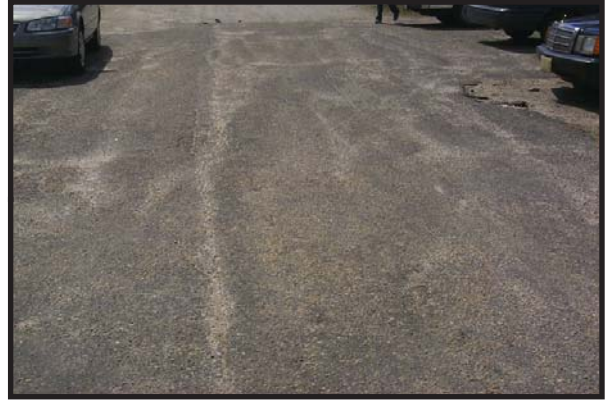
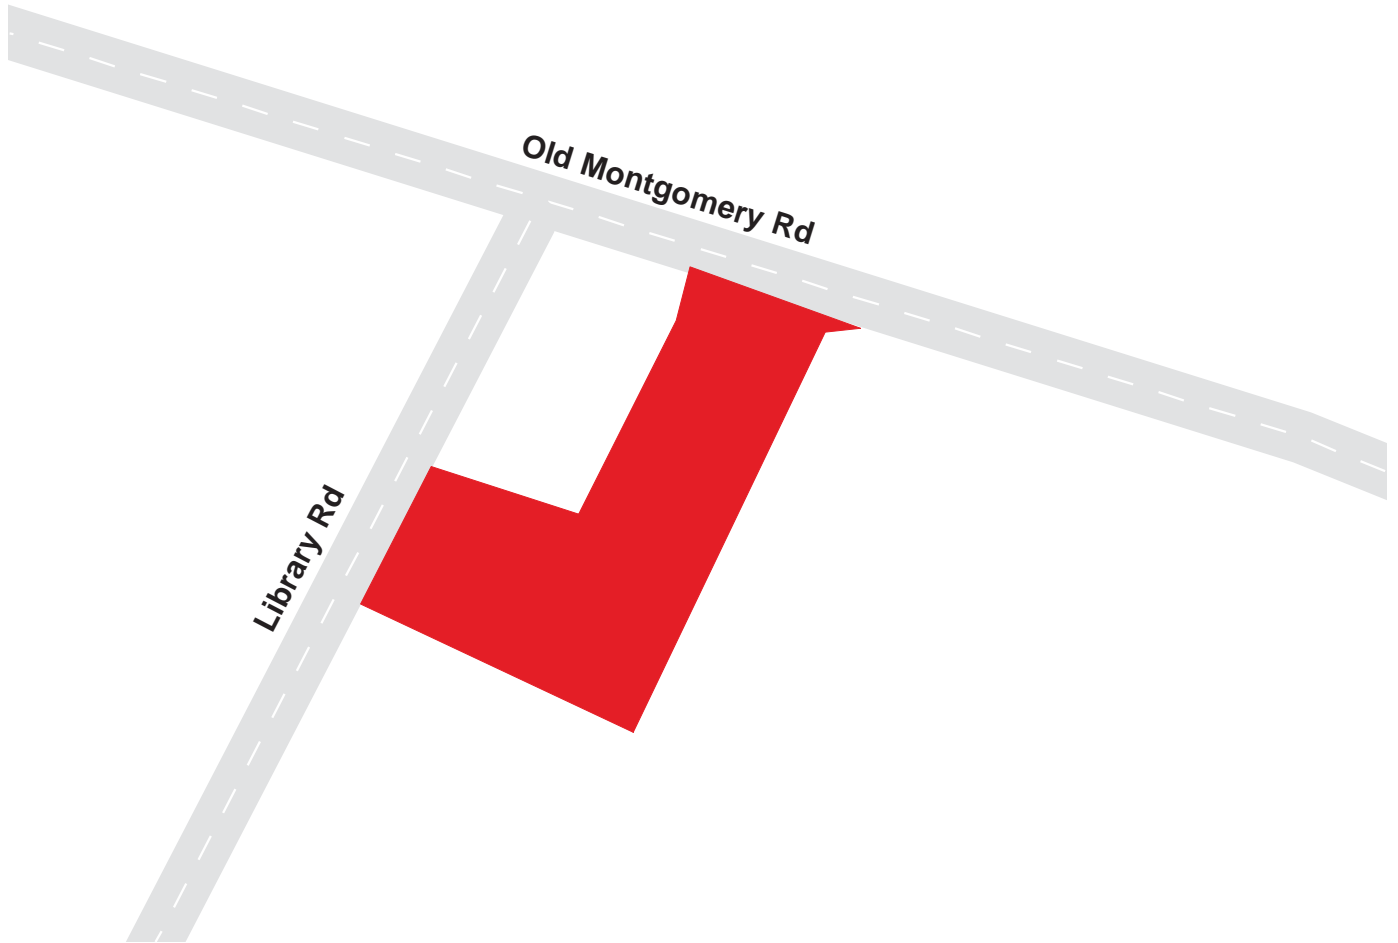
## Route 0905A

ALUMNI HOUSE AND BELTON HOUSE PARKING A  
From Old Montgomery Road

Route	Public / NonPublic	Date Visited	Area (sq ft)	Lane Miles *	Surface Type	Condition / PCR
0905A	NonPublic	3/7/2002	1760	0.03	AS	POOR / 45
