The Road Inventory of Tumacacori National Historical Park TUMA – 8690

Prepared By:
Federal Highway Administration
Eastern Federal Lands Highway Division
Cycle 3

Tumacacori National Historical Park in Arizona

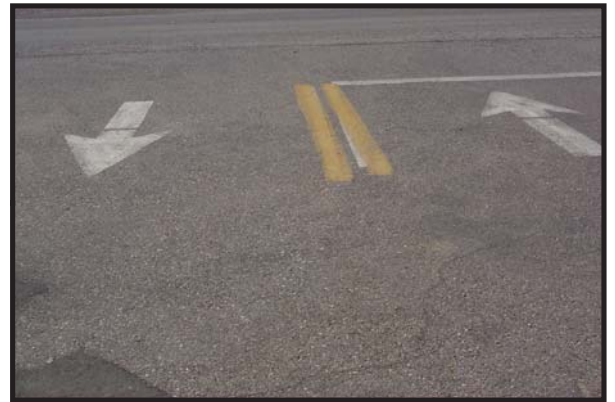
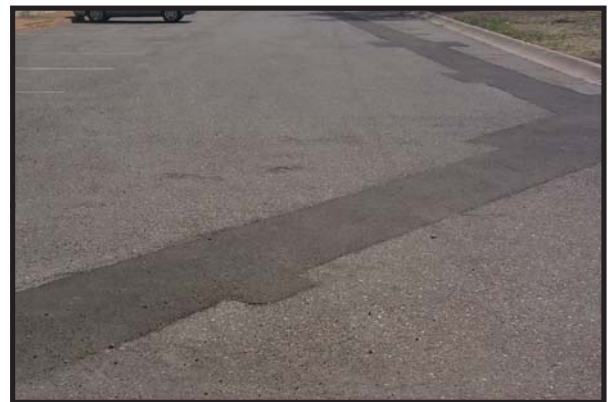
Route	Public / NonPublic	Date Visited	Area (sq ft)	Lane Miles *	Surface Type	Condition / PCR
0900	Public	3/7/2003	34065	0.59	AS	FAIR / 73

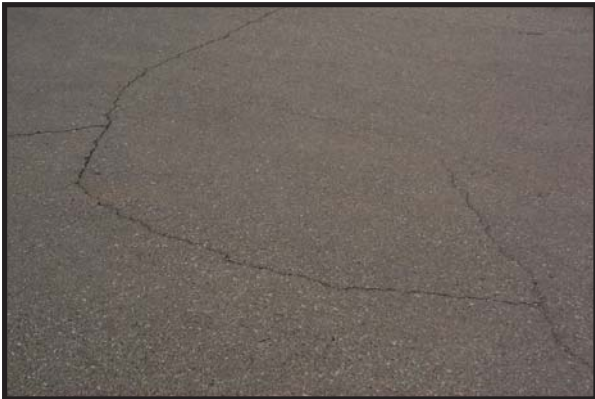
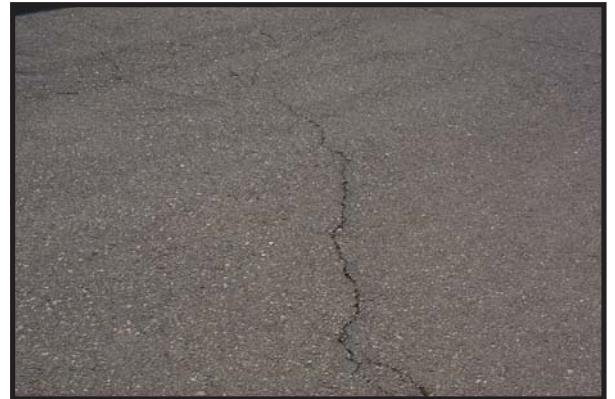
Route 0901

Route	Public / NonPublic	Date Visited	Area (sq ft)	Lane Miles *	Surface Type	Condition / PCR
0901	NonPublic	3/7/2003	5623	0.10	AS	FAIR / 73
