**The Road Inventory
of
Ulysses S. Grant National Historic Site
ULSG - 6519**

Road Inventory Program

Prepared By:
Federal Highway Administration
Eastern Federal Lands Highway Division

Ulysses S. Grant National Historic Site in Missouri

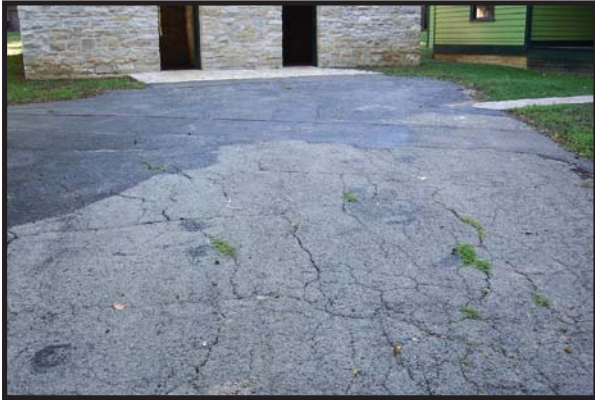
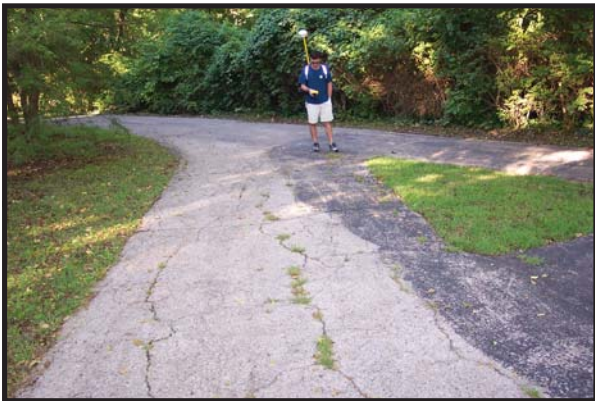
Route 0901

Route	Public / NonPublic	Date Visited	Area (sq ft)	Lane Miles *	Surface Type	Condition / PCR
0901	NonPublic	9/6/2003	1682	0.03	AS	POOR / 45
