**The Road Inventory  
of  
Upper Delaware Scenic and Recreational River  
UPDE - 4870**

**Road Inventory Program**

Prepared By:  
Federal Highway Administration  
Eastern Federal Lands Highway Division  
Cycle 3

# Upper Delaware Scenic and Recreational Area in Pennsylvania

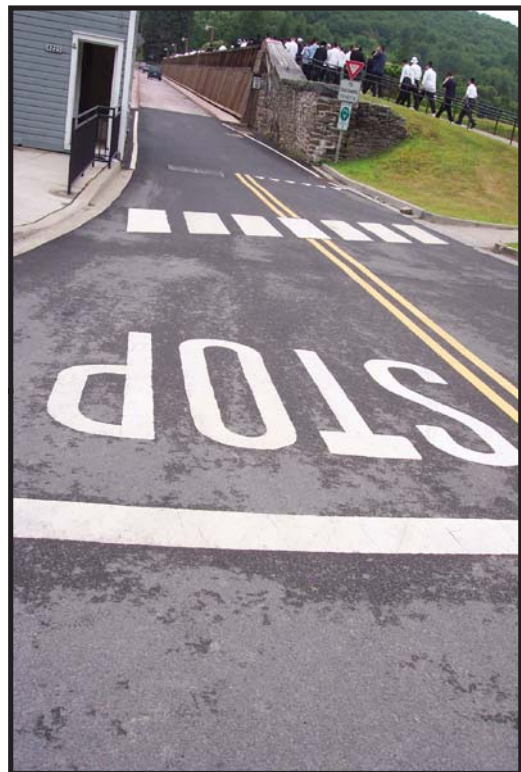
# Upper Delaware Scenic and Recreational River Route 0010

New York Access Road Roebeling Bridge  
From State Highway 97

Route	Length (mi)	Width (ft)	Area (sq ft)	Lane Miles *	Condition / PCR	Surface Type
0010	0.02	18.00	2851	0.05	EXCELLENT / 97	AS

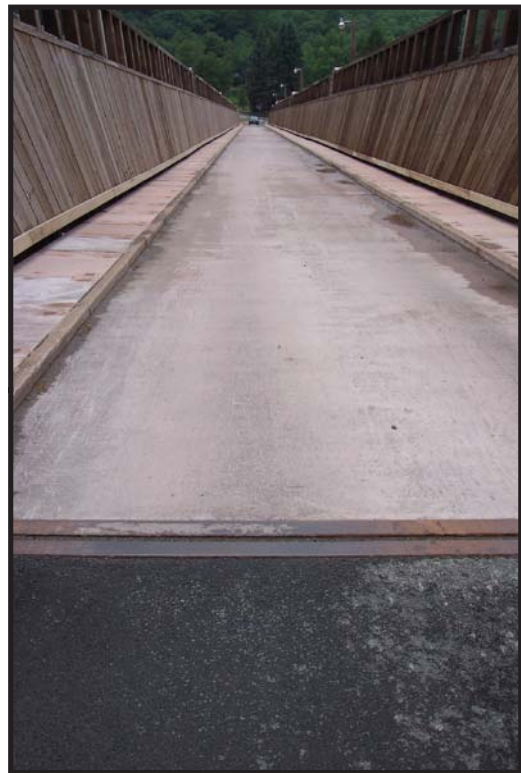
## Route 0011

Roebling Bridge D&H Aqueduct

Route	Length (mi)	Width (ft)	Area (sq ft)	Lane Miles *	Condition / PCR	Surface Type
0011	0.10	11.50	6072	0.10	GOOD / 90	CO

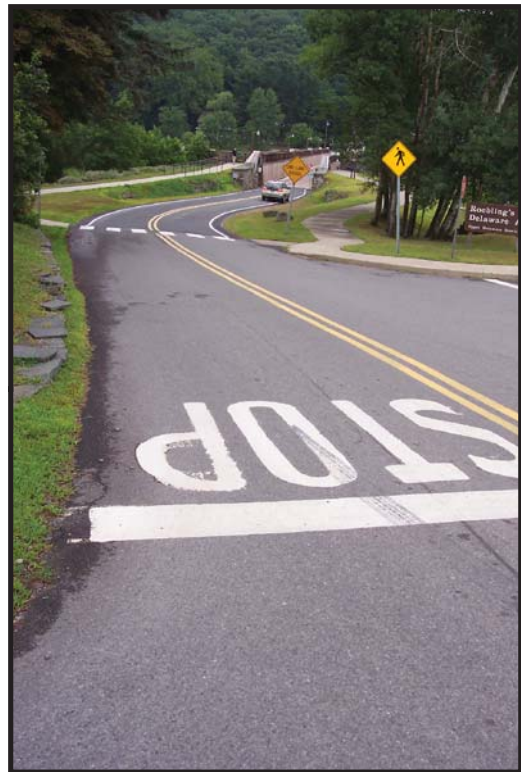
# Upper Delaware Scenic and Recreational River Route 0012

Pennsylvania Access Road Roebling Bridge  
From Route 0011

Route	Length (mi)	Width (ft)	Area (sq ft)	Lane Miles *	Condition / PCR	Surface Type
0012	0.06	21.00	4435	0.08	EXCELLENT / 97	AS

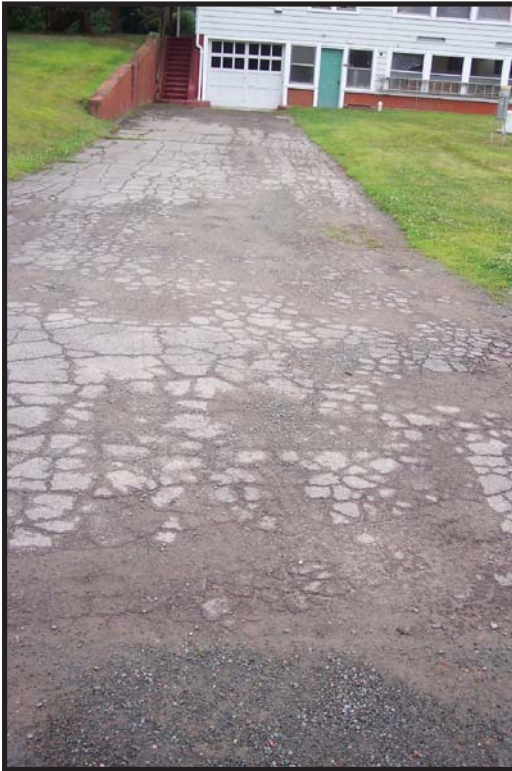
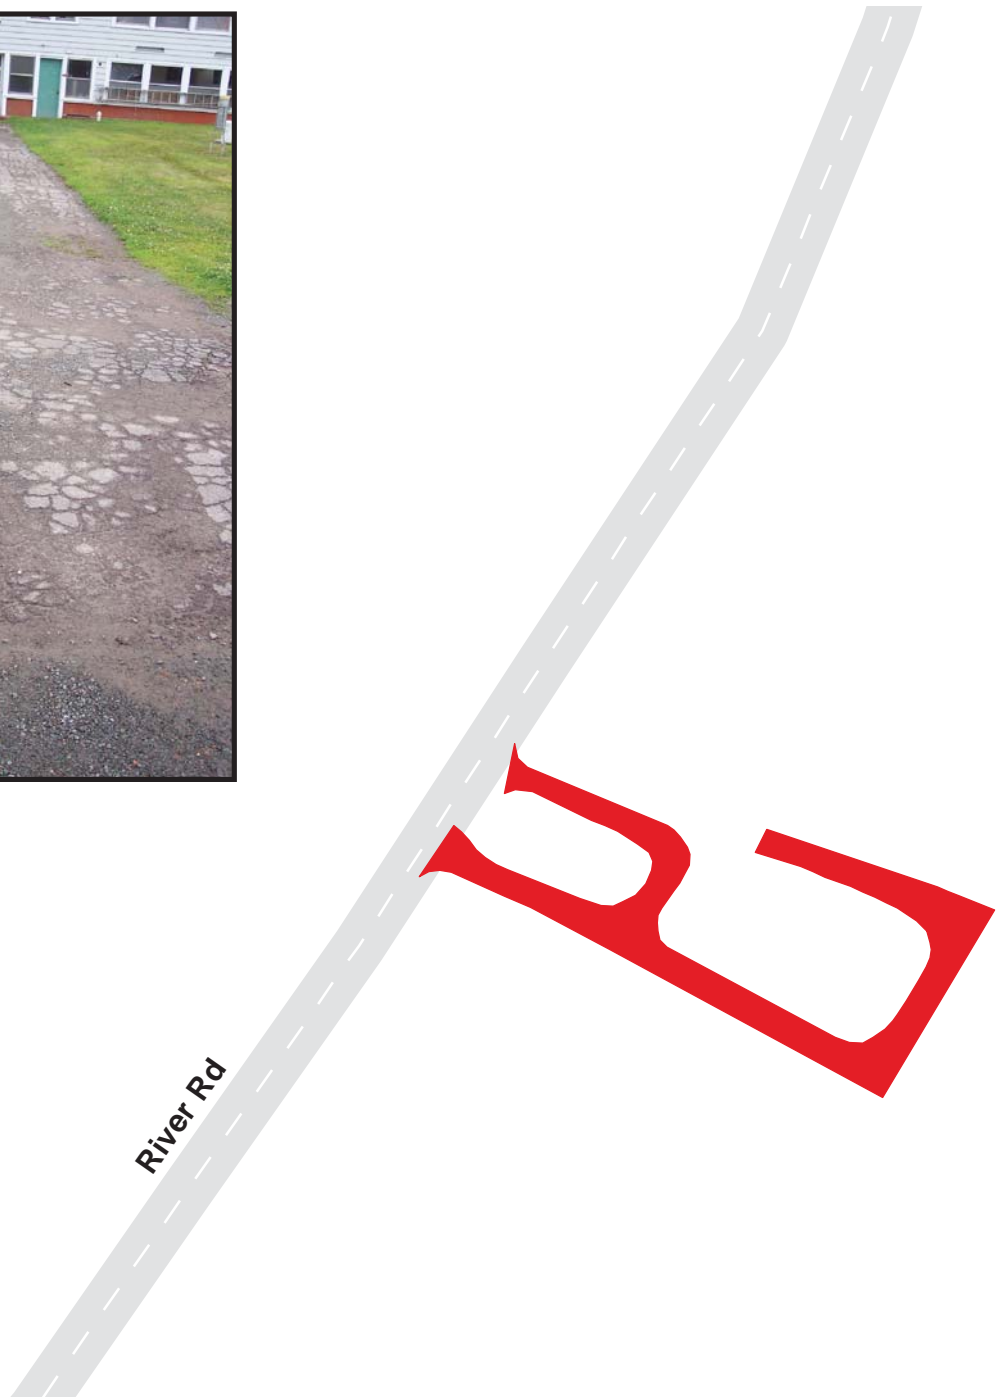
## Route 0901

NORTH DISTRICT RANGER OFFICE

Route	Public / NonPublic	Date Visited	Area (sq ft)	Lane Miles *	Surface Type	Condition / PCR
0901	NonPublic	7/13/2004	6218	0.11	AS	POOR / 45

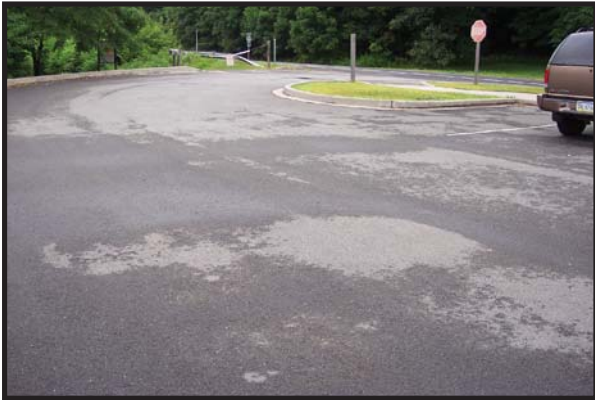
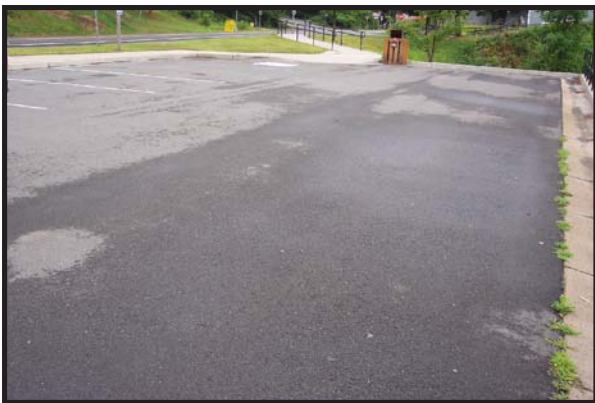
## Route 0903

MINISINK FORD PARKING LOT

Route	Public / NonPublic	Date Visited	Area (sq ft)	Lane Miles *	Surface Type	Condition / PCR
0903	Public	7/13/2004	5846	0.10	AS	GOOD / 90

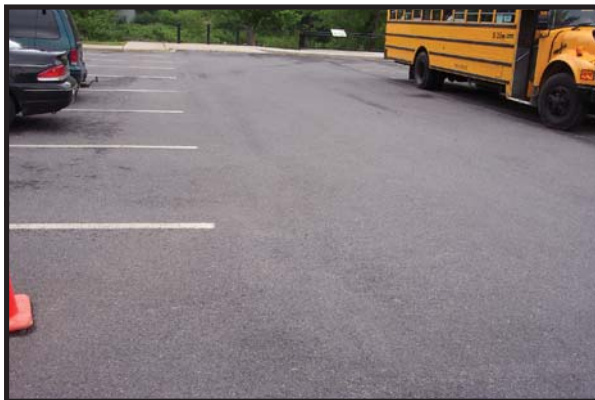
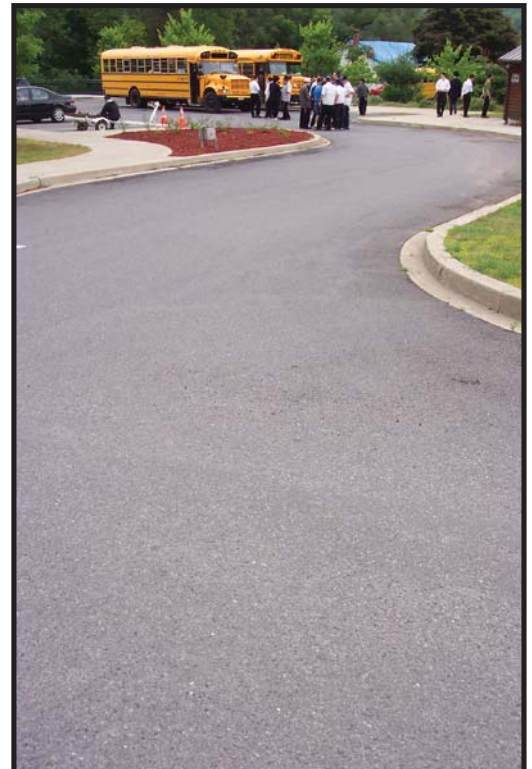
## Route 0904

LACKAWAXEN PARKING LOT

Route	Public / NonPublic	Date Visited	Area (sq ft)	Lane Miles *	Surface Type	Condition / PCR
0904	Public	7/13/2004	7672	0.13	AS	GOOD / 90

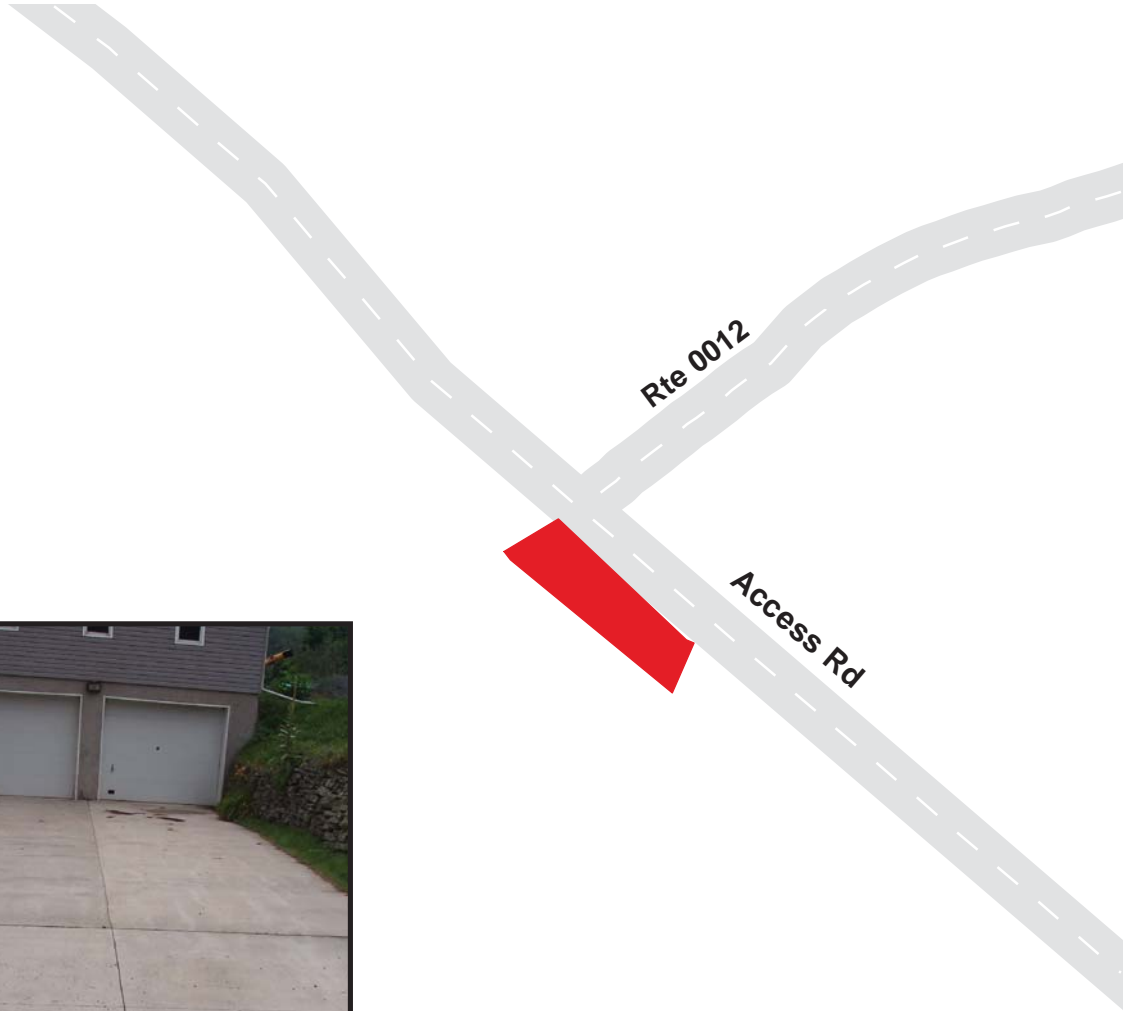
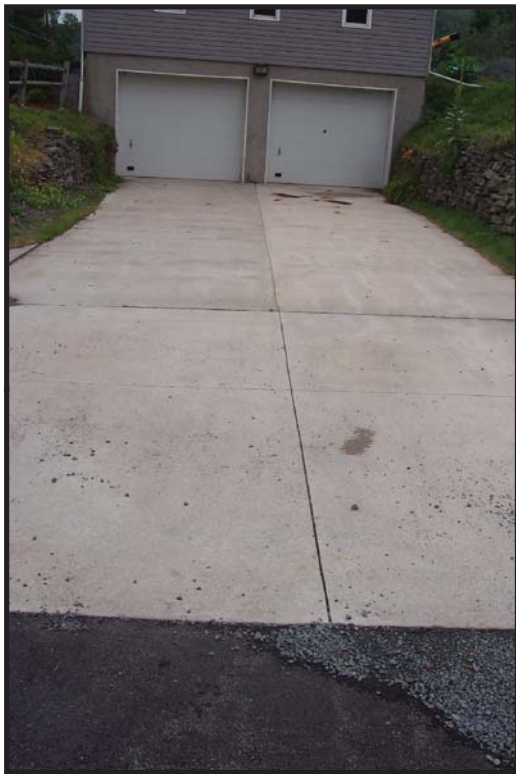
# Upper Delaware Scenic and Recreational River Route 0905

LACKAWAXEN MAINTENANCE OFFICE LOWER DRIVEWAY  
From Access Road

Route	Public / NonPublic	Date Visited	Area (sq ft)	Lane Miles *	Surface Type	Condition / PCR
0905	NonPublic	7/13/2004	1690	0.03	CO	GOOD / 90

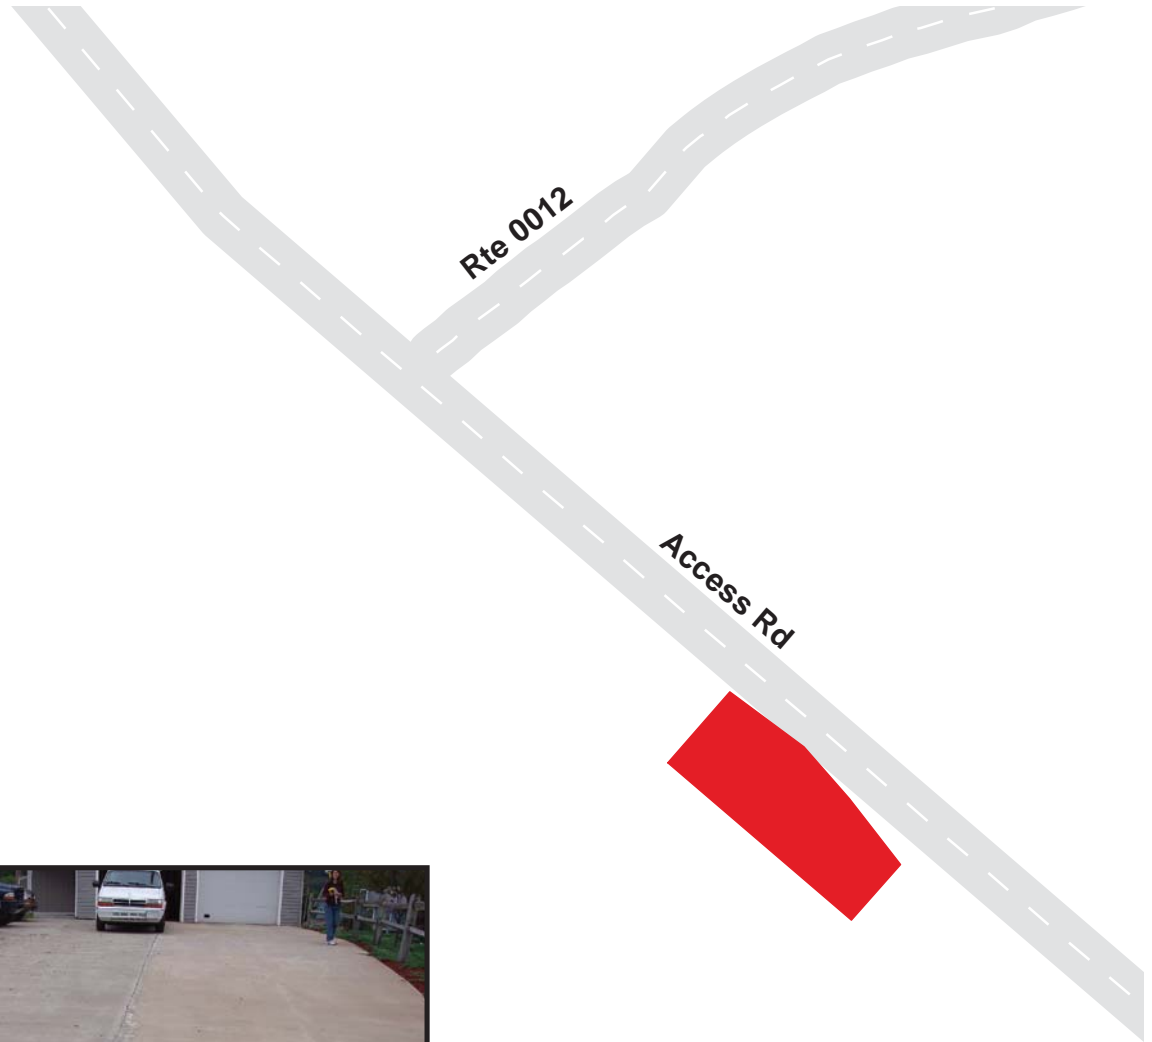
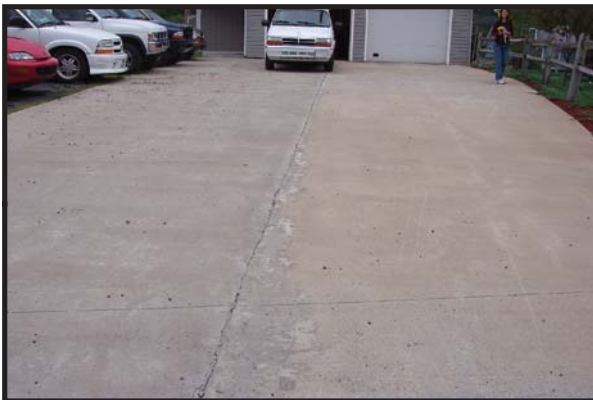
# Upper Delaware Scenic and Recreational River Route 0906

LACKAWAXEN MAINTENANCE OFFICE UPPER DRIVEWAY  
From Access Road

Route	Public / NonPublic	Date Visited	Area (sq ft)	Lane Miles *	Surface Type	Condition / PCR
0906	NonPublic	7/13/2004	2129	0.04	CO	GOOD / 90
