**The Road Inventory  
of  
Valley Forge National Historical Park  
VAFO – 4860**

**Road Inventory Program**

Prepared By:  
Federal Highway Administration  
Eastern Federal Lands Highway Division  
Cycle 3

# Valley Forge National Historical Park in Pennsylvania

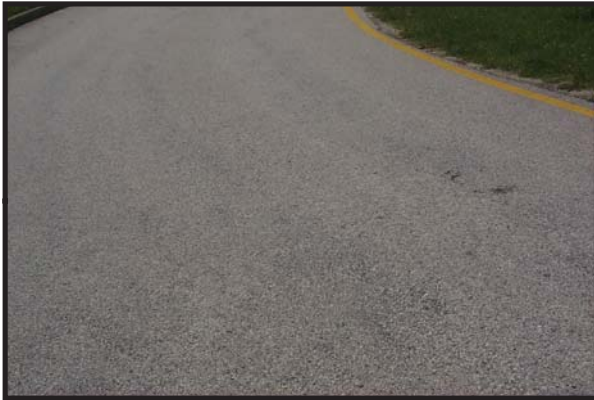
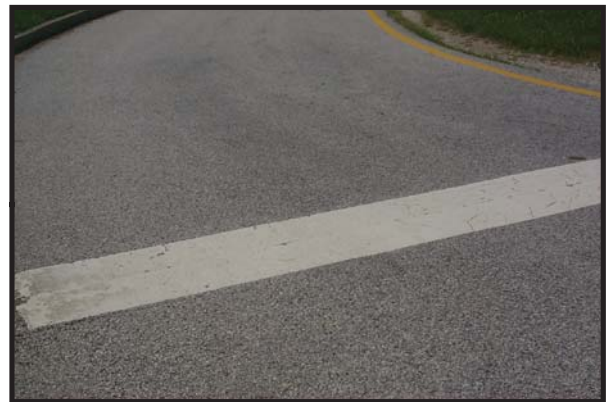
Route	Public / NonPublic	Date Visited	Area (sq ft)	Lane Miles *	Surface Type	Condition / PCR
0900	Public	6/29/2002	9882	0.17	AS	GOOD / 90

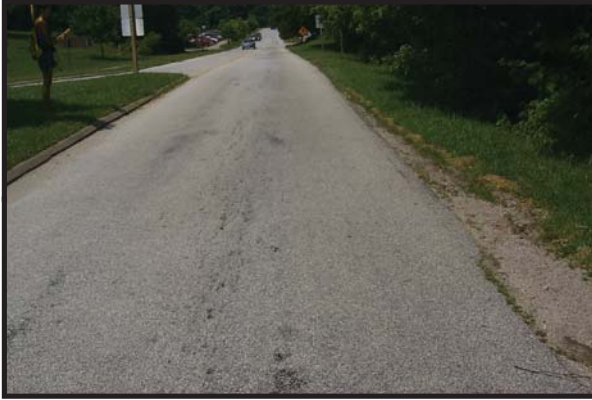
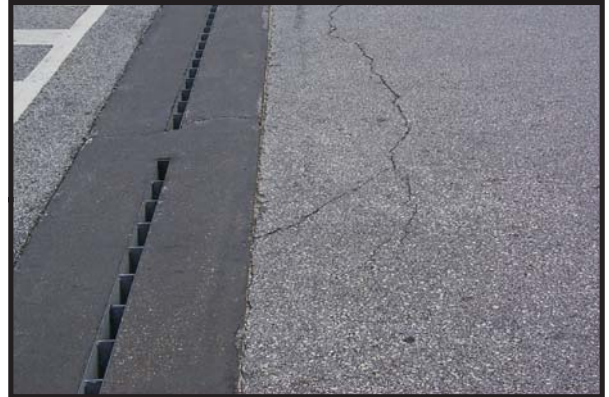
Route	Public / NonPublic	Date Visited	Area (sq ft)	Lane Miles *	Surface Type	Condition / PCR
0901	Public	6/29/2002	203738	3.51	AS	GOOD / 90

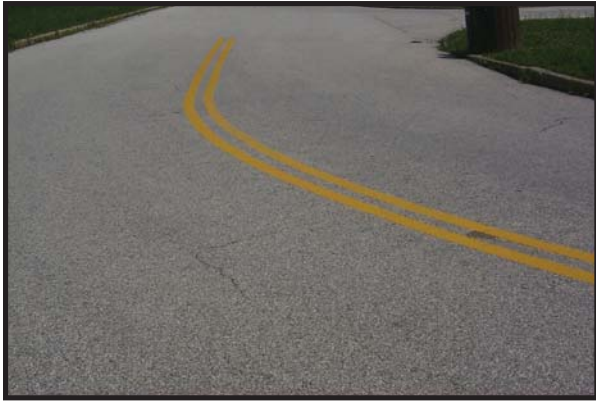
Route	Public / NonPublic	Date Visited	Area (sq ft)	Lane Miles *	Surface Type	Condition / PCR
0903	Public	6/29/2002	58857	1.01	AS	FAIR / 73

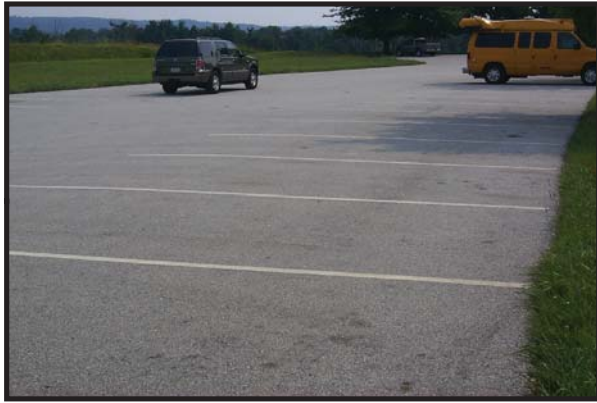
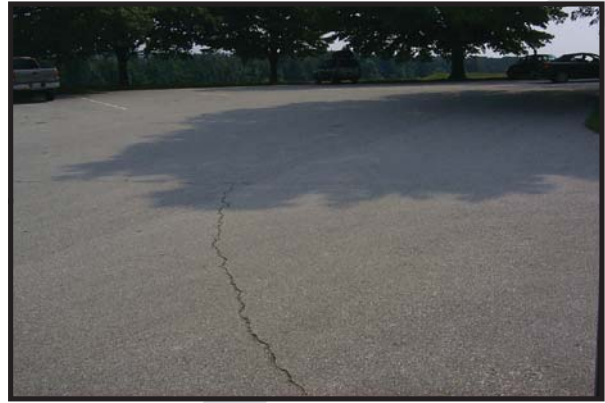
Route	Public / NonPublic	Date Visited	Area (sq ft)	Lane Miles *	Surface Type	Condition / PCR
0904	Public	7/1/2002	24918	0.43	AS	GOOD / 90

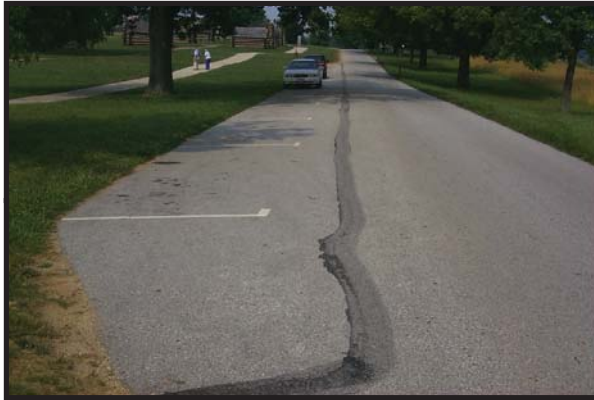
Route	Public / NonPublic	Date Visited	Area (sq ft)	Lane Miles *	Surface Type	Condition / PCR
0905A	Public	7/1/2002	2554	0.04	AS	GOOD / 90

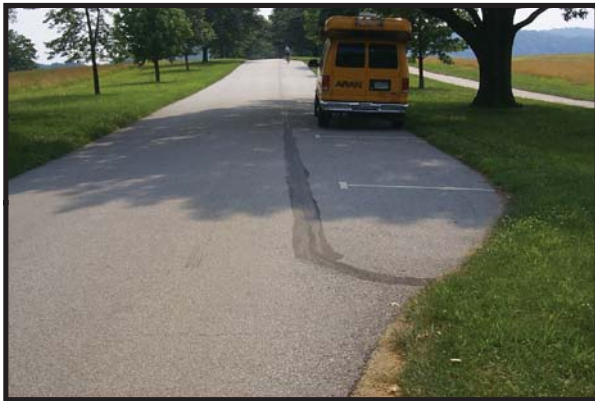
Route	Public / NonPublic	Date Visited	Area (sq ft)	Lane Miles *	Surface Type	Condition / PCR
0905B	Public	7/1/2002	2430	0.04	AS	GOOD / 90

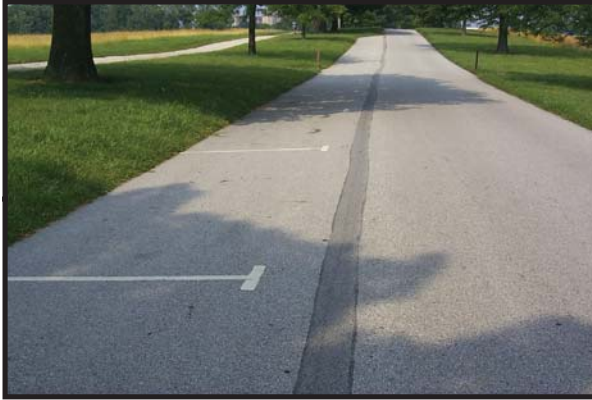
Route	Public / NonPublic	Date Visited	Area (sq ft)	Lane Miles *	Surface Type	Condition / PCR
0905C	Public	7/1/2002	2846	0.05	AS	GOOD / 90

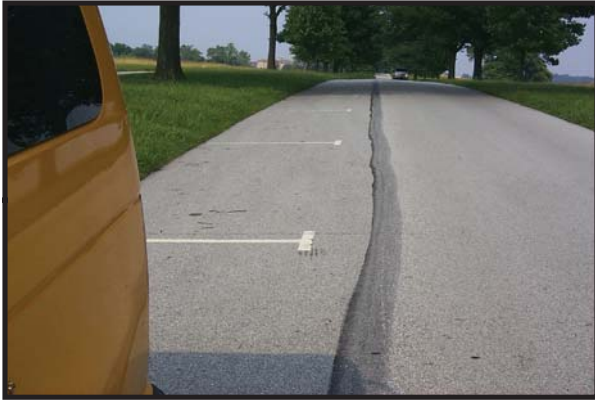
Route	Public / NonPublic	Date Visited	Area (sq ft)	Lane Miles *	Surface Type	Condition / PCR
0905D	Public	7/1/2002	1703	0.03	AS	GOOD / 90

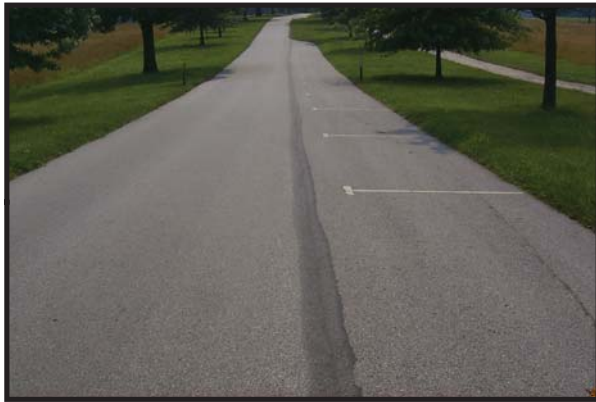
Route	Public / NonPublic	Date Visited	Area (sq ft)	Lane Miles *	Surface Type	Condition / PCR
0905E	Public	7/1/2002	2420	0.04	AS	GOOD / 90

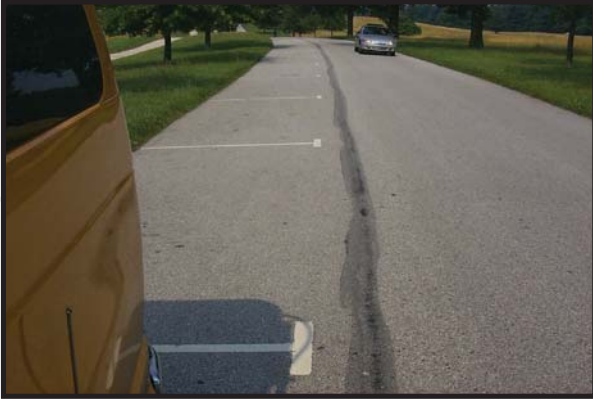
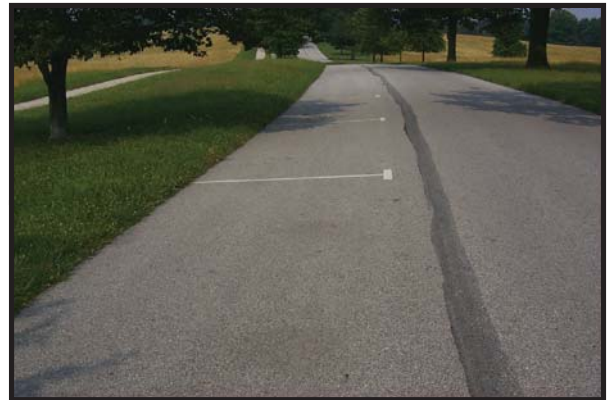
Route	Public / NonPublic	Date Visited	Area (sq ft)	Lane Miles *	Surface Type	Condition / PCR
0905F	Public	7/1/2002	2539	0.04	AS	GOOD / 90

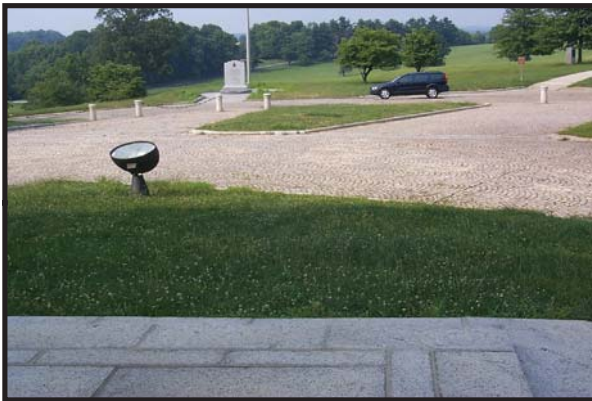
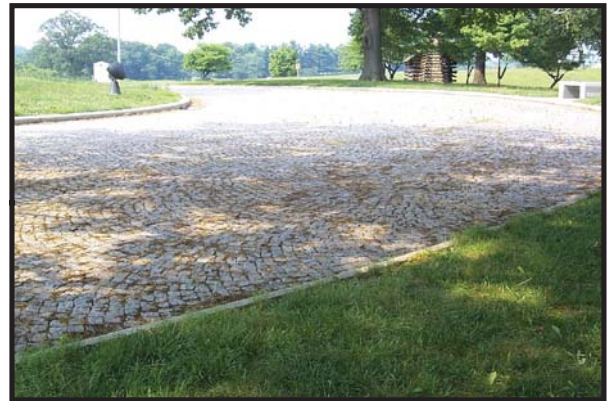
Route	Public / NonPublic	Date Visited	Area (sq ft)	Lane Miles *	Surface Type	Condition / PCR
0906	NonPublic	7/1/2002	33030	0.57	OT	GOOD / 90

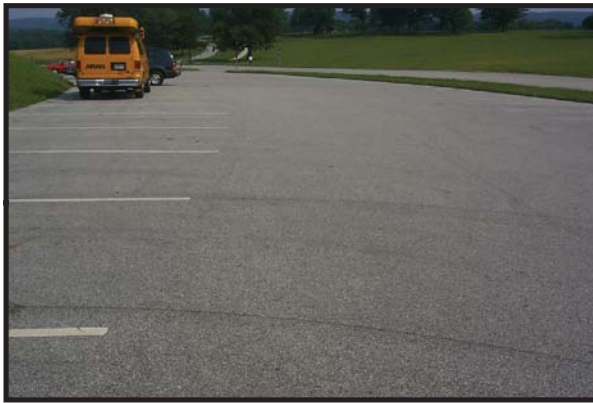
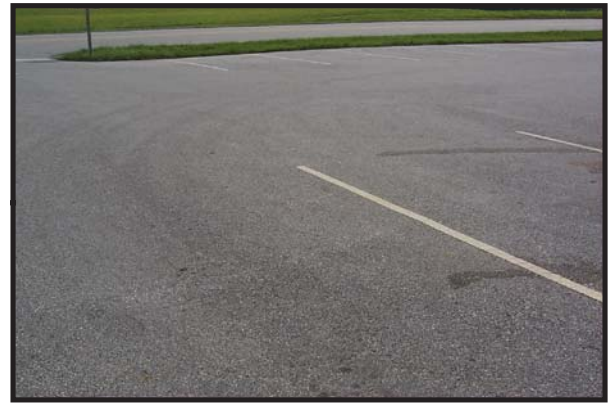
Route	Public / NonPublic	Date Visited	Area (sq ft)	Lane Miles *	Surface Type	Condition / PCR
0907A	Public	7/1/2002	16449	0.28	AS	GOOD / 90

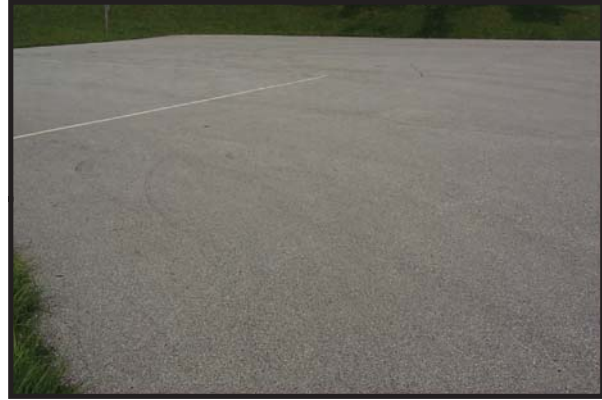
Route	Public / NonPublic	Date Visited	Area (sq ft)	Lane Miles *	Surface Type	Condition / PCR
0907B	Public	7/1/2002	9546	0.16	AS	GOOD / 90

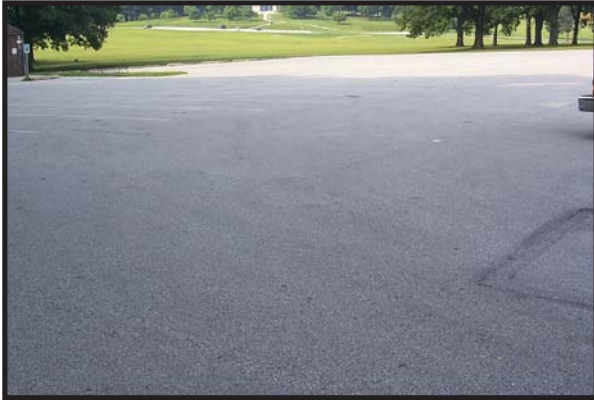
Route	Public / NonPublic	Date Visited	Area (sq ft)	Lane Miles *	Surface Type	Condition / PCR
0908	Public	7/1/2002	38752	0.67	AS	GOOD / 90

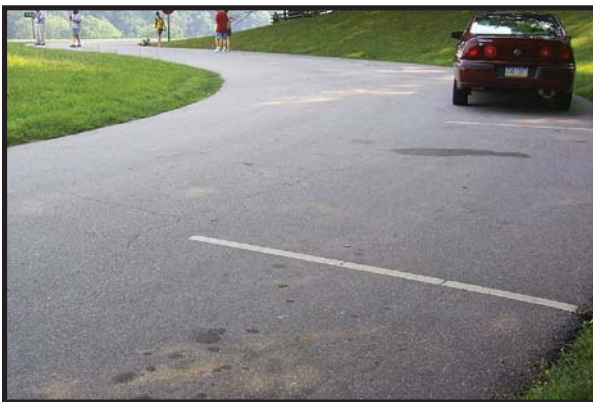
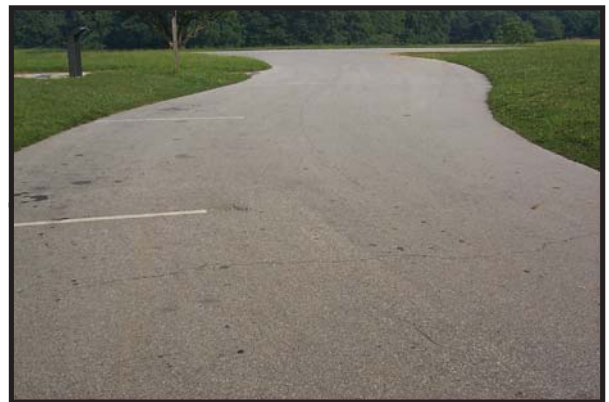
Route	Public / NonPublic	Date Visited	Area (sq ft)	Lane Miles *	Surface Type	Condition / PCR
0909	Public	7/1/2002	7021	0.12	AS	GOOD / 90

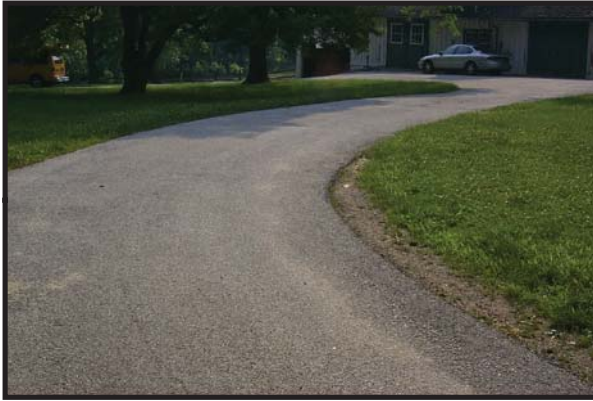
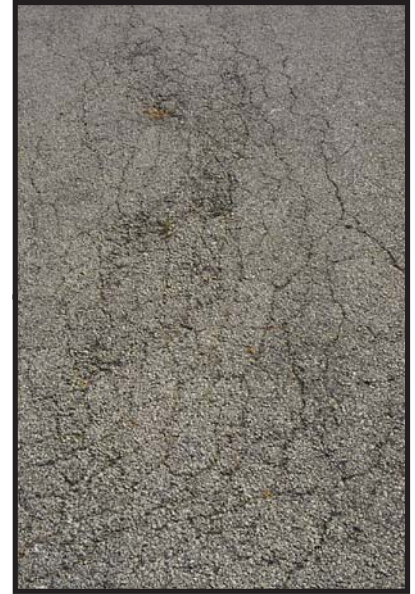
Route	Public / NonPublic	Date Visited	Area (sq ft)	Lane Miles *	Surface Type	Condition / PCR
0911	NonPublic	7/1/2002	10450	0.18	AS	GOOD / 90

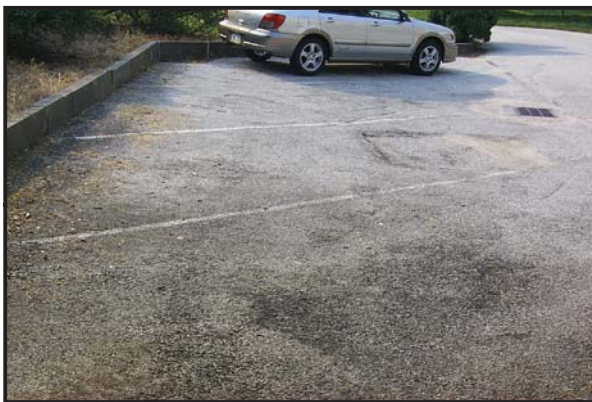
Route	Public / NonPublic	Date Visited	Area (sq ft)	Lane Miles *	Surface Type	Condition / PCR
0913	Public	7/1/2002	907	0.02	AS	FAIR / 73

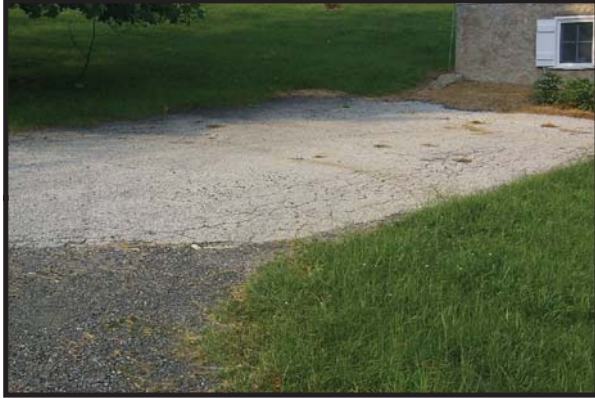
Route	Public / NonPublic	Date Visited	Area (sq ft)	Lane Miles *	Surface Type	Condition / PCR
0914	NonPublic	7/1/2002	1921	0.03	AS	POOR / 45

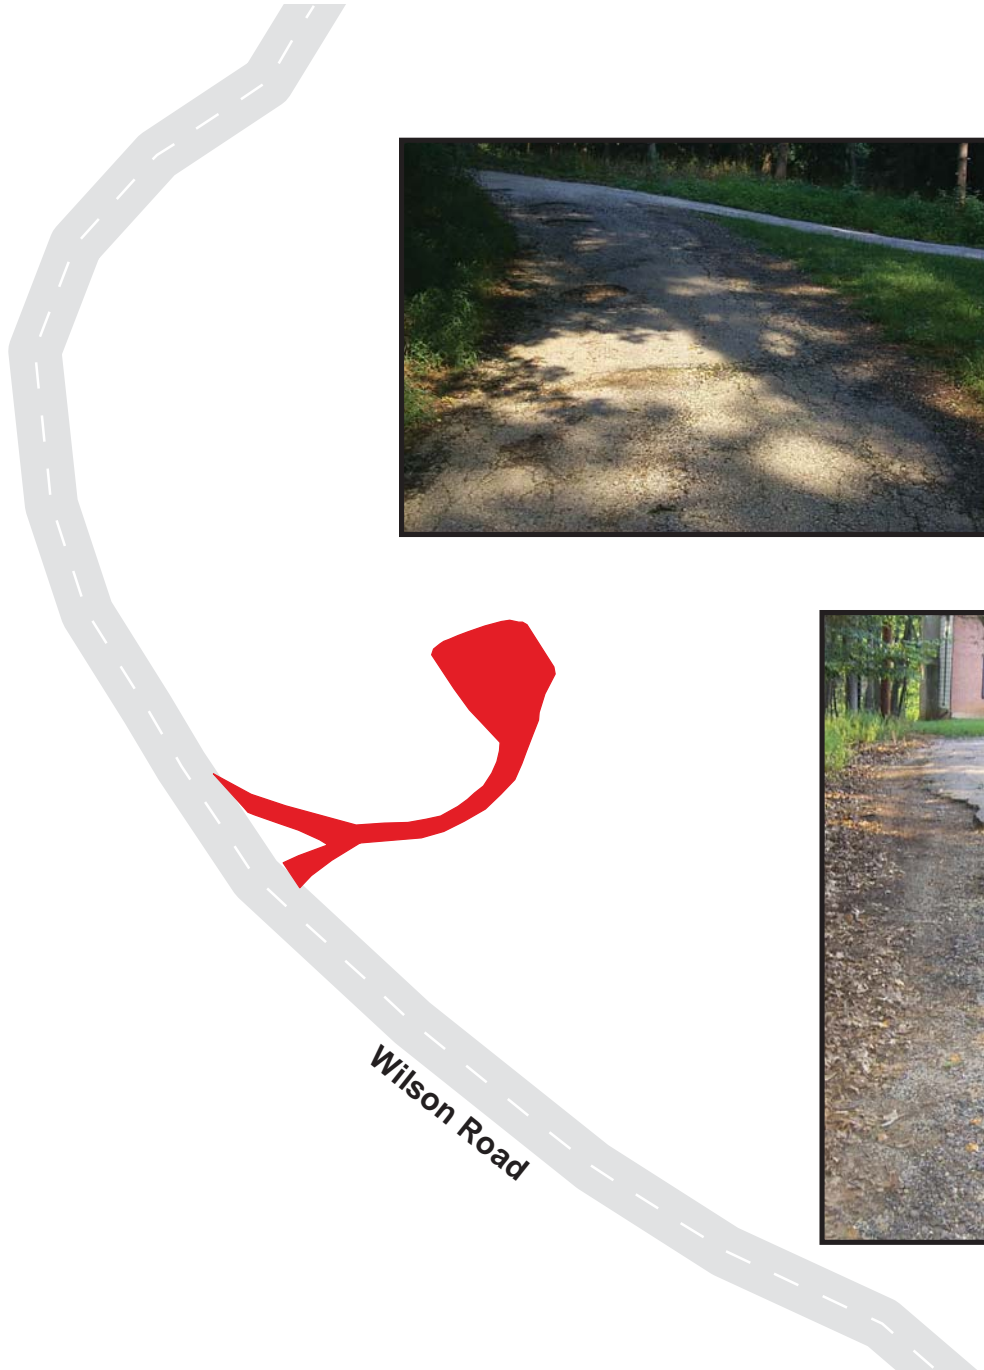
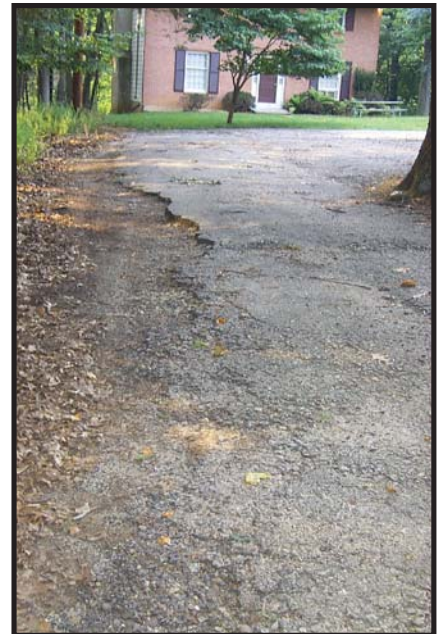
## Route 0916

Route	Public / NonPublic	Date Visited	Area (sq ft)	Lane Miles *	Surface Type	Condition / PCR
0916	NonPublic	7/1/2002	5403	0.09	AS	POOR / 45

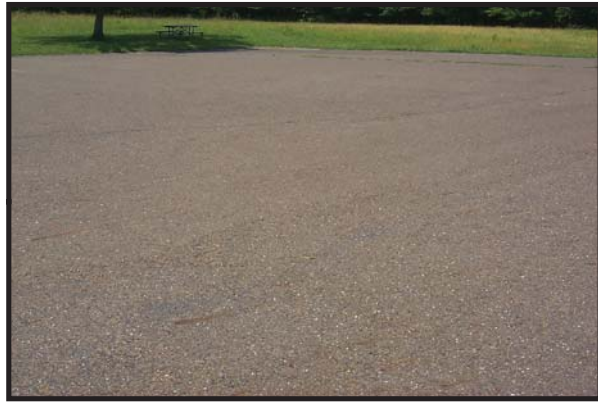
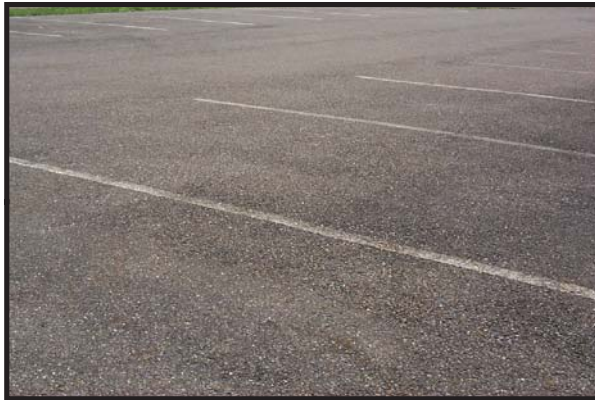
Route	Public / NonPublic	Date Visited	Area (sq ft)	Lane Miles *	Surface Type	Condition / PCR
0917	Public	6/29/2002	28102	0.48	AS	FAIR / 73

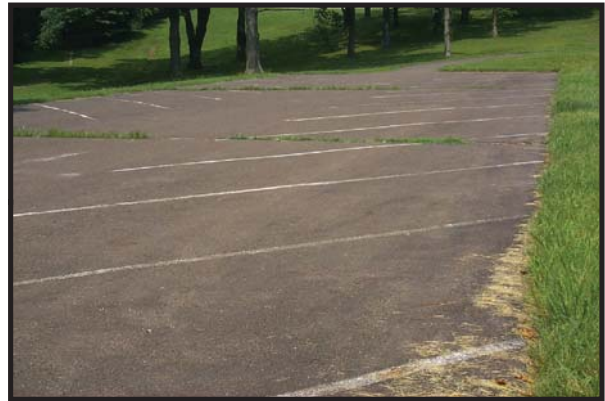
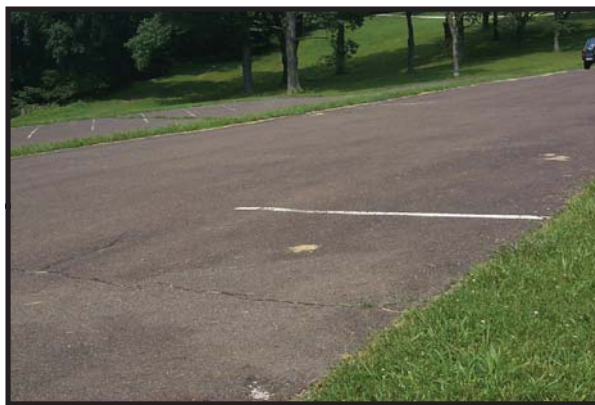
Route	Public / NonPublic	Date Visited	Area (sq ft)	Lane Miles *	Surface Type	Condition / PCR
0918A	Public	6/29/2002	21912	0.38	AS	GOOD / 90

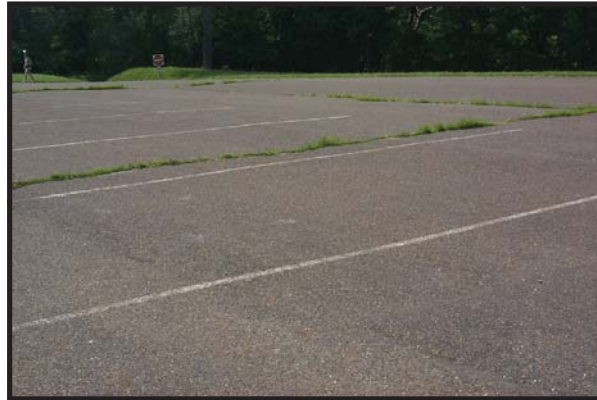
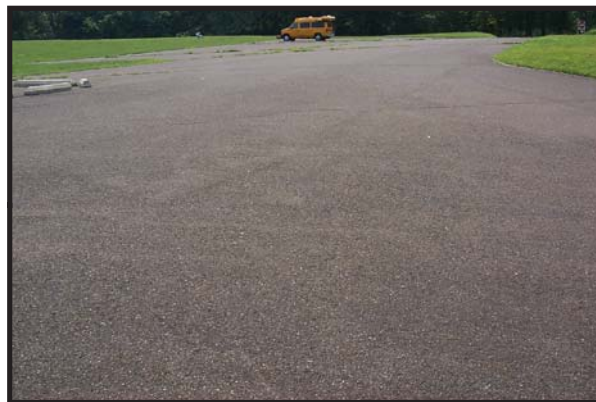
Route	Public / NonPublic	Date Visited	Area (sq ft)	Lane Miles *	Surface Type	Condition / PCR
0918B	Public	6/29/2002	25774	0.44	AS	FAIR / 73

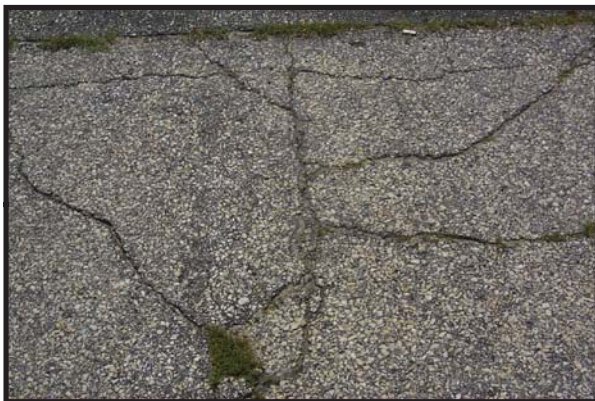
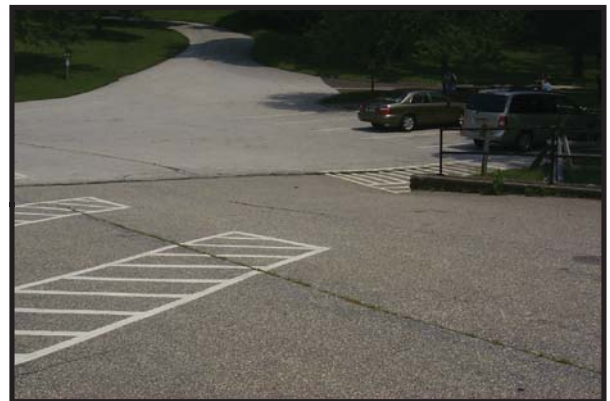
Route	Public / NonPublic	Date Visited	Area (sq ft)	Lane Miles *	Surface Type	Condition / PCR
0919	Public	6/29/2002	11202	0.19	AS	GOOD / 90

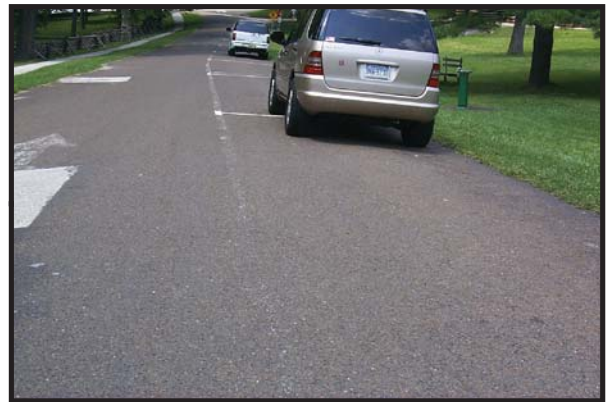
## Route 0920

Route	Public / NonPublic	Date Visited	Area (sq ft)	Lane Miles *	Surface Type	Condition / PCR
0920	Public	6/29/2002	5198	0.09	AS	POOR / 45

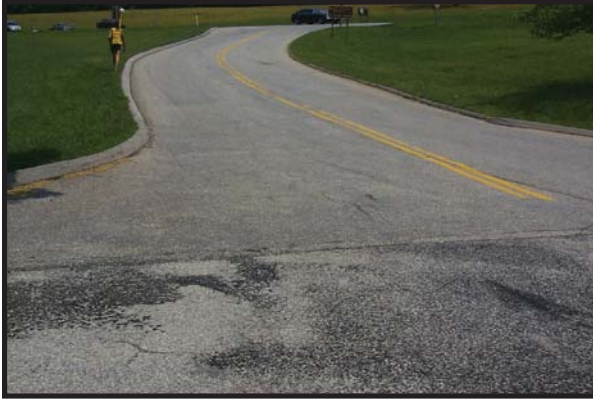
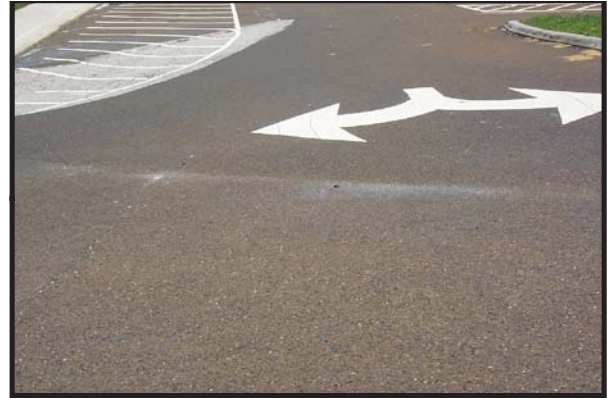
## Route 0921

Route	Public / NonPublic	Date Visited	Area (sq ft)	Lane Miles *	Surface Type	Condition / PCR
0921	Public	6/29/2002	72122	1.24	AS	POOR / 45

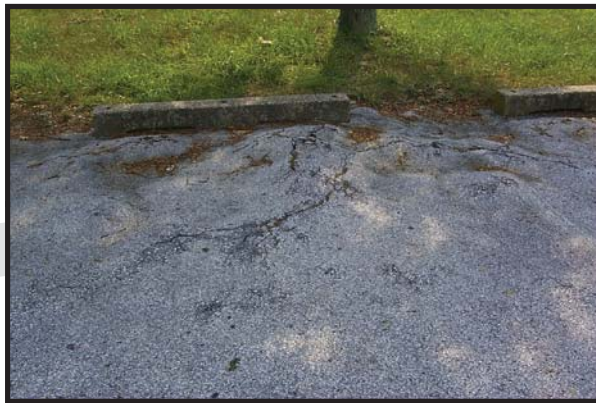
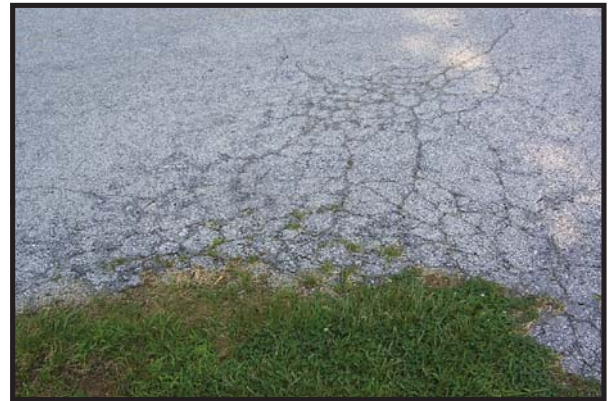
Route	Public / NonPublic	Date Visited	Area (sq ft)	Lane Miles *	Surface Type	Condition / PCR
0924	Public	6/29/2002	32305	0.56	AS	FAIR / 73

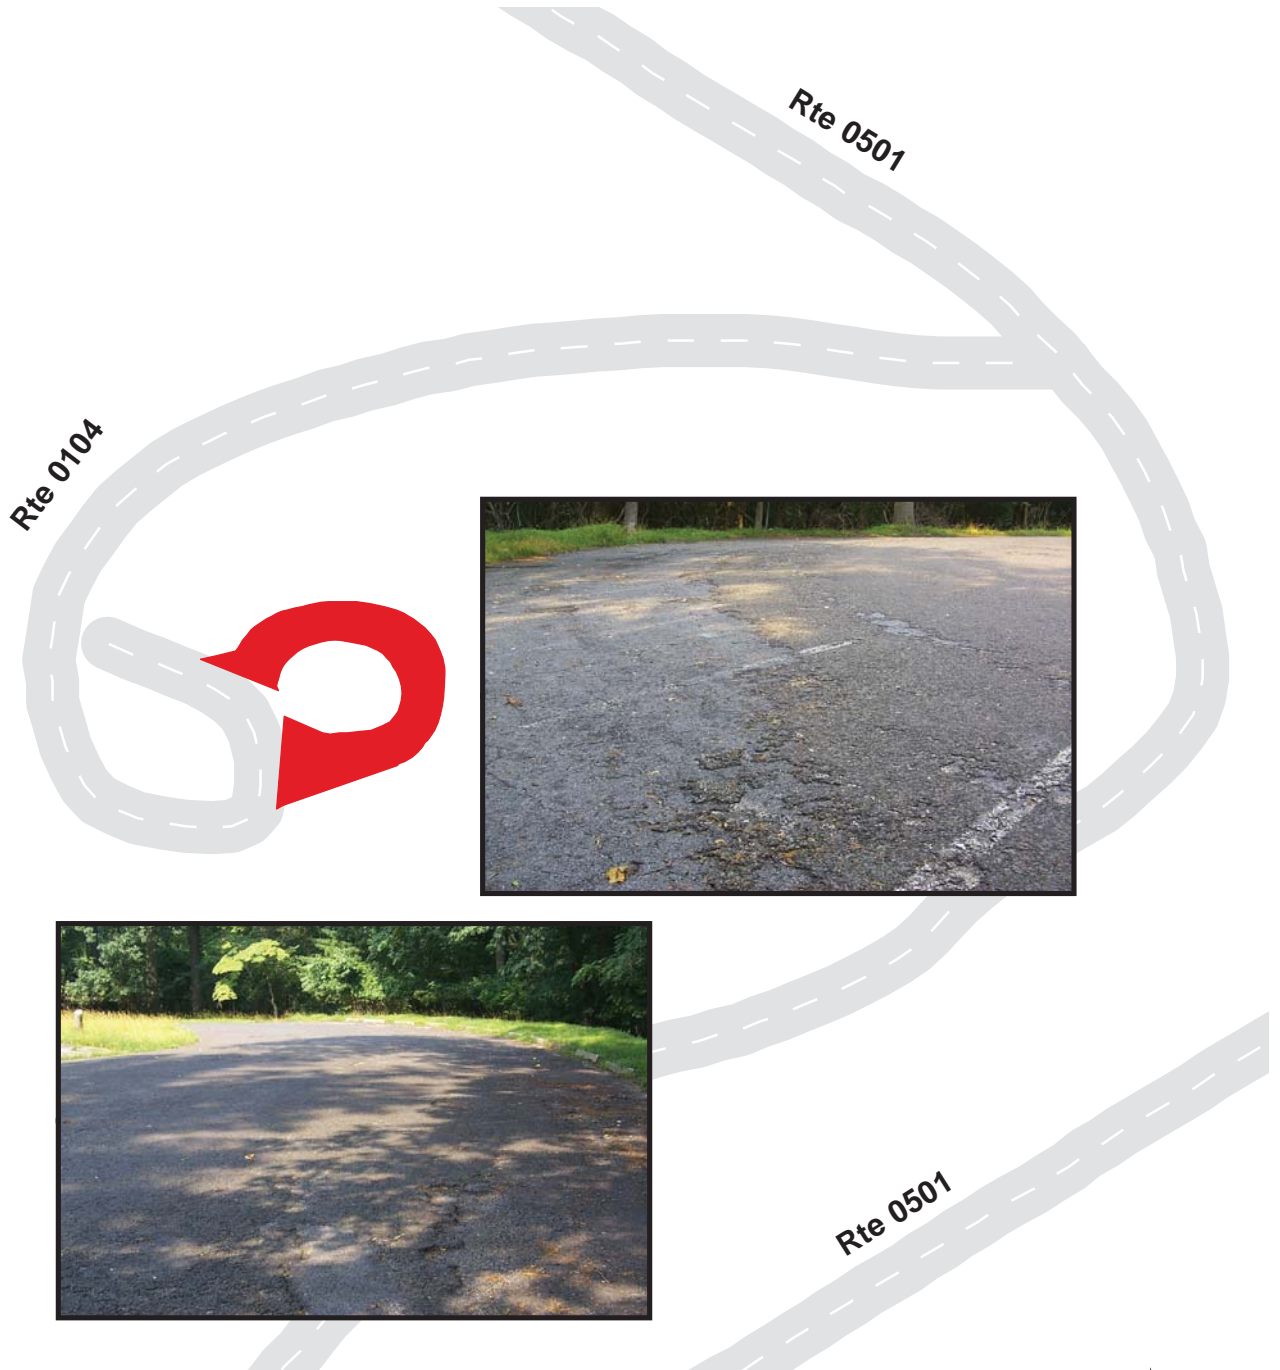
## Route 0925B

Route	Public / NonPublic	Date Visited	Area (sq ft)	Lane Miles *	Surface Type	Condition / PCR
0925B	Public	6/29/2002	11279	0.19	AS	POOR / 45

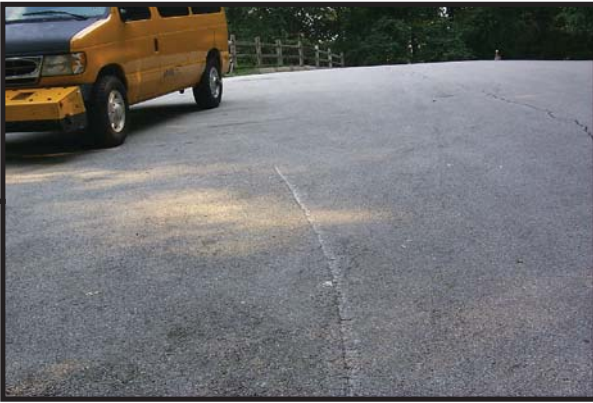
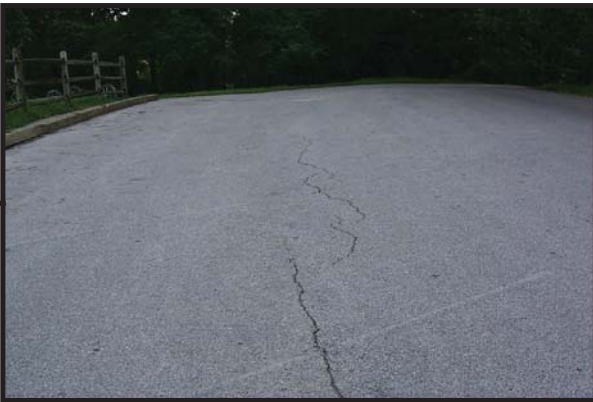
Route	Public / NonPublic	Date Visited	Area (sq ft)	Lane Miles *	Surface Type	Condition / PCR
0926	Public	6/29/2002	5155	0.09	AS	FAIR / 73

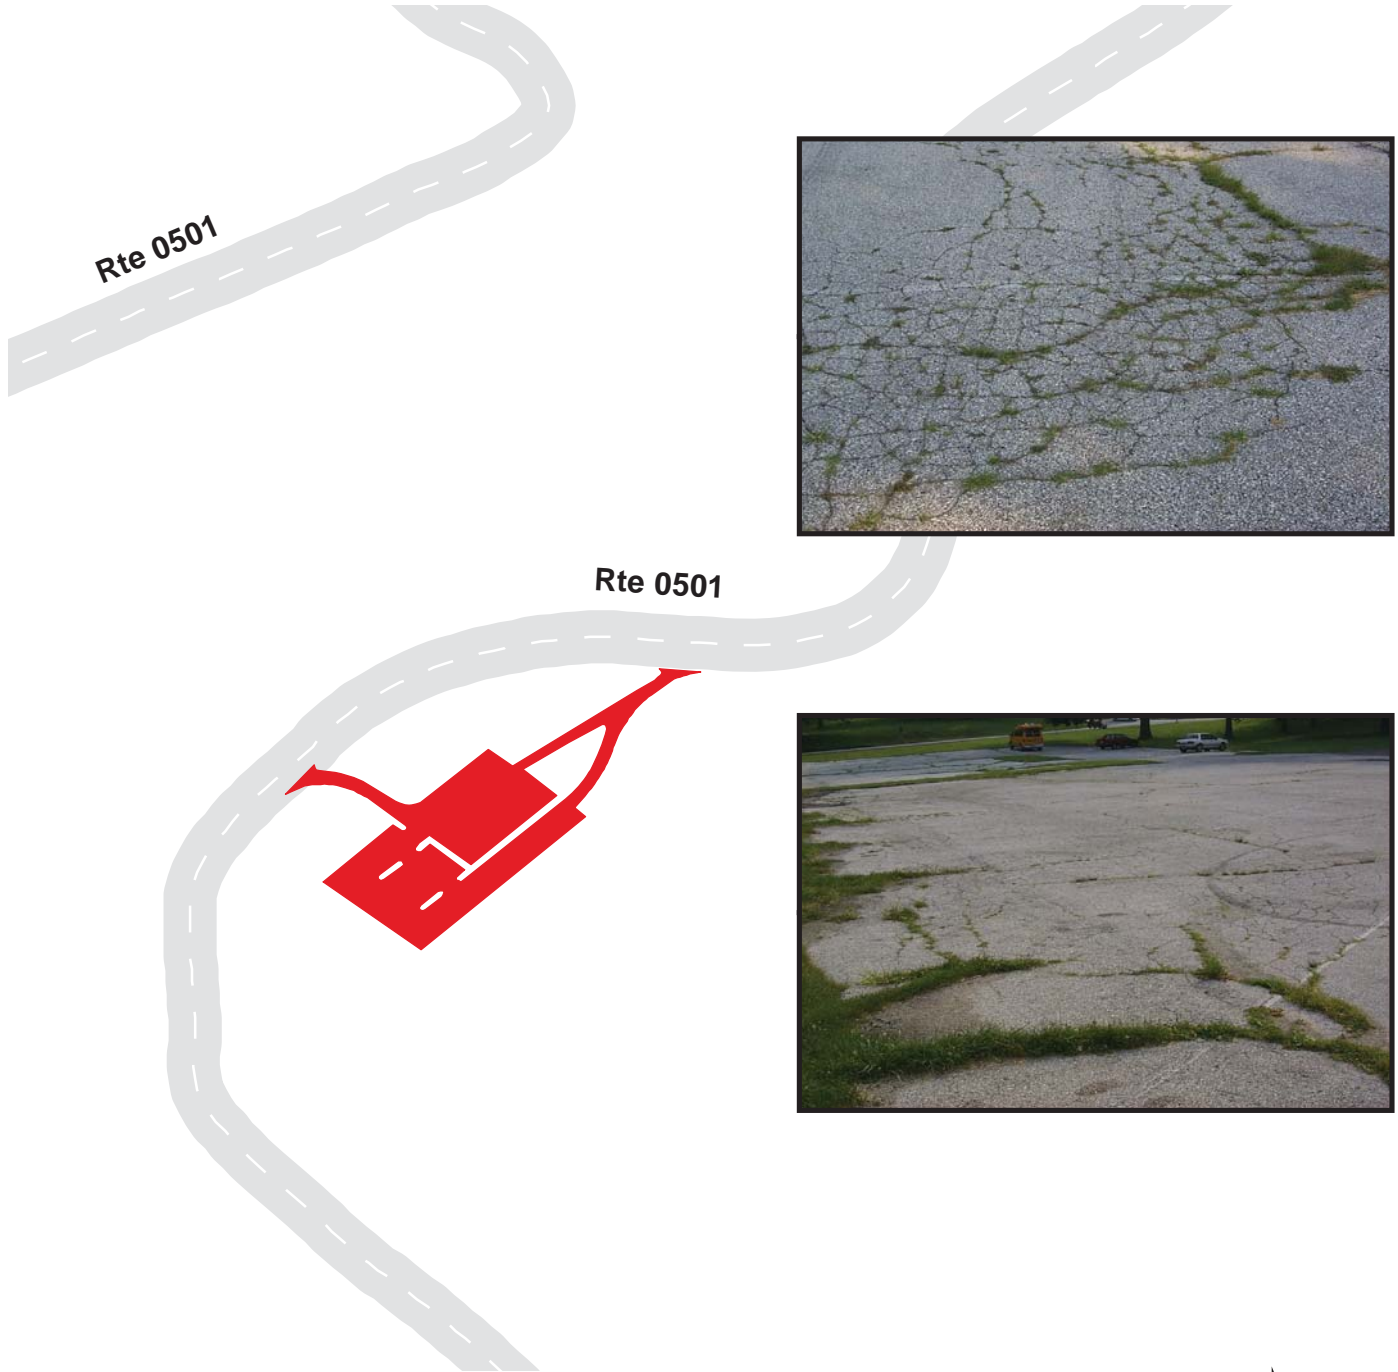
## Route 0928

Route	Public / NonPublic	Date Visited	Area (sq ft)	Lane Miles *	Surface Type	Condition / PCR
0928	Public	6/29/2002	46874	0.81	AS	POOR / 45

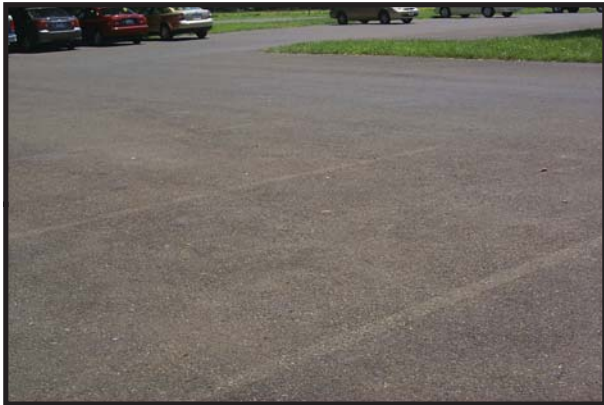
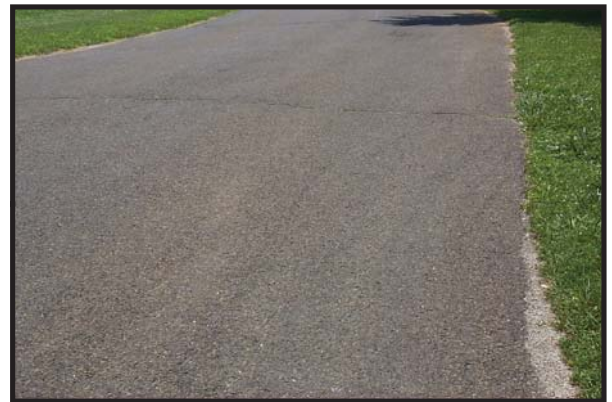
## Route 0930

Route	Public / NonPublic	Date Visited	Area (sq ft)	Lane Miles *	Surface Type	Condition / PCR
0930	Public	6/29/2002	37527	0.65	AS	FAIR / 73

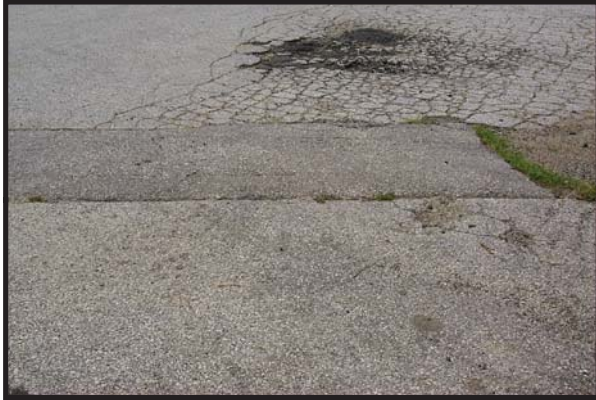
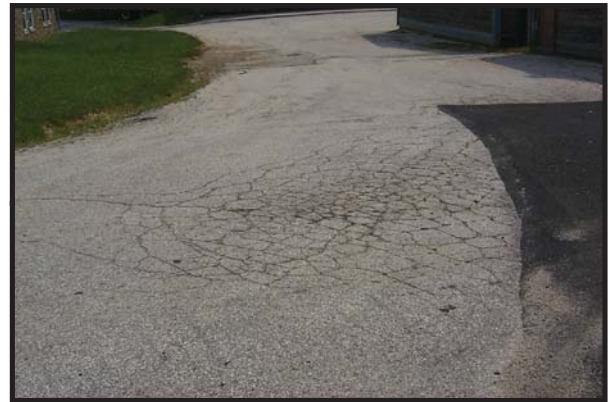
## Route 0932

Route	Public / NonPublic	Date Visited	Area (sq ft)	Lane Miles *	Surface Type	Condition / PCR
0932	NonPublic	7/1/2002	71344	1.23	AS	FAIR / 73

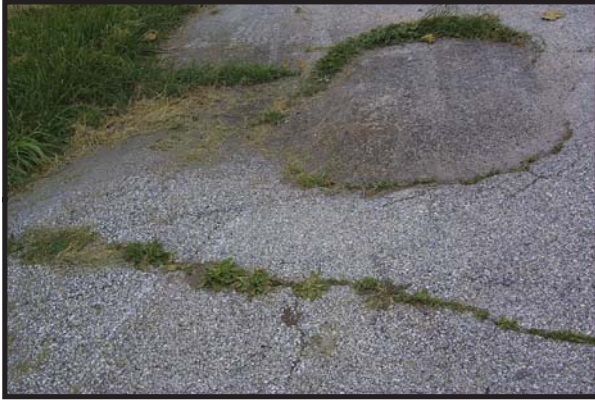
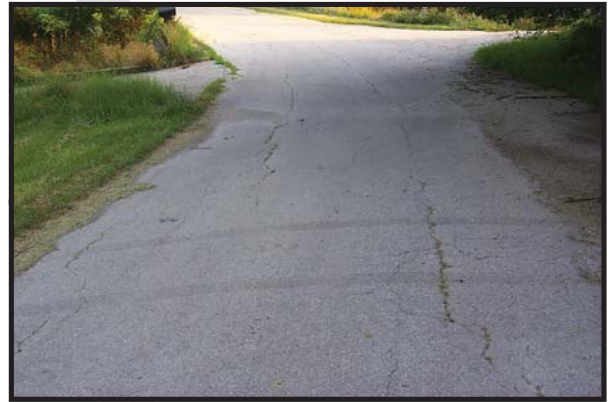
## Route 0934

Route	Public / NonPublic	Date Visited	Area (sq ft)	Lane Miles *	Surface Type	Condition / PCR
0934	Public	7/1/2002	20500	0.35	AS	FAIR / 73

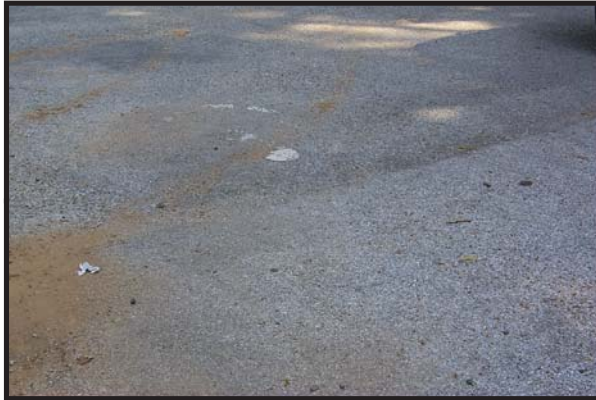
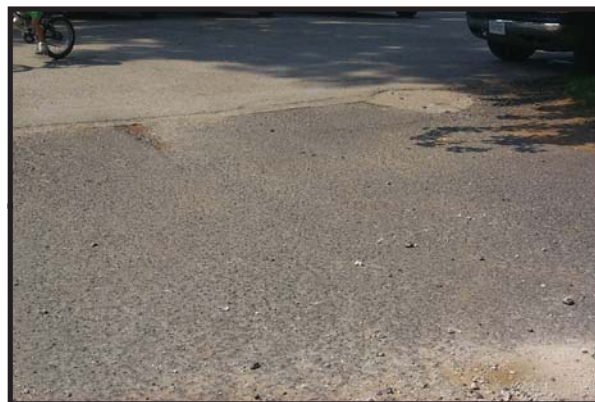
## Route 0938A

Route	Public / NonPublic	Date Visited	Area (sq ft)	Lane Miles *	Surface Type	Condition / PCR
0938A	Public	7/1/2002	3429	0.06	AS	GOOD / 90

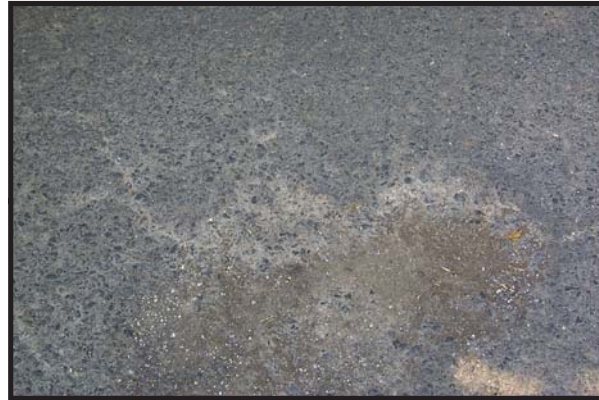
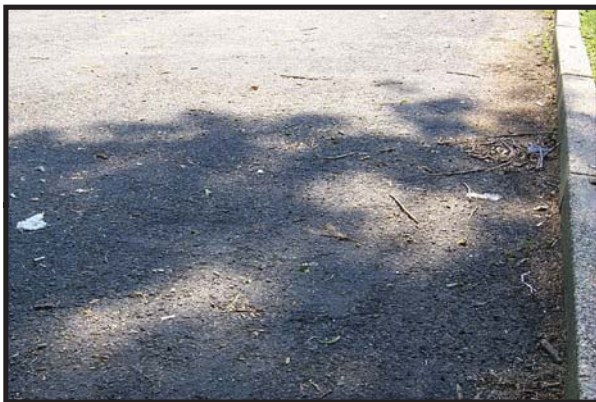
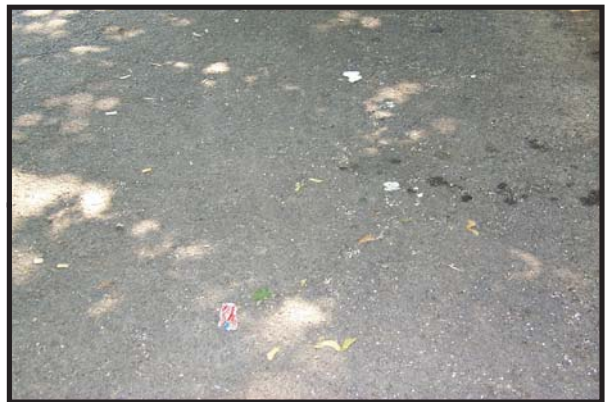
## Route 0938B

Route	Public / NonPublic	Date Visited	Area (sq ft)	Lane Miles *	Surface Type	Condition / PCR
0938B	Public	7/1/2002	5405	0.09	AS	POOR / 45

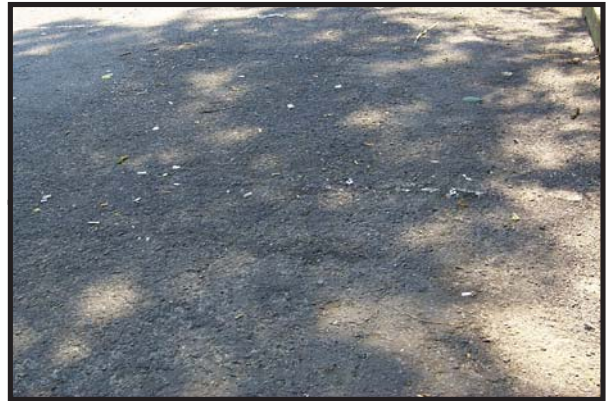
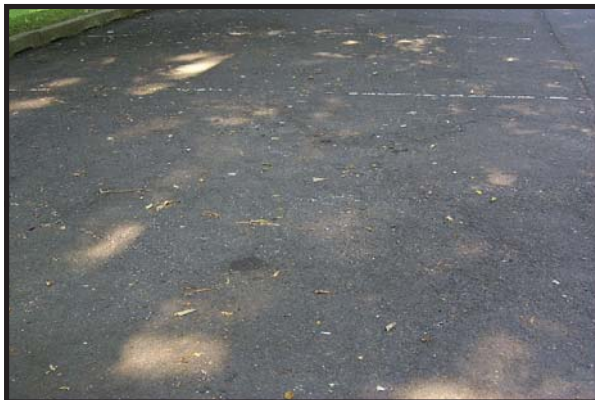
## Route 0938C

Route	Public / NonPublic	Date Visited	Area (sq ft)	Lane Miles *	Surface Type	Condition / PCR
0938C	Public	7/1/2002	4774	0.08	AS	FAIR / 73

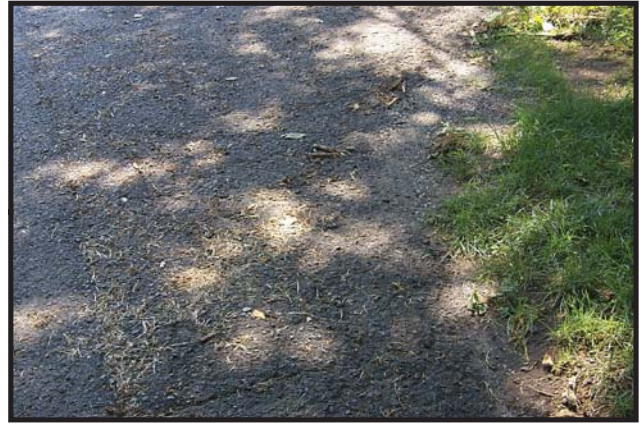
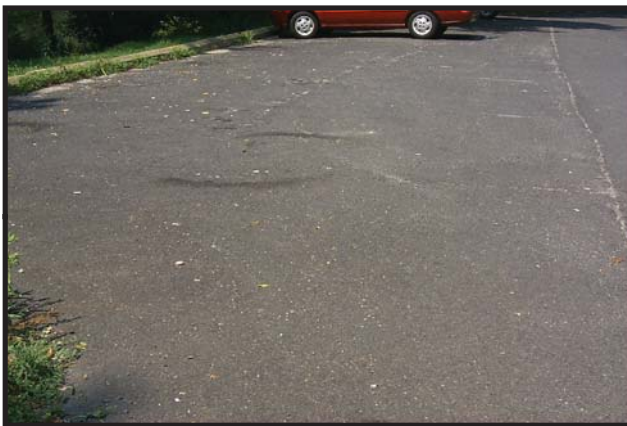
## Route 0938D

Route	Public / NonPublic	Date Visited	Area (sq ft)	Lane Miles *	Surface Type	Condition / PCR
0938D	Public	7/1/2002	2691	0.05	AS	FAIR / 73

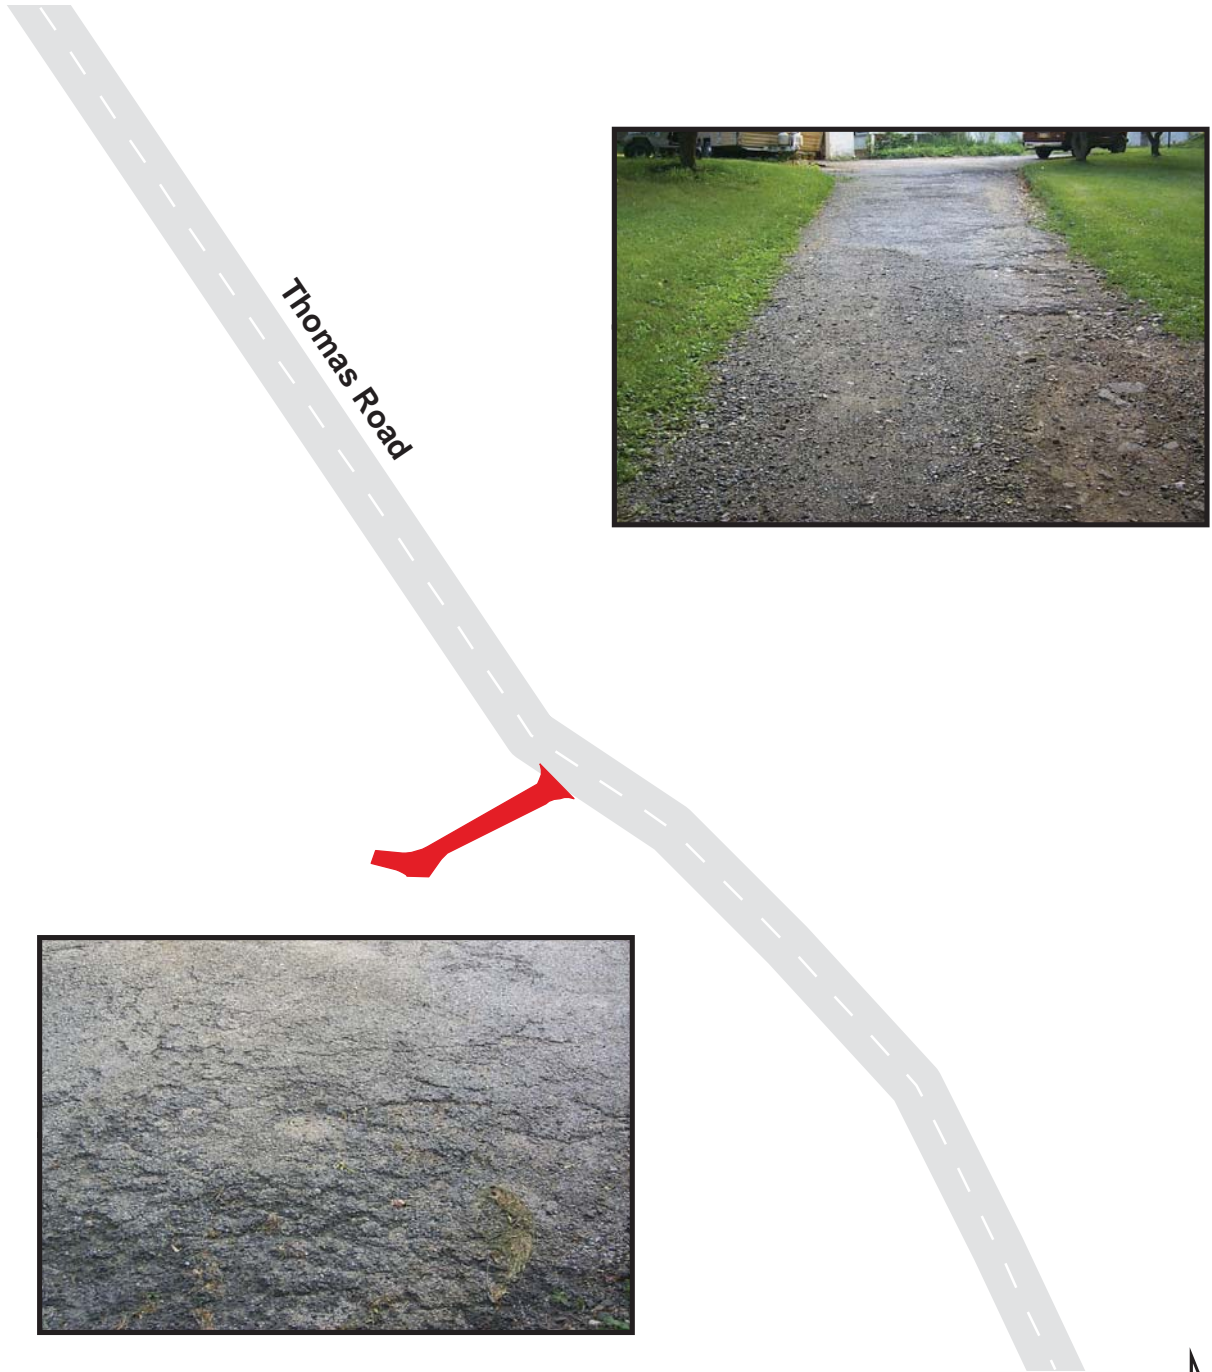
## Route 0942

Route	Public / NonPublic	Date Visited	Area (sq ft)	Lane Miles *	Surface Type	Condition / PCR
0942	NonPublic	7/1/2002	2969	0.05	AS	POOR / 45
