**The Road Inventory
of
Vanderbilt Mansion National Historic Site
VAMA – 1797**

Road Inventory Program

Prepared By:
Federal Highway Administration
Eastern Federal Lands Highway Division
Cycle 3

Vanderbilt Mansion National Historic Site in New York

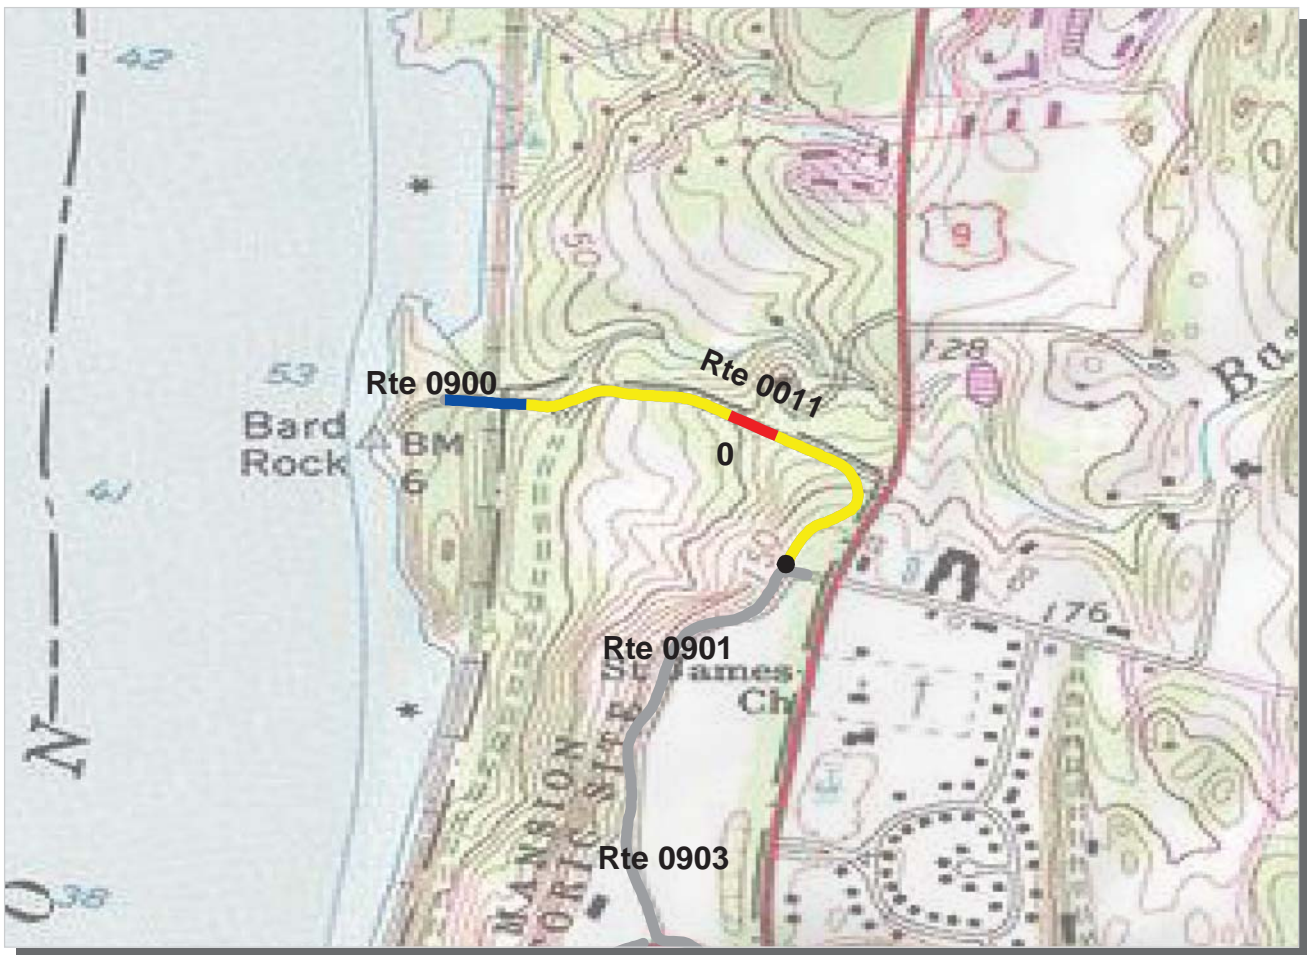
ROUTE: 0011 Bard Rock Road

Section Number	0				
Section Length (mi)	0.46				
AADT	**				
SADT	**				
ADT Date	**				
Cross Section Information					
Number of Lanes	2				
Paved Width (ft)	14				
Lane Width (ft)	14				
Shoulder Width (ft)	5				
Roadway Condition Information					
PCR (Pavement Condition Rating)	77				
RCI (Roughness Condition Index)	67				
SCR (Surface Condition Rating)	81				
Alligator Cracking Index	100				
Rutting Index	81				
Patching Index	100				
Transverse Cracking Index	100				
Longitudinal Cracking Index	99				
Shoulder Condition Rating	N/C				
Drainage Condition Rating	GOOD

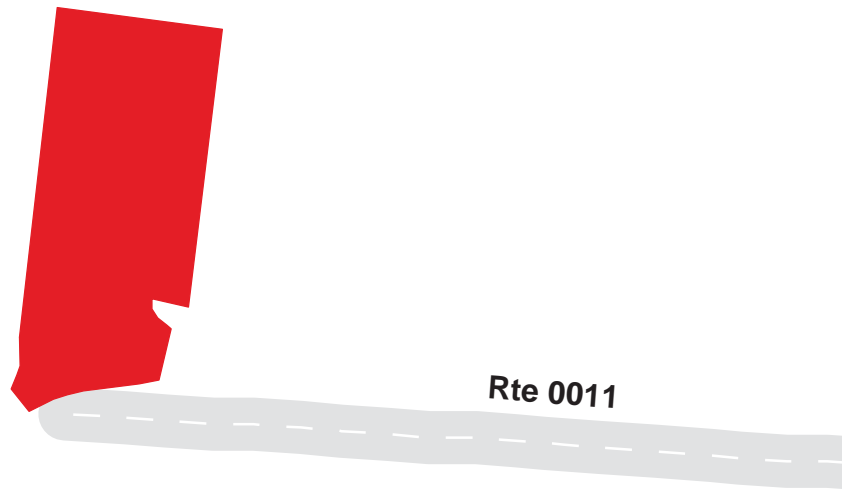
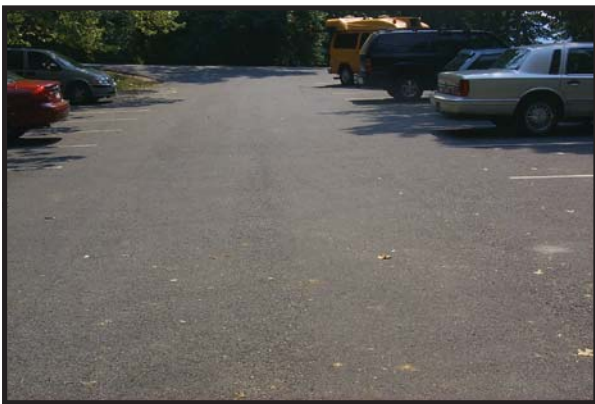
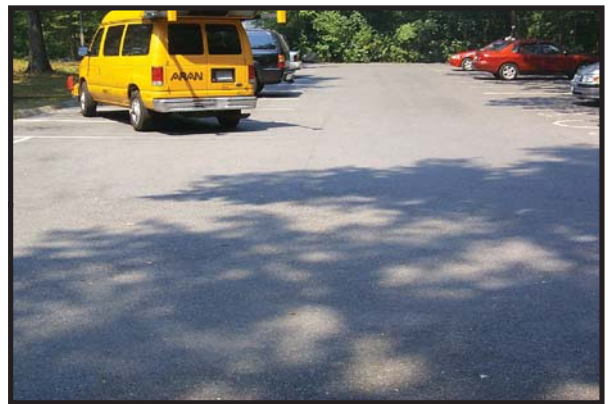
Route	Public / NonPublic	Date Visited	Area (sq ft)	Lane Miles *	Surface Type	Condition / PCR
0900	Public	8/12/2002	7673	0.13	AS	GOOD / 90

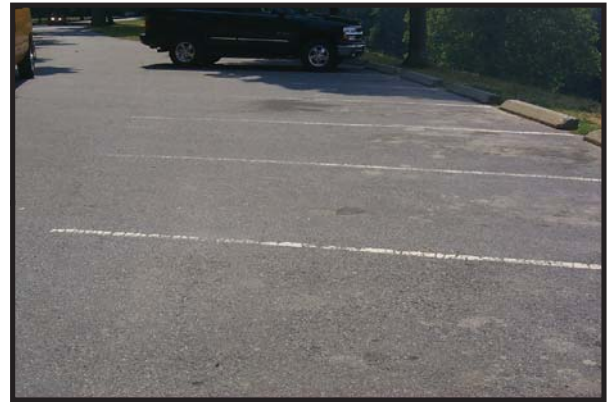
Route 0901

Route	Public / NonPublic	Date Visited	Area (sq ft)	Lane Miles *	Surface Type	Condition / PCR
0901	Public	8/12/2002	1912	0.03	AS	GOOD / 90

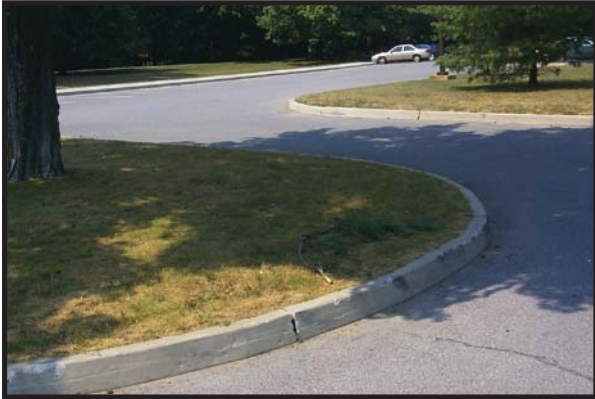
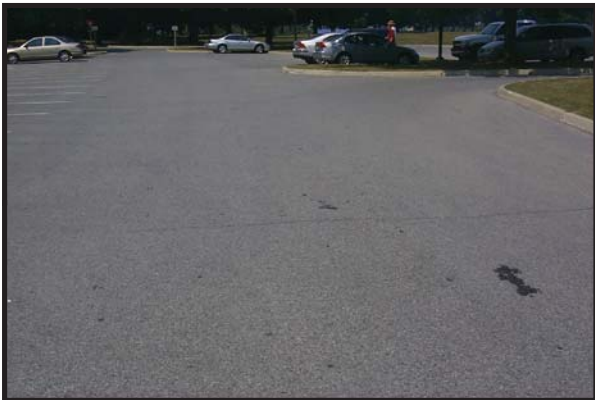
Route 0903

Route	Public / NonPublic	Date Visited	Area (sq ft)	Lane Miles *	Surface Type	Condition / PCR
0903	Public	8/12/2002	52973	0.91	AS	GOOD / 90

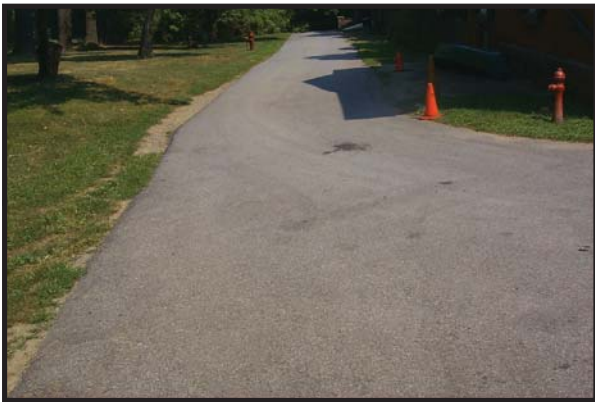
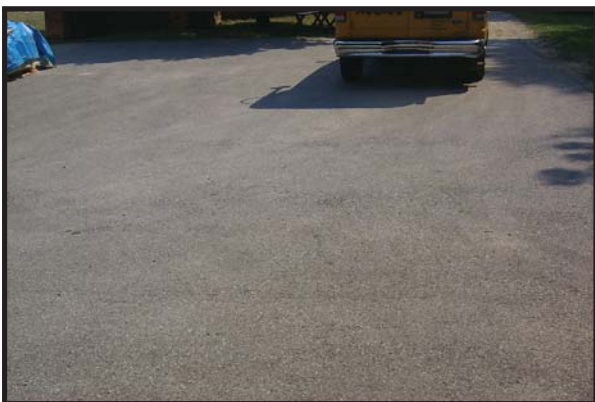
Route 0904

Route	Public / NonPublic	Date Visited	Area (sq ft)	Lane Miles *	Surface Type	Condition / PCR
0904	NonPublic	8/12/2002	9384	0.16	AS	GOOD / 90

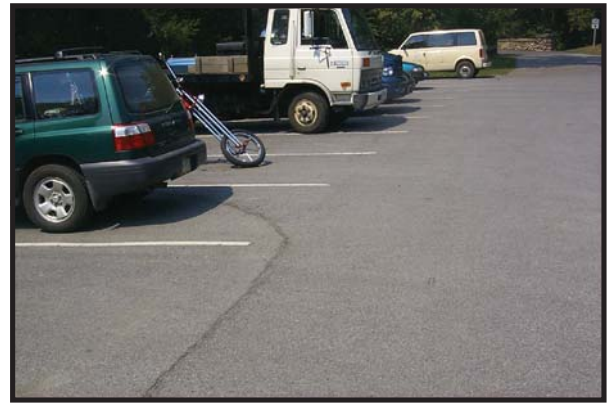
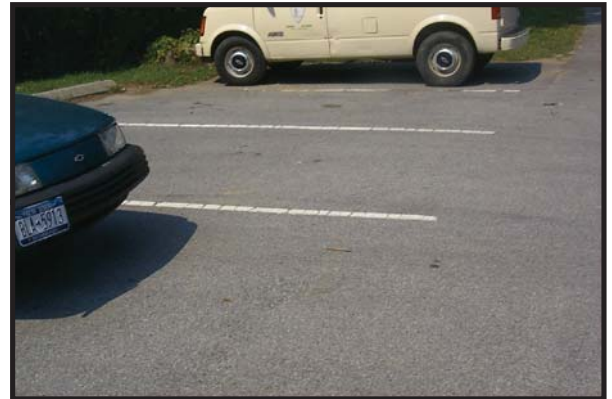
Route 0906A

Route	Public / NonPublic	Date Visited	Area (sq ft)	Lane Miles *	Surface Type	Condition / PCR
0906A	Public	8/12/2002	2115	0.04	AS	GOOD / 90

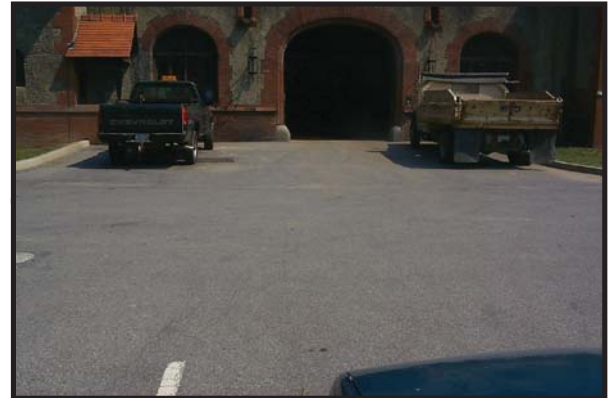
Route 0906B

Route	Public / NonPublic	Date Visited	Area (sq ft)	Lane Miles *	Surface Type	Condition / PCR
0906B	Public	8/12/2002	827	0.01	AS	GOOD / 90
