The Road Inventory of Vicksburg National Military Park VICK - 5600

Prepared By:
Federal Highway Administration
Eastern Federal Lands Highway Division
Cycle 3

Vicksburg National Military Park in Mississippi

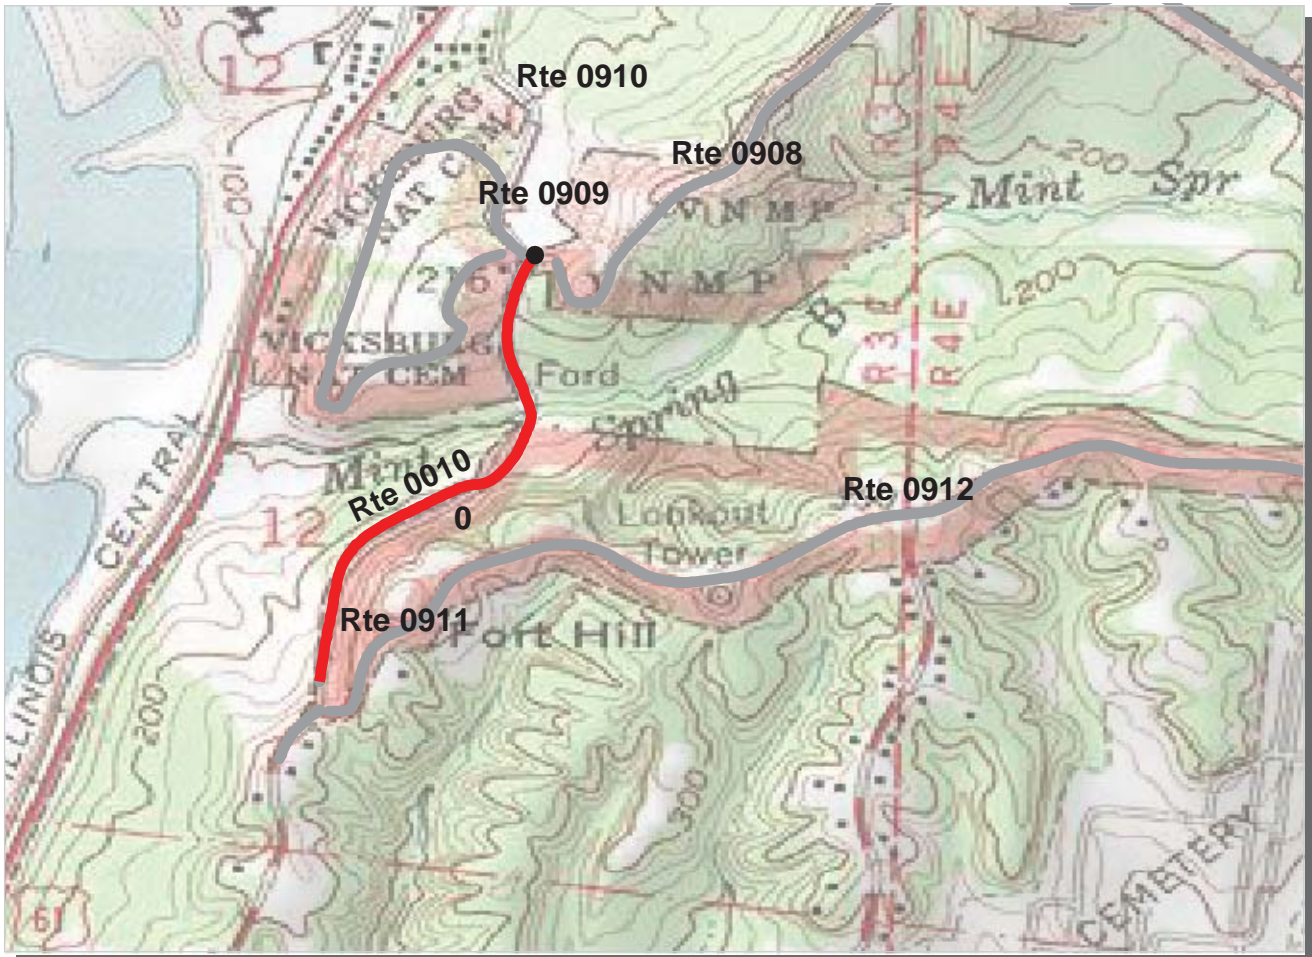
ROUTE: 0010 Connecting Avenue **TOTAL LENGTH: 0.52 Miles**

Section Number	0				
Section Length (mi)	0.52				
AADT	**				
SADT	**				
ADT Date	**				
Cross Section Information					
Number of Lanes	2				
Paved Width (ft)	22				
Lane Width (ft)	12				
Shoulder Width (ft)	9				
Roadway Condition Information					
PCR (Pavement Condition Rating)	49				
RCI (Roughness Condition Index)	76				
SCR (Surface Condition Rating)	37				
Alligator Cracking Index	94				
Rutting Index	52				
Patching Index	99				
Transverse Cracking Index	92				
Longitudinal Cracking Index	96				
Shoulder Condition Rating	GOOD				
Drainage Condition Rating	GOOD

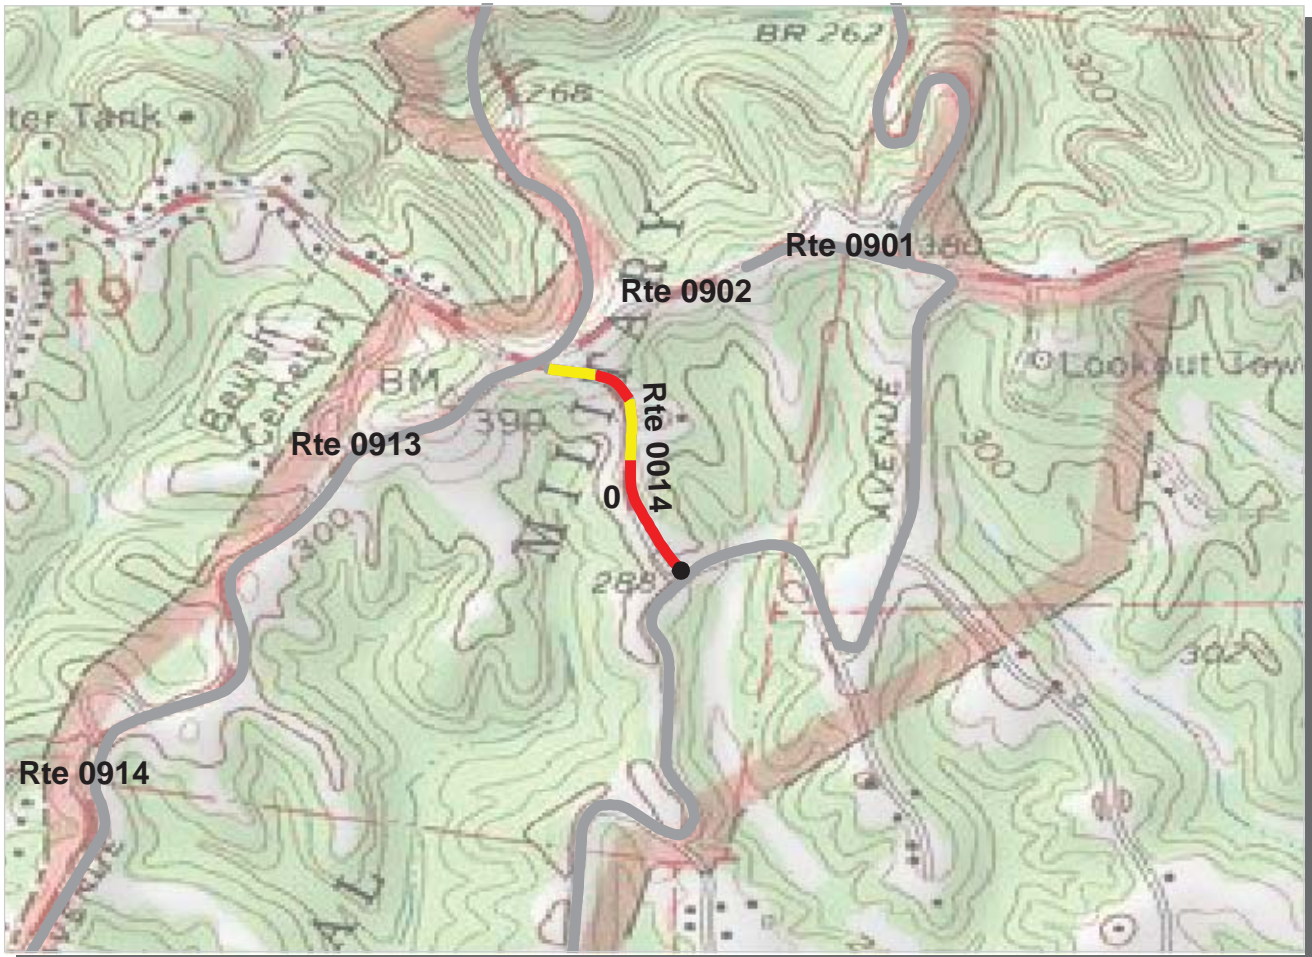
ROUTE: 0014 Pemberton Avenue **TOTAL LENGTH: 0.27 Miles**

Section Number	0				
Section Length (mi)	0.27				
AADT	**				
SADT	**				
ADT Date	**				
Cross Section Information					
Number of Lanes	2				
Paved Width (ft)	15				
Lane Width (ft)	8				
Shoulder Width (ft)	0				
Roadway Condition Information					
PCR (Pavement Condition Rating)	42				
RCI (Roughness Condition Index)	68				
SCR (Surface Condition Rating)	36				
Alligator Cracking Index	71				
Rutting Index	45				
Patching Index	99				
Transverse Cracking Index	96				
Longitudinal Cracking Index	99				
Shoulder Condition Rating	N/A				
Drainage Condition Rating	GOOD

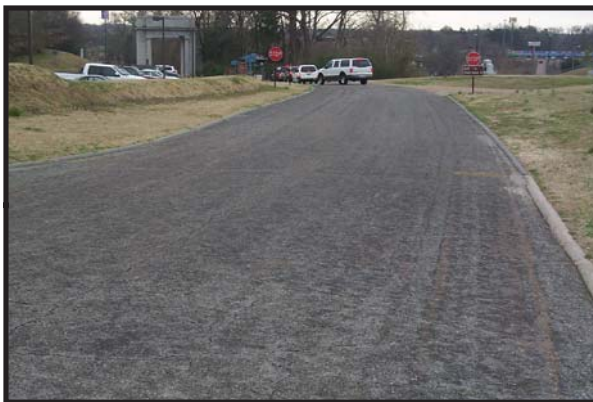
Route 0100

Route	Length (mi)	Width (ft)	Area (sq ft)	Lane Miles *	Condition / PCR	Surface Type
0100	0.13	0.00	7646	0.13	FAIR / 73	AS

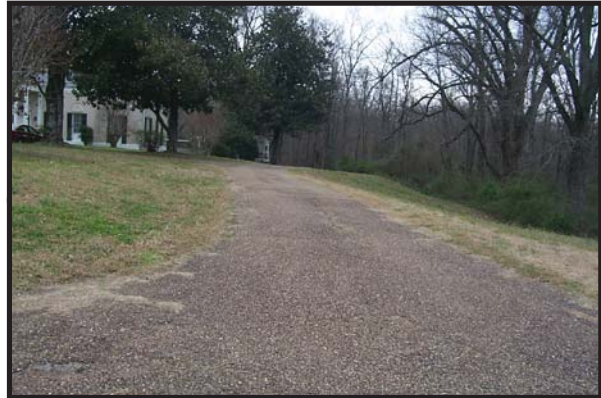
Route 0101

Route	Length (mi)	Width (ft)	Area (sq ft)	Lane Miles *	Condition / PCR	Surface Type
0101	0.12	0.00	7133	0.12	GOOD / 90	OC

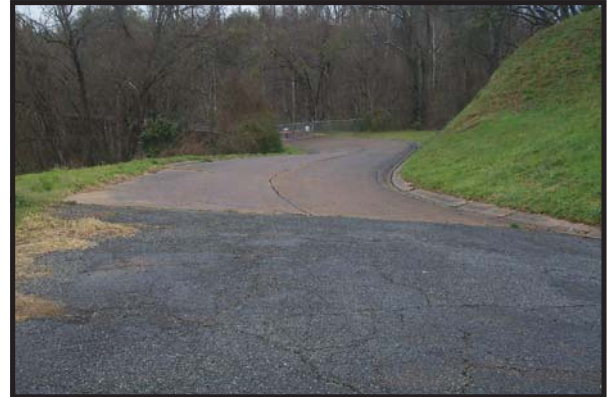
Route 0401

Route	Length (mi)	Width (ft)	Area (sq ft)	Lane Miles *	Condition / PCR	Surface Type
0401	0.07	0.00	8798	0.15	NC / -1	AS

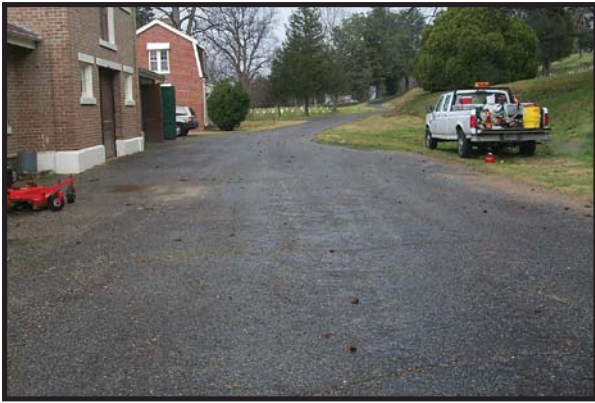
Route 0405

Route	Length (mi)	Width (ft)	Area (sq ft)	Lane Miles *	Condition / PCR	Surface Type
0405	0.12	0.00	7070	0.12	POOR / 45	OC

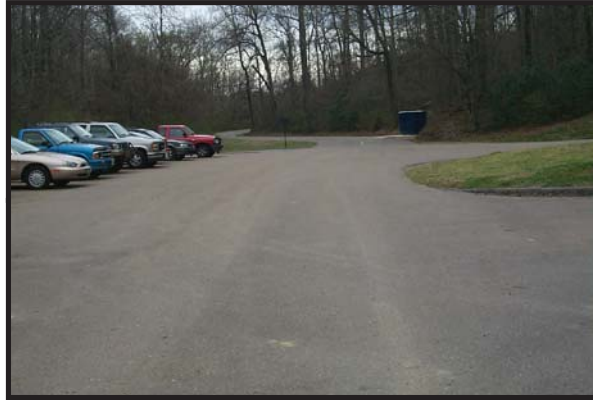
Route 0901

Route	Public / NonPublic	Date Visited	Area (sq ft)	Lane Miles *	Surface Type	Condition / PCR
0901	Public	3/11/2002	4201	0.07	AS	GOOD / 90

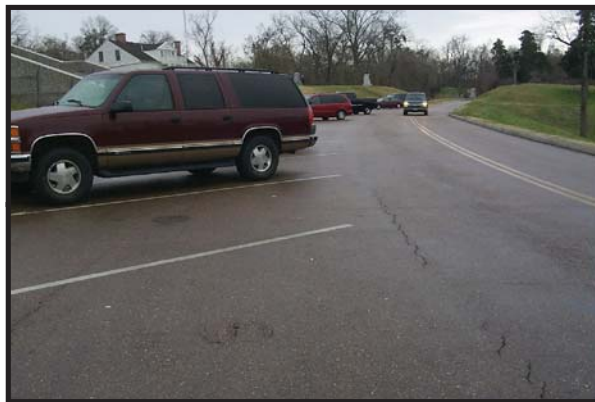
Route 0902

Route	Public / NonPublic	Date Visited	Area (sq ft)	Lane Miles *	Surface Type	Condition / PCR
0902	Public	3/11/2002	13271	0.23	AS	GOOD / 90

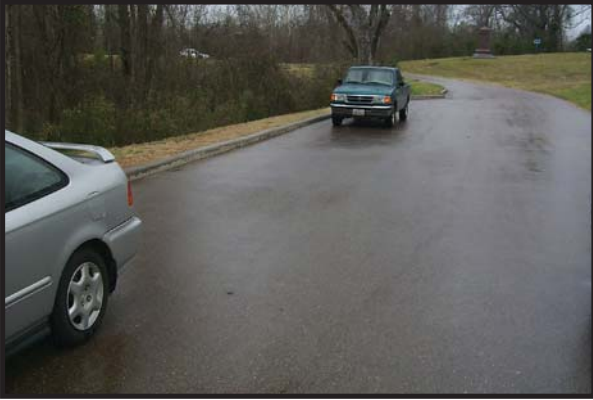
Route 0903B

Route	Public / NonPublic	Date Visited	Area (sq ft)	Lane Miles *	Surface Type	Condition / PCR
0903B	Public	3/11/2002	1107	0.02	AS	GOOD / 90

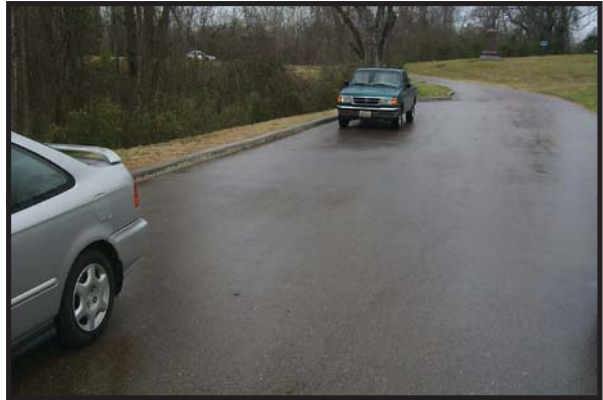
Route 0904

Route	Public / NonPublic	Date Visited	Area (sq ft)	Lane Miles *	Surface Type	Condition / PCR
0904	Public	3/11/2002	1175	0.02	AS	GOOD / 90

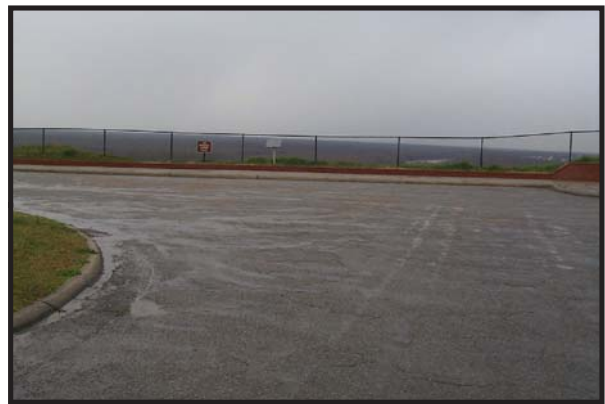
Vicksburg National Military Park
Route 0912
Tennessee Circle
Adjacent to Route 0012 at MP 0.60 on Left

Route	Public / NonPublic	Date Visited	Area (sq ft)	Lane Miles *	Surface Type	Condition / PCR
0912	Public	3/11/2002	5077	0.09	OC	FAIR / 73

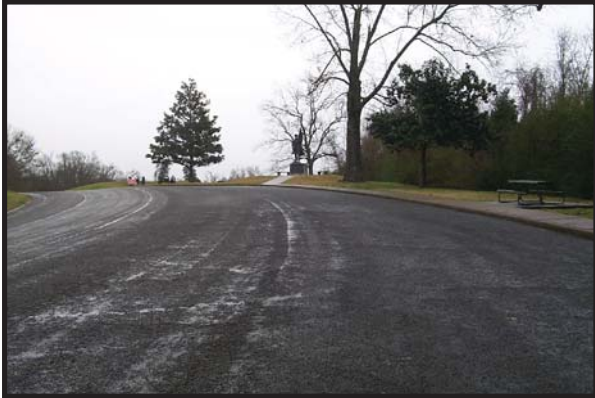
Vicksburg National Military Park
Route 0916
Texas Parking Area
Adjacent to Route 0019 at MP 0.50 on Right

Route	Public / NonPublic	Date Visited	Area (sq ft)	Lane Miles *	Surface Type	Condition / PCR
0916	Public	3/11/2002	4830	0.08	OC	GOOD / 90

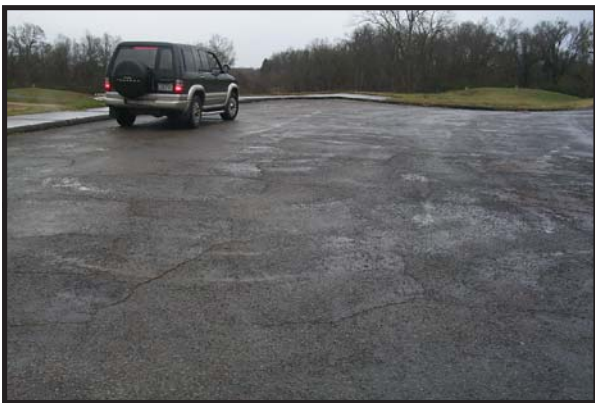
Route 0917

Route	Public / NonPublic	Date Visited	Area (sq ft)	Lane Miles *	Surface Type	Condition / PCR
0917	Public	3/11/2002	4081	0.07	OC	POOR / 45

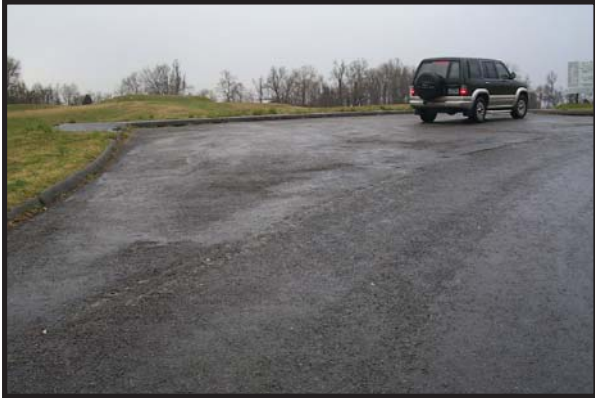
Route 0918

Route	Public / NonPublic	Date Visited	Area (sq ft)	Lane Miles *	Surface Type	Condition / PCR
0918	Public	3/11/2002	1614	0.03	OC	POOR / 45

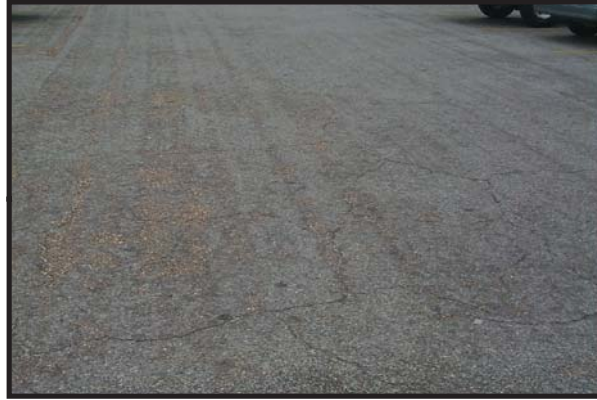
Route 0919

Route	Public / NonPublic	Date Visited	Area (sq ft)	Lane Miles *	Surface Type	Condition / PCR
0919	Public	3/11/2002	36483	0.63	OC	POOR / 45

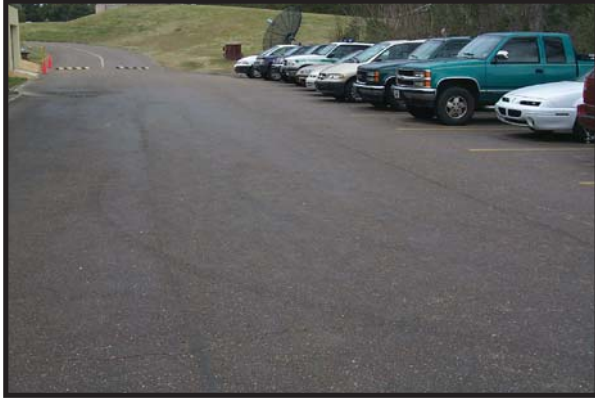
Route 0920

Route	Public / NonPublic	Date Visited	Area (sq ft)	Lane Miles *	Surface Type	Condition / PCR
0920	NonPublic	3/11/2002	4119	0.07	CO	FAIR / 73

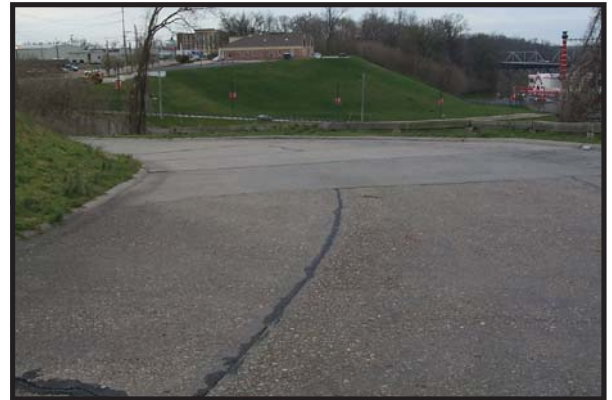
Route 0921

Route	Public / NonPublic	Date Visited	Area (sq ft)	Lane Miles *	Surface Type	Condition / PCR
0921	Public	3/11/2002	9001	0.15	CO	GOOD / 90

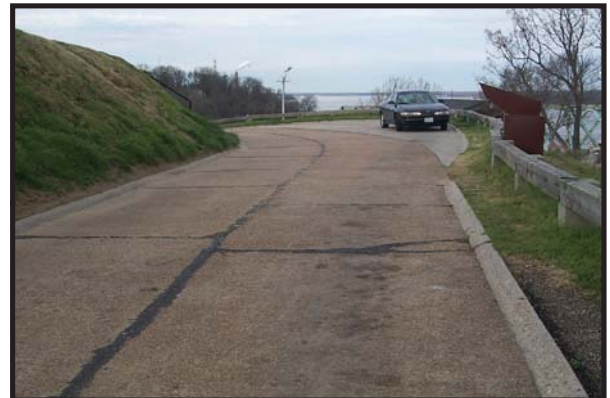
Route 0922

Route	Public / NonPublic	Date Visited	Area (sq ft)	Lane Miles *	Surface Type	Condition / PCR
0922	Public	3/11/2002	9925	0.17	CO	FAIR / 73

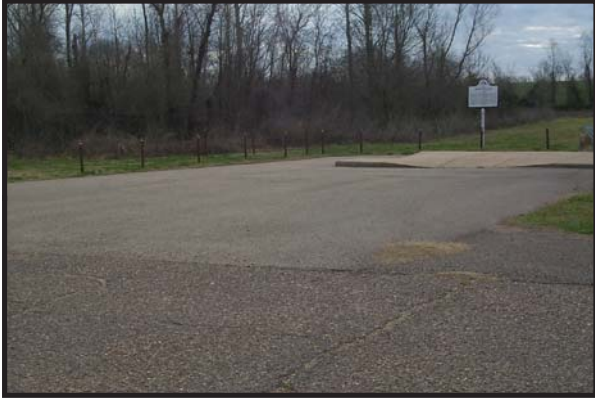
Route 0923

Route	Public / NonPublic	Date Visited	Area (sq ft)	Lane Miles *	Surface Type	Condition / PCR
0923	Public	3/11/2002	2568	0.04	CO	GOOD / 90
