The Road Inventory of Virgin Islands National Park VIIS - 5360

Road Inventory Program

Prepared By:
Federal Highway Administration
Eastern Federal Lands Highway Division
Cycle 3

Virgin Islands National Park in The Virgin Islands

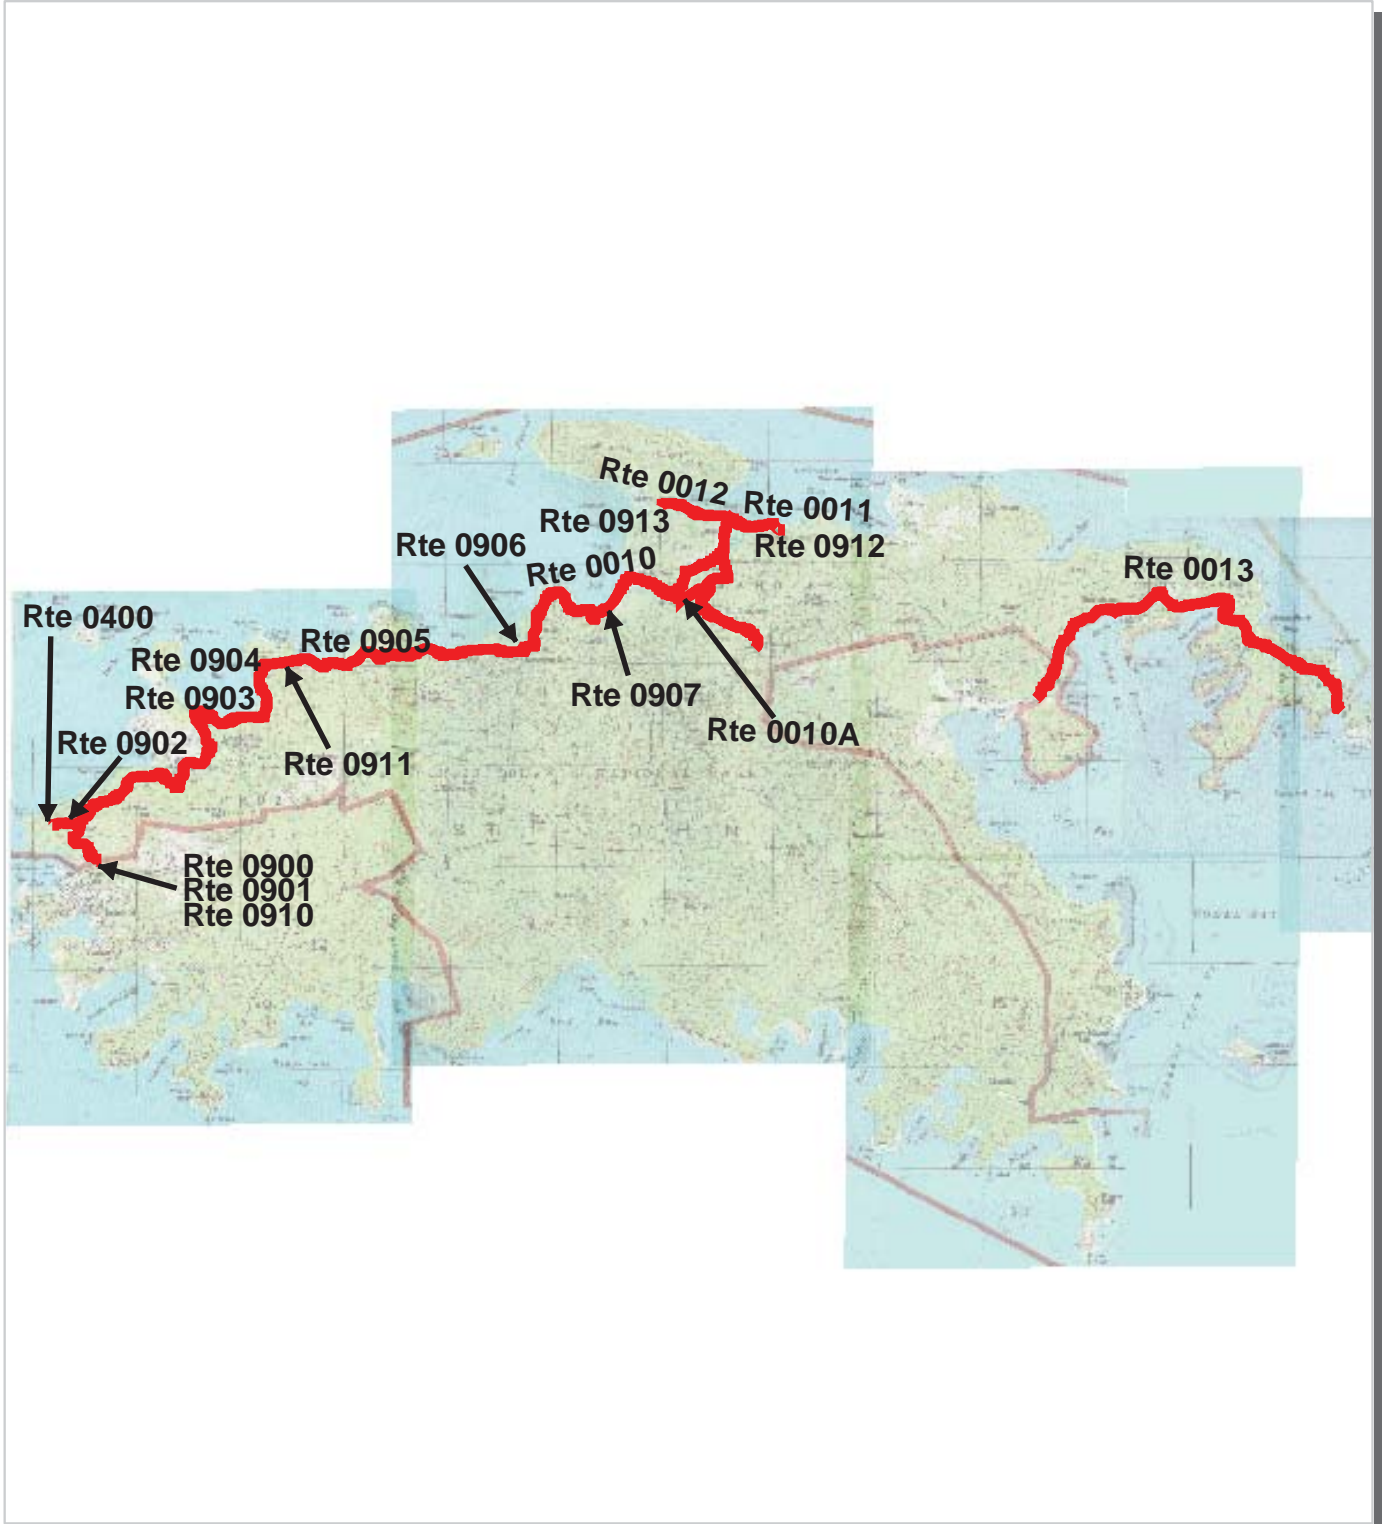
Virgin Islands National Park Route Condition Area Map 2 PCR - Mile by Mile

PCR	Poor

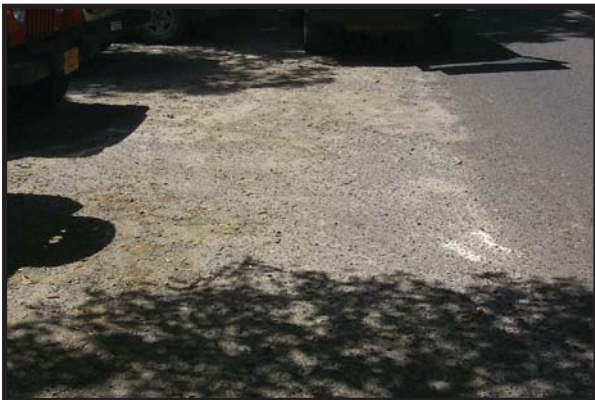
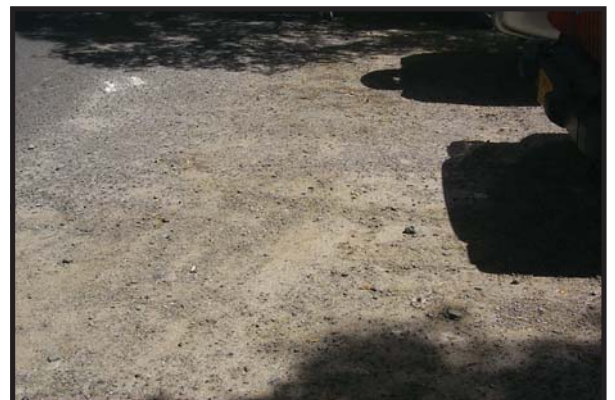
Virgin Islands National Park
Route 0912
 ANNABERG SUGAR MILL PARKING
 From Route 0011

Route	Public / NonPublic	Date Visited	Area (sq ft)	Lane Miles *	Surface Type	Condition / PCR
0912	Public	2/12/2002	6447	0.11	AS	GOOD / 90
