The Road Inventory of Voyageurs National Park VOYA - 6820

Road Inventory Program

Prepared By:
Federal Highway Administration
Eastern Federal Lands Highway Division
Cycle 3

Voyageurs National Park in Minnesota

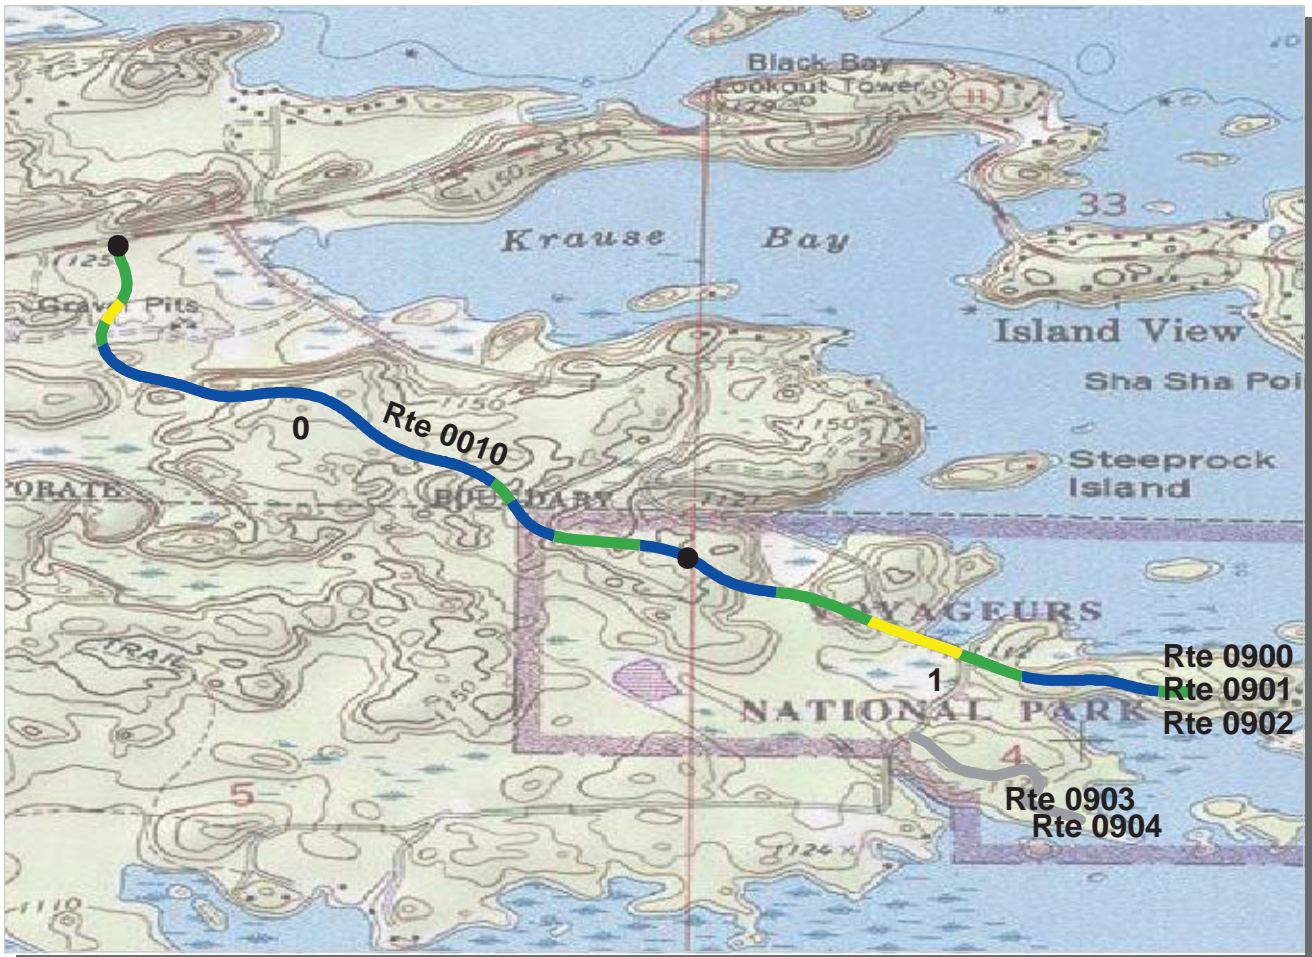
ROUTE: 0010 Rainy Lake Visitor Center Access Road TOTAL LENGTH: 1.65 Miles

Section Number	0	1			
Section Length (mi)	1.00	0.65			
AADT	**				
SADT	**				
ADT Date	**				
Cross Section Information					
Number of Lanes	2	2			
Paved Width (ft)	24	25			
Lane Width (ft)	12	13			
Shoulder Width (ft)	0	0			
Roadway Condition Information					
PCR (Pavement Condition Rating)	93	89			
RCI (Roughness Condition Index)	97	94			
SCR (Surface Condition Rating)	91	86			
Alligator Cracking Index	100	100			
Rutting Index	96	90			
Patching Index	100	100			
Transverse Cracking Index	95	97			
Longitudinal Cracking Index	99	98			
Shoulder Condition Rating	N/A	N/A			
Drainage Condition Rating	GOOD	GOOD

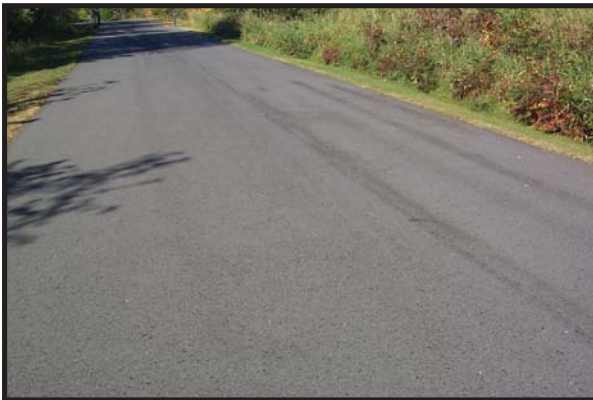
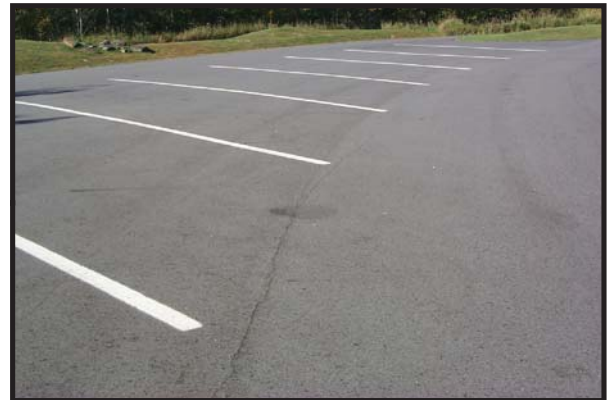
Voyageurs National Park
Route 0901
 RAINY LAKE BOAT LAUNCH PARKING
 From Route 0010

Route	Public / NonPublic	Date Visited	Area (sq ft)	Lane Miles *	Surface Type	Condition / PCR
0901	Public	9/27/2001	65560	1.13	AS	GOOD / 90

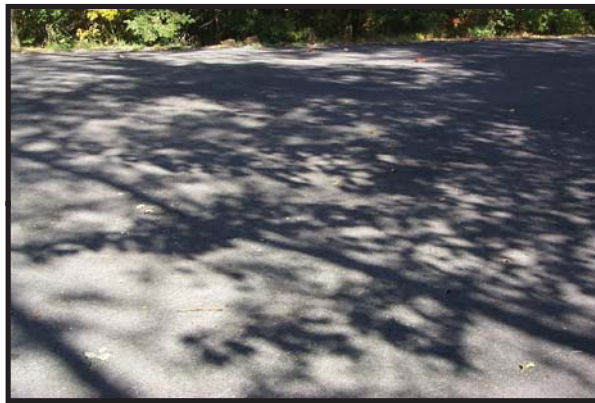
Voyageurs National Park
Route 0904
RAINY LAKE BOAT FUELING AREA
From Route 0400

Route	Public / NonPublic	Date Visited	Area (sq ft)	Lane Miles *	Surface Type	Condition / PCR
0904	NonPublic	9/27/2001	4477	0.08	AS	EXCELLENT / 97

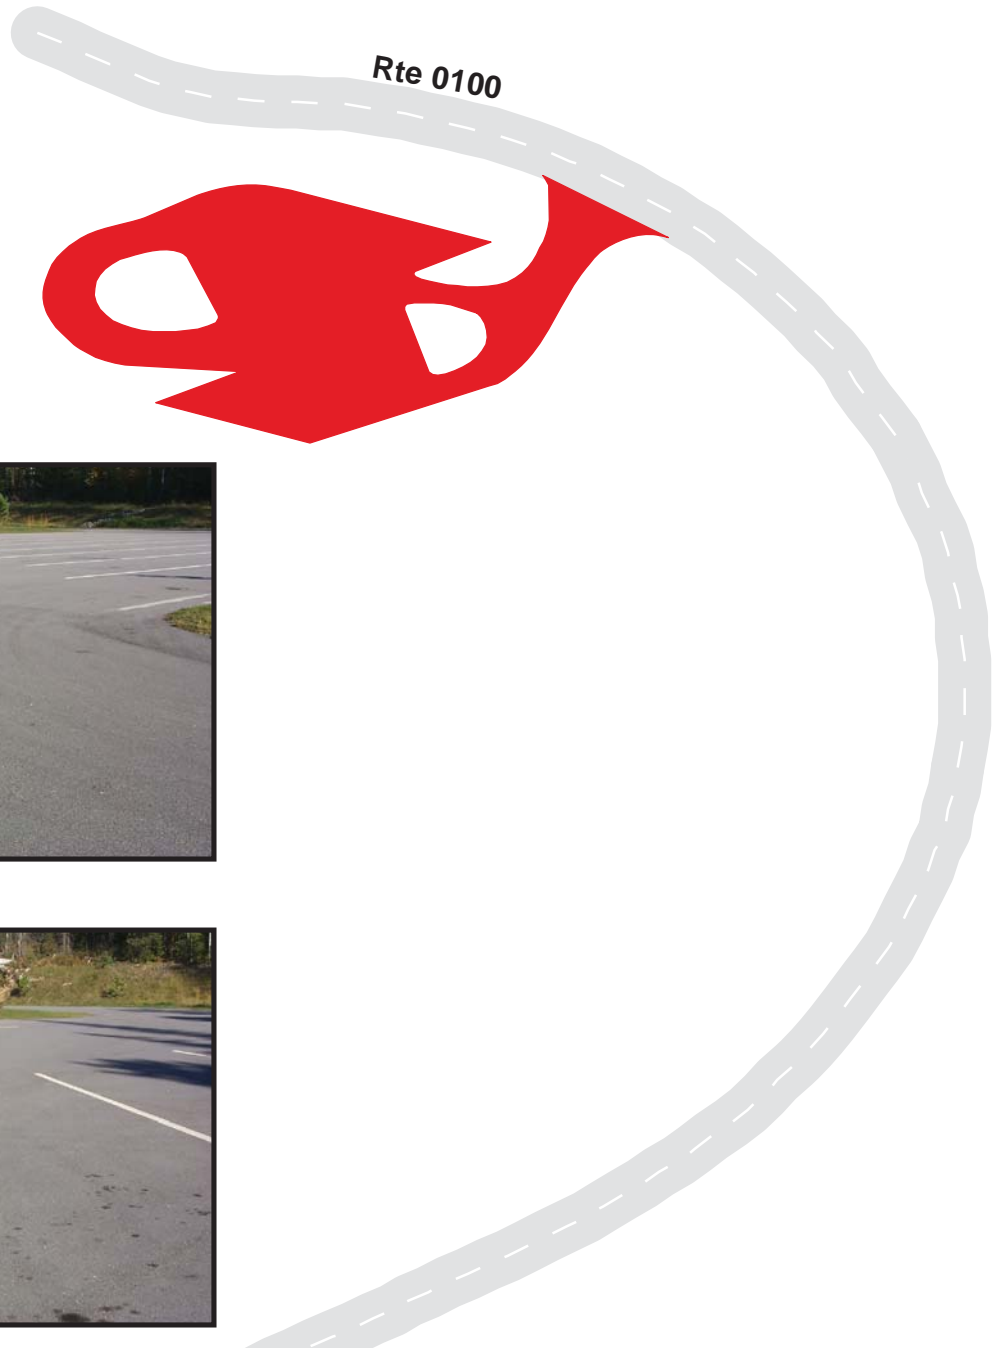
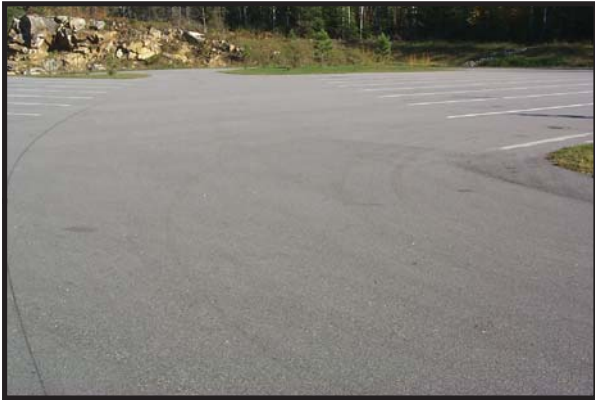
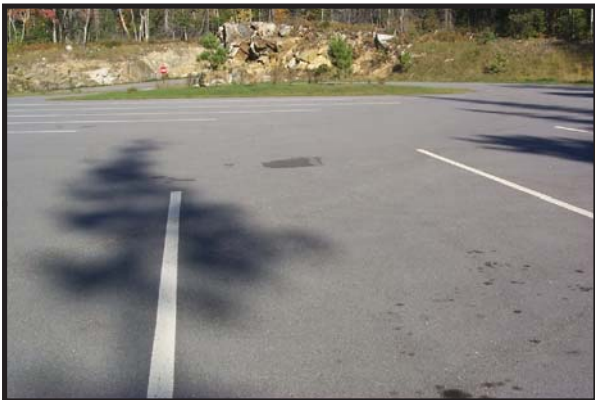
Voyageurs National Park
Route 0910
 WHISPERING PINES HOUSING AREA
 From Route 0100

Route	Public / NonPublic	Date Visited	Area (sq ft)	Lane Miles *	Surface Type	Condition / PCR
0910	NonPublic	9/26/2001	31652	0.54	AS	GOOD / 90
