# The Road Inventory of Walnut Canyon National Monument WACA – 7450

## Road Inventory Program

Prepared By:  
Federal Highway Administration  
Eastern Federal Lands Highway Division  
Cycle 3

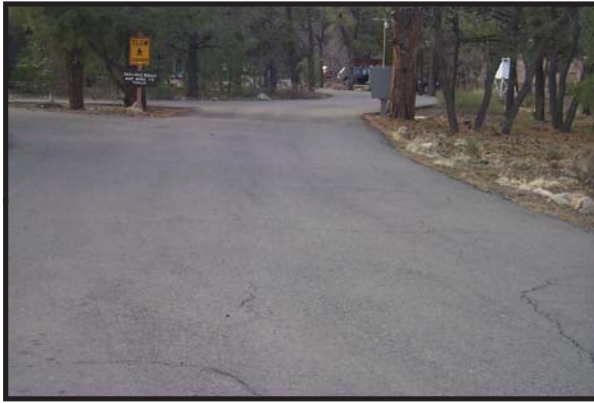
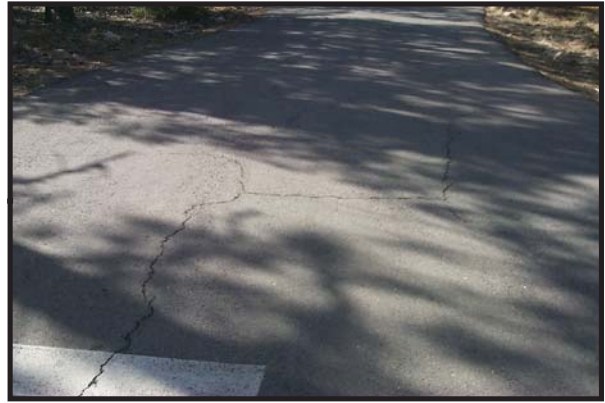
Route	Length (mi)	Width (ft)	Area (sq ft)	Lane Miles *	Condition / PCR	Surface Type
0405	0.25	0.00	34142	0.59	GOOD / 90	AS

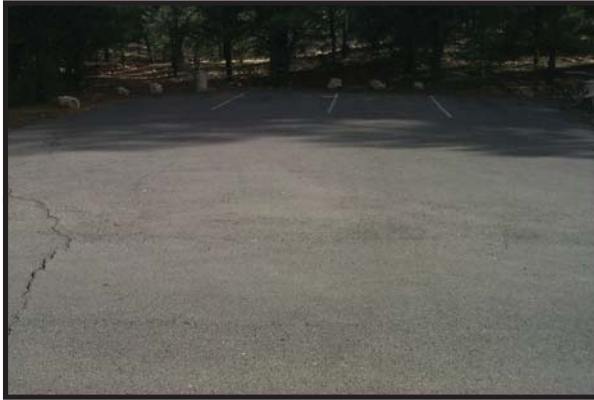
## Route 0917

Route	Public / NonPublic	Date Visited	Area (sq ft)	Lane Miles *	Surface Type	Condition / PCR
0917	Public	5/9/2002	3301	0.06	AS	GOOD / 90

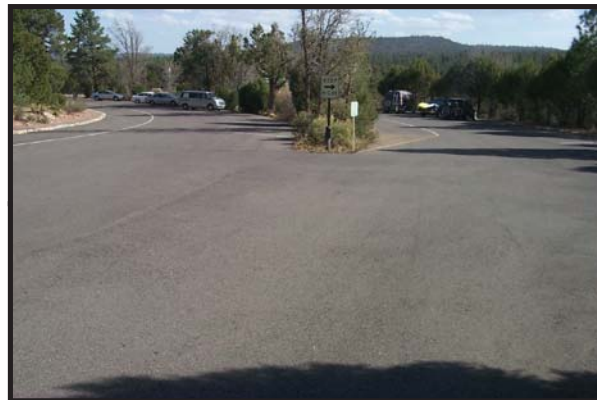
## Route 0918

Route	Public / NonPublic	Date Visited	Area (sq ft)	Lane Miles *	Surface Type	Condition / PCR
0918	Public	5/9/2002	33725	0.58	AS	GOOD / 90
