# The Road Inventory of War in the Pacific National Historical Park WAPA - 8790

## Road Inventory Program

Prepared By:  
Federal Highway Administration  
Eastern Federal Lands Highway Division  
Cycle 3

# War in the Pacific National Historical Park in Guam

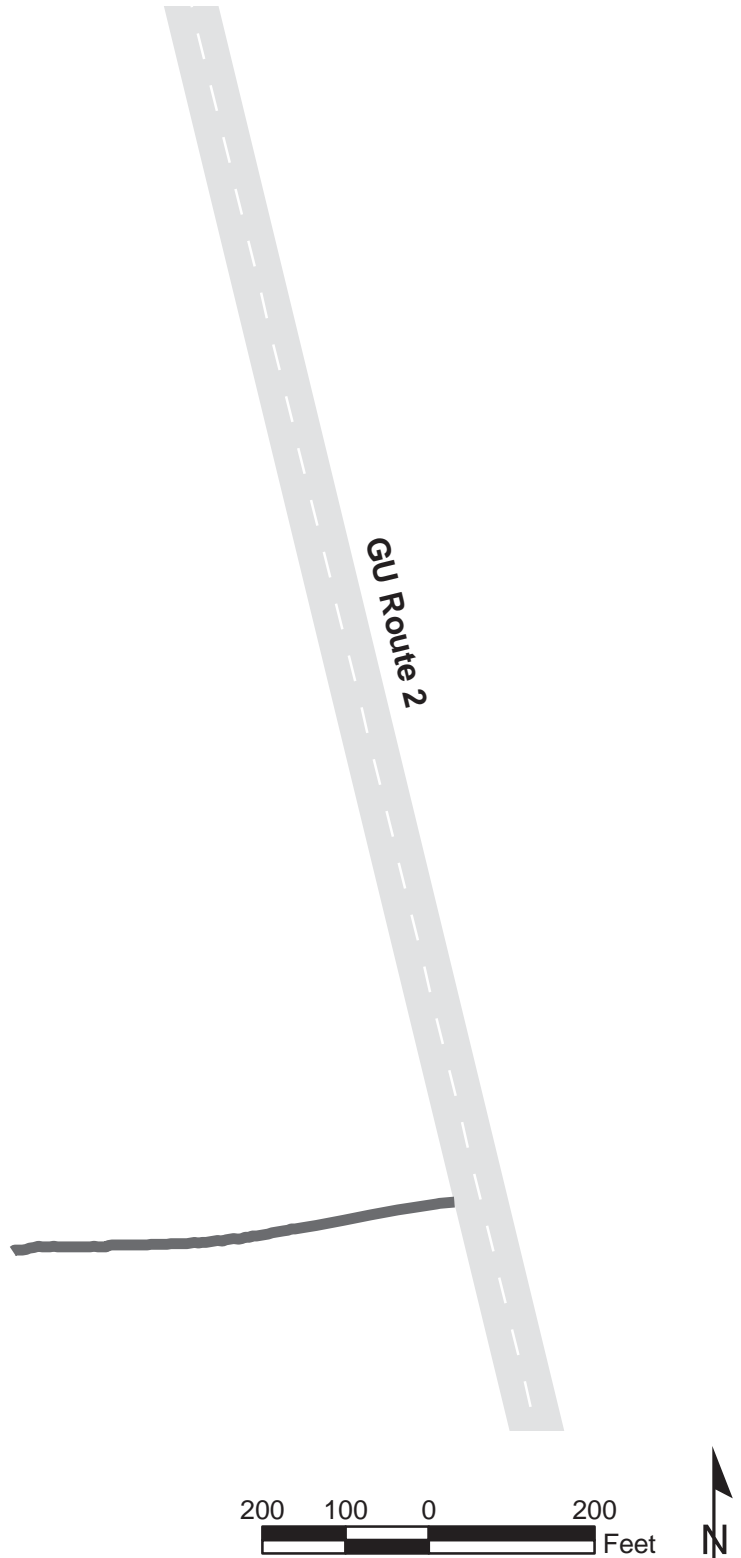
## Route 0101

Route	Length (mi)	Width (ft)	Area (sq ft)	Lane Miles *	Condition / PCR	Surface Type
0101	0.04	20.00	4013	0.07	POOR / 45	AS

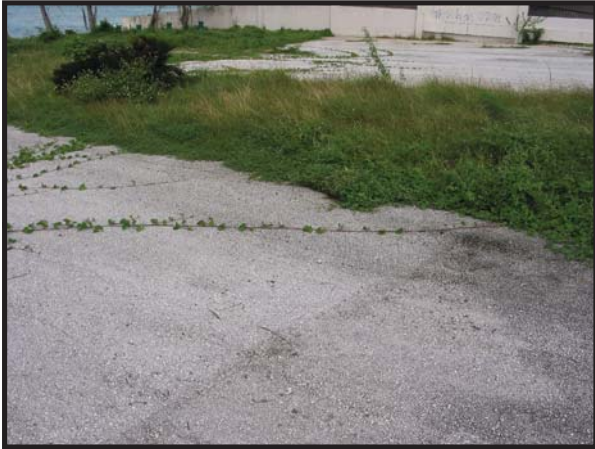
## Route 0900

Route	Public / NonPublic	Date Visited	Area (sq ft)	Lane Miles *	Surface Type	Condition / PCR
0900	Public	12/9/2003	15789	0.27	AS	POOR / 45

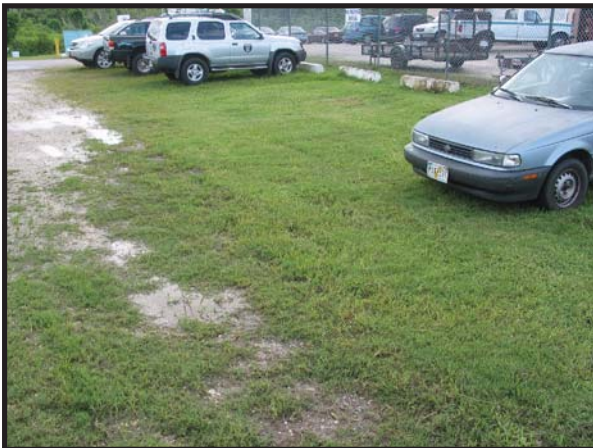
## Route 0901A

Route	Public / NonPublic	Date Visited	Area (sq ft)	Lane Miles *	Surface Type	Condition / PCR
0901A	NonPublic	12/9/2003	2343	0.04	OT	N/A

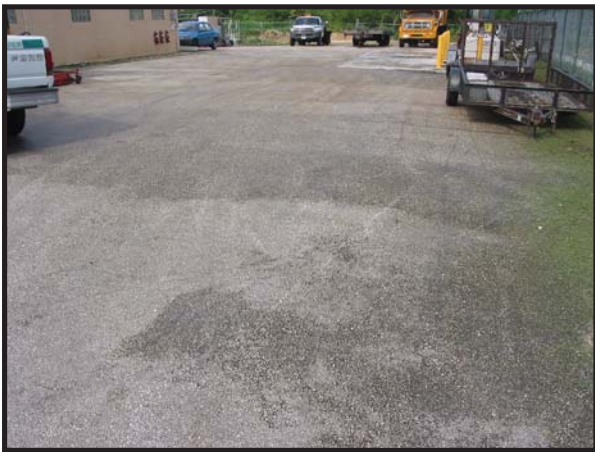
## Route 0901B

Route	Public / NonPublic	Date Visited	Area (sq ft)	Lane Miles *	Surface Type	Condition / PCR
0901B	NonPublic	12/9/2003	11053	0.19	AS	GOOD / 90

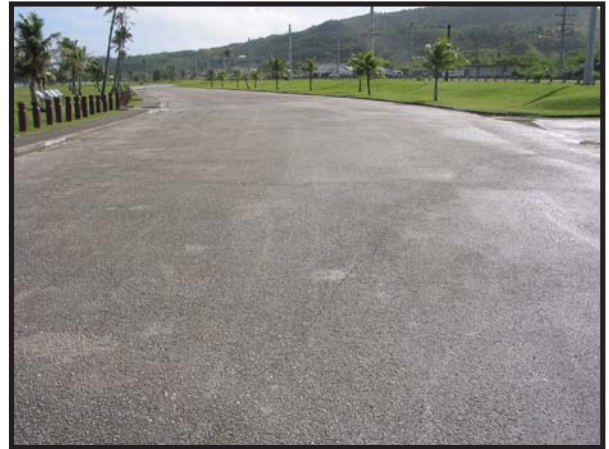
## Route 0902

Route	Public / NonPublic	Date Visited	Area (sq ft)	Lane Miles *	Surface Type	Condition / PCR
0902	Public	12/9/2003	19523	3.37	AS	POOR / 45

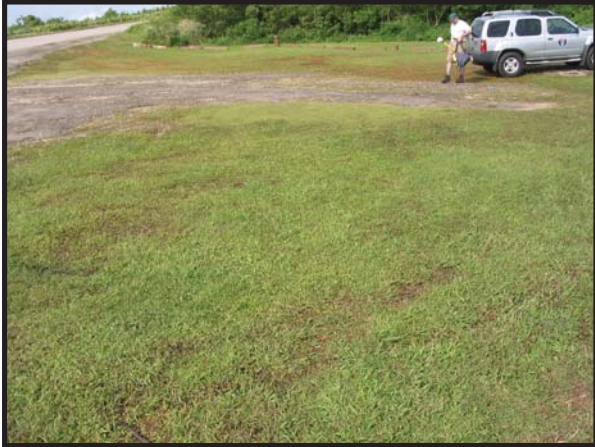
## Route 0903

Route	Public / NonPublic	Date Visited	Area (sq ft)	Lane Miles *	Surface Type	Condition / PCR
0903	Public	12/9/2003	13837	0.24	AS	POOR / 45

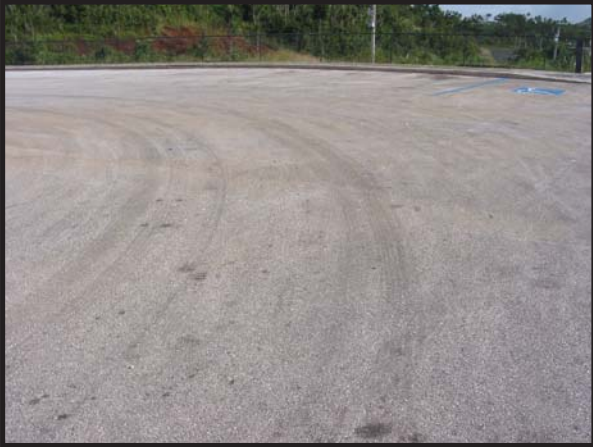
## Route 0904

Route	Public / NonPublic	Date Visited	Area (sq ft)	Lane Miles *	Surface Type	Condition / PCR
0904	Public	12/10/2003	41253	0.71	AS	GOOD / 90

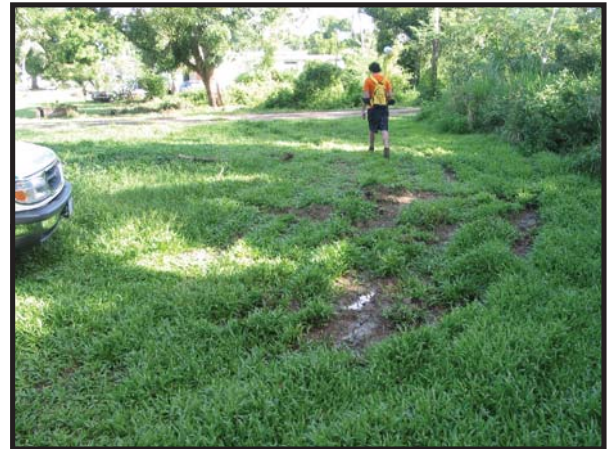
## Route 0905

Route	Public / NonPublic	Date Visited	Area (sq ft)	Lane Miles *	Surface Type	Condition / PCR
0905	Public	12/10/2003	976	0.02	OT	N/A

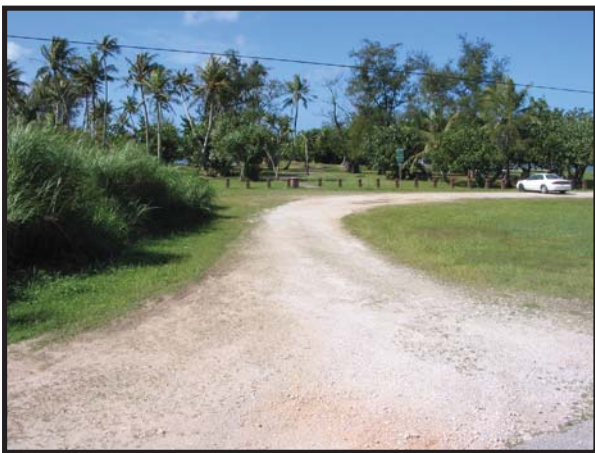
## Route 0906A

Route	Public / NonPublic	Date Visited	Area (sq ft)	Lane Miles *	Surface Type	Condition / PCR
0906A	Public	12/10/2003	8137	0.14	GR	N/A

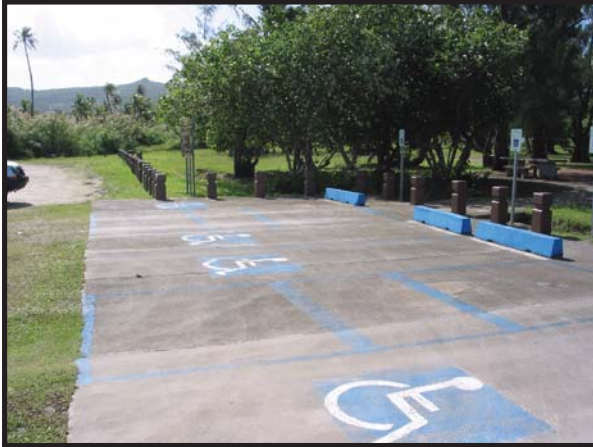
## Route 0906B

Route	Public / NonPublic	Date Visited	Area (sq ft)	Lane Miles *	Surface Type	Condition / PCR
0906B	Public	12/10/2003	1514	0.03	CO	GOOD / 90

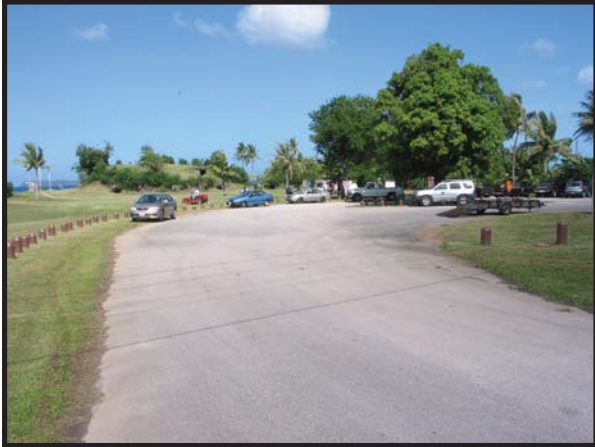
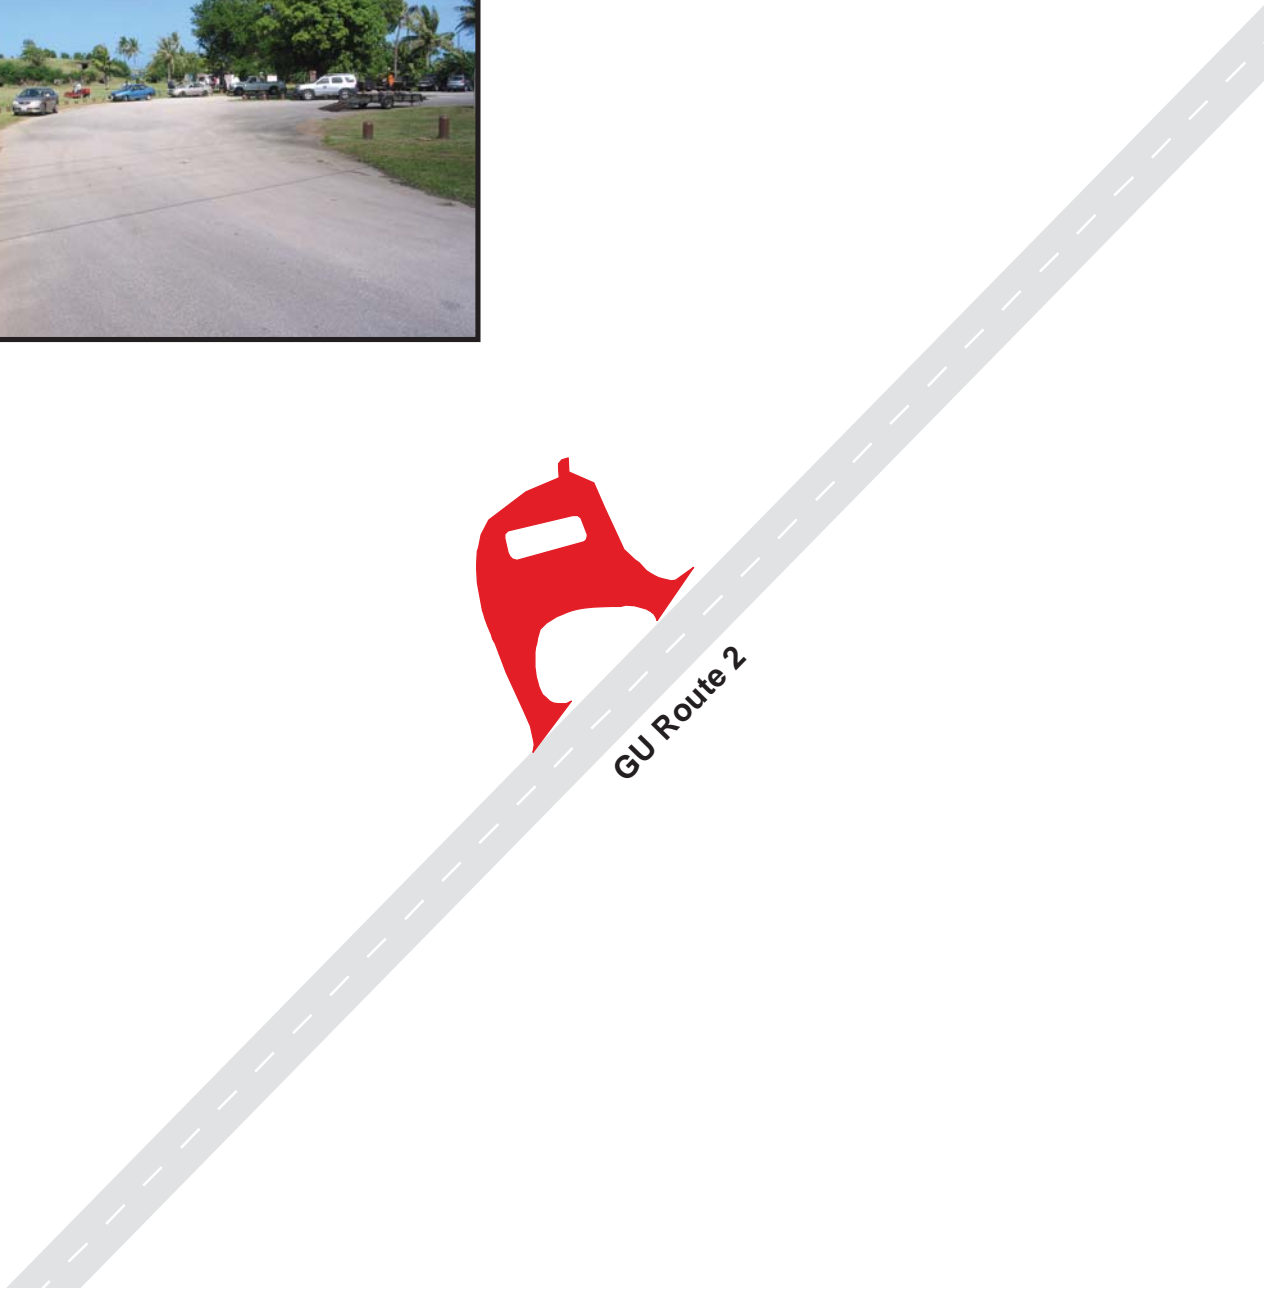
## Route 0907

Route	Public / NonPublic	Date Visited	Area (sq ft)	Lane Miles *	Surface Type	Condition / PCR
0907	Public	12/10/2003	18256	0.31	AS	FAIR / 73

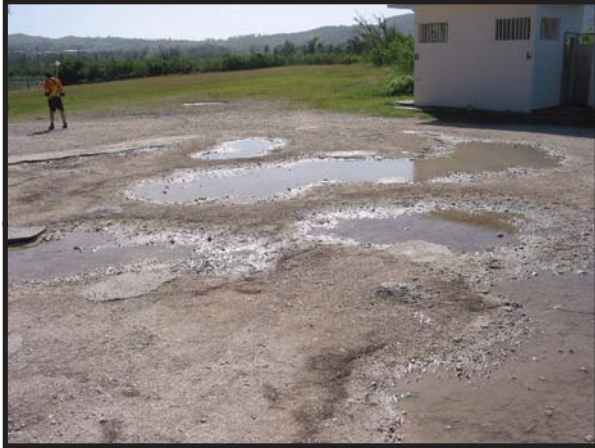
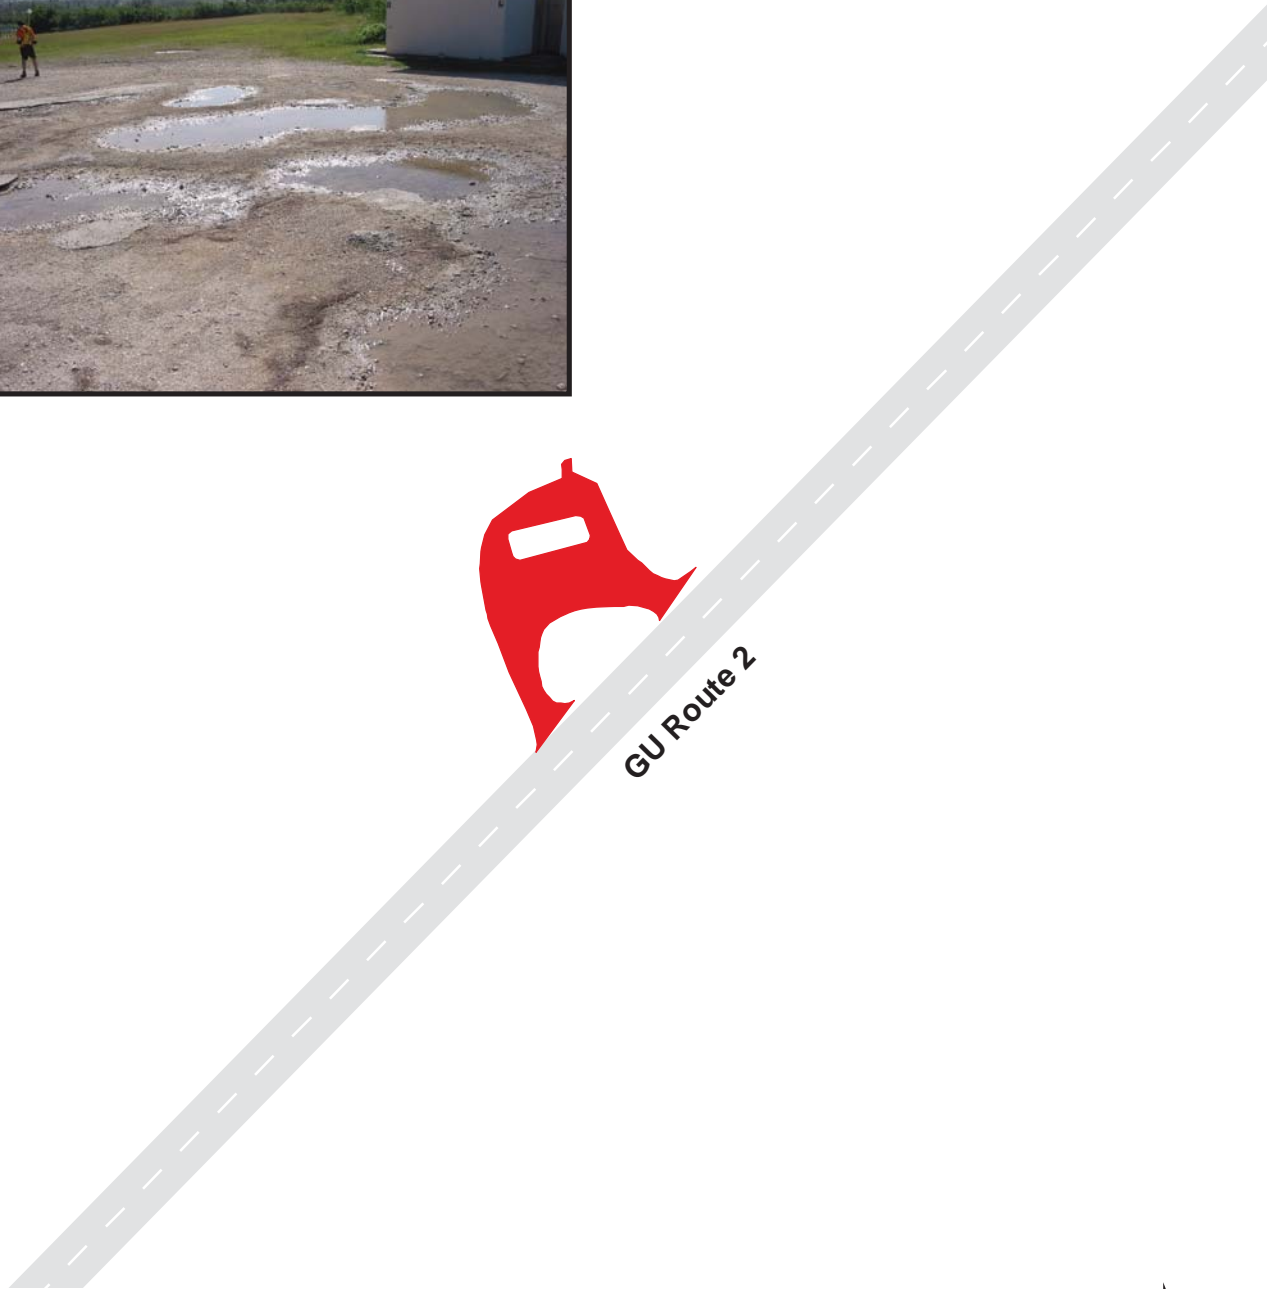
## Route 0910

Route	Public / NonPublic	Date Visited	Area (sq ft)	Lane Miles *	Surface Type	Condition / PCR
0910	Public	12/10/2003	4724	0.08	GR	N/A
