**The Road Inventory  
of  
Whiskeytown-Shasta-Trinity National Recreation Area  
WHIS - 8750**

## Road Inventory Program

Prepared By:  
Federal Highway Administration  
Eastern Federal Lands Highway Division  
Cycle 3

# Whiskeytown-Shasta-Trinity National Recreation Area in California

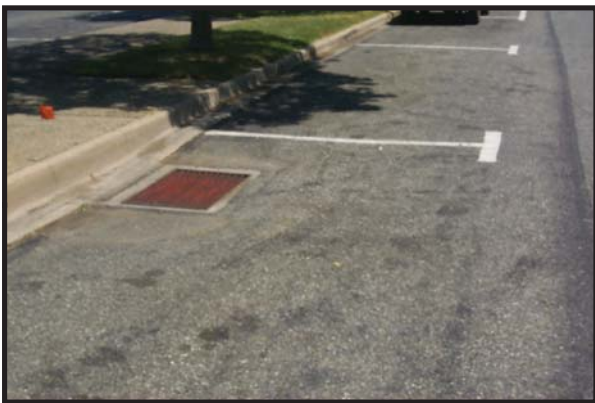
Route	Public / NonPublic	Date Visited	Area (sq ft)	Lane Miles *	Surface Type	Condition / PCR
0900A	Public	6/10/2003	1507	0.03	NC	GOOD / 90

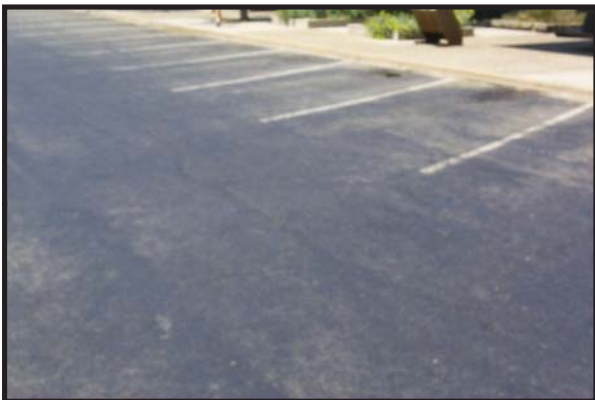
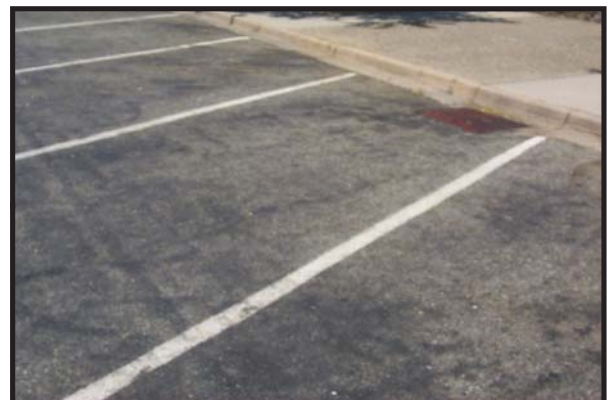
## Route 0900B

Route	Public / NonPublic	Date Visited	Area (sq ft)	Lane Miles *	Surface Type	Condition / PCR
0900B	Public	6/10/2003	17902	0.31	NC	GOOD / 90

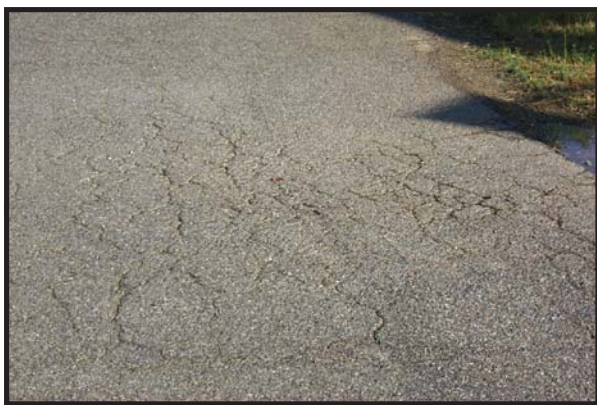
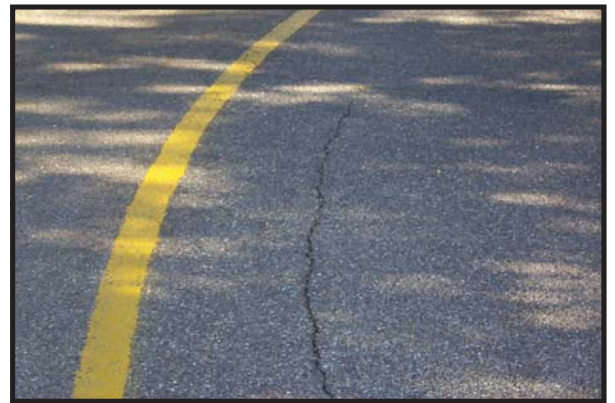
## Route 0901

Route	Public / NonPublic	Date Visited	Area (sq ft)	Lane Miles *	Surface Type	Condition / PCR
0901	Public	6/10/2003	5173	0.09	AS	FAIR / 73

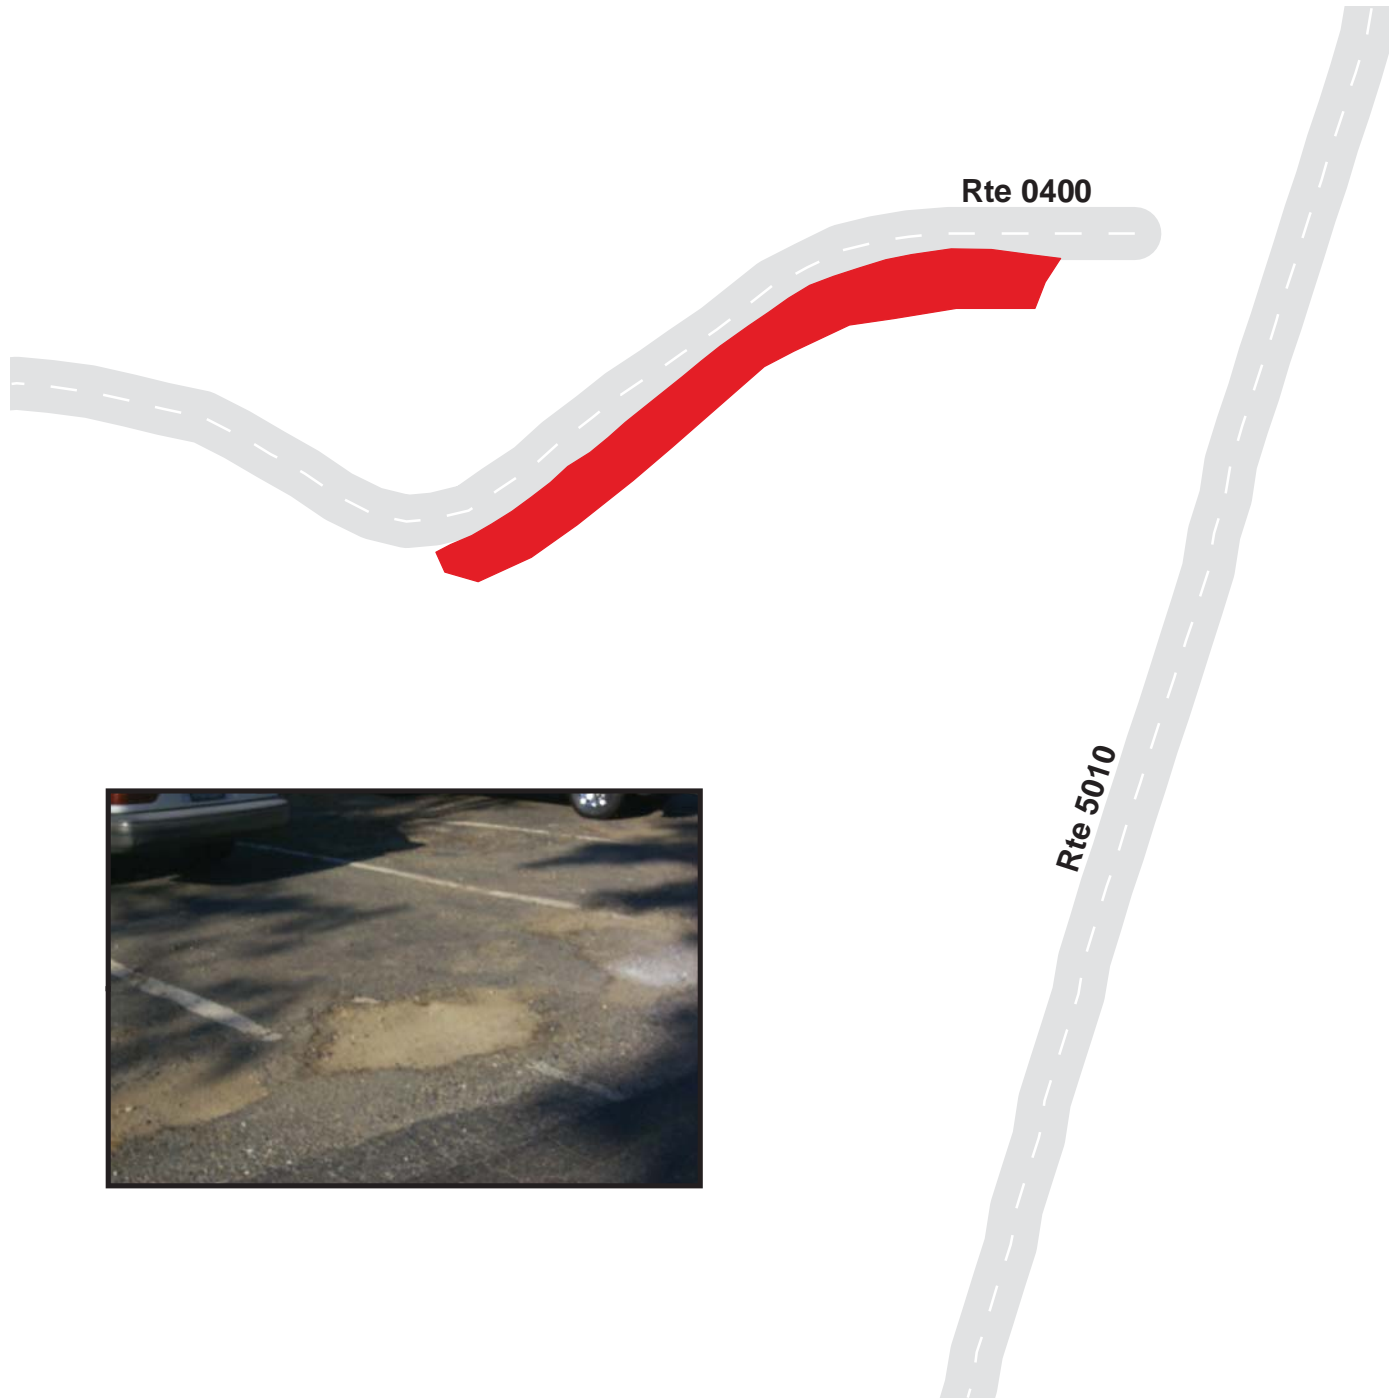
## Route 0902B

Route	Public / NonPublic	Date Visited	Area (sq ft)	Lane Miles *	Surface Type	Condition / PCR
0902A	NonPublic	6/10/2003	6387	0.11	AS	POOR / 45

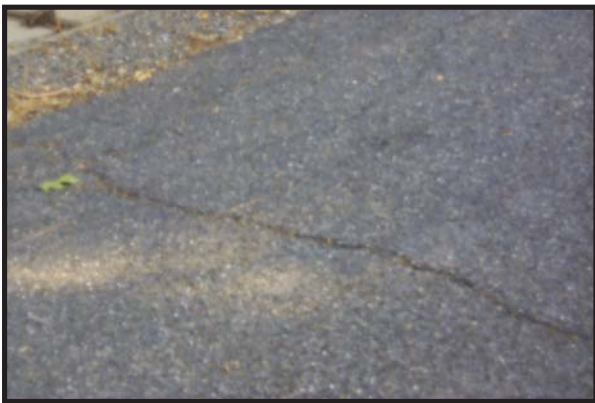
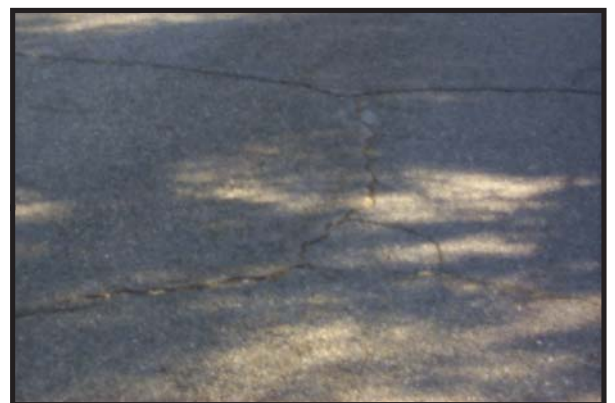
## Route 0905

Route	Public / NonPublic	Date Visited	Area (sq ft)	Lane Miles *	Surface Type	Condition / PCR
0905	NonPublic	6/10/2003	3785	0.07	AS	POOR / 45

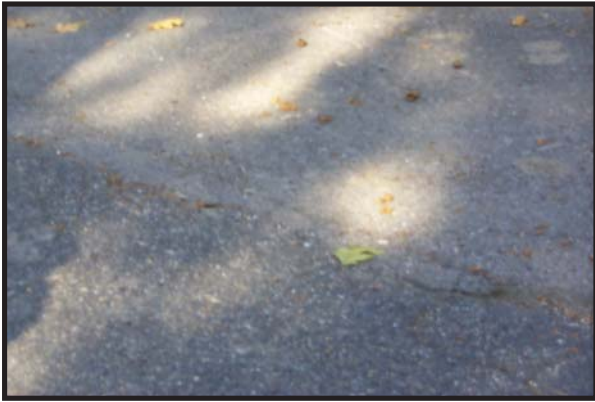
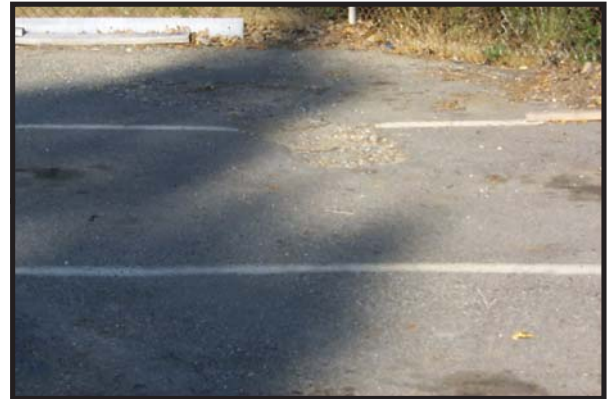
## Route 0907

Route	Public / NonPublic	Date Visited	Area (sq ft)	Lane Miles *	Surface Type	Condition / PCR
0907	NonPublic	6/10/2003	1133	0.02	AS	FAIR / 73

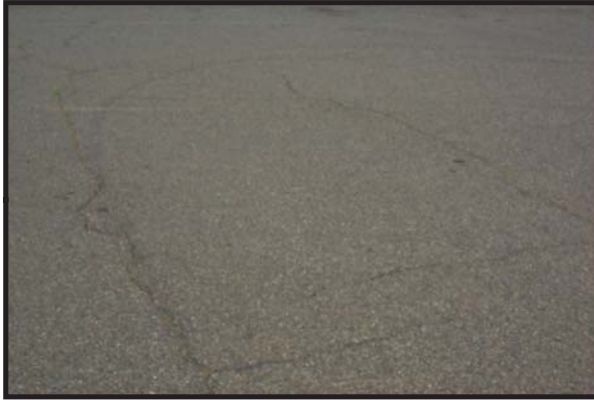
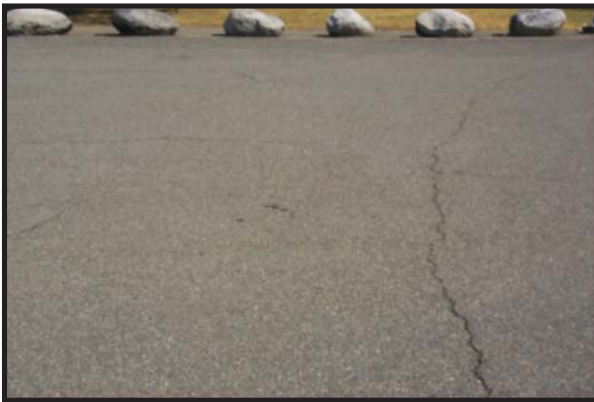
Route	Public / NonPublic	Date Visited	Area (sq ft)	Lane Miles *	Surface Type	Condition / PCR
0911A	Public	6/10/2003	7939	0.14	AS	POOR / 45

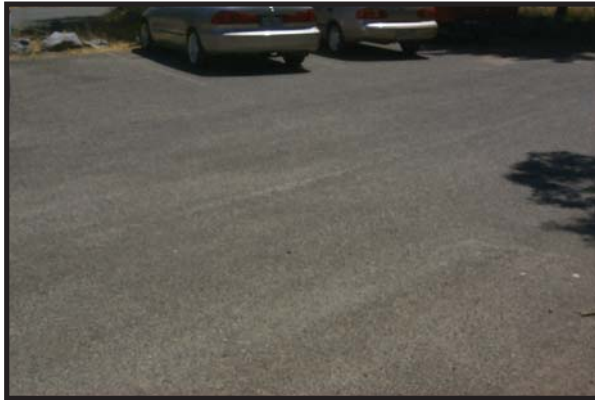
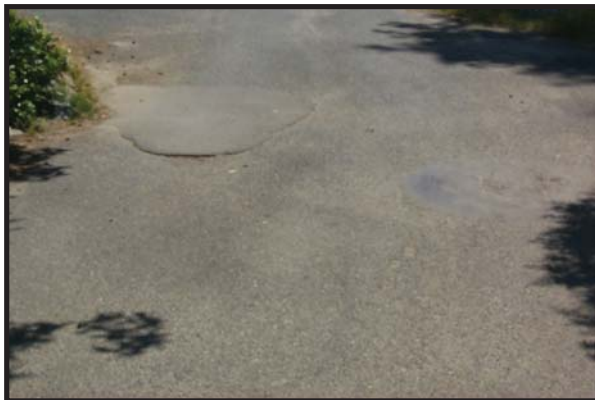
Route	Public / NonPublic	Date Visited	Area (sq ft)	Lane Miles *	Surface Type	Condition / PCR
0914	Public	6/10/2003	13442	0.23	AS	FAIR / 73

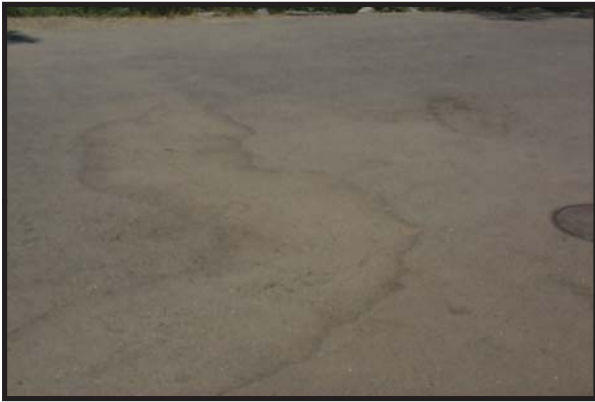
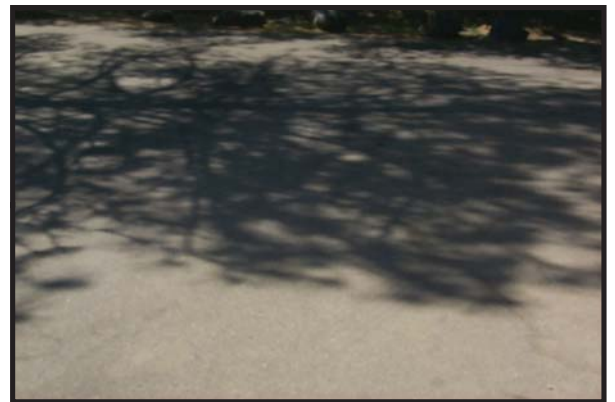
## Route 0915

Route	Public / NonPublic	Date Visited	Area (sq ft)	Lane Miles *	Surface Type	Condition / PCR
0915	Public	6/10/2003	2526	0.04	AS	GOOD / 90

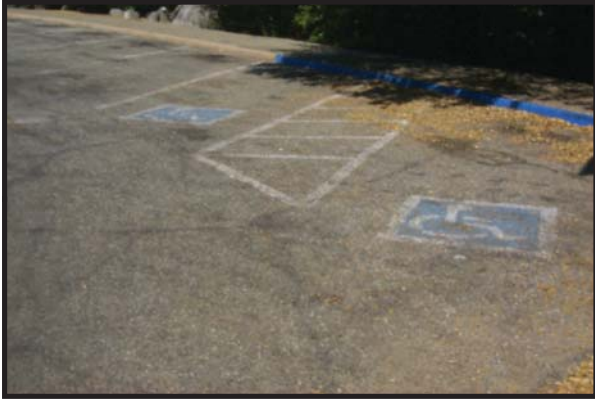
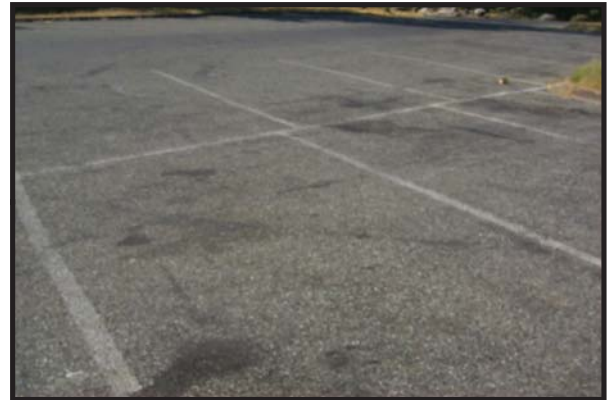
## Route 0919

Route	Public / NonPublic	Date Visited	Area (sq ft)	Lane Miles *	Surface Type	Condition / PCR
0919	Public	6/10/2003	45142	0.78	OC	GOOD / 90

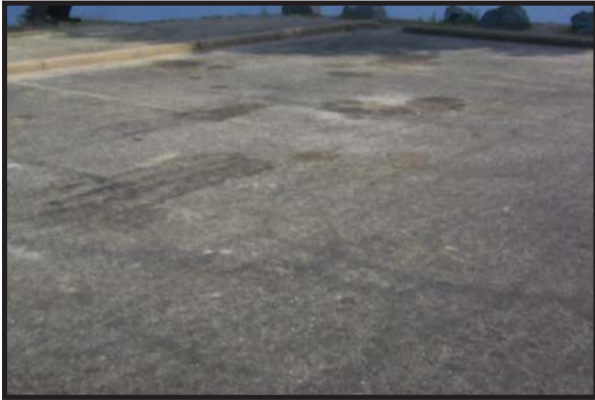
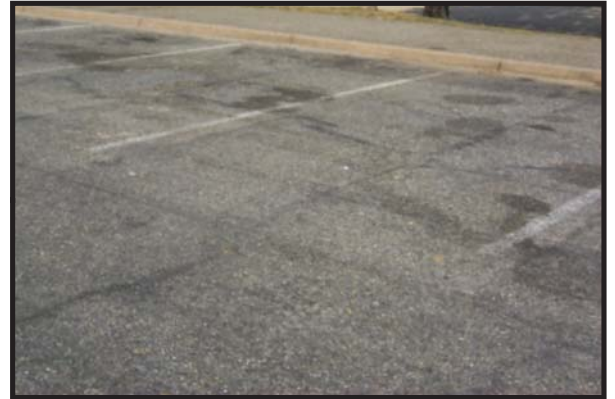
## Route 0920

Route	Public / NonPublic	Date Visited	Area (sq ft)	Lane Miles *	Surface Type	Condition / PCR
0920	Public	6/10/2003	113069	1.95	OC	GOOD / 90

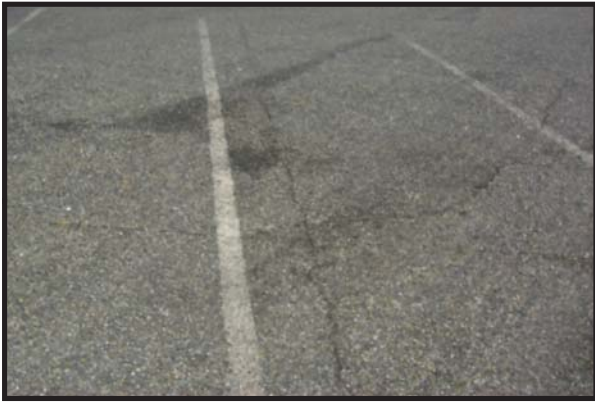
## Route 0922

Route	Public / NonPublic	Date Visited	Area (sq ft)	Lane Miles *	Surface Type	Condition / PCR
0922	Public	6/10/2003	181167	3.12	OC	FAIR / 73

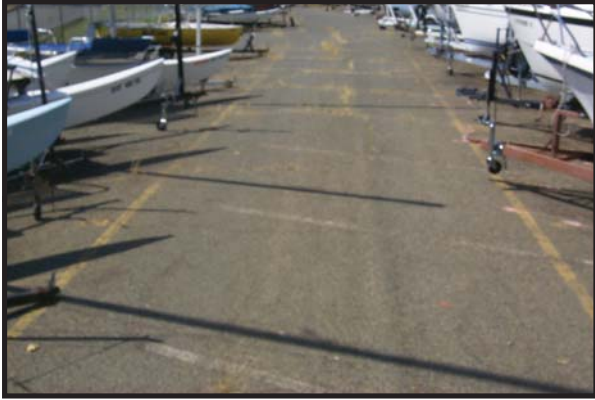
## Route 0923

Route	Public / NonPublic	Date Visited	Area (sq ft)	Lane Miles *	Surface Type	Condition / PCR
0923	NonPublic	6/10/2003	22297	0.38	OC	POOR / 45

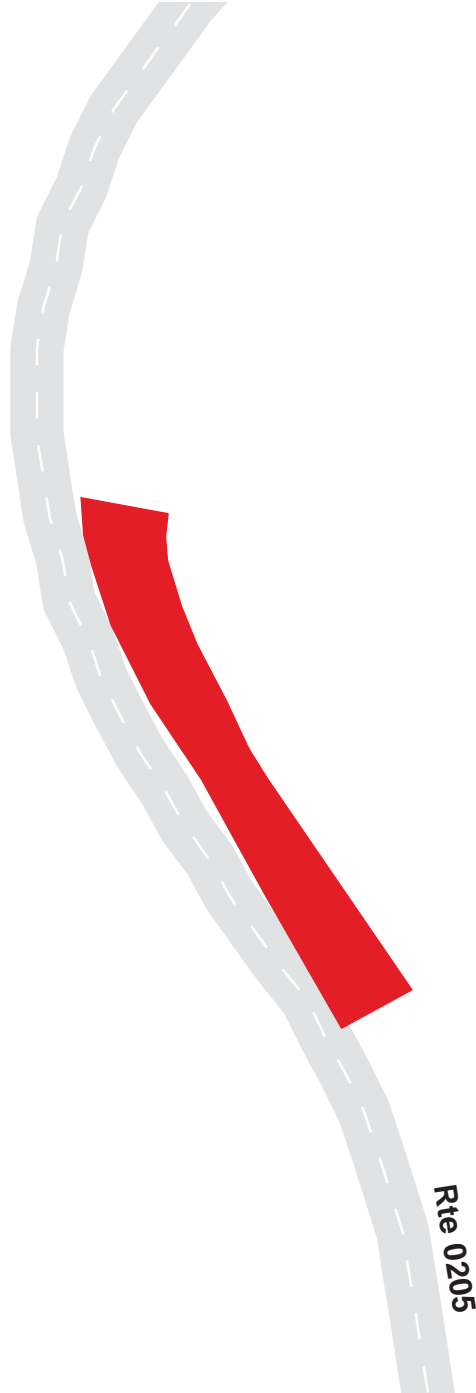
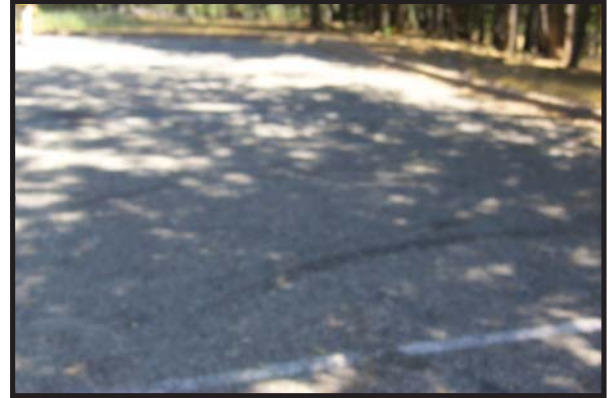
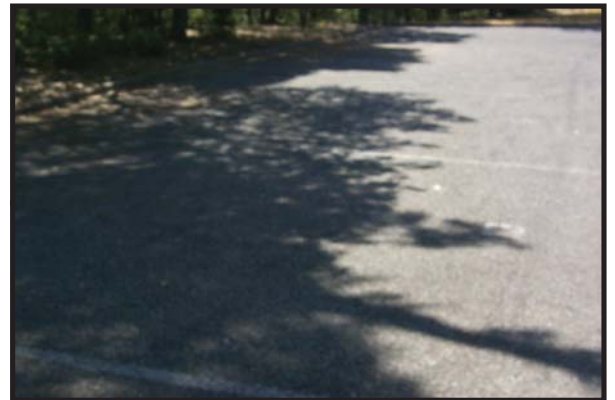
## Route 0924C

Route	Public / NonPublic	Date Visited	Area (sq ft)	Lane Miles *	Surface Type	Condition / PCR
0924C	Public	6/10/2003	2773	0.05	AS	GOOD / 90

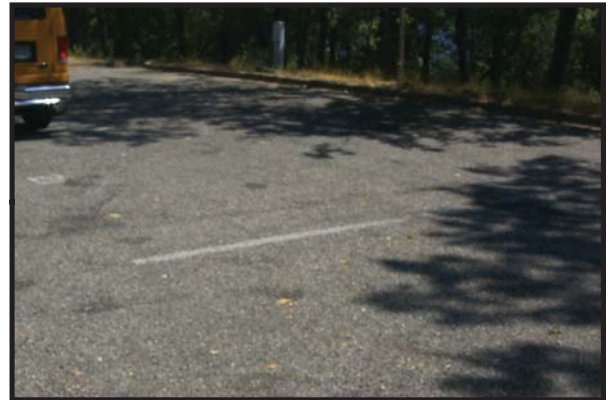
## Route 0924D

Route	Public / NonPublic	Date Visited	Area (sq ft)	Lane Miles *	Surface Type	Condition / PCR
0924D	Public	6/10/2003	4222	0.07	AS	GOOD / 90

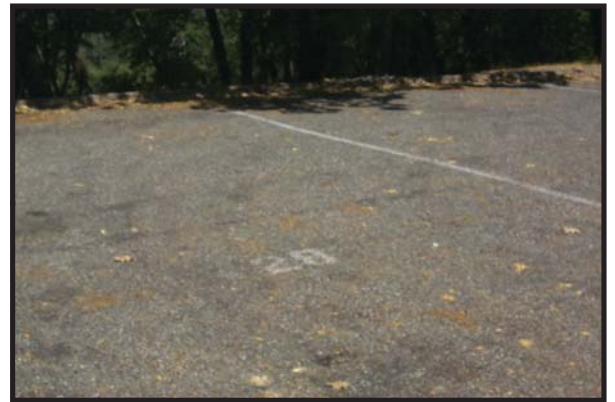
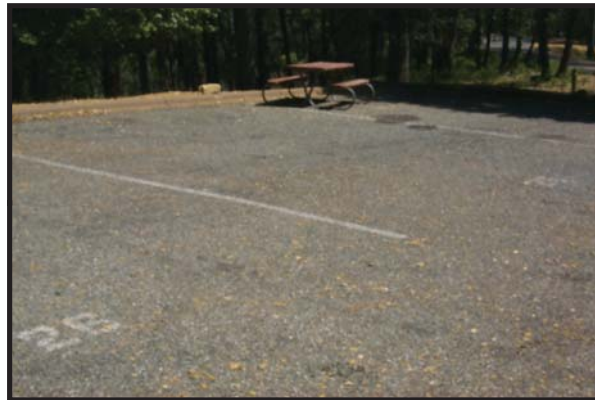
## Route 0924E

Route	Public / NonPublic	Date Visited	Area (sq ft)	Lane Miles *	Surface Type	Condition / PCR
0924E	Public	6/10/2003	4579	0.08	AS	GOOD / 90

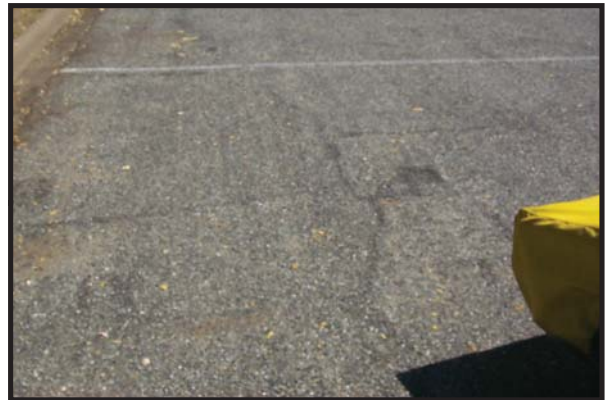
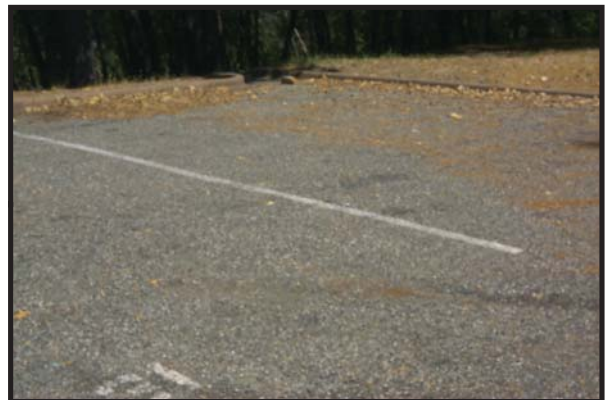
## Route 0925

Route	Public / NonPublic	Date Visited	Area (sq ft)	Lane Miles *	Surface Type	Condition / PCR
0925	Public	6/10/2003	21238	0.37	AS	POOR / 45

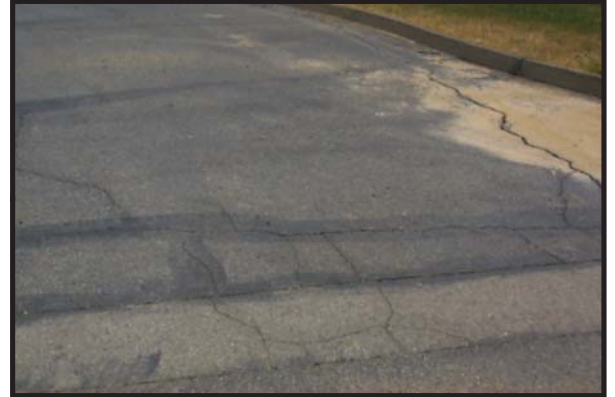
## Route 0928

Route	Public / NonPublic	Date Visited	Area (sq ft)	Lane Miles *	Surface Type	Condition / PCR
0928	Public	6/10/2003	30413	0.52	AS	GOOD / 90

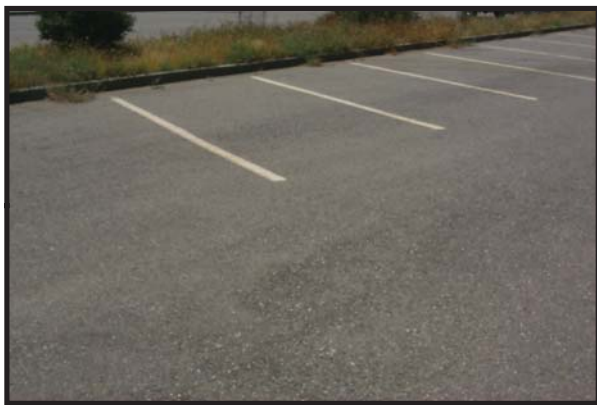
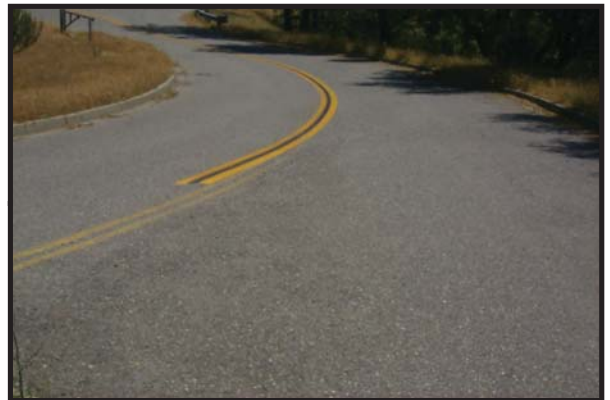
## Route 0930

Route	Public / NonPublic	Date Visited	Area (sq ft)	Lane Miles *	Surface Type	Condition / PCR
0930	Public	6/10/2003	9387	0.16	OC	FAIR / 73

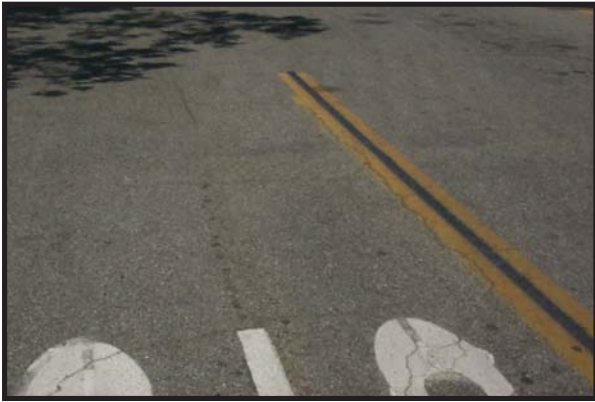
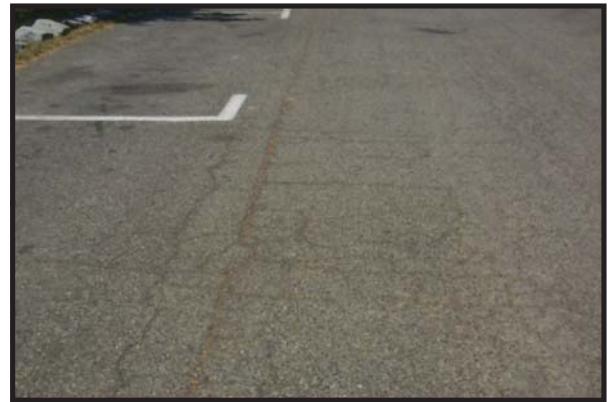
## Route 0931

Route	Public / NonPublic	Date Visited	Area (sq ft)	Lane Miles *	Surface Type	Condition / PCR
0931	Public	6/10/2003	36362	0.63	OC	GOOD / 90

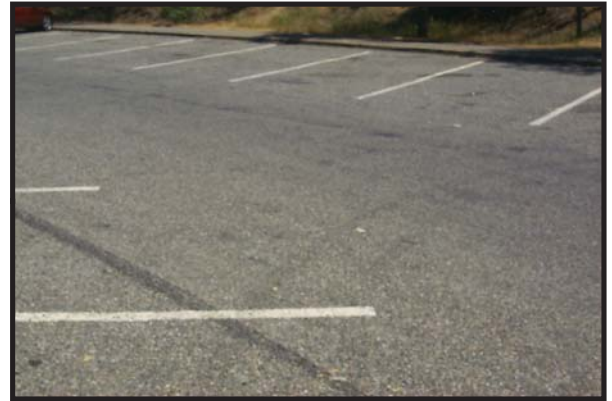
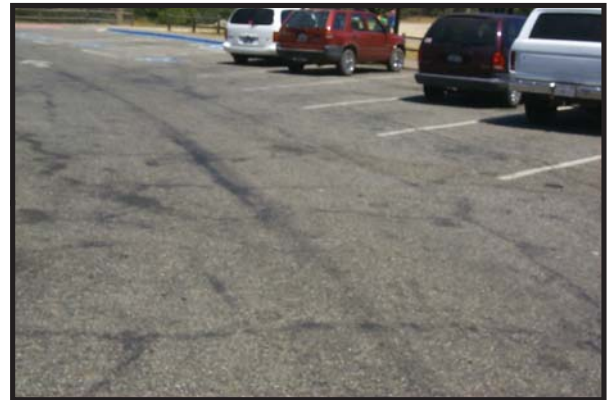
## Route 0932

Route	Public / NonPublic	Date Visited	Area (sq ft)	Lane Miles *	Surface Type	Condition / PCR
0932	Public	6/10/2003	38873	0.67	OC	POOR / 45

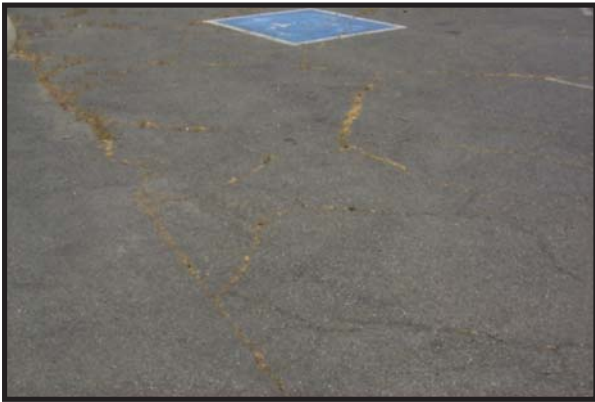
## Route 0933

Route	Public / NonPublic	Date Visited	Area (sq ft)	Lane Miles *	Surface Type	Condition / PCR
0933	Public	6/10/2003	129803	2.23	OC	FAIR / 73

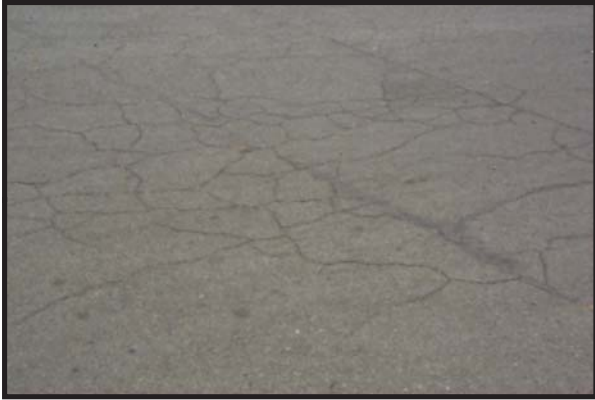
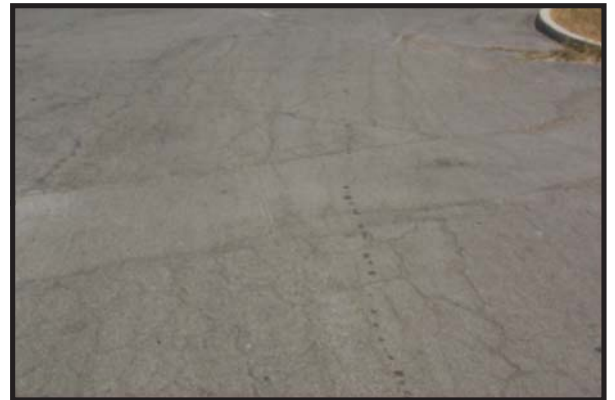
## Route 0934

Route	Public / NonPublic	Date Visited	Area (sq ft)	Lane Miles *	Surface Type	Condition / PCR
0934	Public	6/10/2003	6608	0.11	OC	FAIR / 73

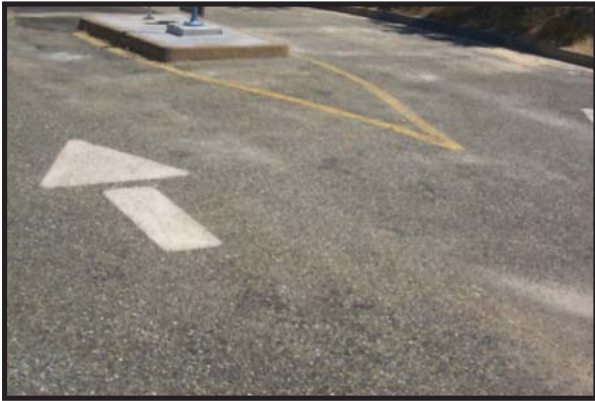
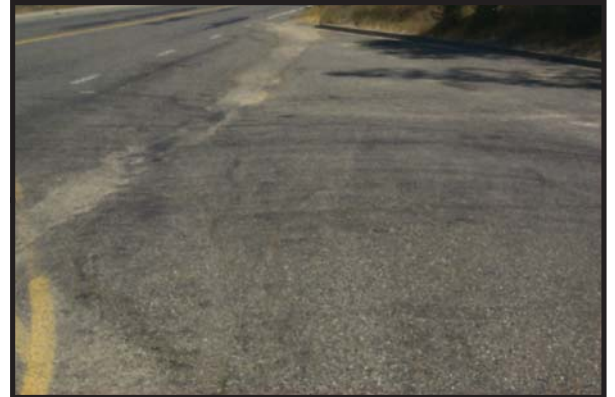
## Route 0935

Route	Public / NonPublic	Date Visited	Area (sq ft)	Lane Miles *	Surface Type	Condition / PCR
0935	Public	6/10/2003	57068	0.98	OC	FAIR / 73

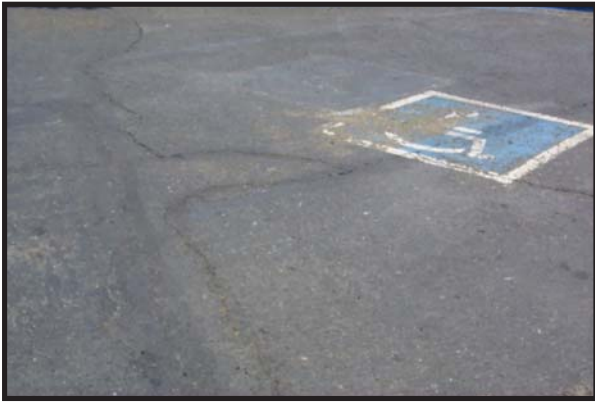
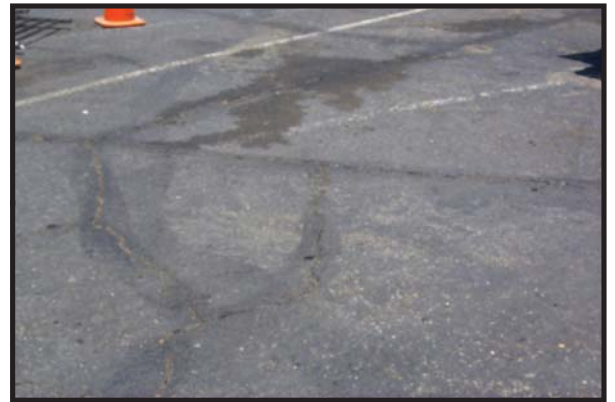
## Route 0936A

Route	Public / NonPublic	Date Visited	Area (sq ft)	Lane Miles *	Surface Type	Condition / PCR
0936A	Public	6/10/2003	1150	0.02	OC	FAIR / 73

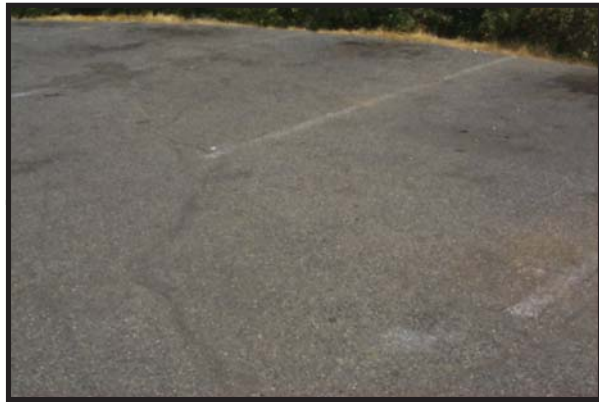
## Route 0936E

Route	Public / NonPublic	Date Visited	Area (sq ft)	Lane Miles *	Surface Type	Condition / PCR
0936E	Public	6/10/2003	3750	0.06	OC	FAIR / 73

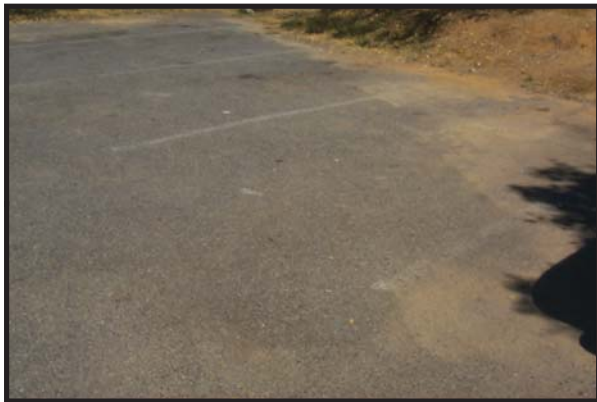
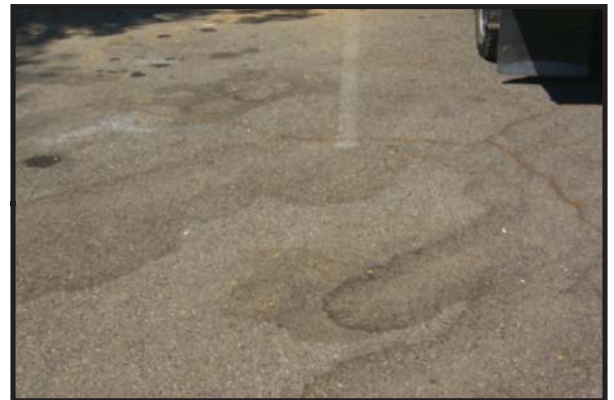
## Route 0936F

Route	Public / NonPublic	Date Visited	Area (sq ft)	Lane Miles *	Surface Type	Condition / PCR
0936F	Public	6/10/2003	2821	0.05	OC	FAIR / 73

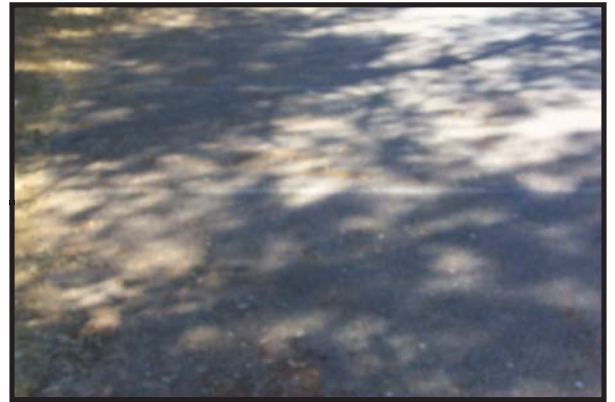
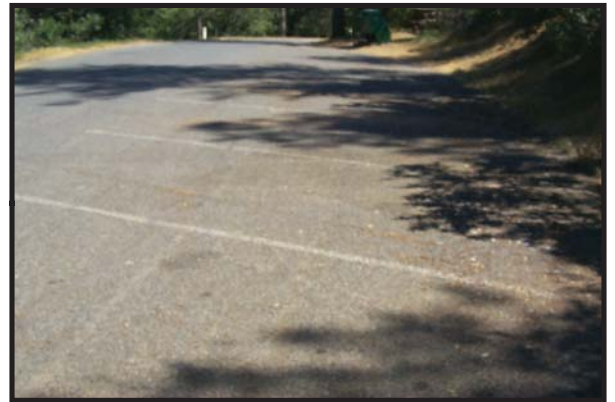
## Route 0937

Route	Public / NonPublic	Date Visited	Area (sq ft)	Lane Miles *	Surface Type	Condition / PCR
0937	Public	6/10/2003	66413	1.14	AS	GOOD / 90

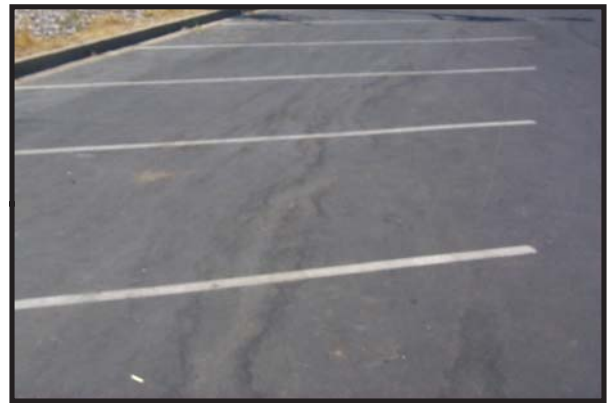
## Route 0940

Route	Public / NonPublic	Date Visited	Area (sq ft)	Lane Miles *	Surface Type	Condition / PCR
0940	NonPublic	6/10/2003	379	0.01	OC	GOOD / 90

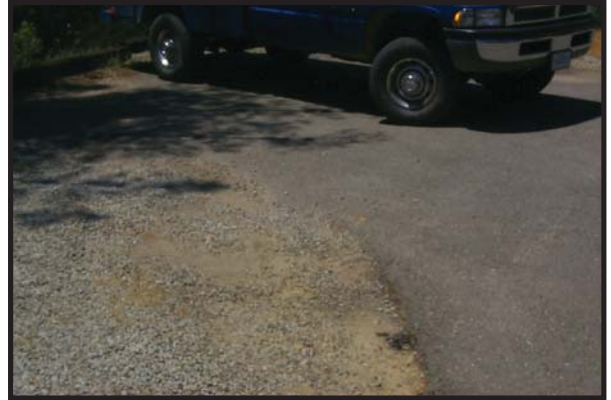
## Route 0941

Route	Public / NonPublic	Date Visited	Area (sq ft)	Lane Miles *	Surface Type	Condition / PCR
0941	NonPublic	6/10/2003	5752	0.10	OC	FAIR / 73

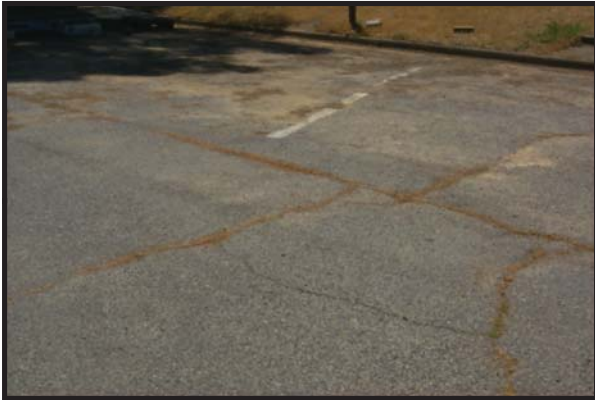
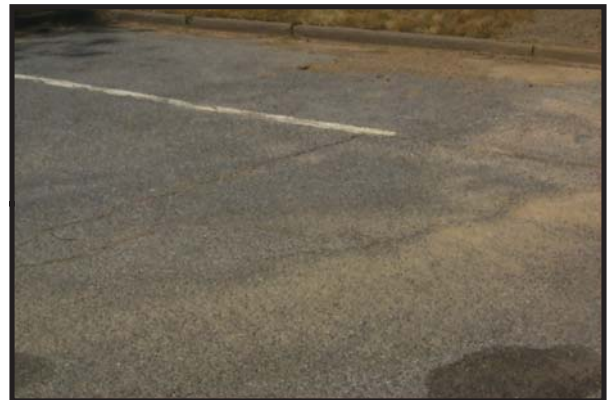
## Route 0942

Route	Public / NonPublic	Date Visited	Area (sq ft)	Lane Miles *	Surface Type	Condition / PCR
0942	NonPublic	6/10/2003	3867	0.07	OC	POOR / 45
