The Road Inventory of Whitman Mission National Historic Site WHMI - 9550

Prepared By:
Federal Highway Administration
Eastern Federal Lands Highway Division
Cycle 3

Whitman Mission National Historic Site in Washington

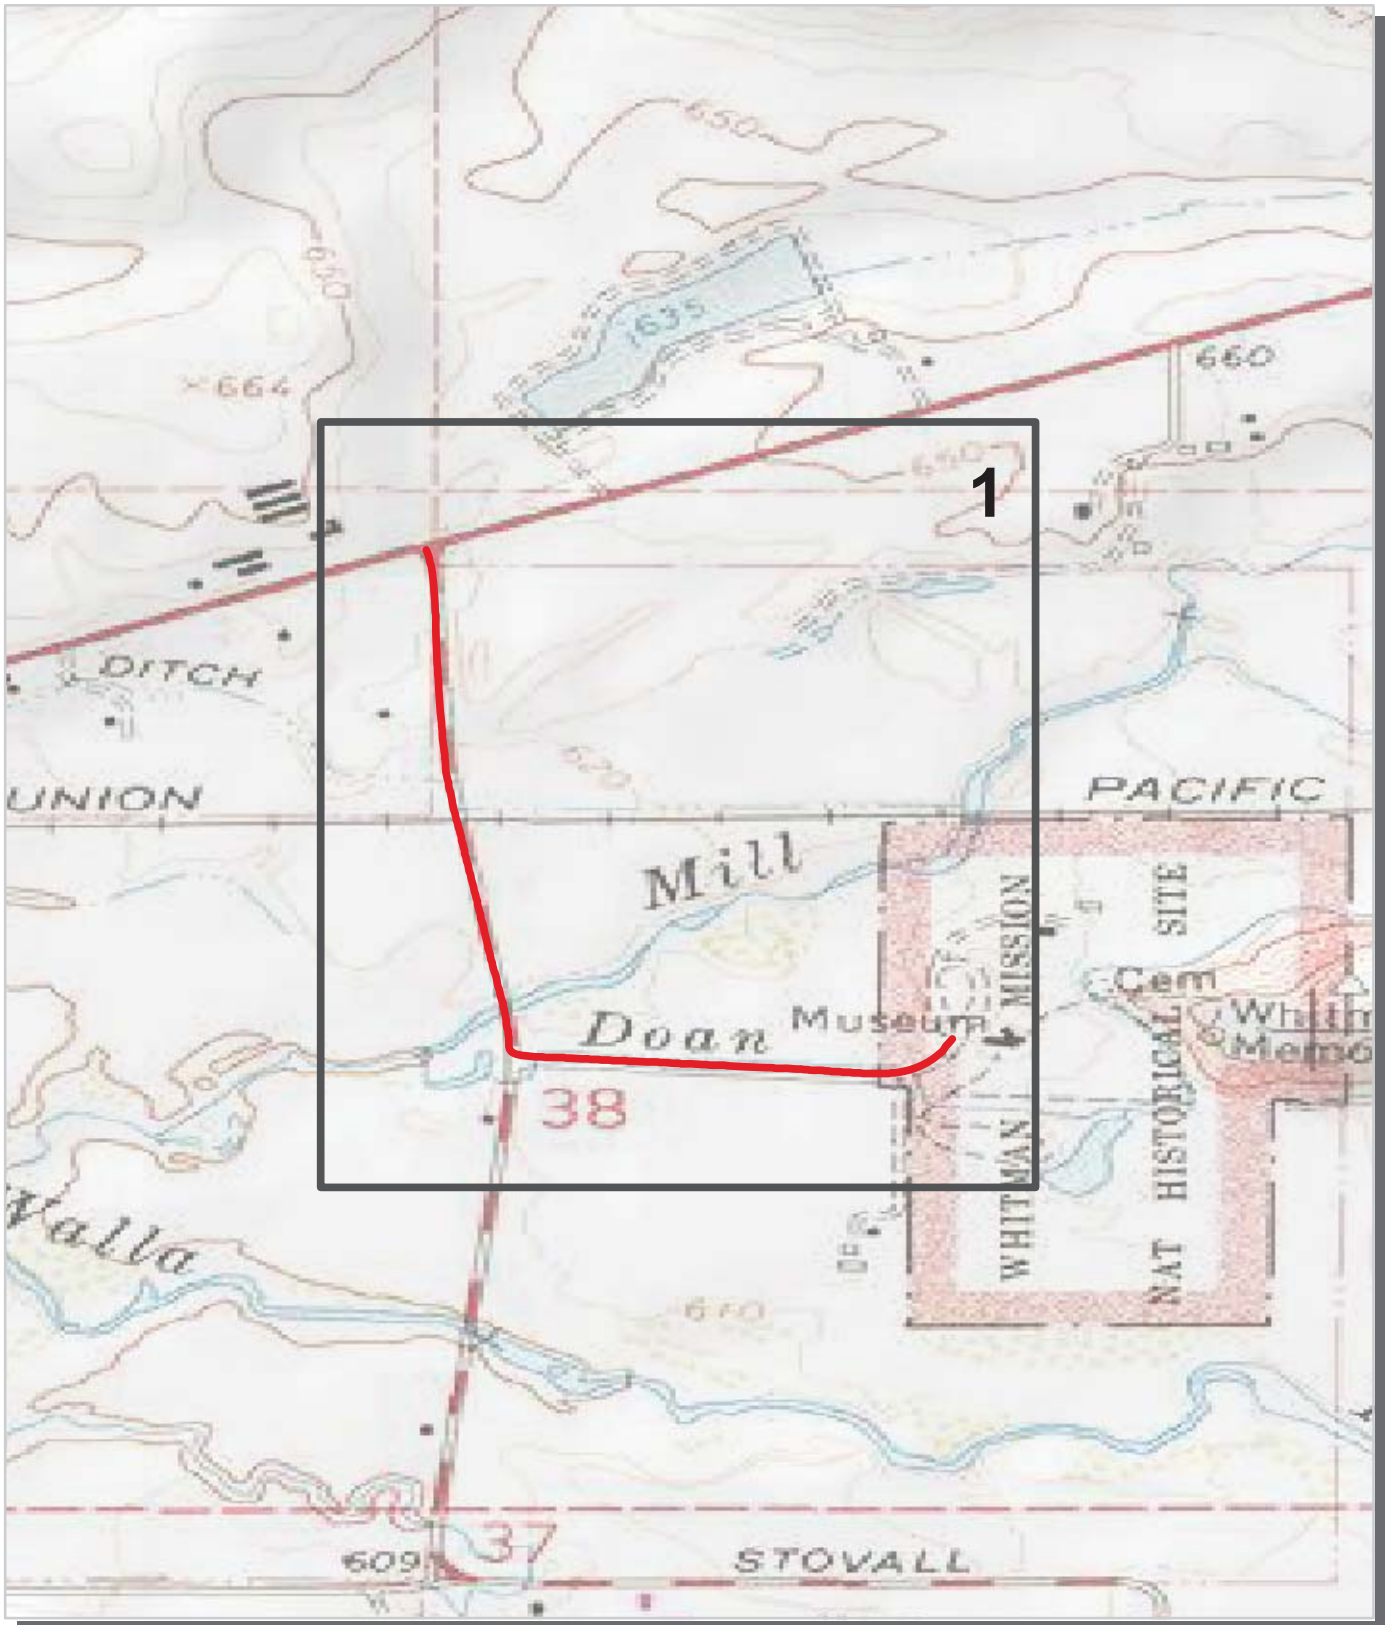
Whitman Mission National Historic Site Route Location Key Map

Park Owned Routes

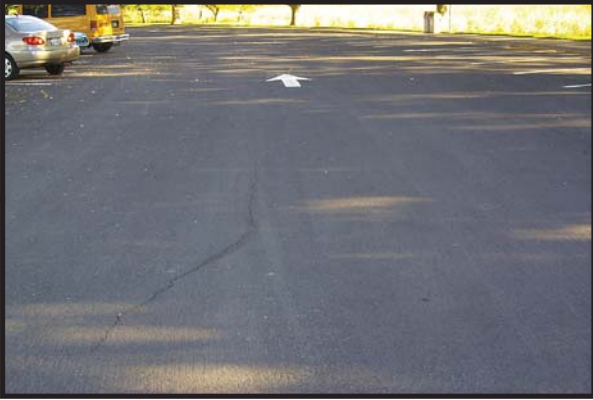
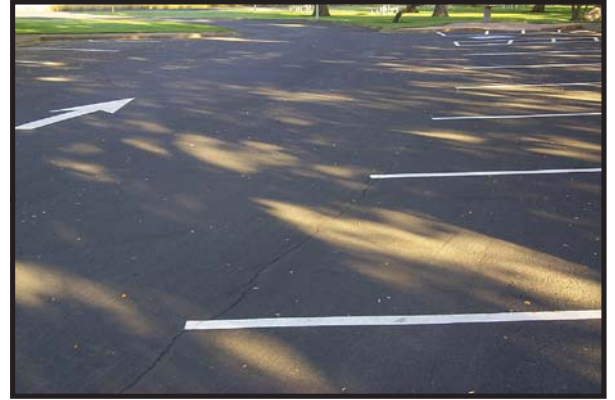
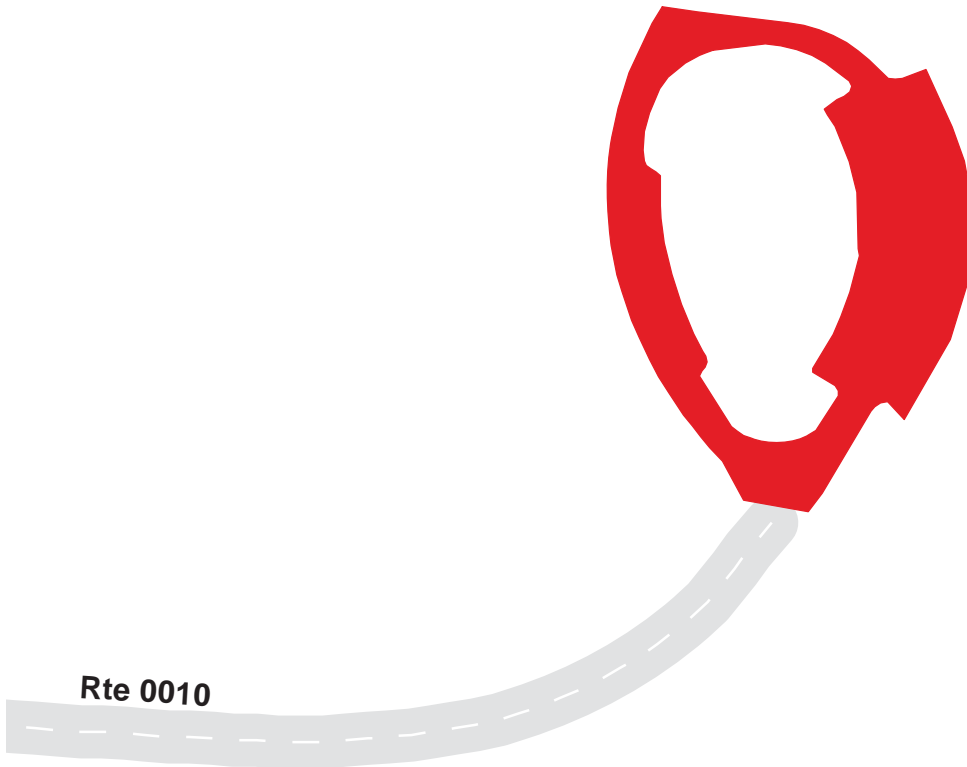
Route	Public / NonPublic	Date Visited	Area (sq ft)	Lane Miles *	Surface Type	Condition / PCR
0900	Public	10/7/2002	33678	0.58	AS	GOOD / 90

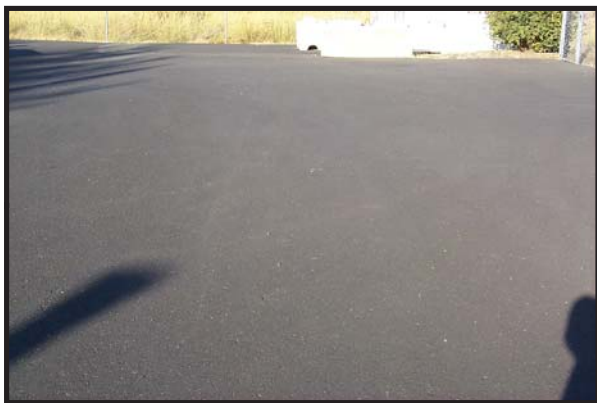
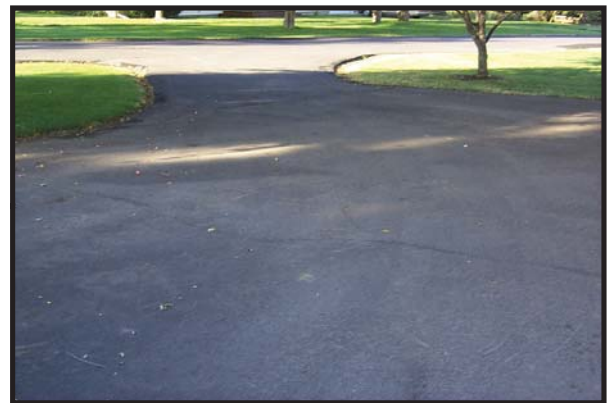
Route 0901

Route	Public / NonPublic	Date Visited	Area (sq ft)	Lane Miles *	Surface Type	Condition / PCR
0901	NonPublic	10/7/2002	29881	0.51	AS	GOOD / 90
