# The Road Inventory of White Sands National Monument WNSA - 7810

## Road Inventory Program

Prepared By:  
Federal Highway Administration  
Eastern Federal Lands Highway Division  
Cycle 3

# White Sands National Monument in New Mexico

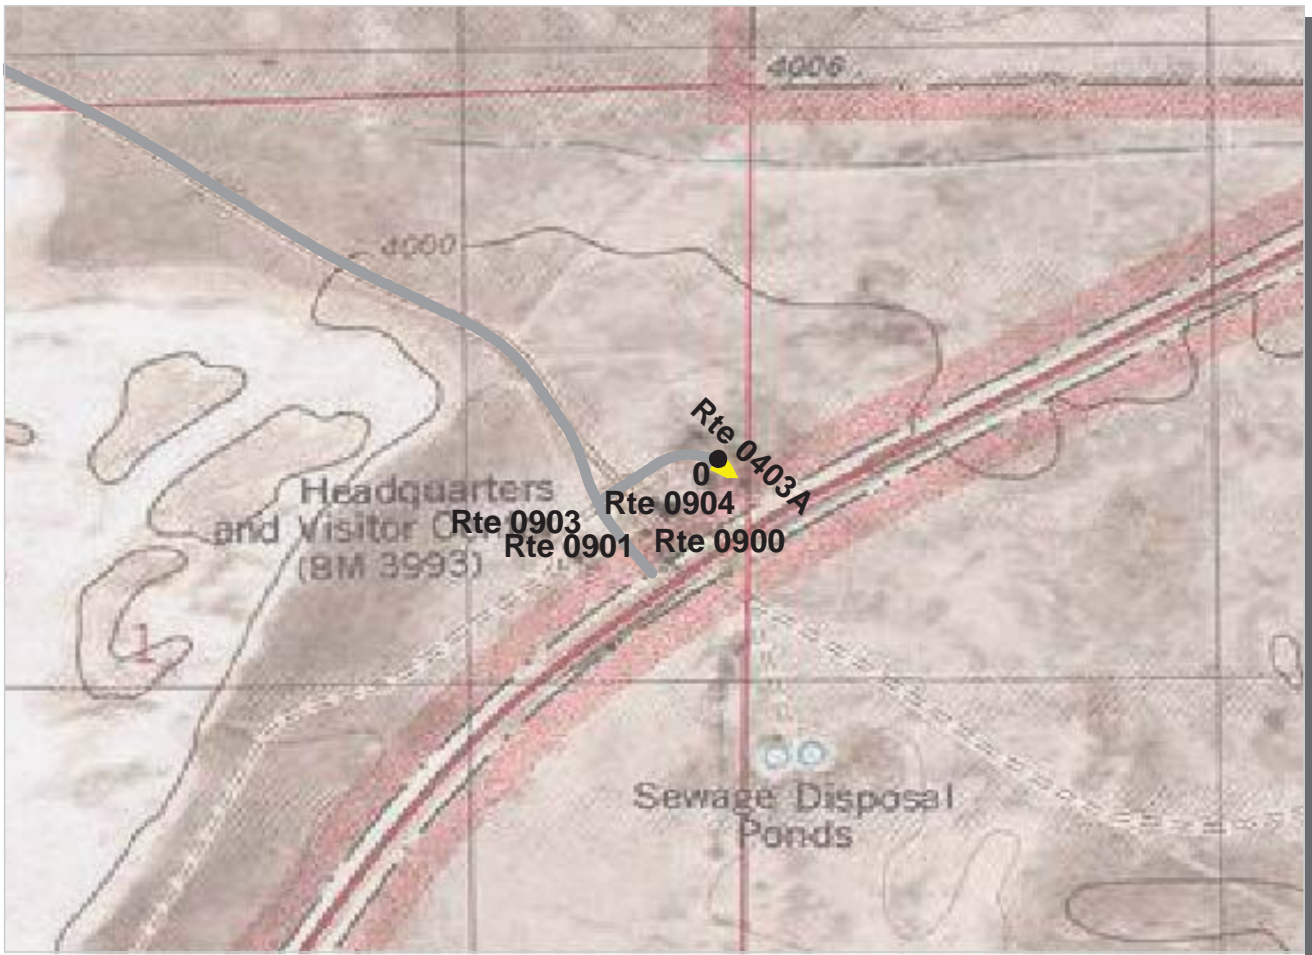
**ROUTE: 0403A RESIDENCE AREA ROAD LOOP** **TOTAL LENGTH: 0.06 Miles**

Section Number	0				
Section Length (mi)	0.06				
AADT	**				
SADT	**				
ADT Date	**				
<b>Cross Section Information</b>					
Number of Lanes	1				
Paved Width (ft)	13				
Lane Width (ft)	13				
Shoulder Width (ft)	0				
<b>Roadway Condition Information</b>					
PCR (Pavement Condition Rating)	54				
RCI (Roughness Condition Index)	NC				
SCR (Surface Condition Rating)	54				
Alligator Cracking Index	100				
Rutting Index	59				
Patching Index	100				
Transverse Cracking Index	95				
Longitudinal Cracking Index	100				
Shoulder Condition Rating	N/A				
Drainage Condition Rating	GOOD

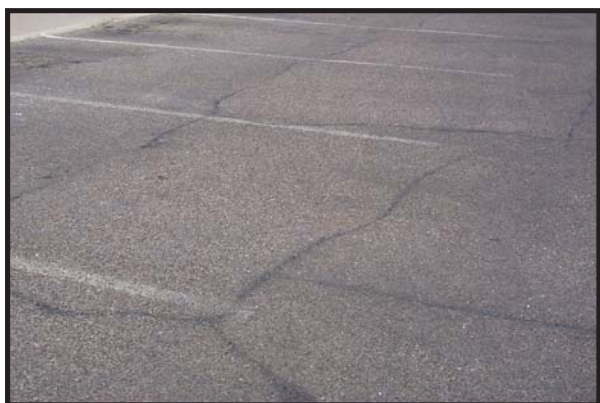
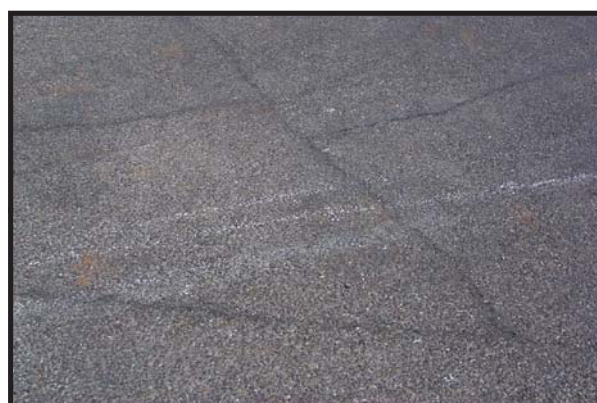
Route	Public / NonPublic	Date Visited	Area (sq ft)	Lane Miles *	Surface Type	Condition / PCR
0900	Public	3/5/2003	32639	0.56	NC	GOOD / 90

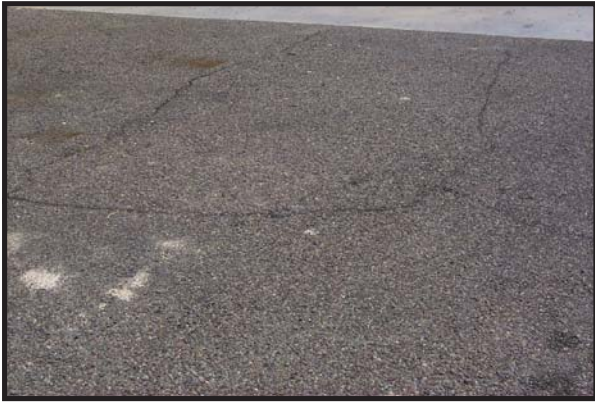
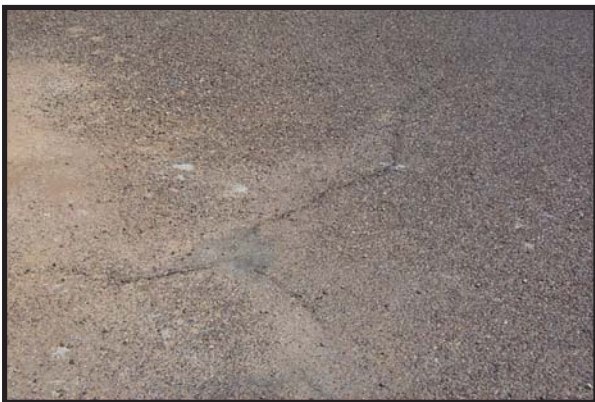
## Route 0901

Route	Public / NonPublic	Date Visited	Area (sq ft)	Lane Miles *	Surface Type	Condition / PCR
0901	NonPublic	3/5/2003	14335	0.25	NC	FAIR / 73

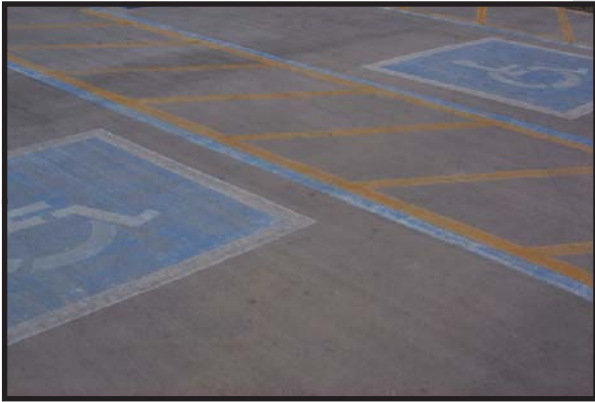
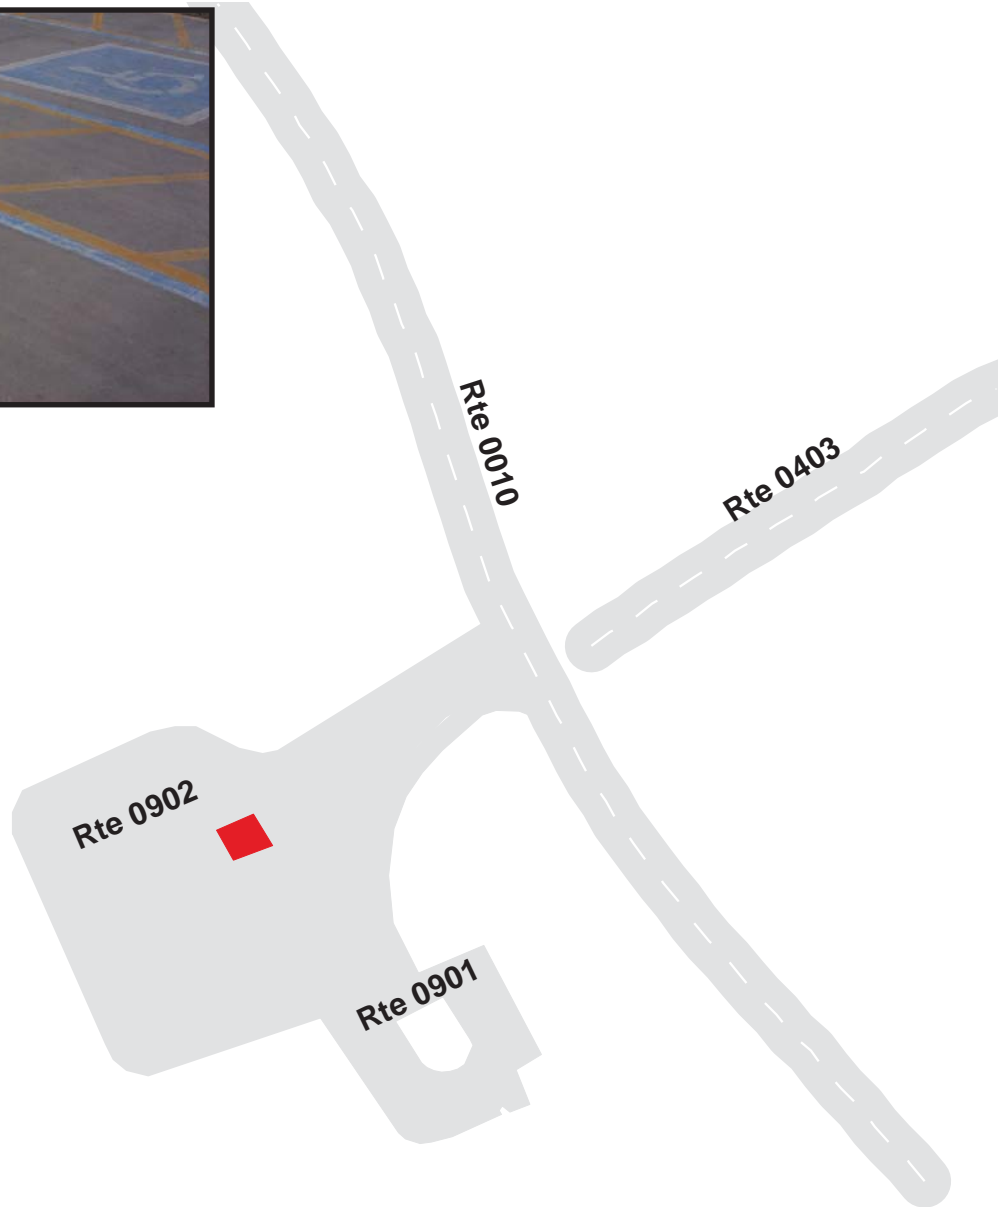
## Route 0903

Route	Public / NonPublic	Date Visited	Area (sq ft)	Lane Miles *	Surface Type	Condition / PCR
0903	NonPublic	3/5/2003	650	0.01	CO	GOOD / 90

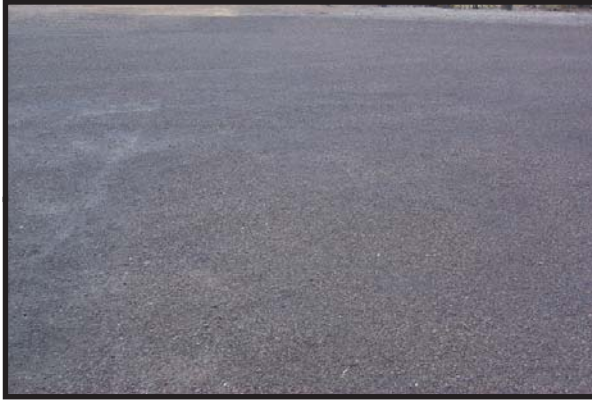
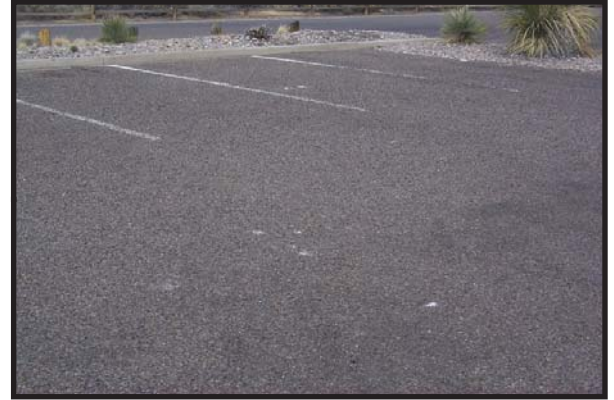
**White Sands National Monument**  
**Route 0904**  
 GIFT SHOP AND REFRESHMENTS PARKING  
 From Route 0403

Route	Public / NonPublic	Date Visited	Area (sq ft)	Lane Miles *	Surface Type	Condition / PCR
0904	Public	3/5/2003	15753	0.27	NC	FAIR / 73

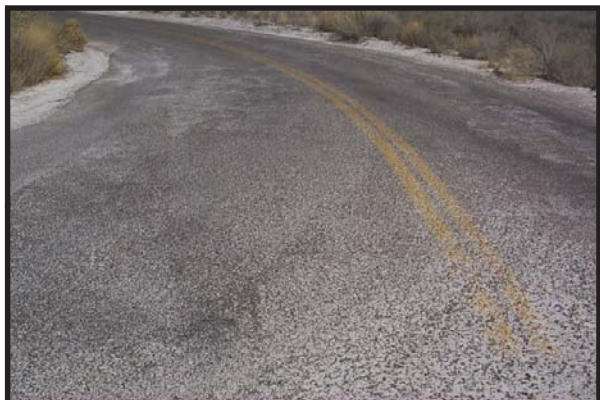
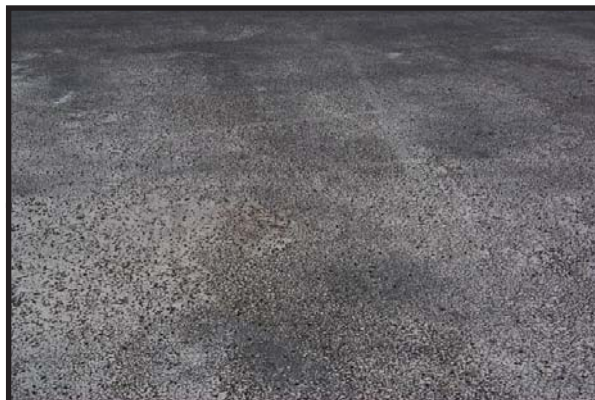
## Route 0906

Route	Public / NonPublic	Date Visited	Area (sq ft)	Lane Miles *	Surface Type	Condition / PCR
0906	Public	3/5/2003	14706	0.25	NC	G / -1
