The Road Inventory of Wind Cave National Park WICA - 1560

Prepared By:
Federal Highway Administration
Eastern Federal Lands Highway Division
Cycle 3

Wind Cave National Park in South Dakota

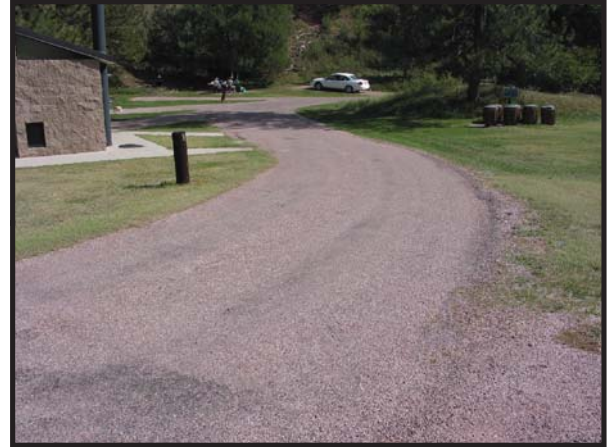
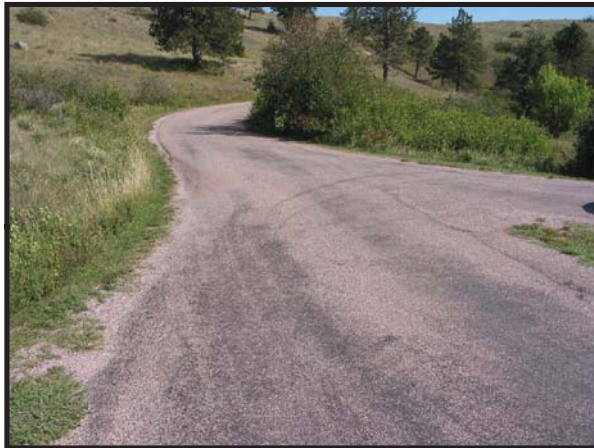
Route	Length (mi)	Width (ft)	Area (sq ft)	Lane Miles *	Condition / PCR	Surface Type
0206A	0.24	12.00	15333	0.26	GOOD / 90	OC

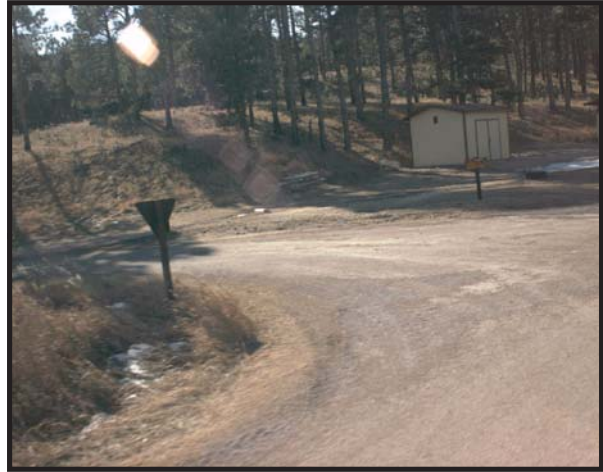
Route	Length (mi)	Width (ft)	Area (sq ft)	Lane Miles *	Condition / PCR	Surface Type
0206B	0.10	12.00	6146	0.11	GOOD / 90	OC

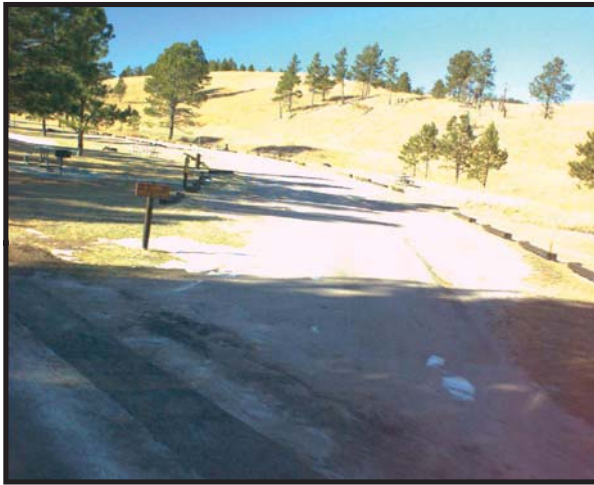
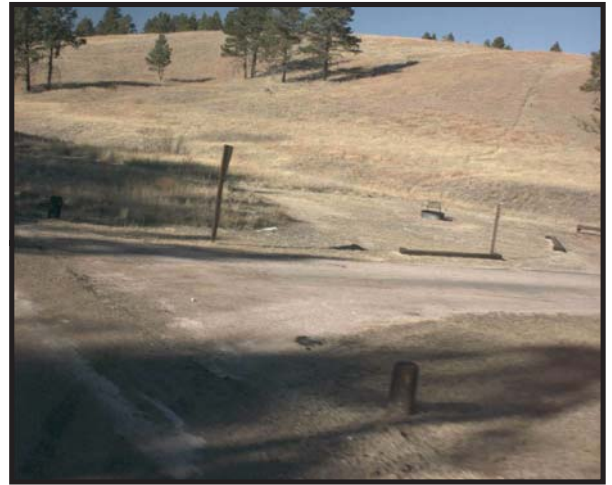
Route	Length (mi)	Width (ft)	Area (sq ft)	Lane Miles *	Condition / PCR	Surface Type
0206C	0.13	12.00	8173	0.14	GOOD / 90	OC

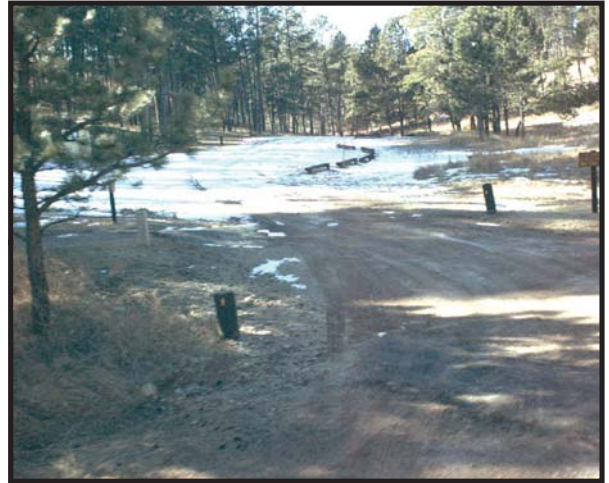
Route	Length (mi)	Width (ft)	Area (sq ft)	Lane Miles *	Condition / PCR	Surface Type
0206D	0.17	12.00	10898	0.19	GOOD / 90	OC

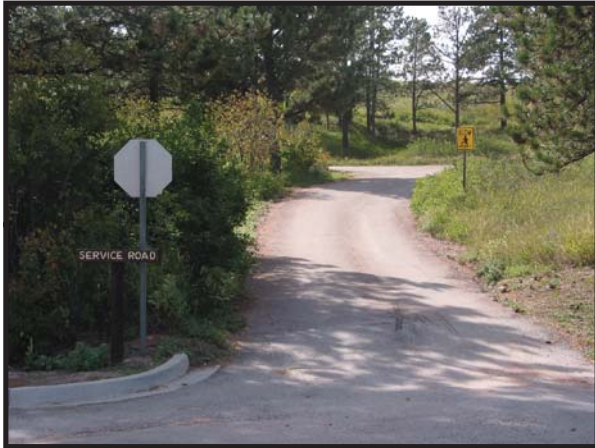
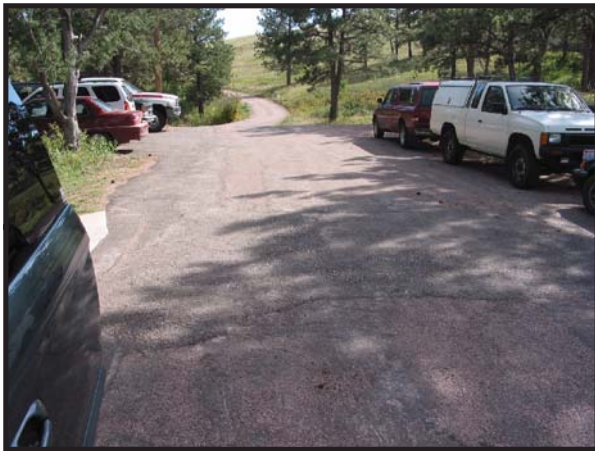
Route 0900A

Route	Public / NonPublic	Date Visited	Area (sq ft)	Lane Miles *	Surface Type	Condition / PCR
0900A	Public	9/16/2002	17800	0.31	AS	FAIR / 73

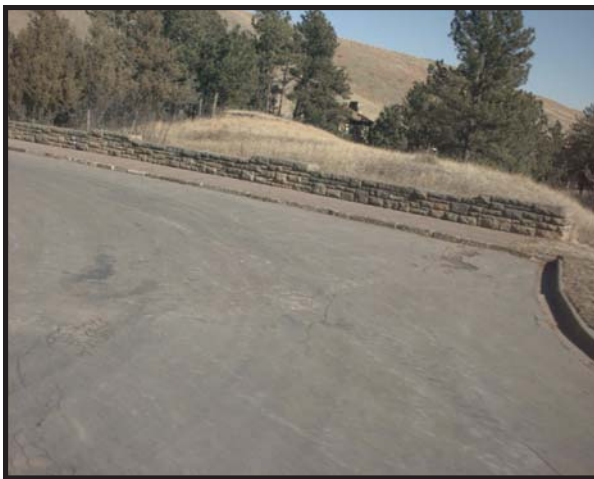
Route 0900B

Route	Public / NonPublic	Date Visited	Area (sq ft)	Lane Miles *	Surface Type	Condition / PCR
0900B	Public	9/16/2002	40816	0.70	AS	FAIR / 73

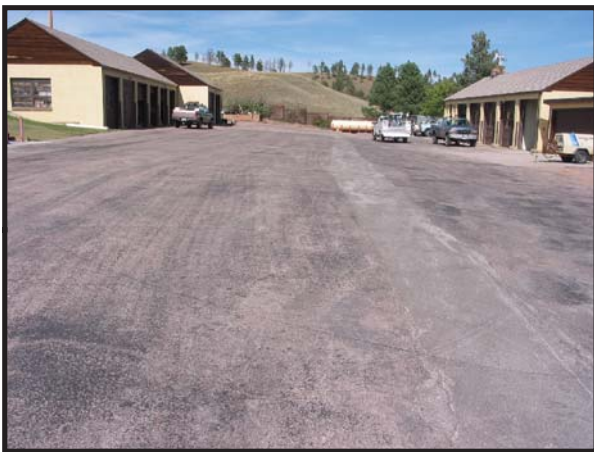
Route 0902A

Route	Public / NonPublic	Date Visited	Area (sq ft)	Lane Miles *	Surface Type	Condition / PCR
0902A	Public	9/16/2002	9894	0.17	OC	FAIR / 73

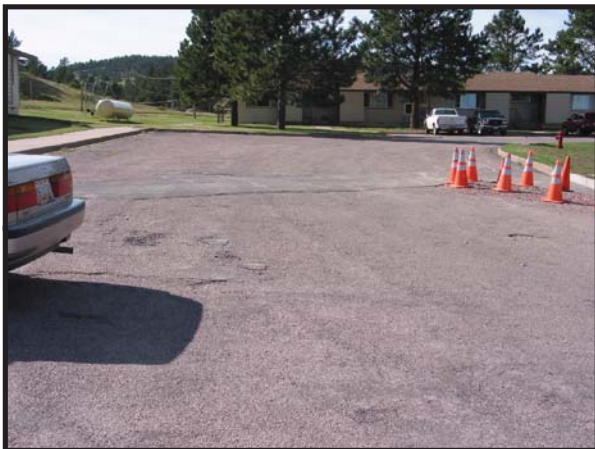
Route 0902B

Route	Public / NonPublic	Date Visited	Area (sq ft)	Lane Miles *	Surface Type	Condition / PCR
0902B	Public	9/16/2002	2186	0.04	OC	FAIR / 73

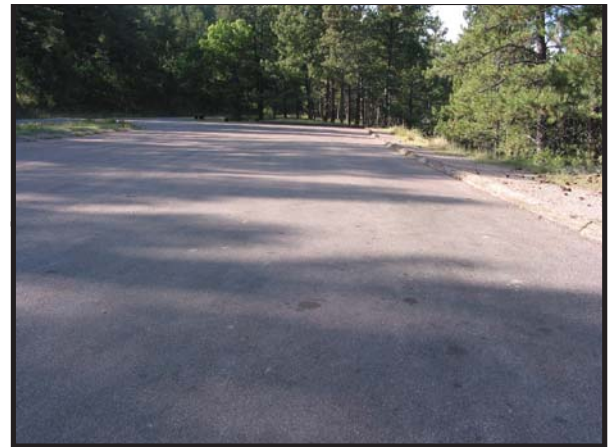
Route 0905D

Route	Public / NonPublic	Date Visited	Area (sq ft)	Lane Miles *	Surface Type	Condition / PCR
0905D	Public	9/16/2002	4154	0.07	AS	GOOD / 90

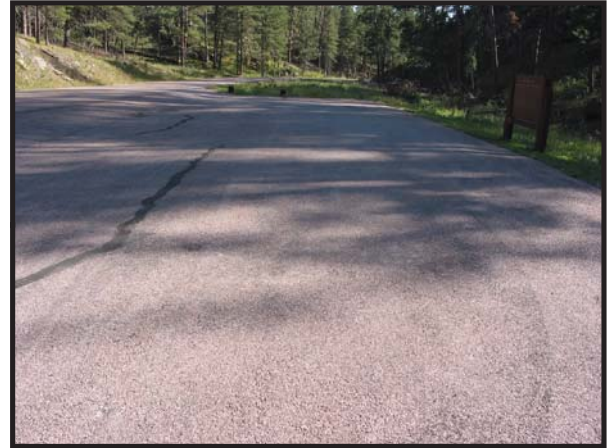
Route 0905E

Route	Public / NonPublic	Date Visited	Area (sq ft)	Lane Miles *	Surface Type	Condition / PCR
0905E	Public	9/16/2002	4412	0.08	AS	FAIR / 73

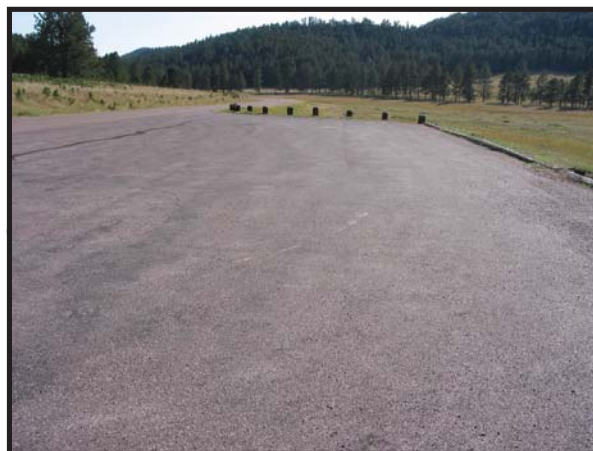
Route 0905F

Route	Public / NonPublic	Date Visited	Area (sq ft)	Lane Miles *	Surface Type	Condition / PCR
0905F	Public	9/16/2002	4067	0.07	AS	FAIR / 73

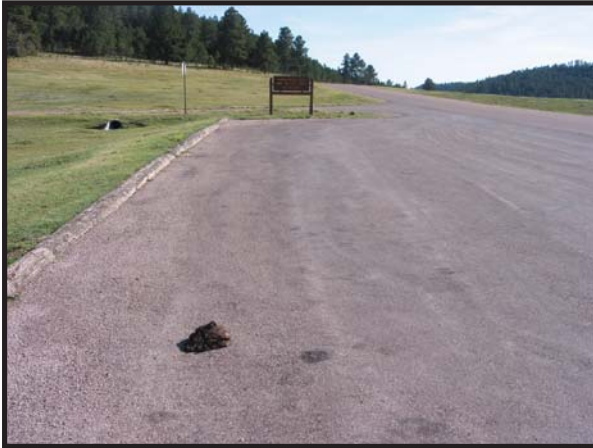
Route 0905G

Route	Public / NonPublic	Date Visited	Area (sq ft)	Lane Miles *	Surface Type	Condition / PCR
0905G	Public	9/16/2002	6984	0.12	OC	GOOD / 90

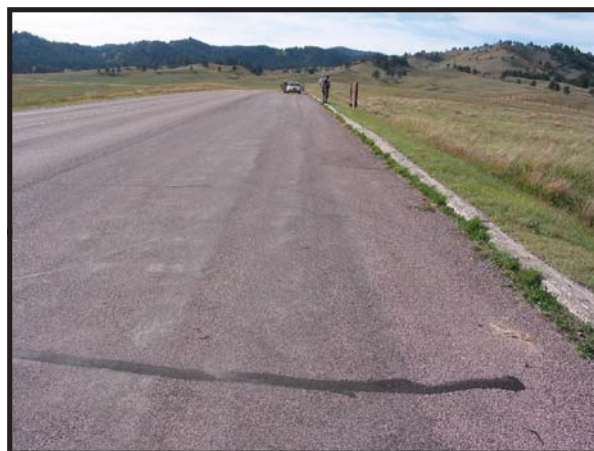
Route 0906

Route	Public / NonPublic	Date Visited	Area (sq ft)	Lane Miles *	Surface Type	Condition / PCR
0906	Public	9/16/2002	5539	0.10	OC	FAIR / 73

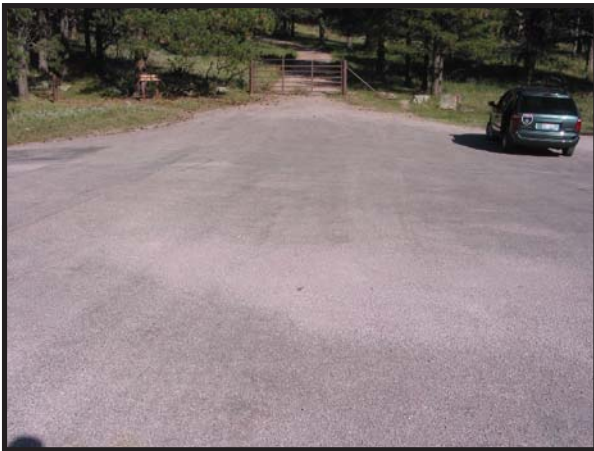
Route 0907A

Route	Public / NonPublic	Date Visited	Area (sq ft)	Lane Miles *	Surface Type	Condition / PCR
0907A	Public	9/16/2002	2371	0.04	OC	FAIR / 73

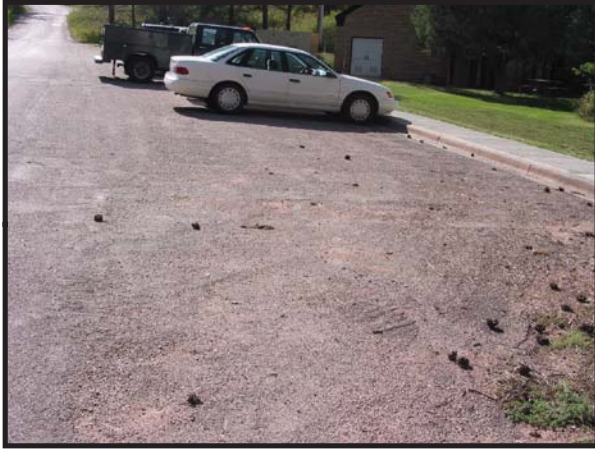
Route	Public / NonPublic	Date Visited	Area (sq ft)	Lane Miles *	Surface Type	Condition / PCR
0907B	Public	9/16/2002	552	0.01	OC	FAIR / 73

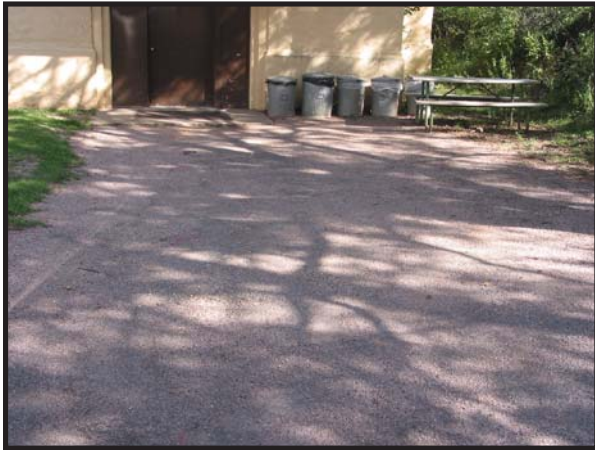
Route 0908

Route	Public / NonPublic	Date Visited	Area (sq ft)	Lane Miles *	Surface Type	Condition / PCR
0908	Public	9/16/2002	15989	0.28	OC	FAIR / 73
